# **ASOR Cultural Heritage Initiatives (CHI): Safeguarding the Heritage of the Near East Initiative**

## **Special Report: Current Status of the Tell Ain Dara Temple<sup>1</sup>**

S-IZ-100-17-CA021

Initial Release: March 2, 2018

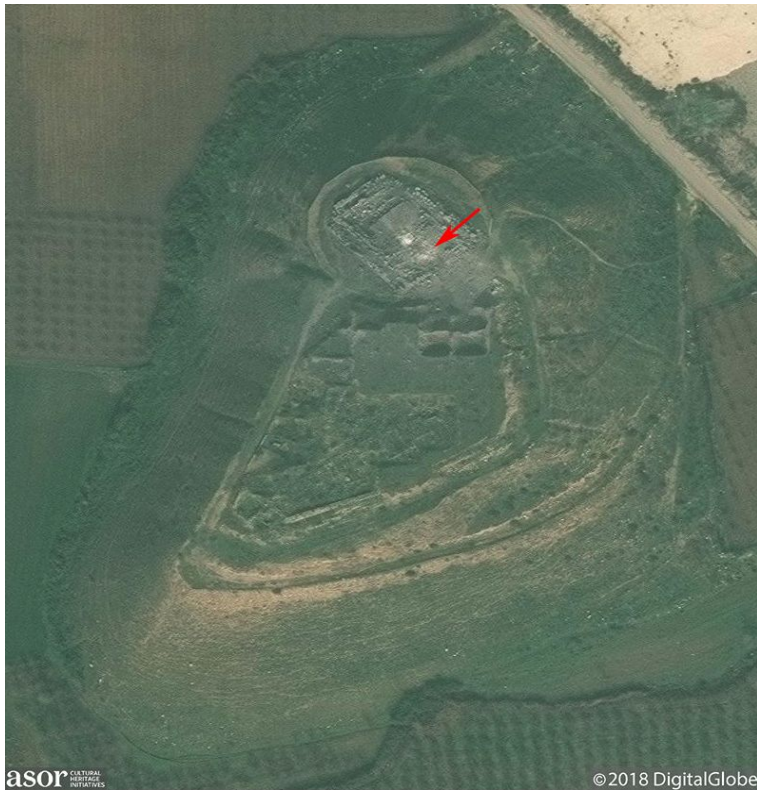
Location of the attack within the Tell Ain Dara temple, indicated by the red arrow (DigitalGlobe NextView License; January 22, 2018)

ASOR CHI analysis of DigitalGlobe imagery confirms that an attack on the Ain Dara temple occurred on or before January 22, 2018 and that no additional damage to the site occurred in the following days. This correlates with the report in NOS, which was published the following day. The damage to the temple is the only identifiable combat damage at the site.

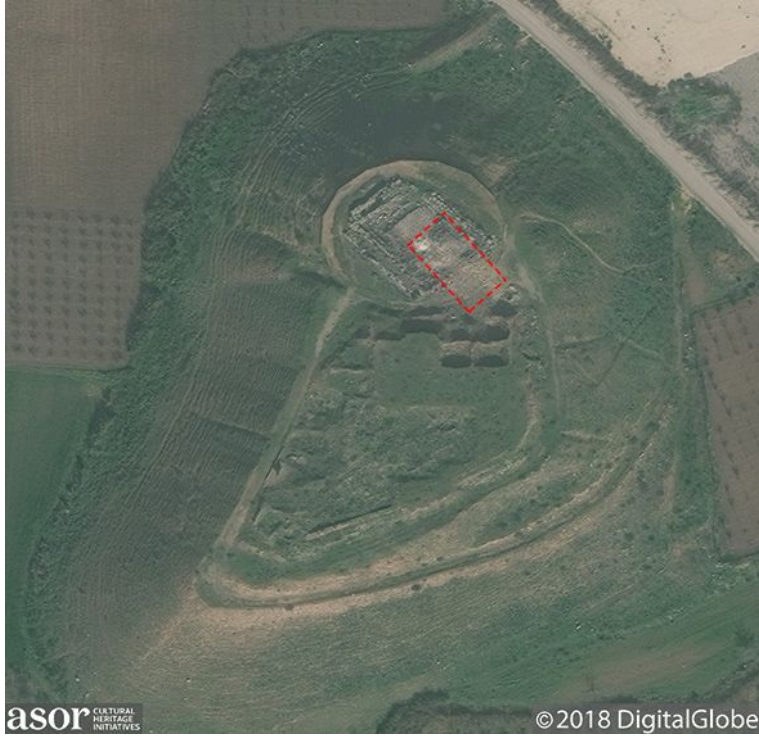
Damage from attack on Tell Ain Dara temple, with debris field indicated by the red box (DigitalGlobe NextView License; January 29, 2018)

The attack left two craters in the temple—one in the entrance to the building and the other in the entrance to the cella. Both craters project down deep below the level of the temple's pavement. The blasts created a linear debris field that extends southeast across the antecella and out through the entrance portico of the building. The orientation of the debris field and the minimal damage evident in the temple's cella indicate that the attack originated from the northwest.

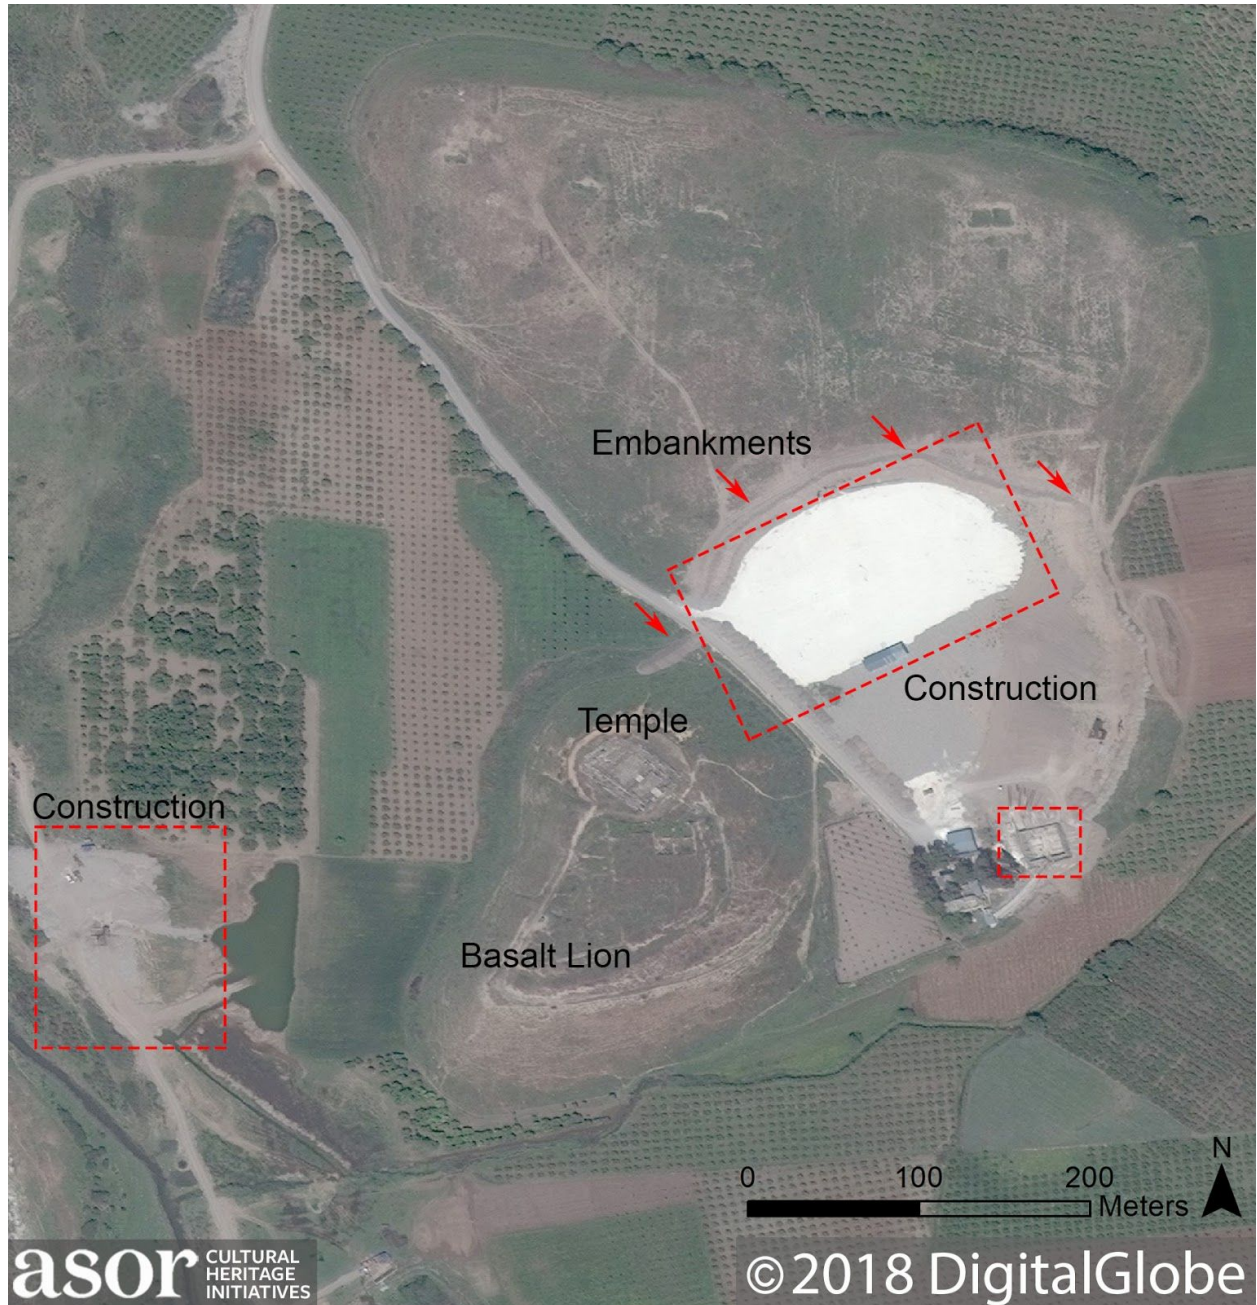
New construction and earthen embankments built on the eastern part of the low mound at Tell Ain Dara (DigitalGlobe NextView License; April 17, 2016)

ASOR CHI's geospatial analysis has also identified possible militarization at the site over the last few years. Between 2013 and 2016, the eastern area of the low mound was cleared of vegetation and a sand or gravel rectangular area was spread on the ground. Earthen embankments were built up around the area and up onto the northern slope of the high mound. New construction is also visible in the southeastern corner of the low mound as well as off-site to the west of the high mound. In an image from November 9, 2017, new construction has continued, including a structure built into the ground just east of the low mound. A roadblock was also erected on the main road running between the high mound and the eastern low mound. In an image from January 29, 2018, the road block is still in place, while the new construction on the east has been covered in soil with just the entrance to the underground building visible. None of this possible militarization is in the immediate vicinity of the temple. The closest element is the embankment on the northern slope of the high mound, which is roughly 40 m away.

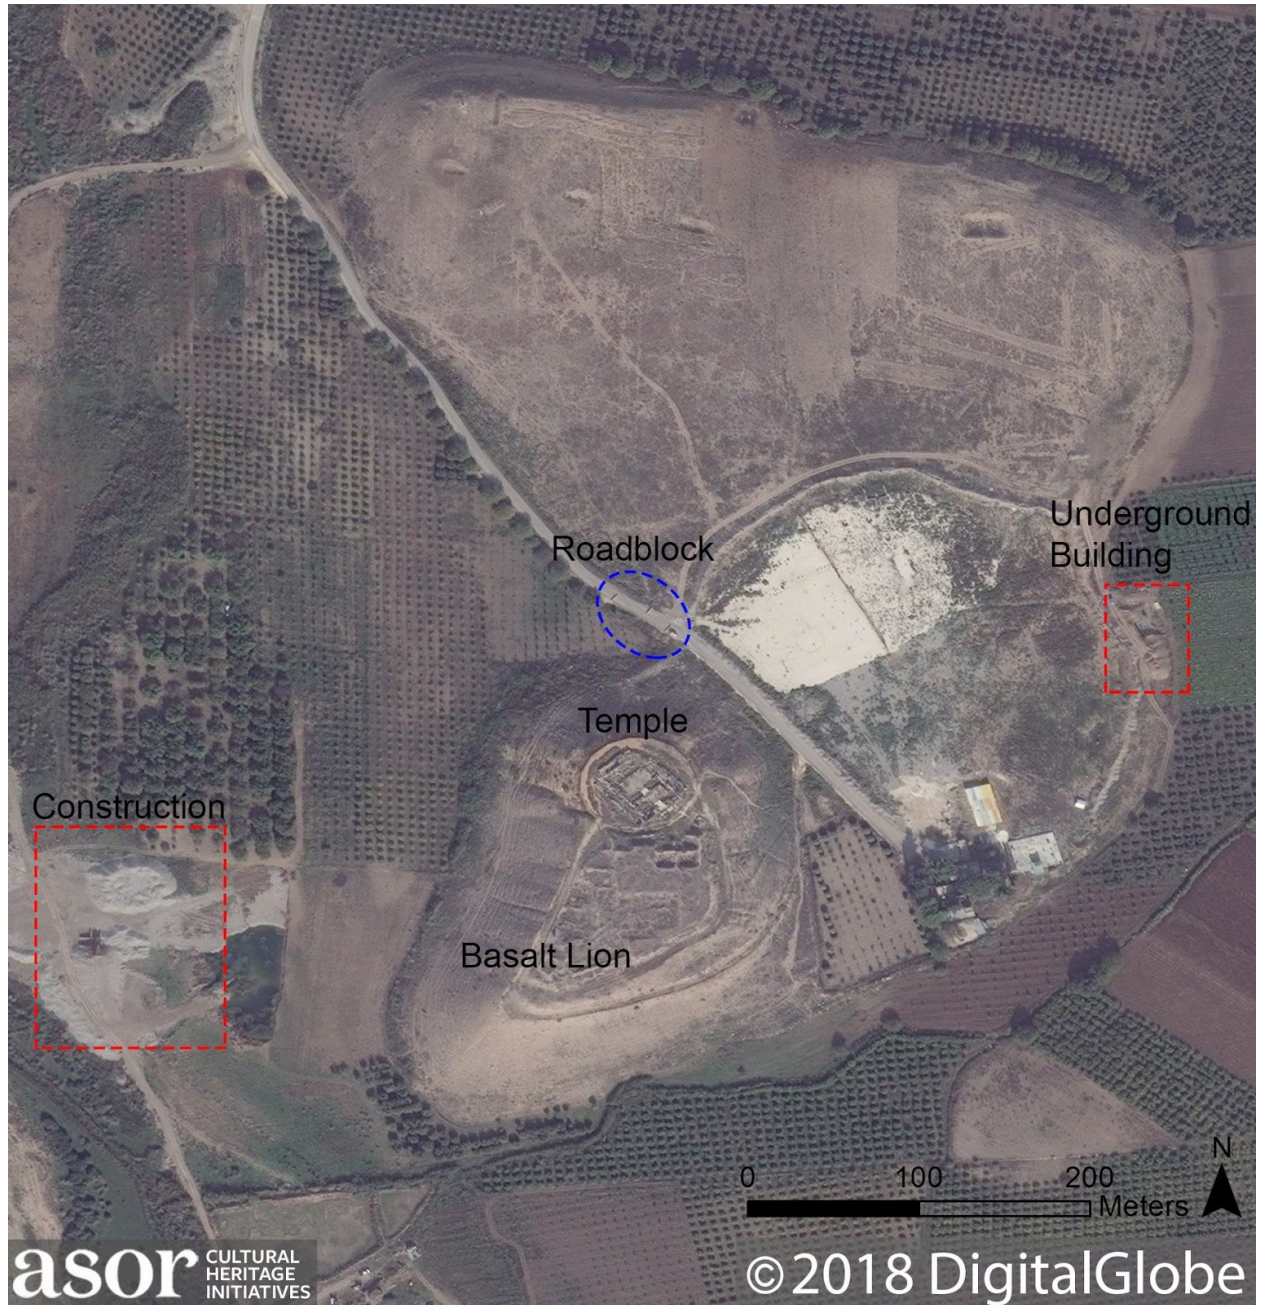
Construction on the eastern side of Tell Ain Dara and a roadblock near the site (DigitalGlobe NextView License; November 9, 2017)

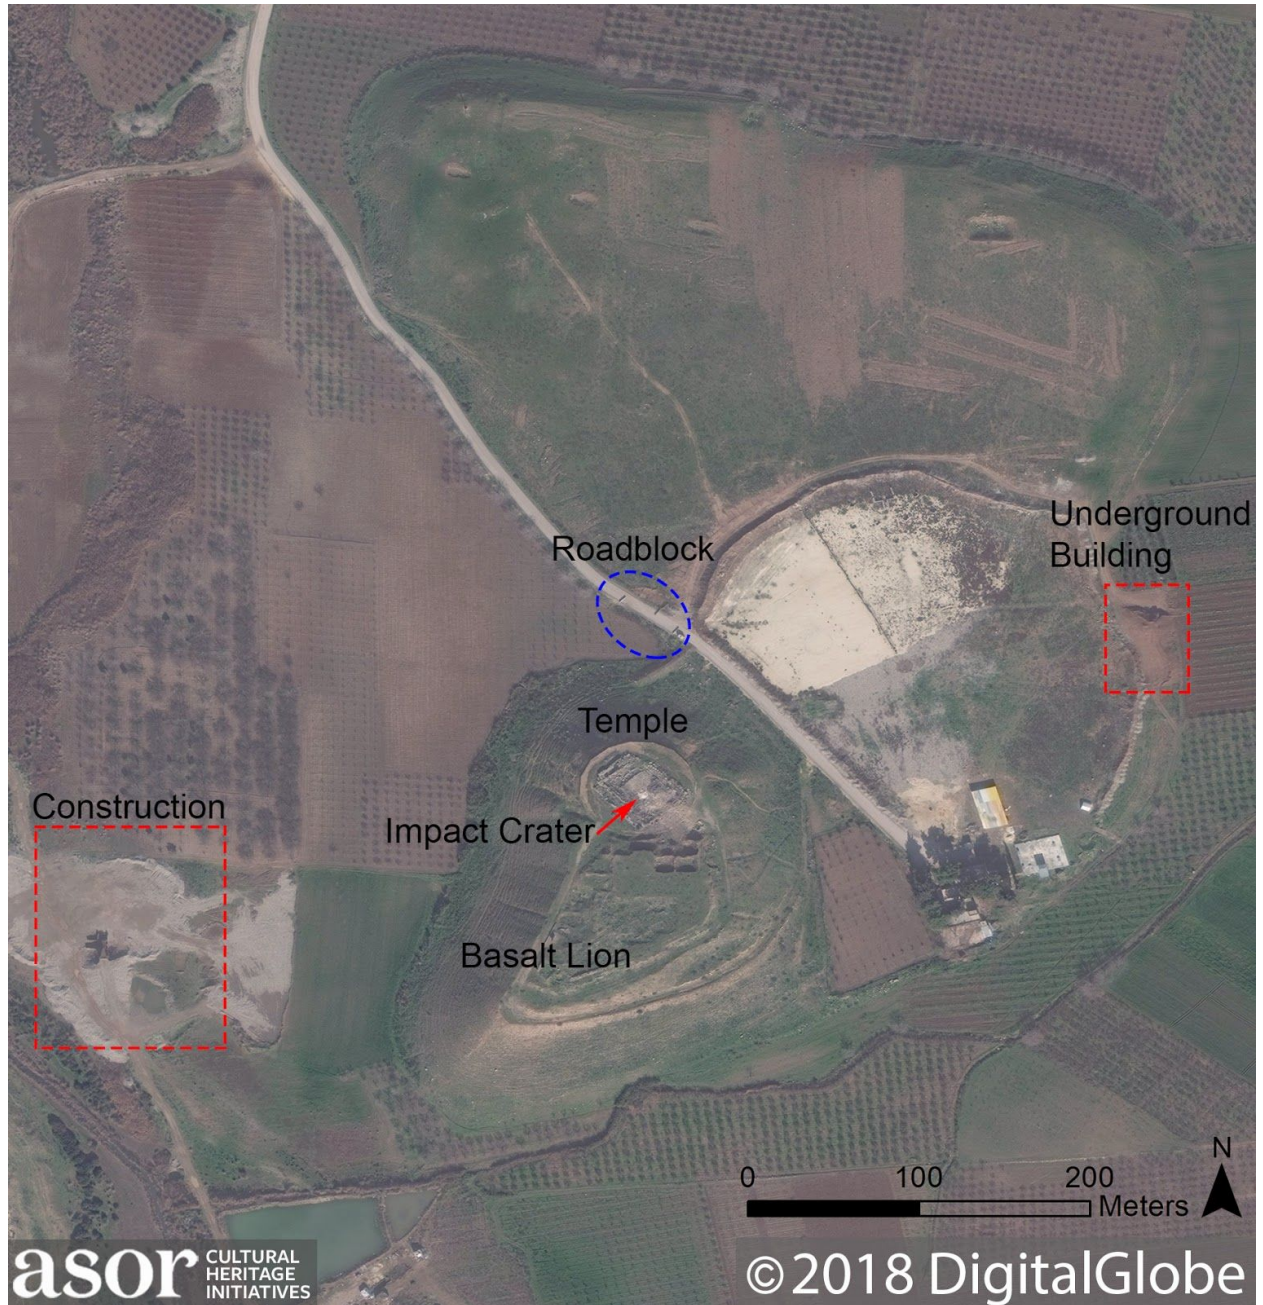
Damage to the Tell Ain Dara temple indicated by a red arrow (DigitalGlobe NextView License; January 29, 2018)

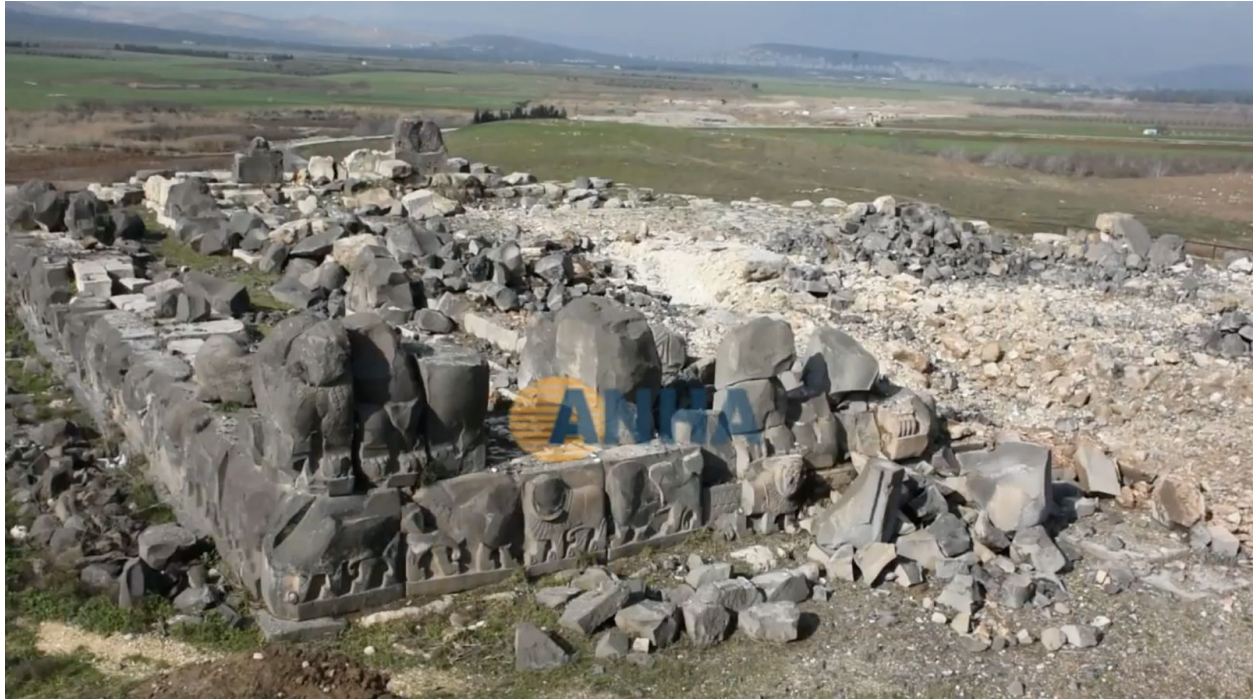
Video still of the temple after the attack (ANHA; January 27, 2018)

The explosions heavily damaged the central and southeastern portions of the temple. The majority of the damage occurred in the interior of the temple, but portions of the entrance portico and southeastern facade have also been severely impacted. The exterior walls on the west, north, and east appear to be largely undamaged as does the northern half of the temple. However, these areas are poorly documented in the currently available photographs and video.

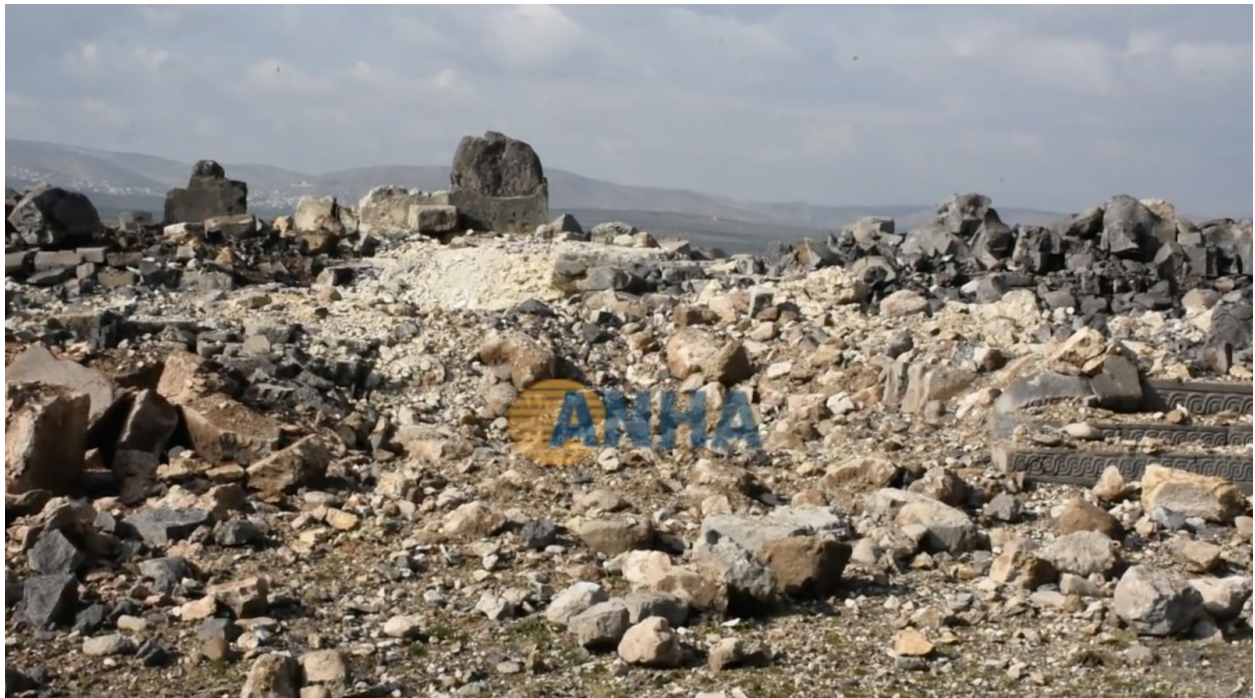
Video still of the entrance to the temple following the attack (ANHA; January 27, 2018)

The blast in the entrance portico also caused extensive damage. The explosion occurred directly on top of the two stone thresholds with carved human footprints in the entrance to the building, which disintegrated them. The basalt decorations, including the column bases on either side of the doorway, have also been uprooted and fragmented.

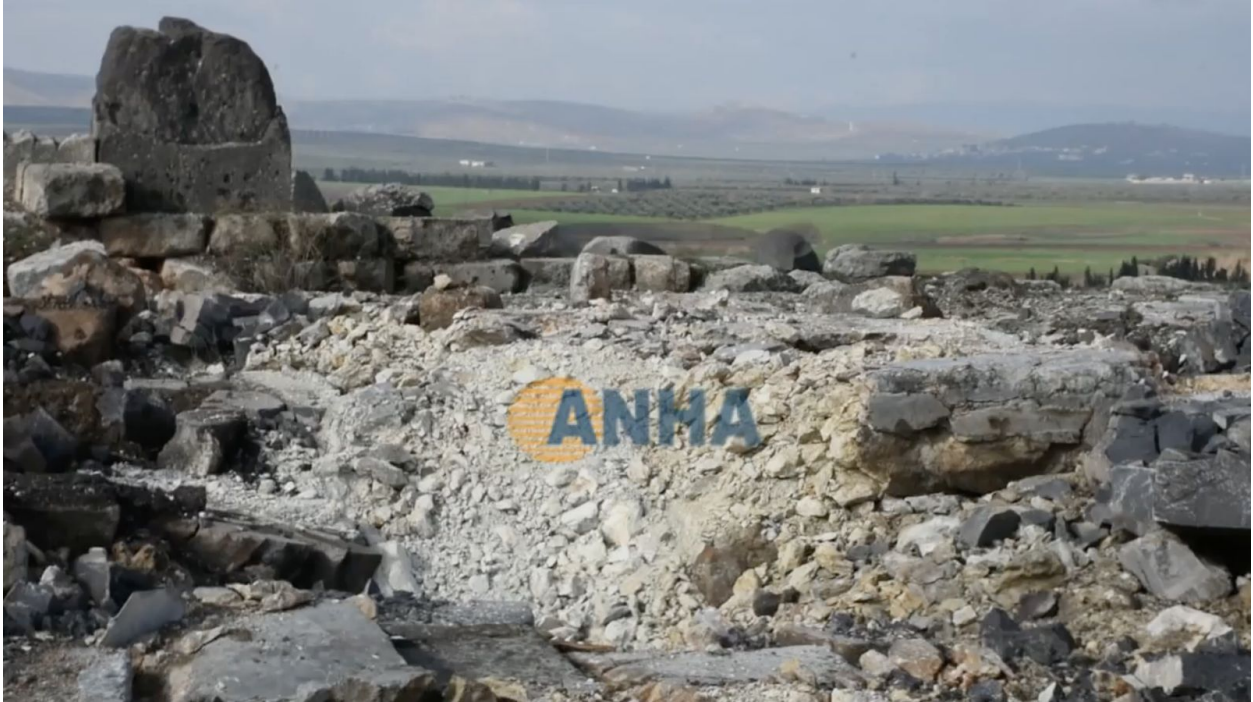
Video still of the crater in the threshold of the doorway to the cella, seen from the southeast (ANHA; January 27, 2018)

The explosion in the doorway to the cella badly damaged the remains in the northwestern end of the antecella. The blast destroyed most of the stone threshold in the doorway. This threshold had a carved impression of a human right foot. Partially-preserved door jambs with carvings of lions have also been severely damaged. Further, the sculpture and reliefs on either side of the doorway between the antecella and cella have been reduced to rubble. The force of the blast has also scattered the basalt steps that lead up to the doorway into the cella as well as dislodged portions of the limestone paving in the antecella.

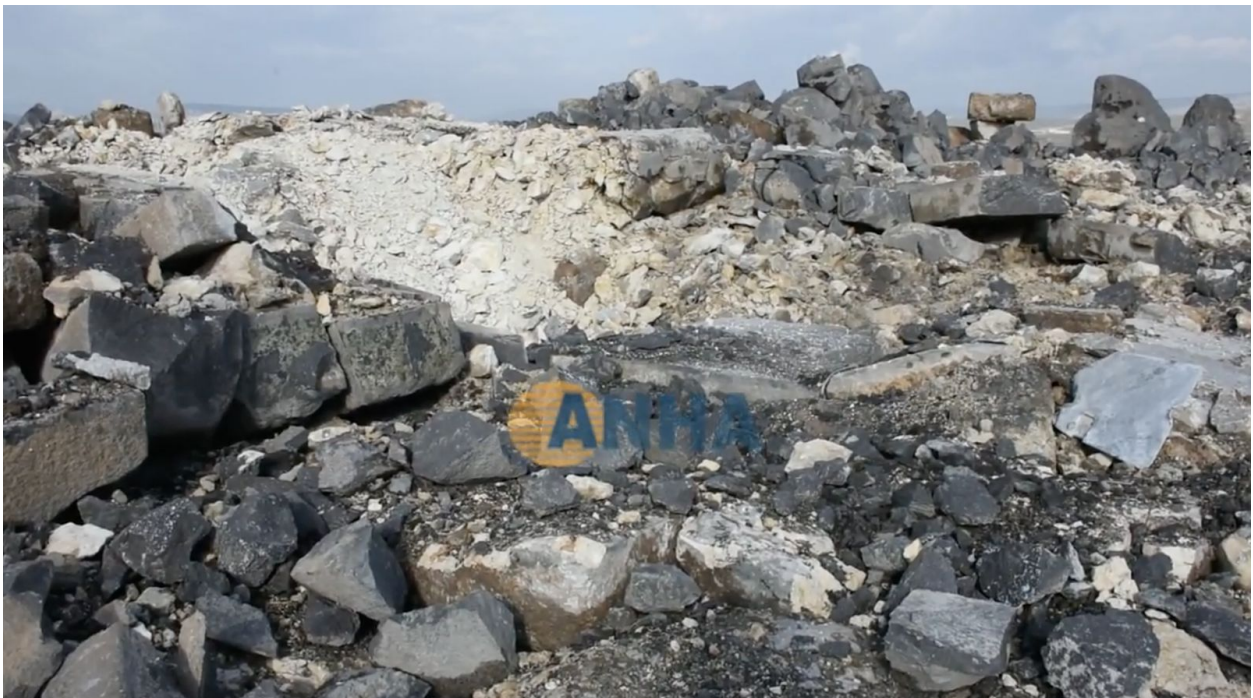
Video still of the crater in the threshold of the doorway to the cella, seen from the south. The remains of the reliefs and sculpture in the northeastern corner of the room are visible in the background (ANHA; January 27, 2018)

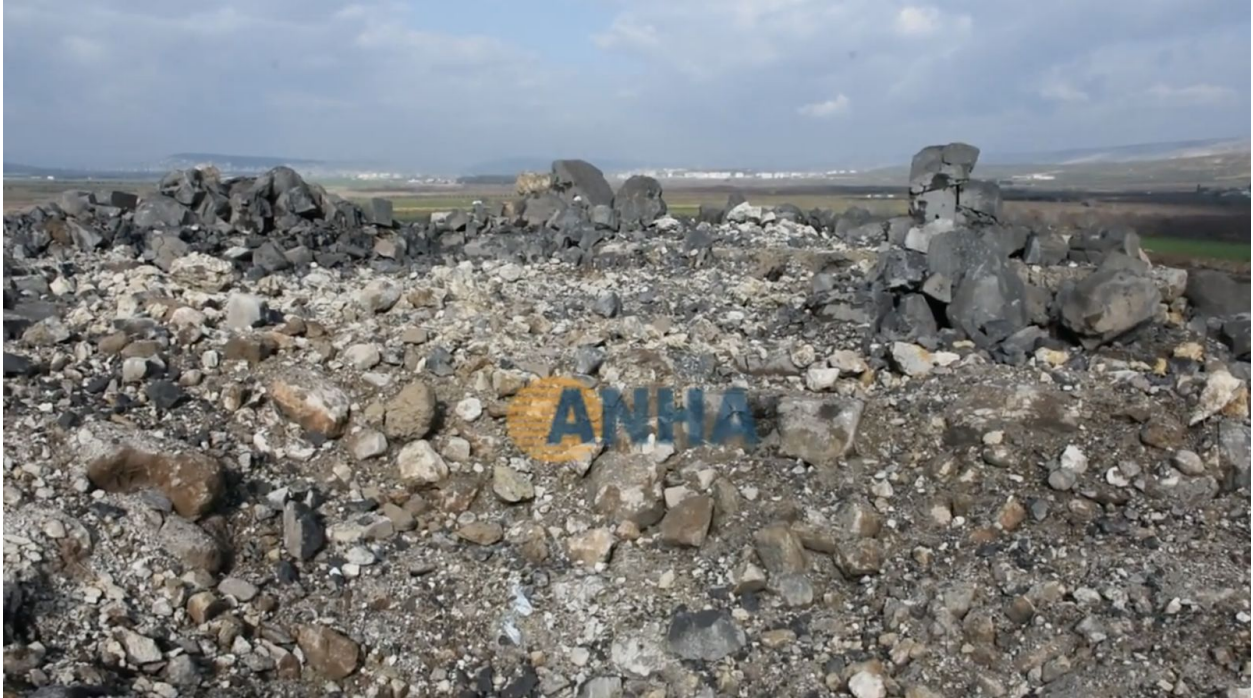
Video still of the antecella, seen from the southwest. The remains of the reliefs and sculpture in the northeastern corner of the room are visible in the upper left corner (ANHA; January 27, 2018)

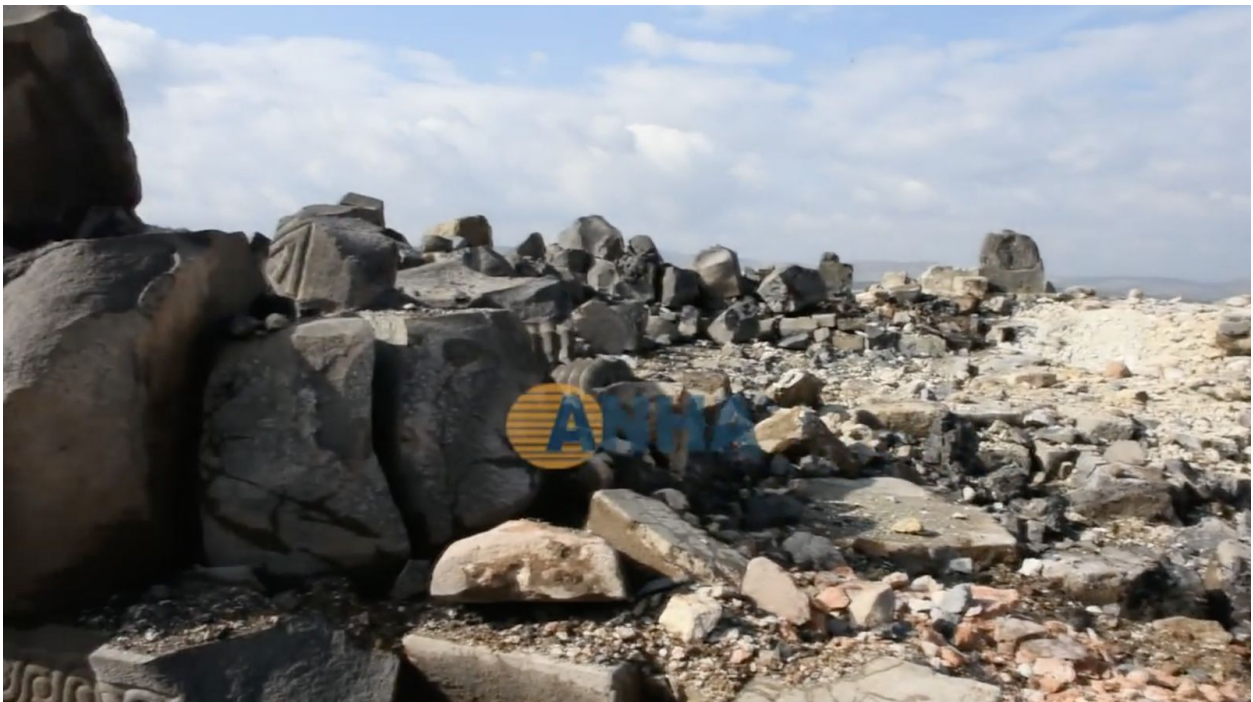
Video still of the western half of the portico and antecella, seen from the southeast. The remains of the reliefs and sculpture in the northwestern corner of the antecella are visible in the background to the left of the crater, which is present along the right edge of the image (ANHA; January 27, 2018)

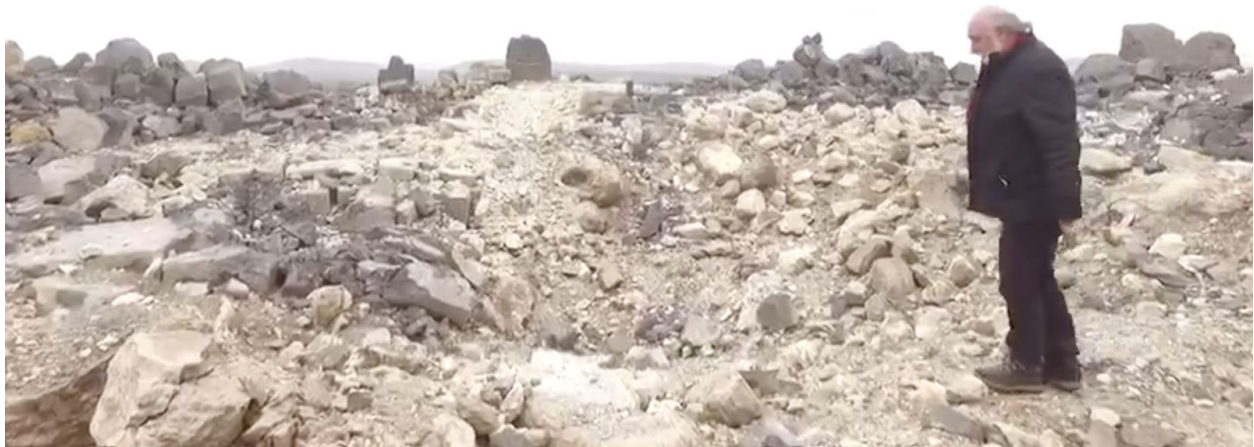
Video still of the crater in the entrance, seen from the southeast (Ghassan Shami; March 5, 2018)

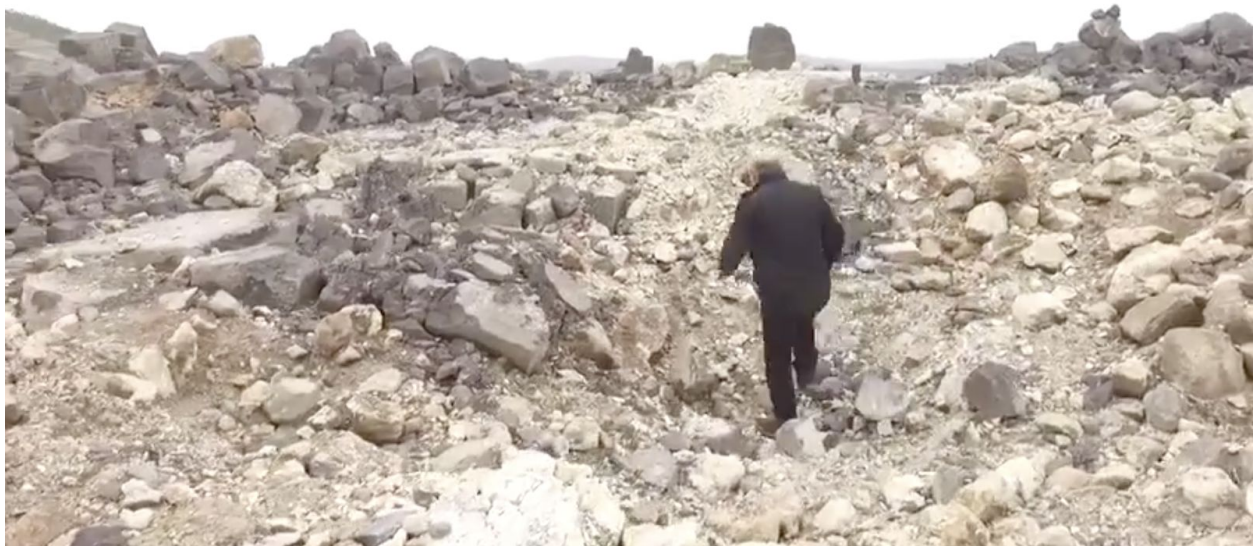
Video still of the crater in the entrance, seen from the southeast. Note the depth of the man in the crater relative to the original level of the pavement, which is visible on the left side of the image (Ghassan Shami; March 5, 2018)

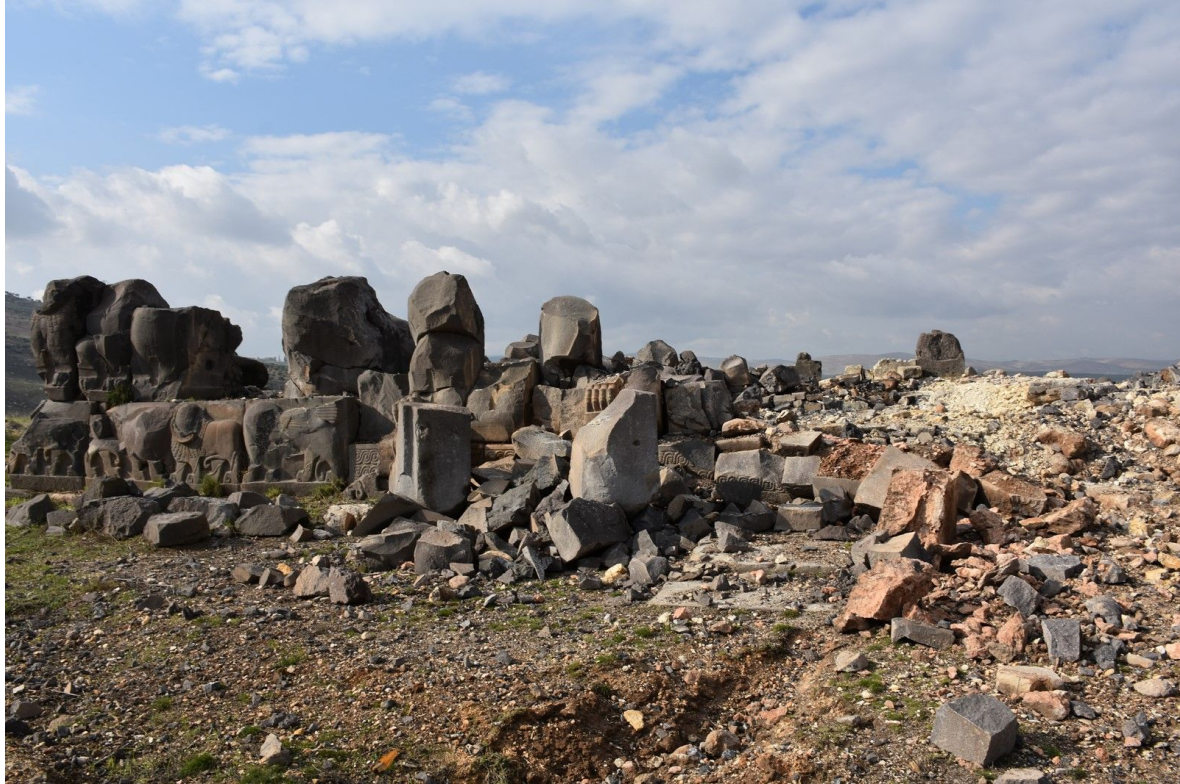
The western side of the entrance portico and temple facade after the attack (ANHA; January 27, 2018)

The explosion in the entrance portico also affected the decorations on the southeastern facade of the temple. To the west of the portico, three out of five large lion sculptures collapsed towards the southeast. The fragments of these fell onto a pair of smaller lion and sphinx reliefs along the base of the temple, breaking them into pieces as well.

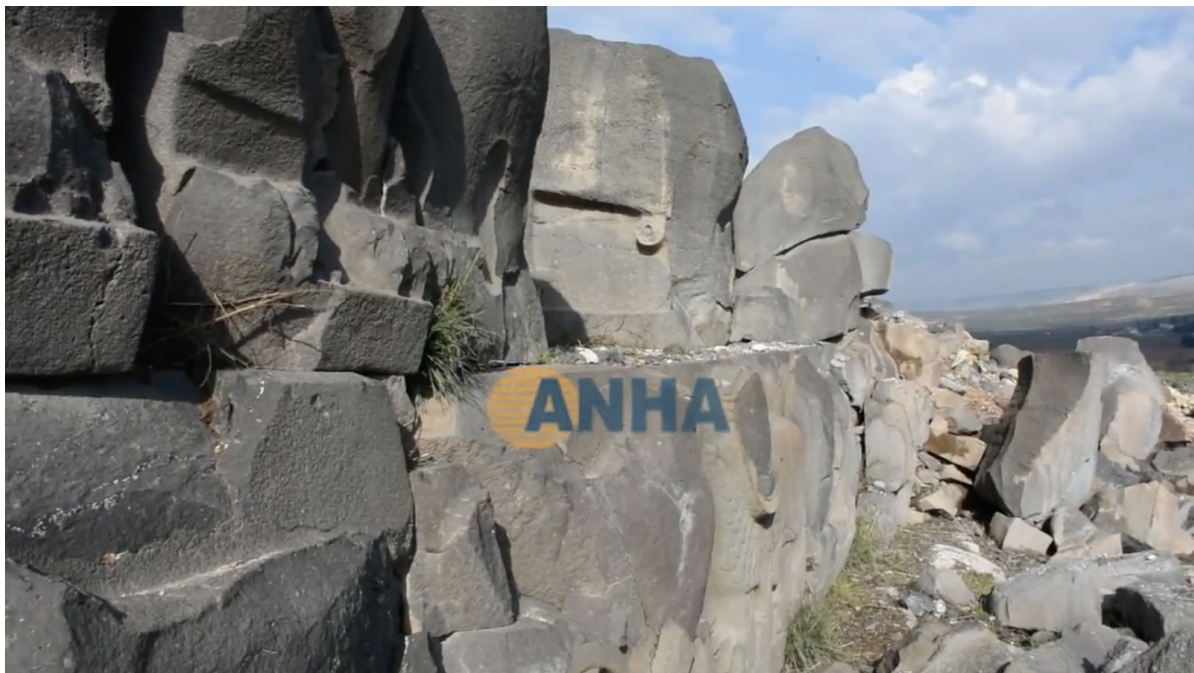
Video still of the facade west of the entrance after the attack, seen from the southwest (ANHA; January 27, 2018)

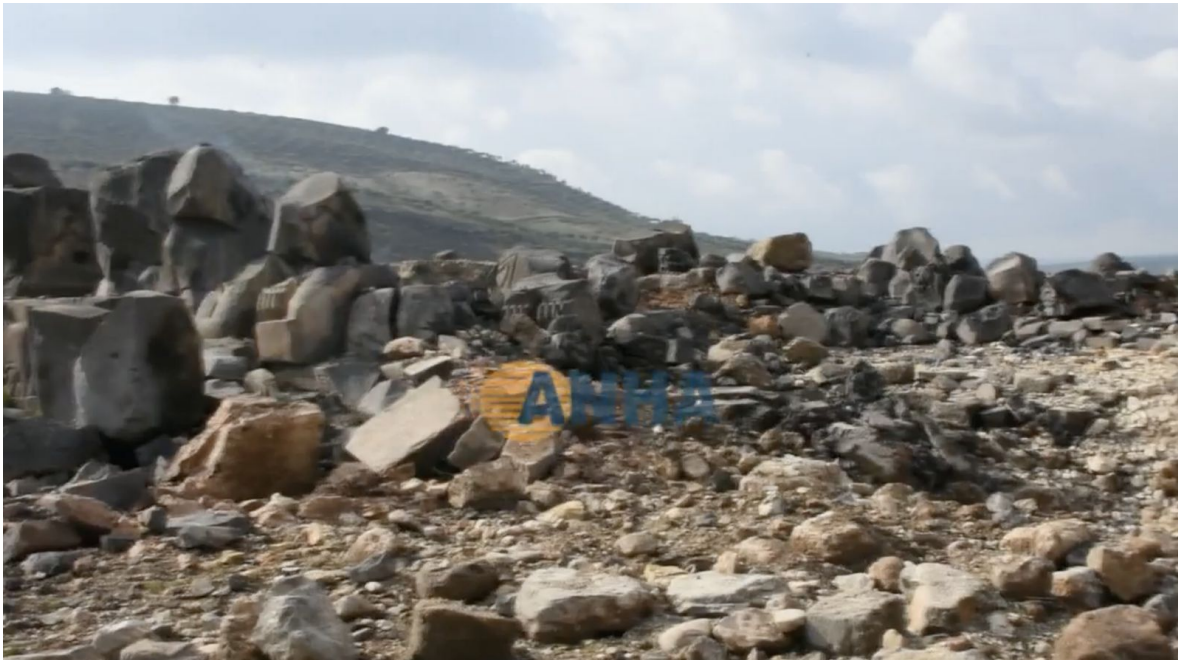
Video still of the western end of the entrance portico after the attack (ANHA; January 27, 2018)

The remains of the basalt stairs in front of the portico were also affected. The blast dislodged both the single step at the western end of the portico and the four steps at its eastern end. Though covered in rubble, the constituent parts of the stairs appear to be largely intact.

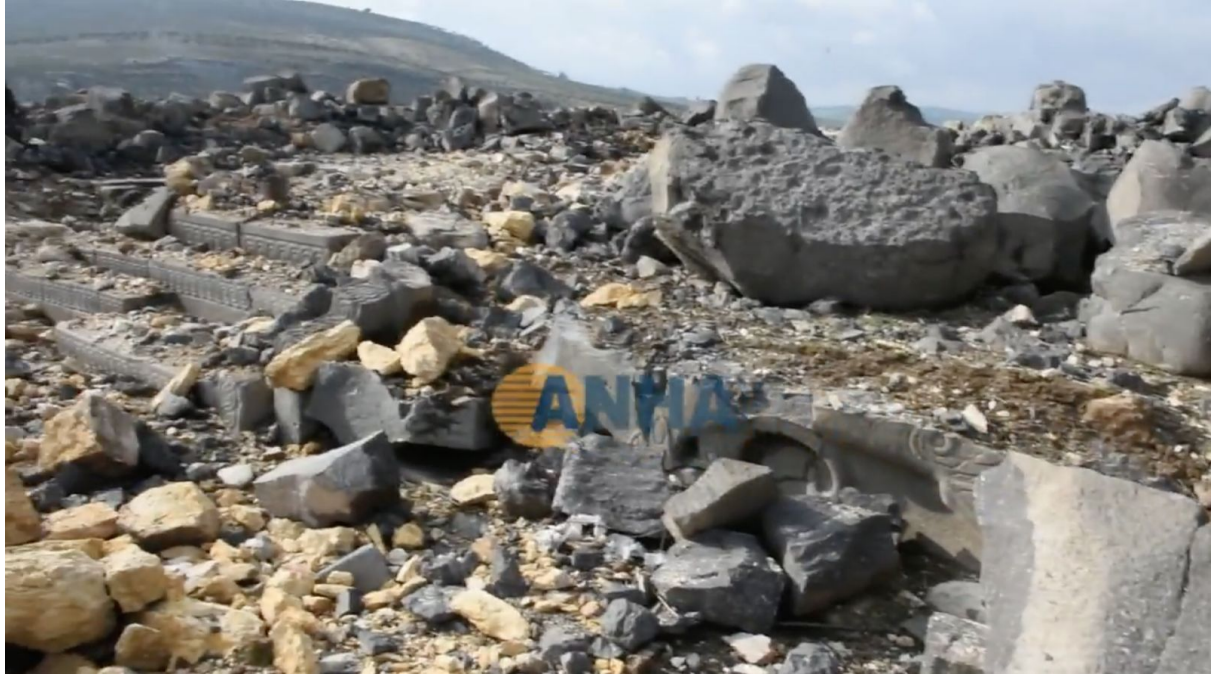
Video still of the temple facade east of the entrance after the attack, seen from the east (ANHA; January 27, 2018)

Finally, the reliefs east of the portico have been damaged as well. A pair of reliefs—one sphinx, one lion—immediately east of the stairs have been broken in half and partially dislodged.

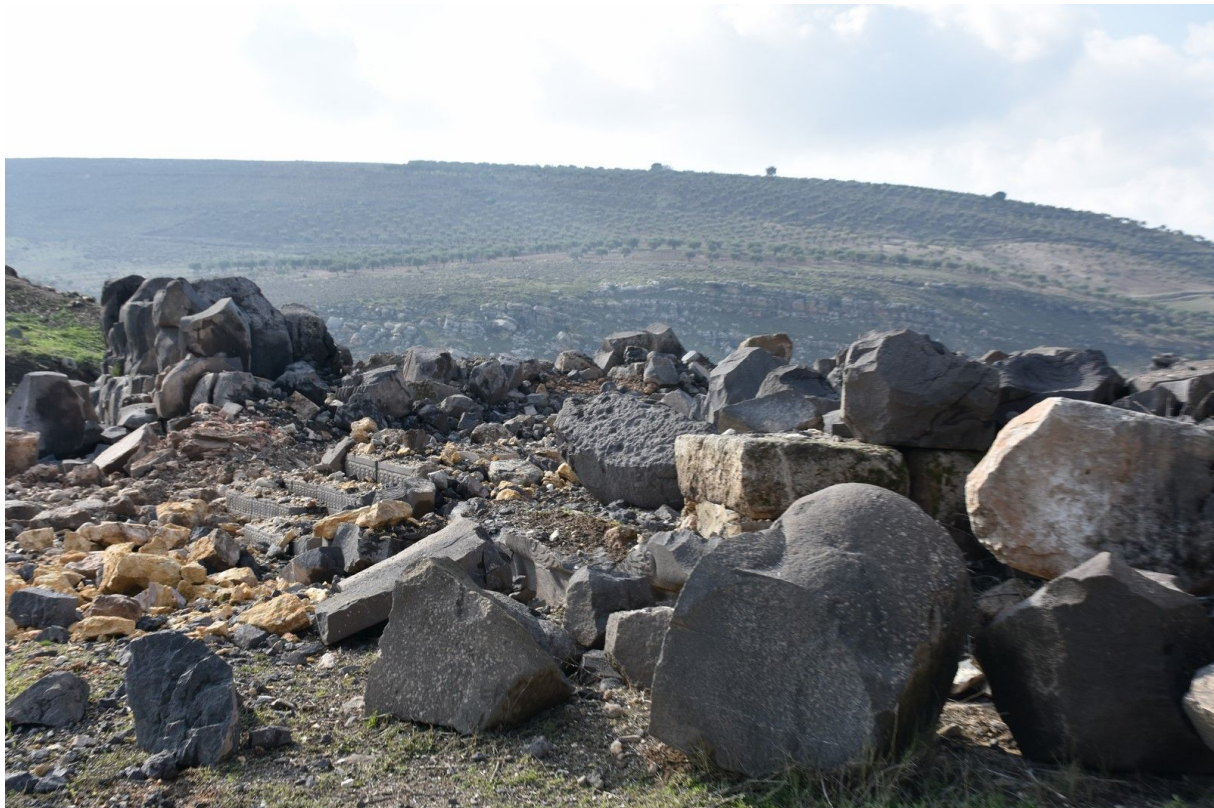
The temple facade east of the entrance after the attack, seen from the east (ANHA; January 27, 2018)

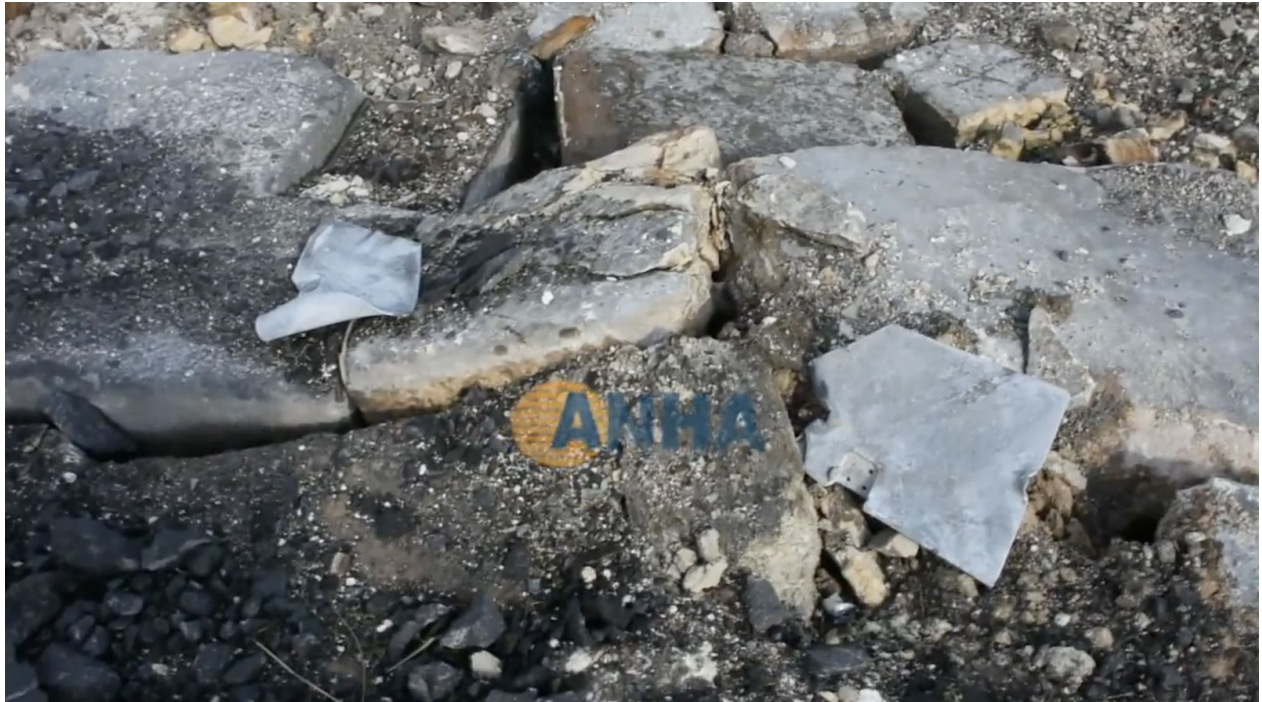
Video still of tail fins, probably from a JDAM, on the floor of the antecella (ANHA; January 27, 2018)

Two of the fragments bear a close resemblance to the tail fin present on the Joint Direct Attack Munition (JDAM).<sup>17</sup> The JDAM is a GPS-guided weapon.<sup>18</sup> It consists of an unguided bomb equipped with a tail control system and an internal guidance system that make the weapon “smart.” The weapon has a 5 m-radius of accuracy when using GPS and a 30 m-radius when GPS is unavailable, provided certain conditions. Although Boeing is the primary producer of this conversion kit, Tübitak Sage, a Turkish company, also manufactures its own version of the technology.<sup>19</sup> The Turkish Air Force has the JDAM in its arsenal. Turkish F-16C/Ds are equipped to carry the weapon.

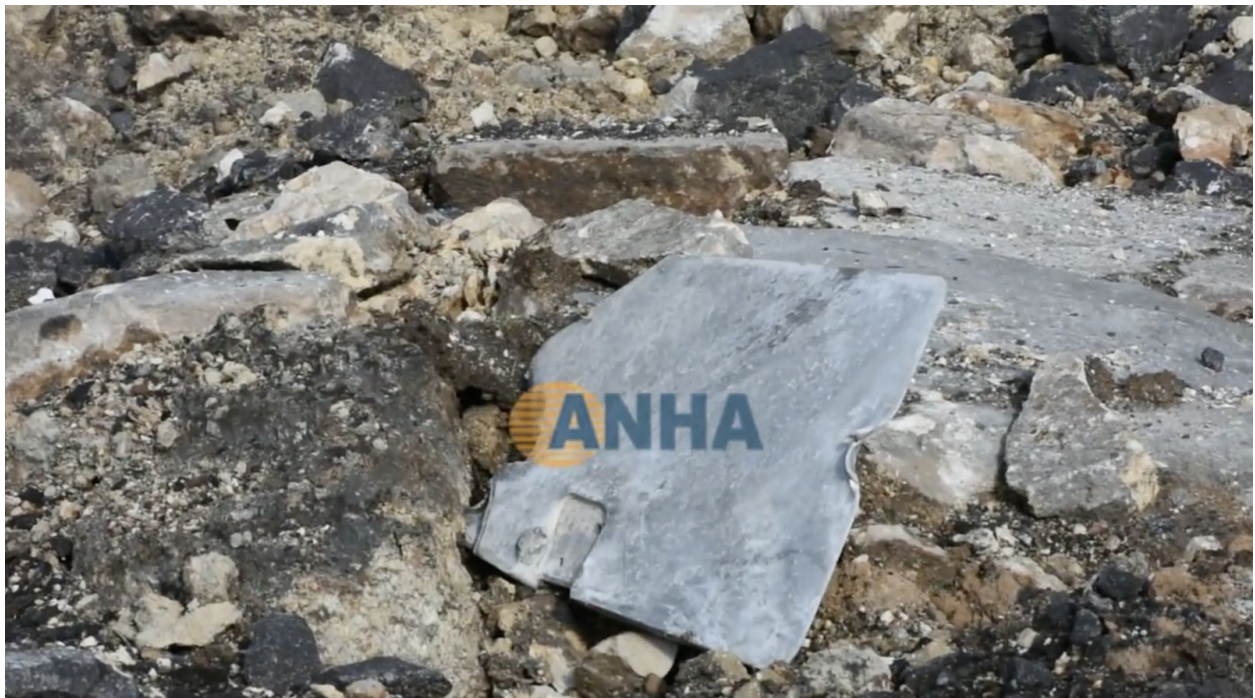
Video still of a tail fin, probably from a JDAM, on the floor of the antecella (ANHA; January 27, 2018)

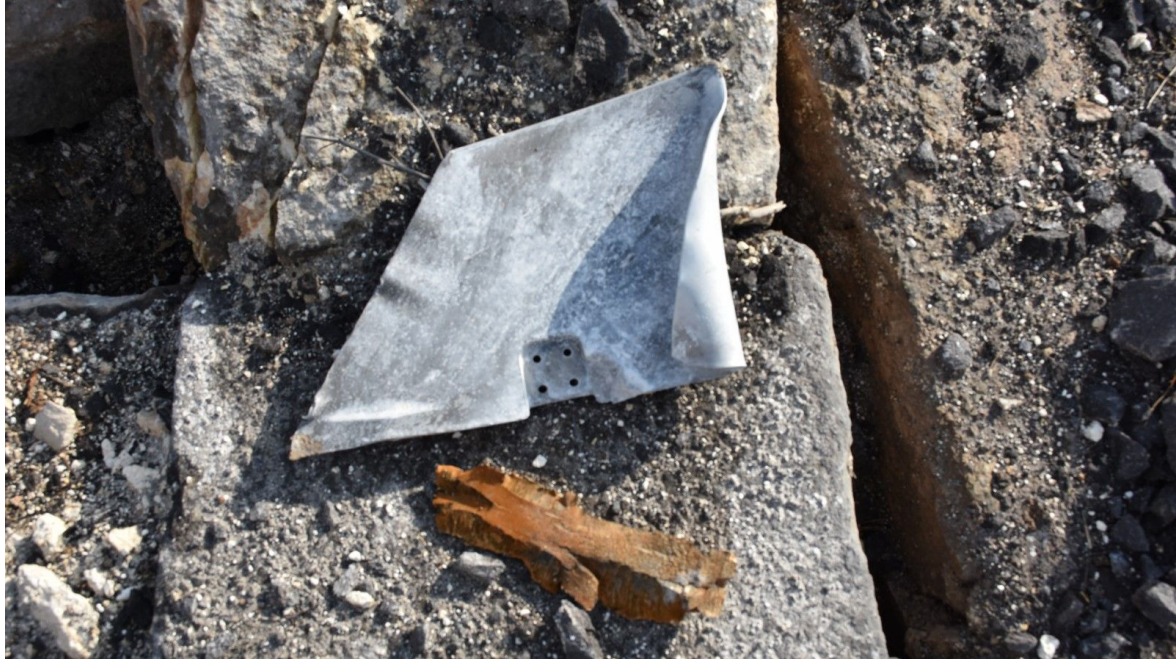
Tail fin, probably from a JDAM, on the floor of the antecella. Both fragments were likely moved to this location from elsewhere in the temple for photographic purposes (ANHA; January 27, 2018)

The presence of two craters indicates that multiple weapons were used in the attack. Hawar News published photographs of metal fragments purportedly recovered at the site. Video evidence demonstrates that one of these fragments was moved to another location, probably for photographic purposes.

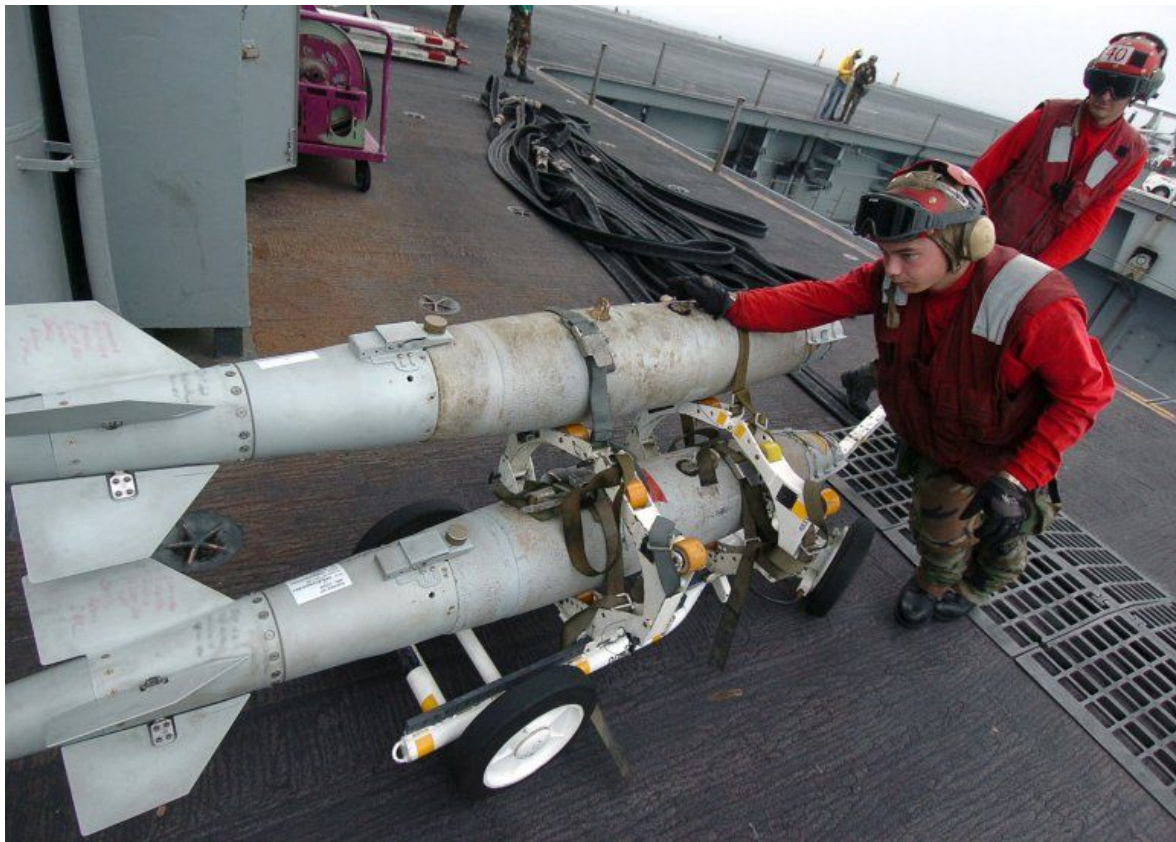
A GBU-38 JDAM (Global Security)

If JDAMs caused the damage at the temple, the scale of the damage suggests that GBU-38s, the smallest variety, were used in the attack.
