ASOR CULTURAL HERITAGE INITIATIVES

Report on the Destruction of the Northwest Palace at Nimrud

May 5, 2015

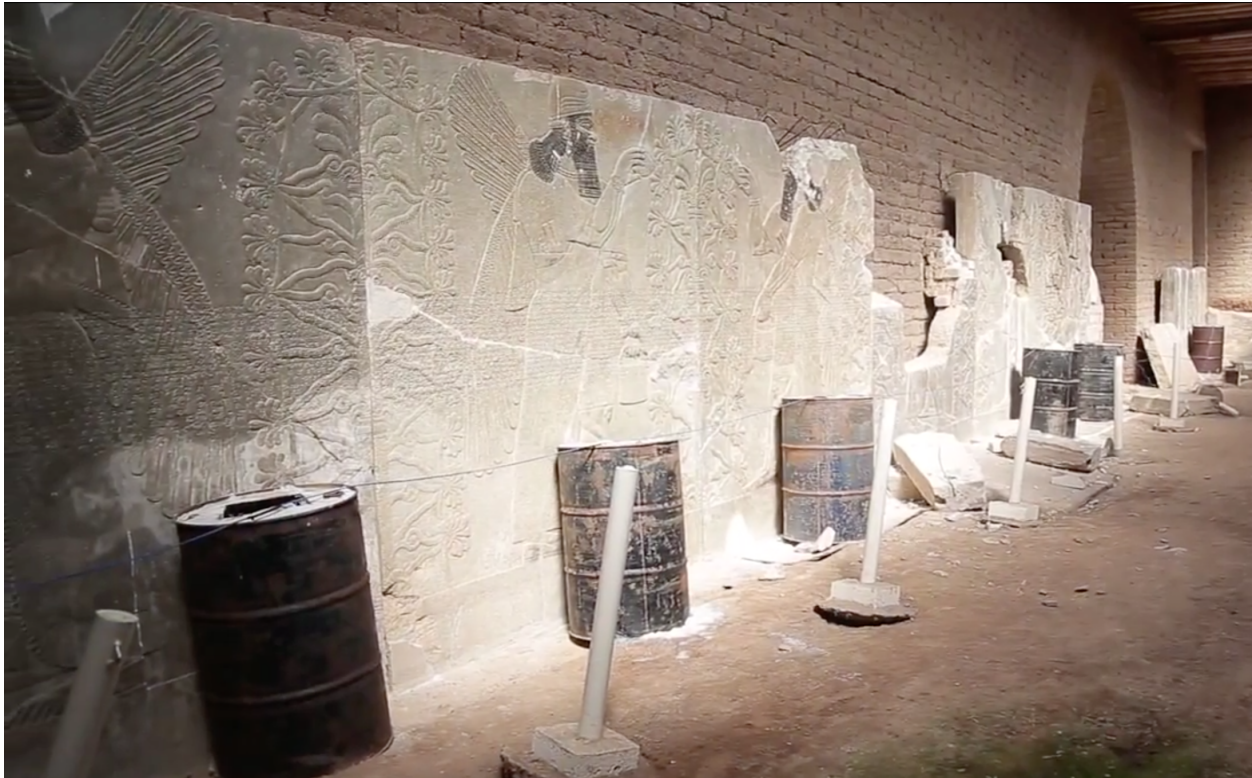
Nimrud, Northwest Palace, barrel bombs arranged in front of relief panels (still image from video released by ISIL on April 11, 2015)

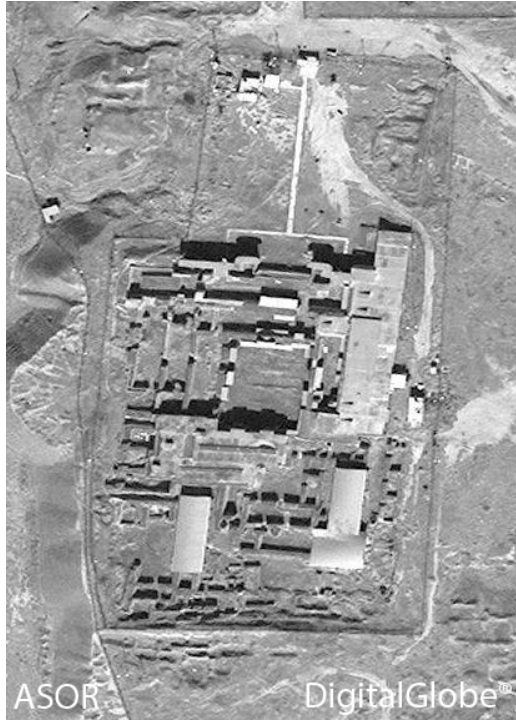
1. Nimrud, Acropolis, no recent damage visible (DigitalGlobe; taken February 26, 2015)

1. *February 26, 2015*: This image shows no obvious, recent damage to the site.
2. *March 7, 2015*: This image shows that a road has been cut through the modern wall that runs between the two side doors of the Throne Room of the Northwest Palace. The central entrance to the Throne Room was originally located in this area but has since eroded away; the space was closed off by a modern wall when the palace was restored. The image also shows a pile of rubble outside the Throne Room in the outer courtyard. The pile appears to include too much material to have been generated by the destruction of the modern wall alone and probably includes fragments of destroyed sculpture (as shown in this location in the ISIL video). The image also shows evidence for disturbance within the Throne Room, directly in front of relief slabs 12–15, the best-preserved relief sculptures excavated in the Throne Room. The disturbance suggests that these relief slabs may have been removed or demolished, most likely using mechanized equipment. The absence of further evidence for heavy disturbance elsewhere in the palace suggests that mechanized equipment may not have been brought into these other areas. Damage done below the shed roof using hand-held tools such as sledgehammers or jackhammers would not, however, be visible in the satellite imagery.

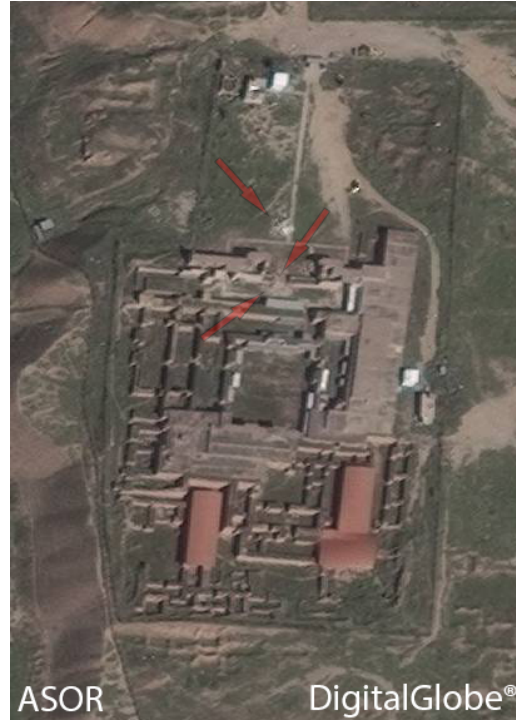
2. Nimrud, Northwest Palace, arrows point to rubble pile, cut in modern wall, and disturbance in Throne Room (DigitalGlobe; taken March 7, 2015)

Analysis of these satellite images suggests that the events shown in the ISIL video probably took place on (at least) two separate occasions. If the pile of rubble visible in the DigitalGlobe image taken on March 7, 2015, is the same as the pile of relief panels shown in the ISIL video released on April 11, 2015, then the piling up of these relief panels must have taken place prior to March 7, 2015. The detonation of the Northwest Palace, on the other hand, must have taken place after April 1, 2015, when a satellite image shows the palace still intact, and before April 11, when the ISIL video was released. The satellite image taken on April 17, 2015, provides further confirmation for the destruction of the Northwest Palace, as shown in the video.

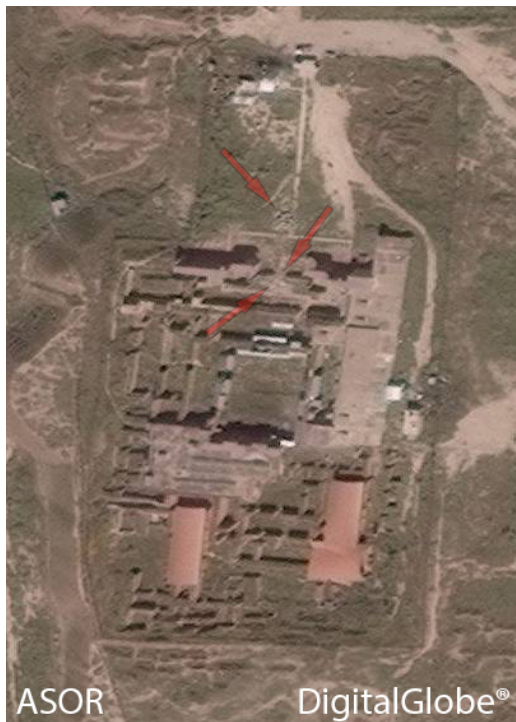
3. Nimrud, Northwest Palace, arrows point to rubble pile, cut in modern wall, and disturbance in Throne Room (DigitalGlobe; taken April 1, 2015)

3. *April 1, 2015*: This image shows the palace still intact, but, again, any further damage done using handheld equipment would not necessarily be visible in the image.

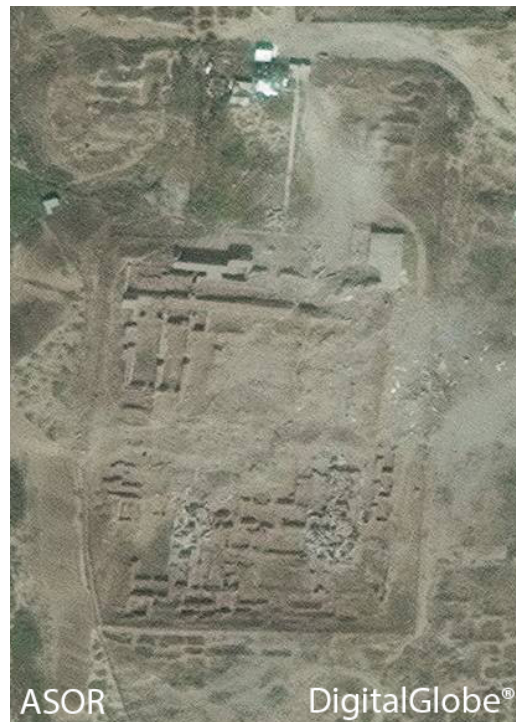
4. Nimrud, Northwest Palace, showing the palace in ruins following the detonation of barrel bombs by ISIL (DigitalGlobe; taken April 17, 2015)

4. *April 17, 2015*: This image shows the palace in ruins, following the detonation of the barrel bombs shown in the ISIL video.
