ASOR Syrian Heritage Initiative (SHI): Planning for Safeguarding Heritage Sites in Syria¹

NEA-PSHSS-14-001

Weekly Report 2 — August 18, 2014

Michael D. Danti

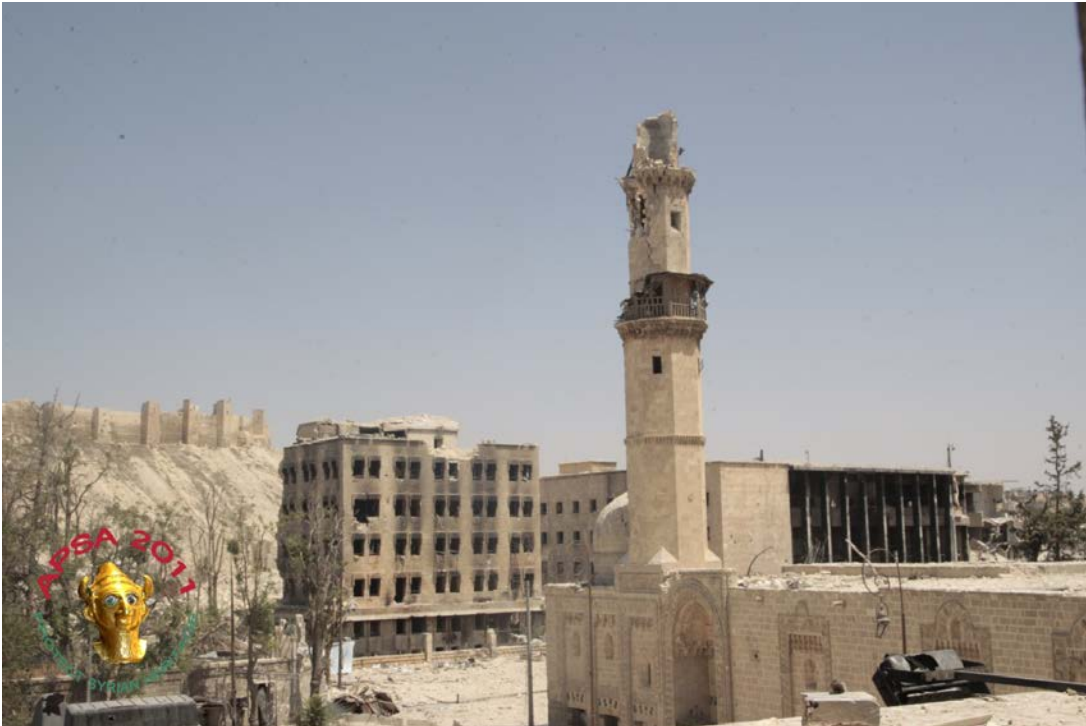
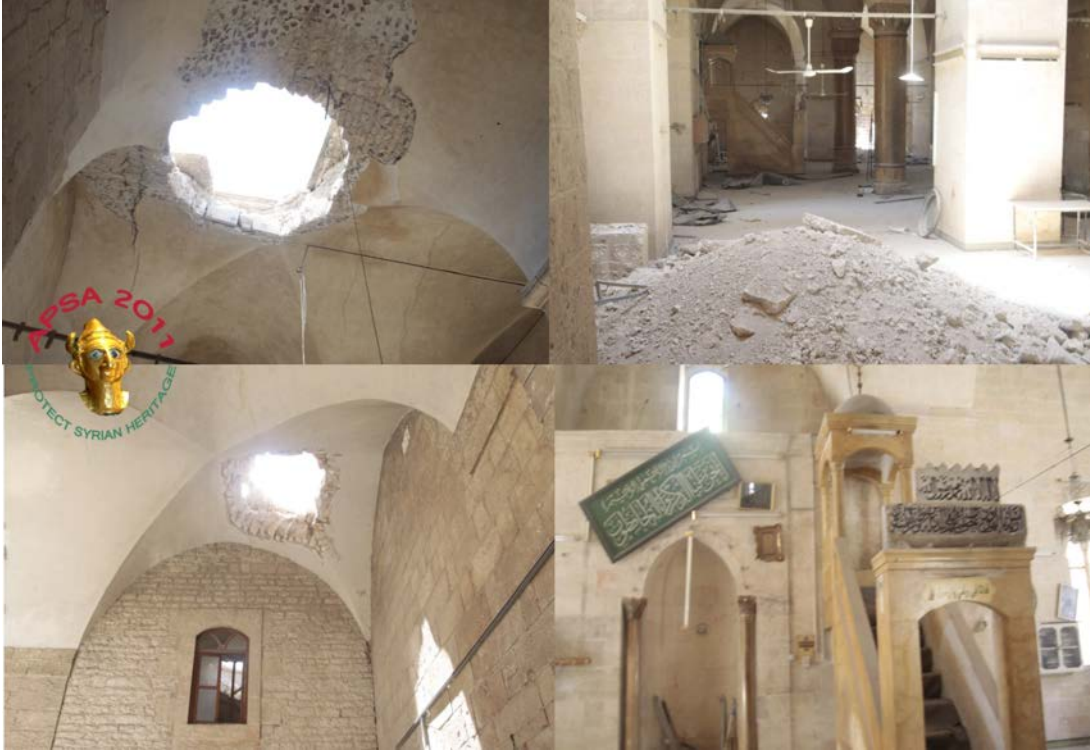
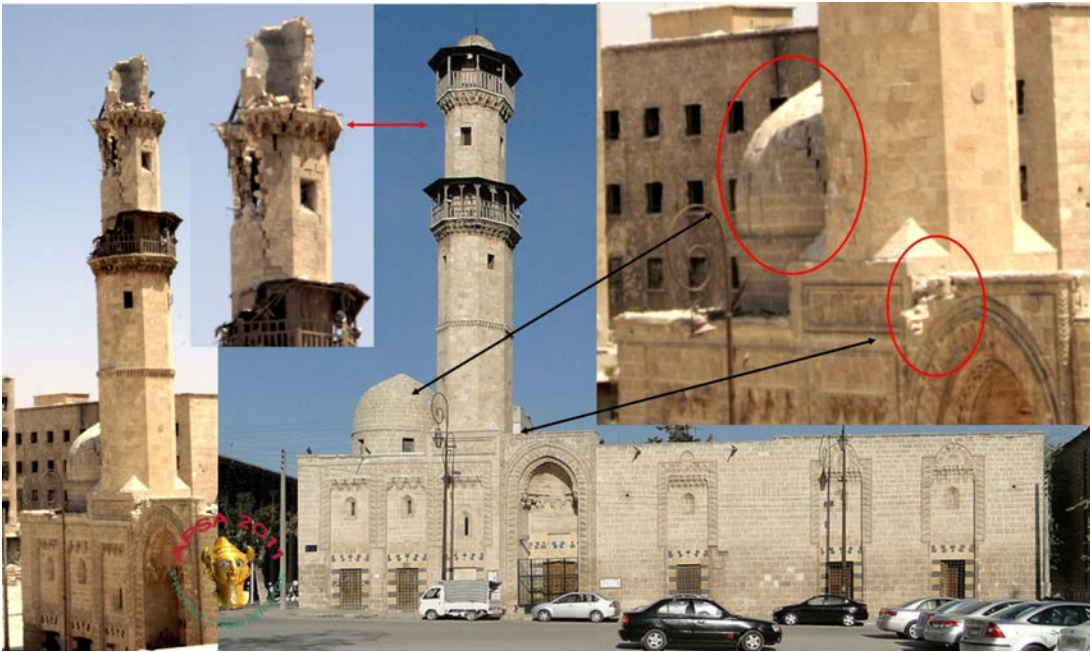
Photographs posted on the APSA website and a number of other online sites show severe damage to the roof, dome, façade, and minaret.

Damage to the al-Otrush Mosque (APSA).

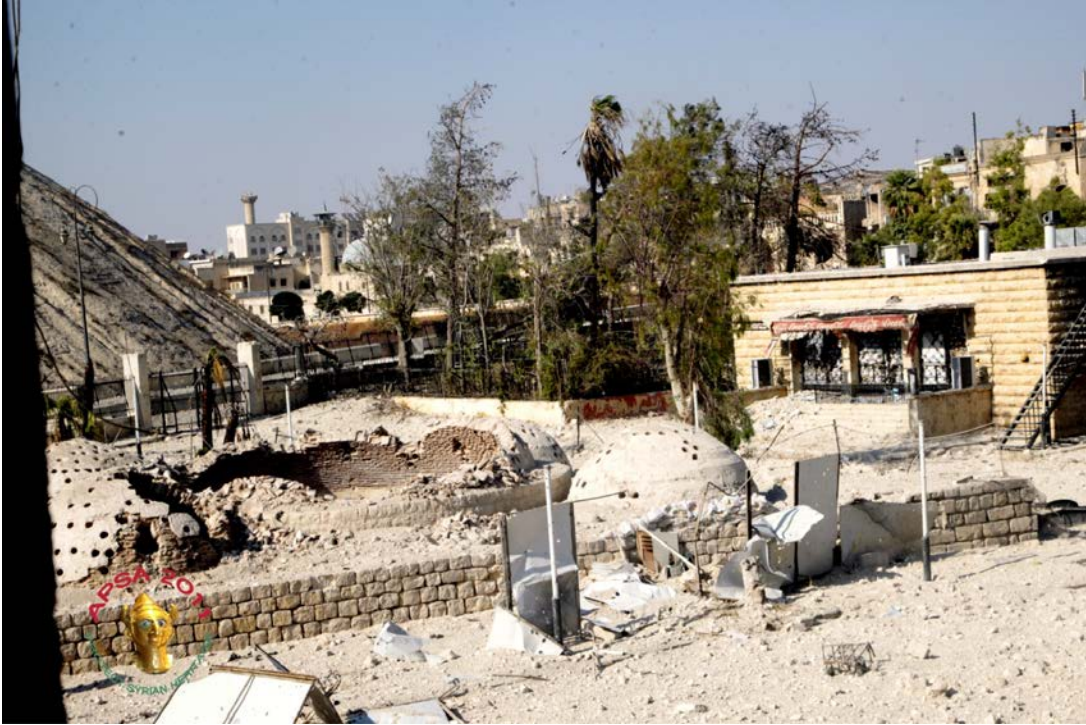
- **Hammam Yalbugha** (36°11'51.71"N, 37° 9'50.30"E): These baths, also known as the Hammam al-Lababidiya, were damaged by the tunnel bomb and during the fighting following the detonation. DGAM claims the attack was intentional.¹⁴ The eastern parts of the building were leveled. According to Ross Burns, they are

Damage to the Yalbugha Bath. The eastern portion of the bath (left) has been destroyed by the detonation of tunnel bombs nearby (APSA).

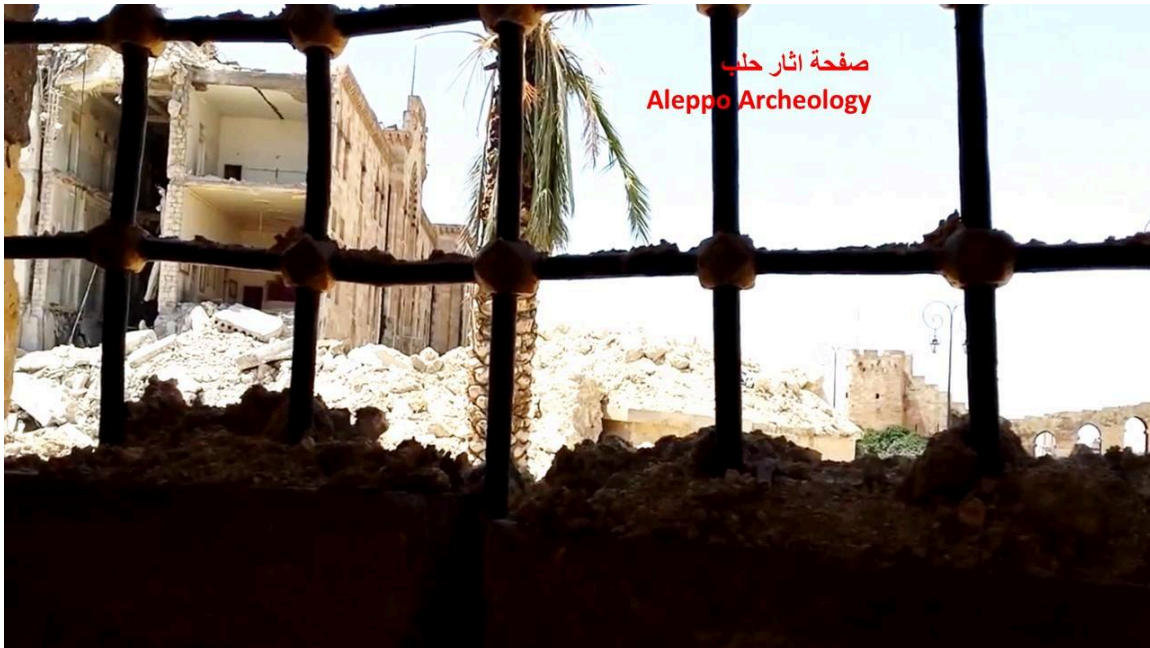
View of the rubble field of the east side of the Serail (Aleppo Archaeology, Aug. 12, 2014). The exposed rooms led into the missing east wing.

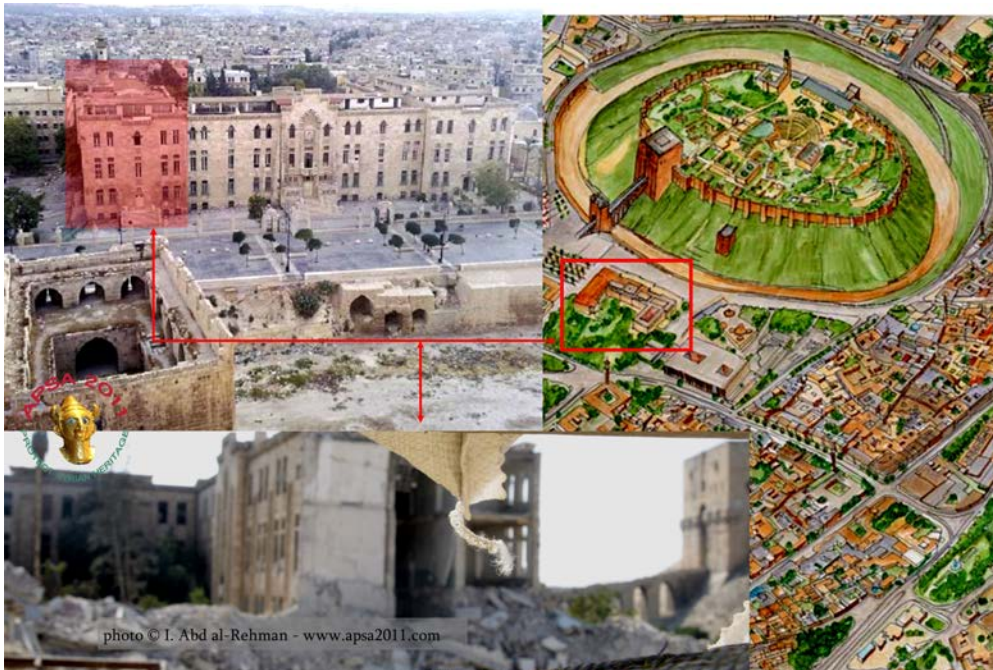
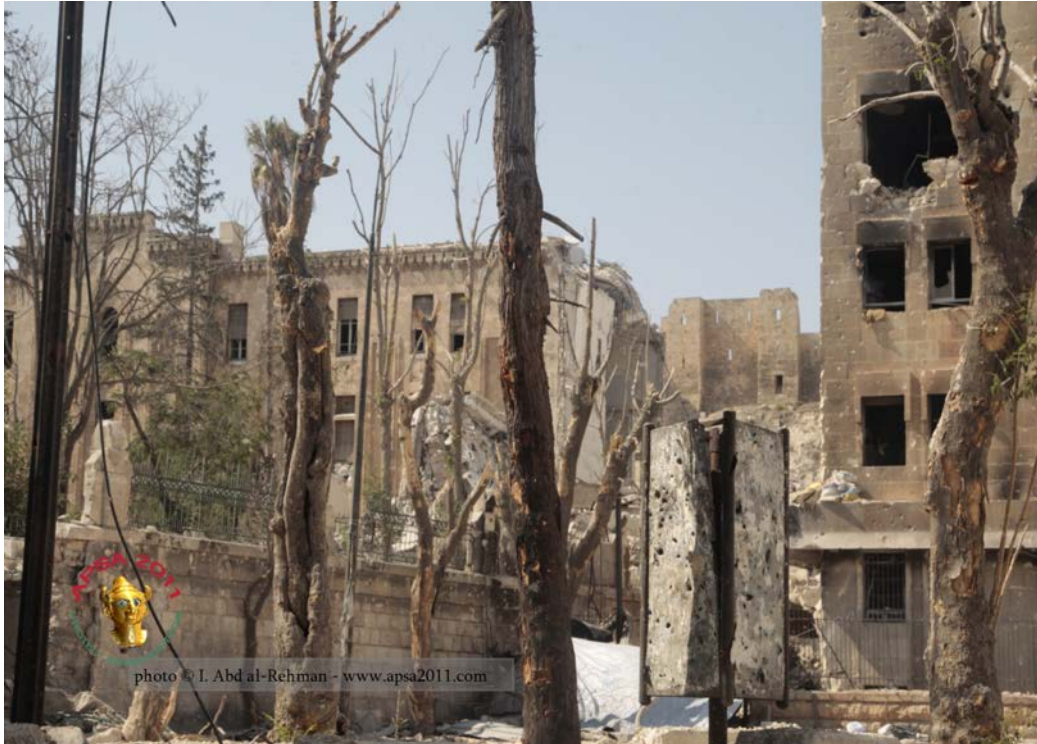
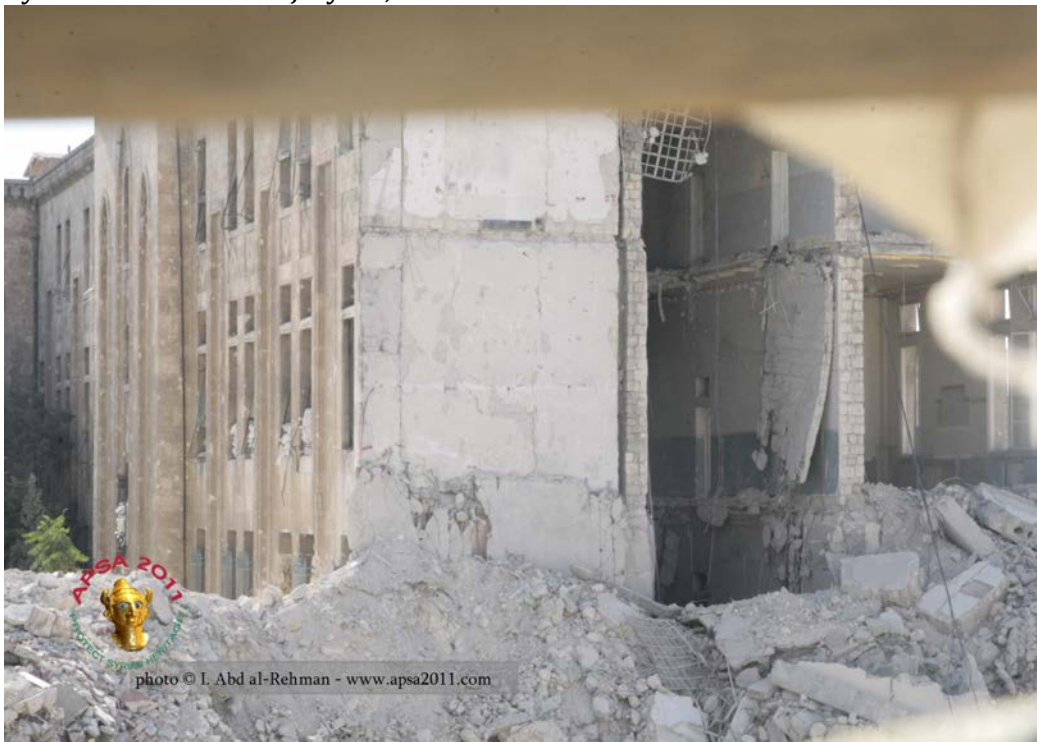
View of the historic Serail (APSA, Aug. 12, 2014). The east wing was completely destroyed by a tunnel bomb on July 29, 2014.

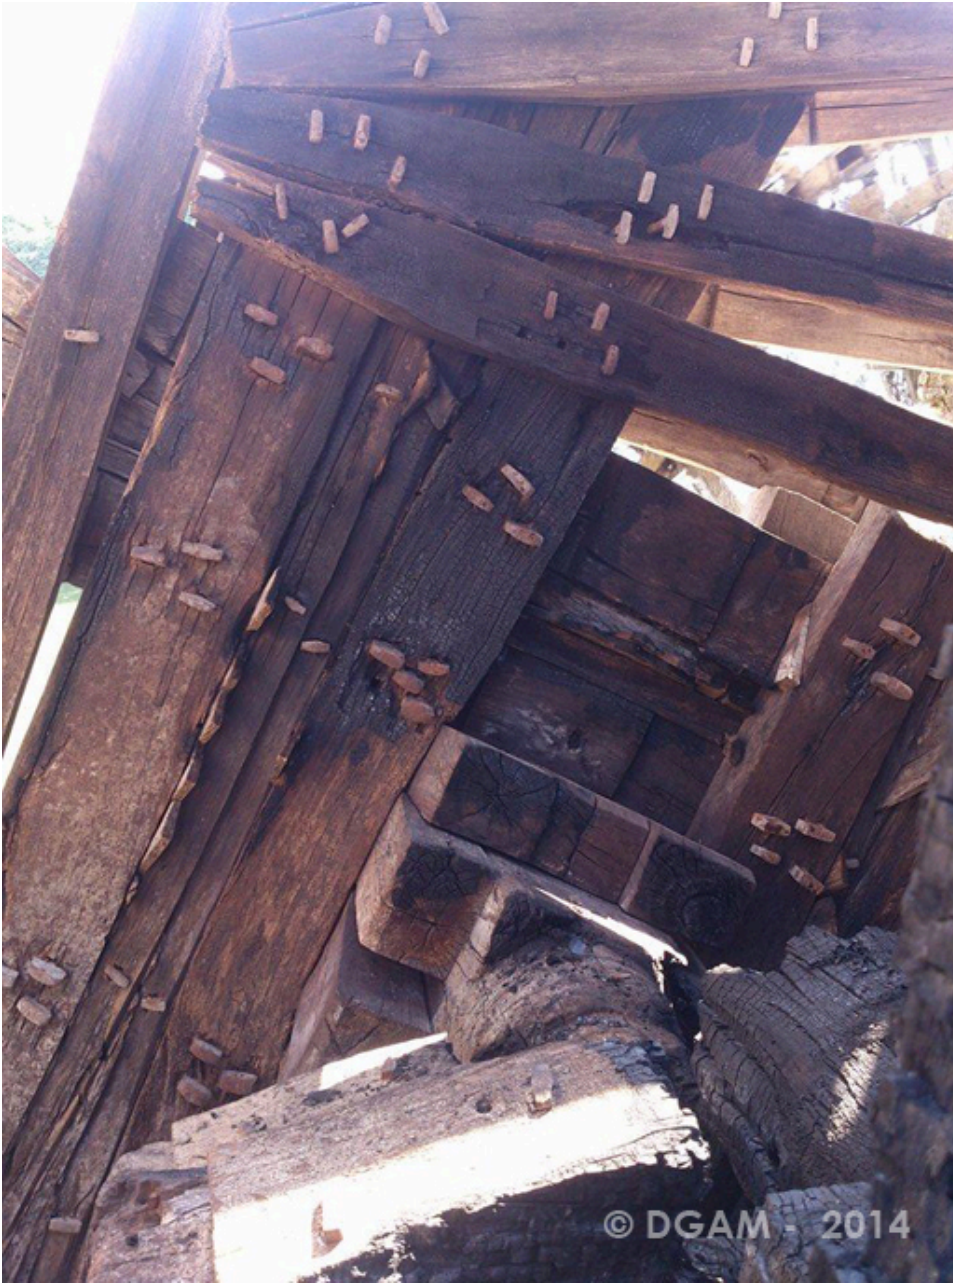
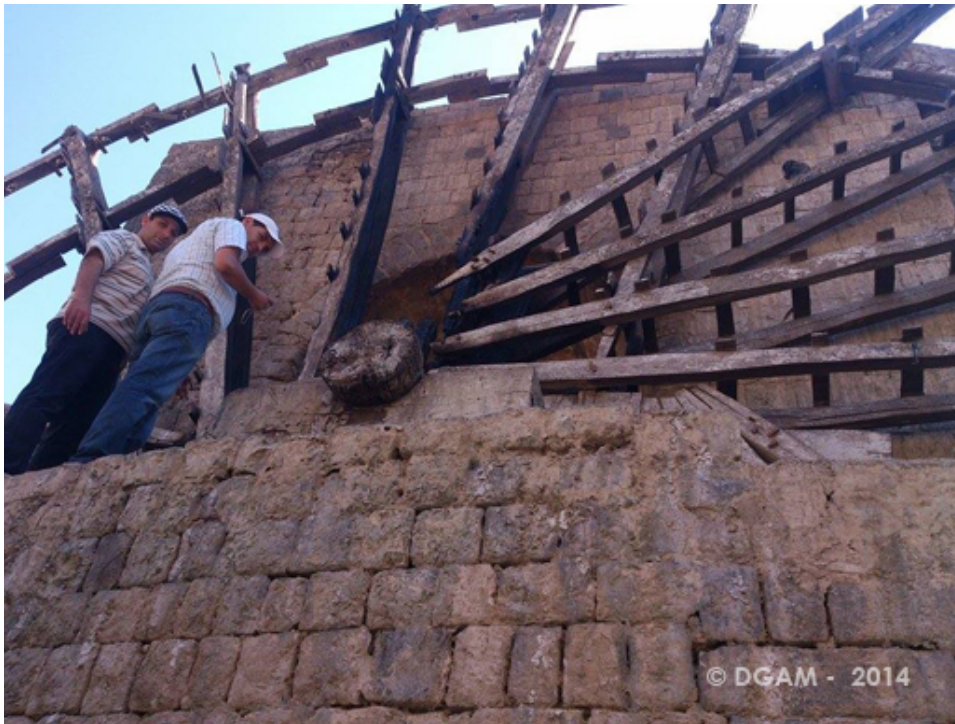
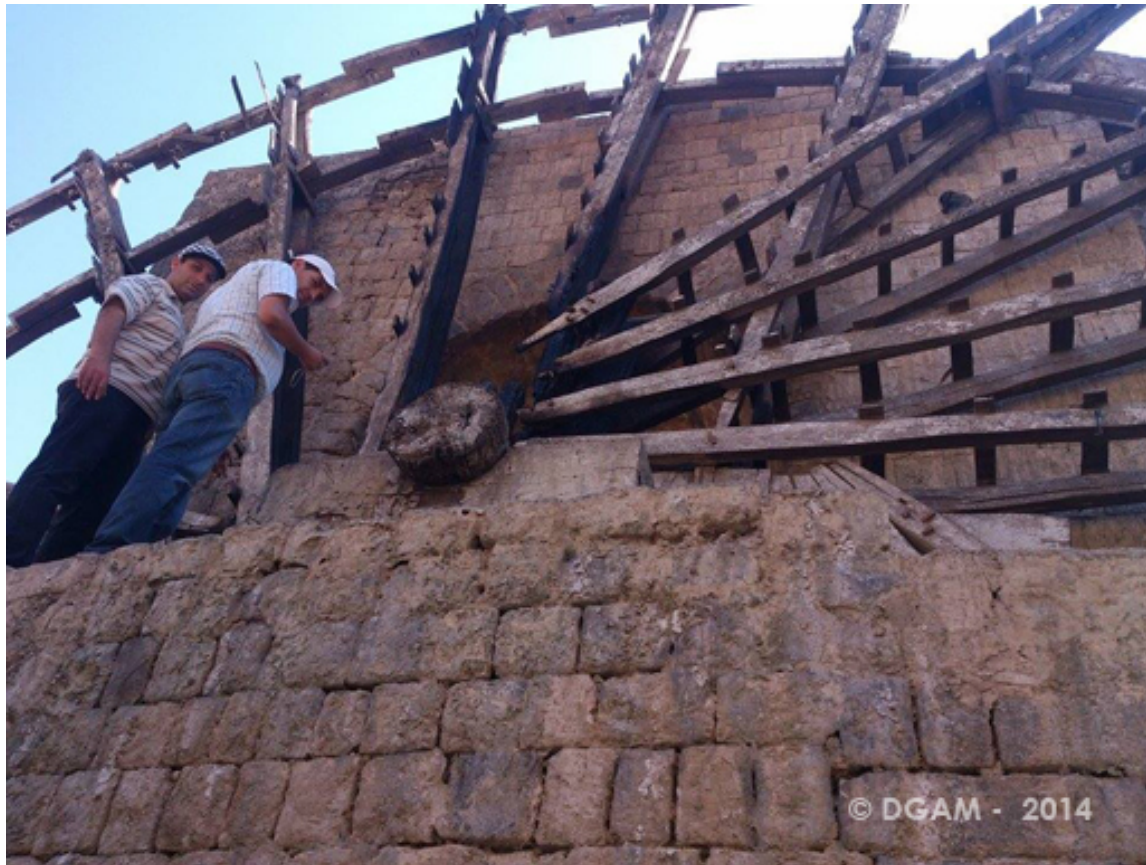
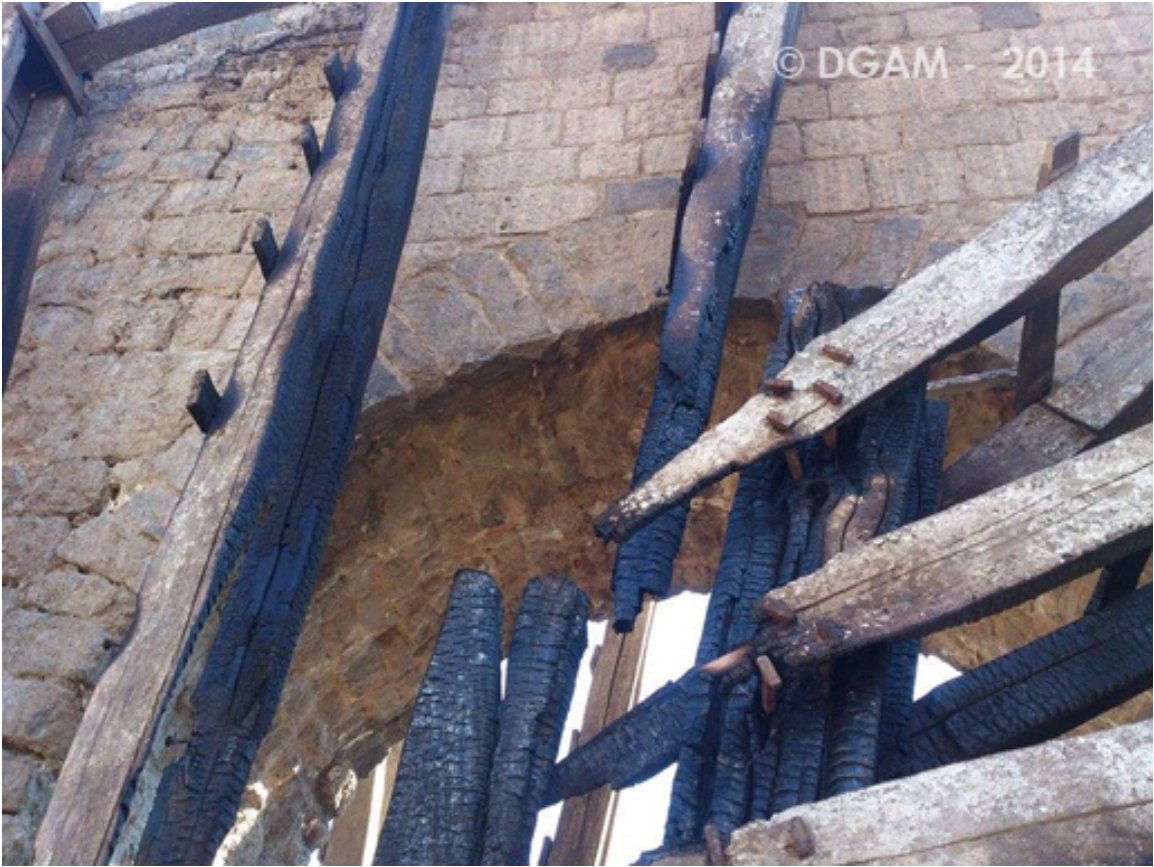
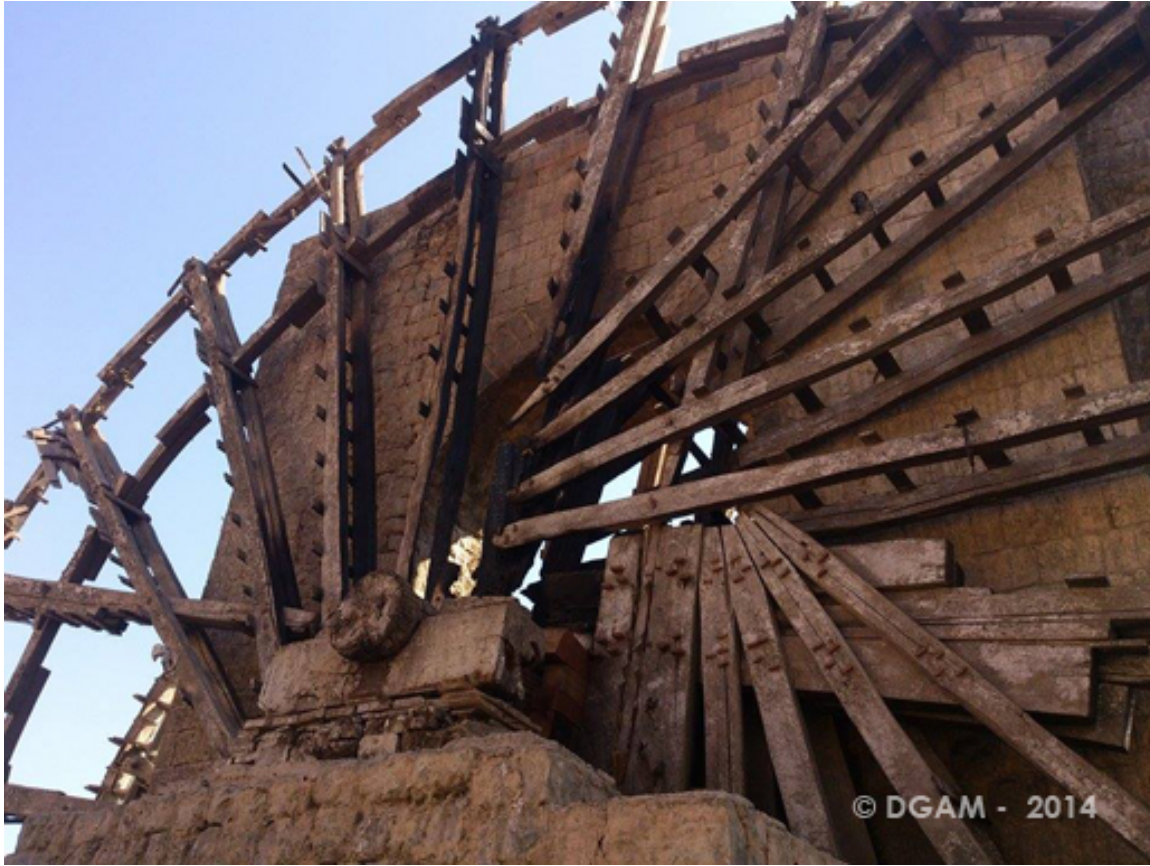
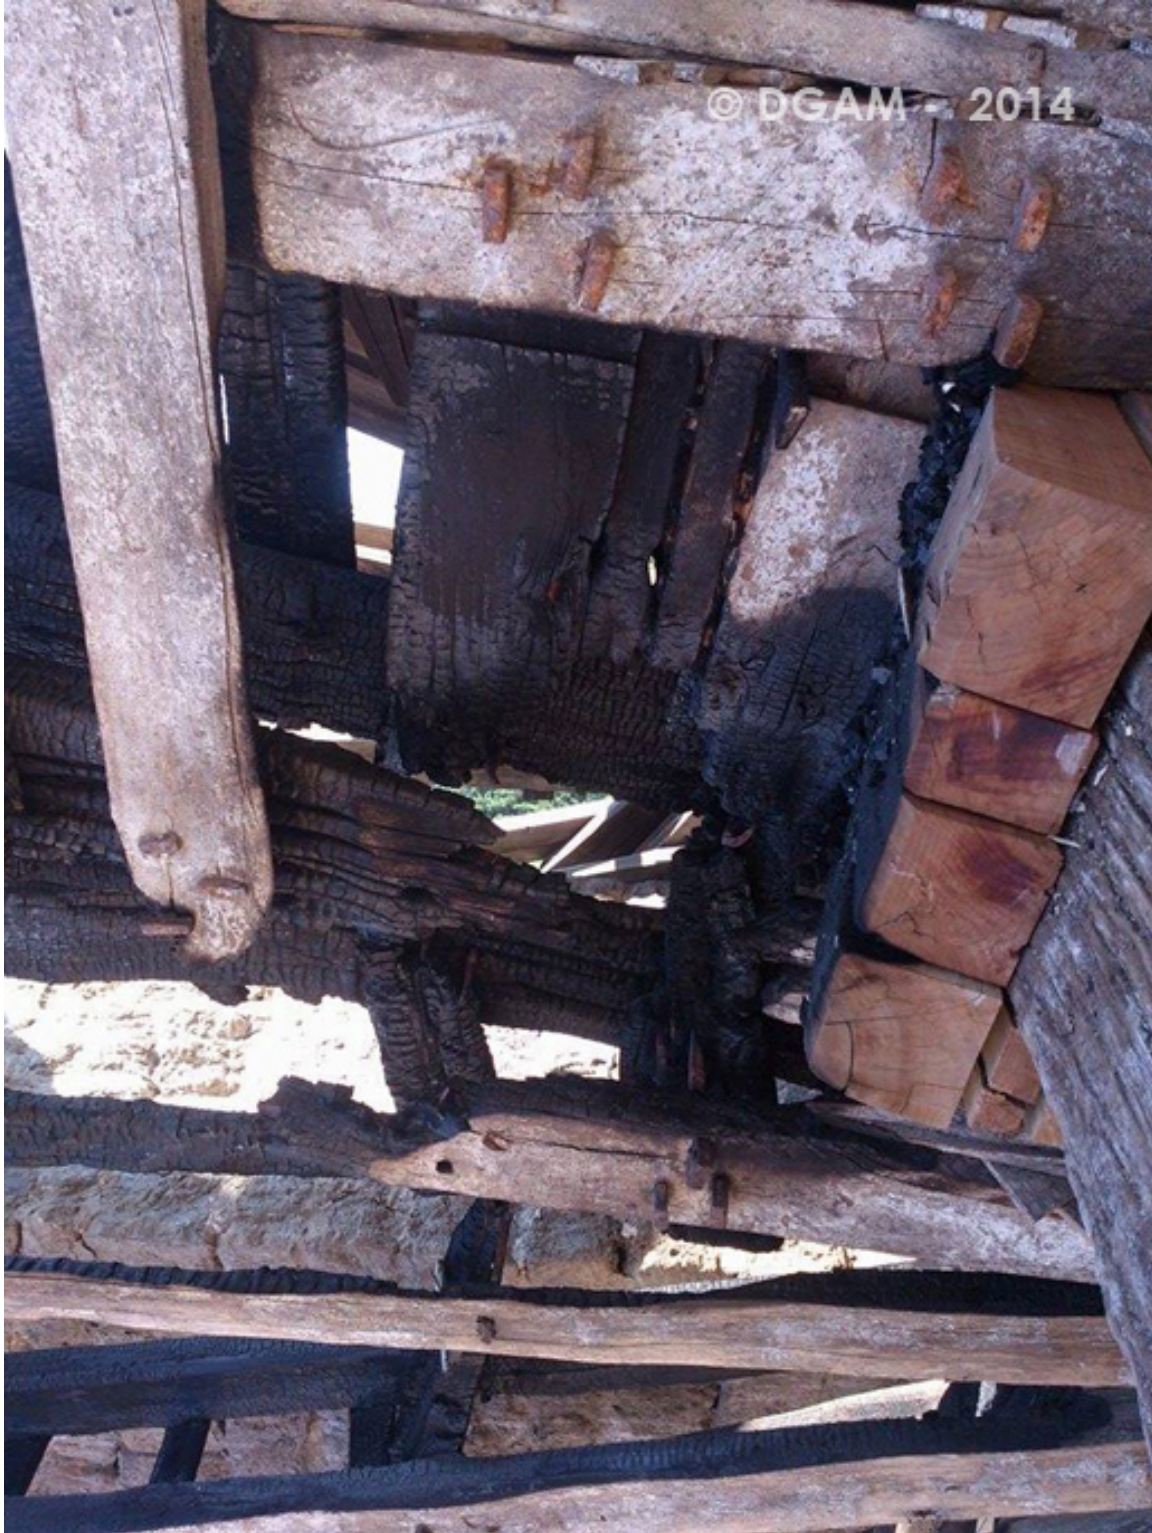
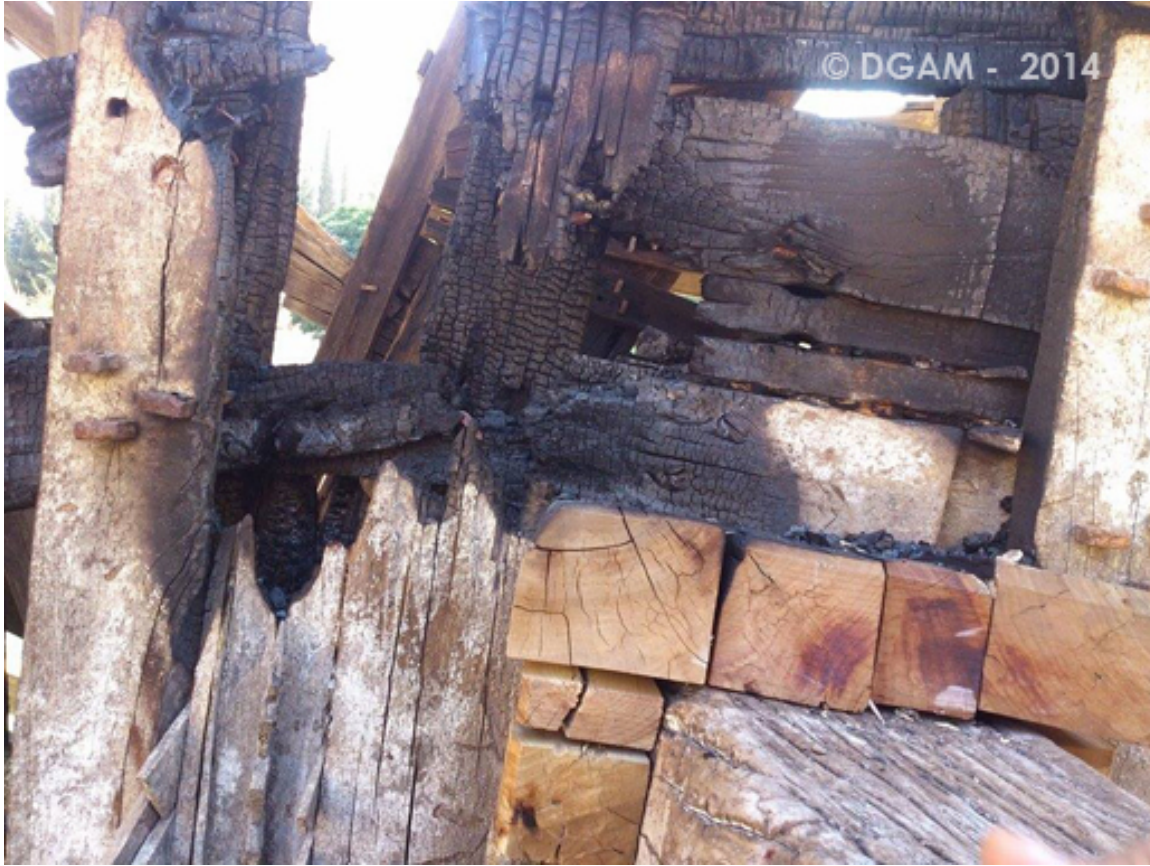
Source of Destruction: Electrical fire in the Sultan restaurant. DGAM claims "burned down by an unknown group."

Fire damage to the Noria al-J'berihe, Hama (DGAM).

Fire damage to the Noria al-J'berihé, Hama (DGAM).

Monitoring Recommendations and Mitigation Measures: This incident may be a deliberate act of arson. SHI will continue to monitor the situation in Hama, which has seen an upsurge in fighting since the spring and the struggle to control routes to Aleppo and Idlib.

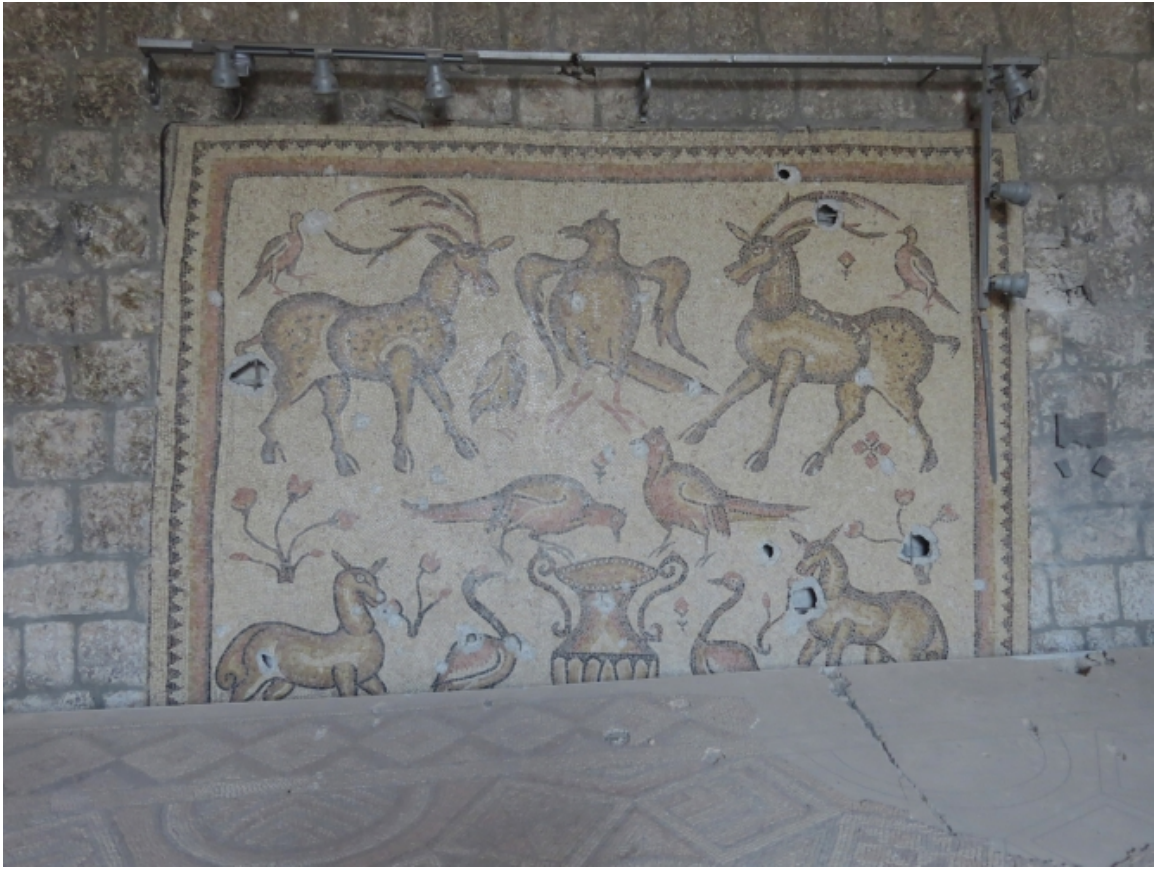
Site Description: The Smithsonian post does not disambiguate the location of this damage and the full implications of the incident. The damage shown in the photo, clearly caused by urban combat, occurred within the Maarat al-Numan Museum, which is located in the historic, Ottoman Period, Khan Murad Pahsa, which was restored in 1985. Previous media reports have detailed damage to this building and its collections. A full SHI incident report is in process. The photo suggests heavy combat within the historic structure, which contains large numbers of mosaics and other antiquities. According to Ross Burns²⁵,

The damaged mosaic in the Maarat al-Numan Museum from the site of al-Firkiye (510 AD) (Photo: Smithsonian Newsdesk).

Monitoring Recommendations and Mitigation Measures: This museum merits the special attention of SHI given the historic significance of the building, its contents, and
