ASOR Syrian Heritage Initiative (SHI): Planning for Safeguarding Heritage Sites in Syria¹

NEA-PSHSS-14-001

Weekly Report 5 — September 8, 2014

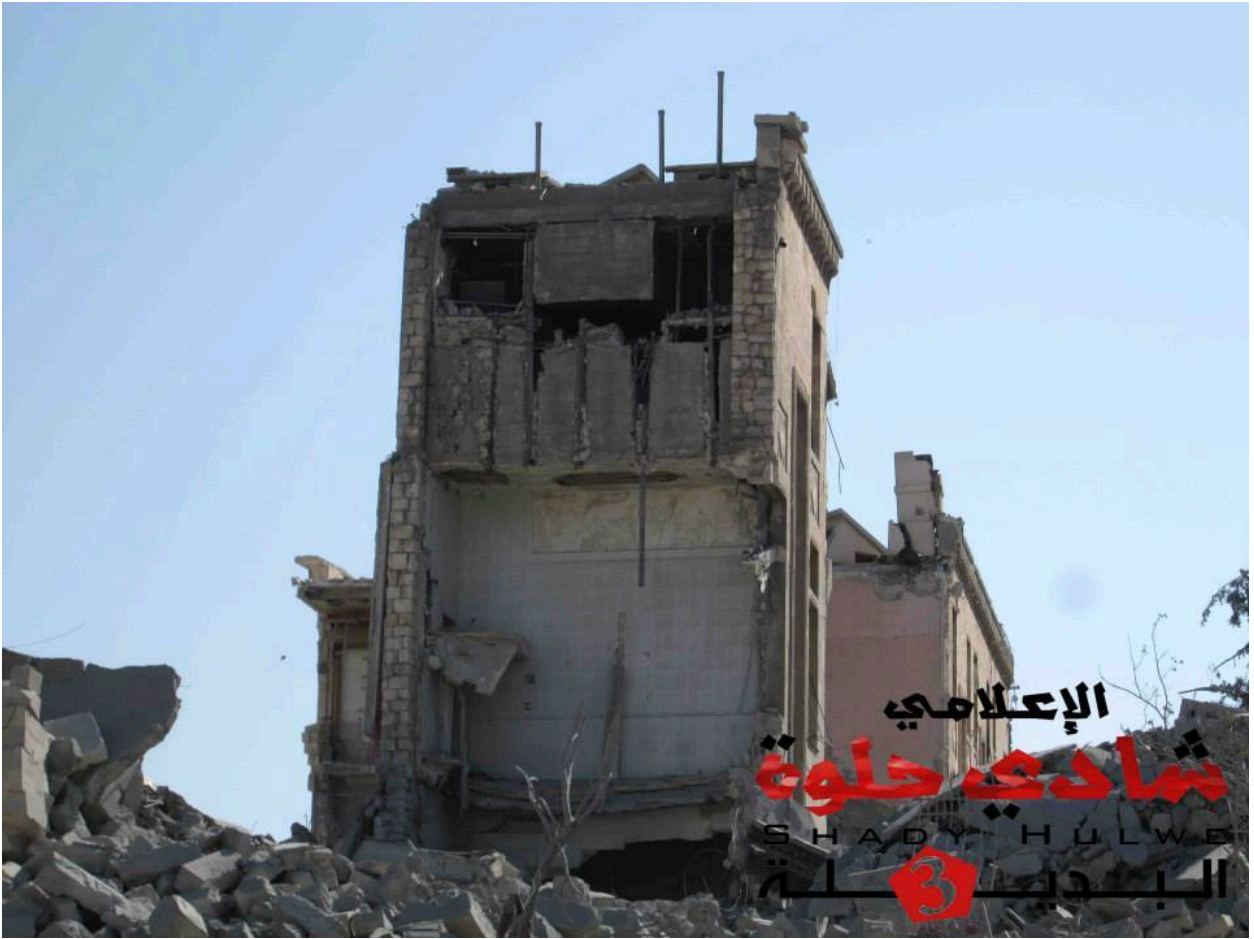
The remains of the Serail in the UNESCO World Heritage Site Old City of Aleppo following the two tunnel bombing of July 29 and two tunnel bombings on September 2, 2014. The neighboring Hammam Yalbougha was also reportedly damaged in the blasts (Shady Hulwe).

Source of Destruction: Allegedly two tunnel bombs were detonated on September 2, 2014 — the blast(s) destroyed the west wing of the Serail (see Map 1). Sources vary on the perpetrators, although previous tunnel bombings in this same theater of operations and against this same target (Serail) were claimed by the Islamic Front, as reported in SHI14-004. SARG forces were allegedly using the building at the time of (or just prior to) the bombing and in the months leading up to it. The neighboring Hammam Yalbougha was also damaged. This historic bathhouse was not the intended target, but as in the case of the July 27, 2014 tunnel bombing suffered extensive collateral damage due to its proximity. The blast(s) must surely have also caused collateral damage to the neighboring Madrasa Sultaniye — it too was previously damaged in the July 27 tunnel bombing.

Monitoring Recommendations and Mitigation Measures: SHI is currently producing a special report on the use of tunnel bombs in the conflict and the implications of this tactic for cultural heritage.

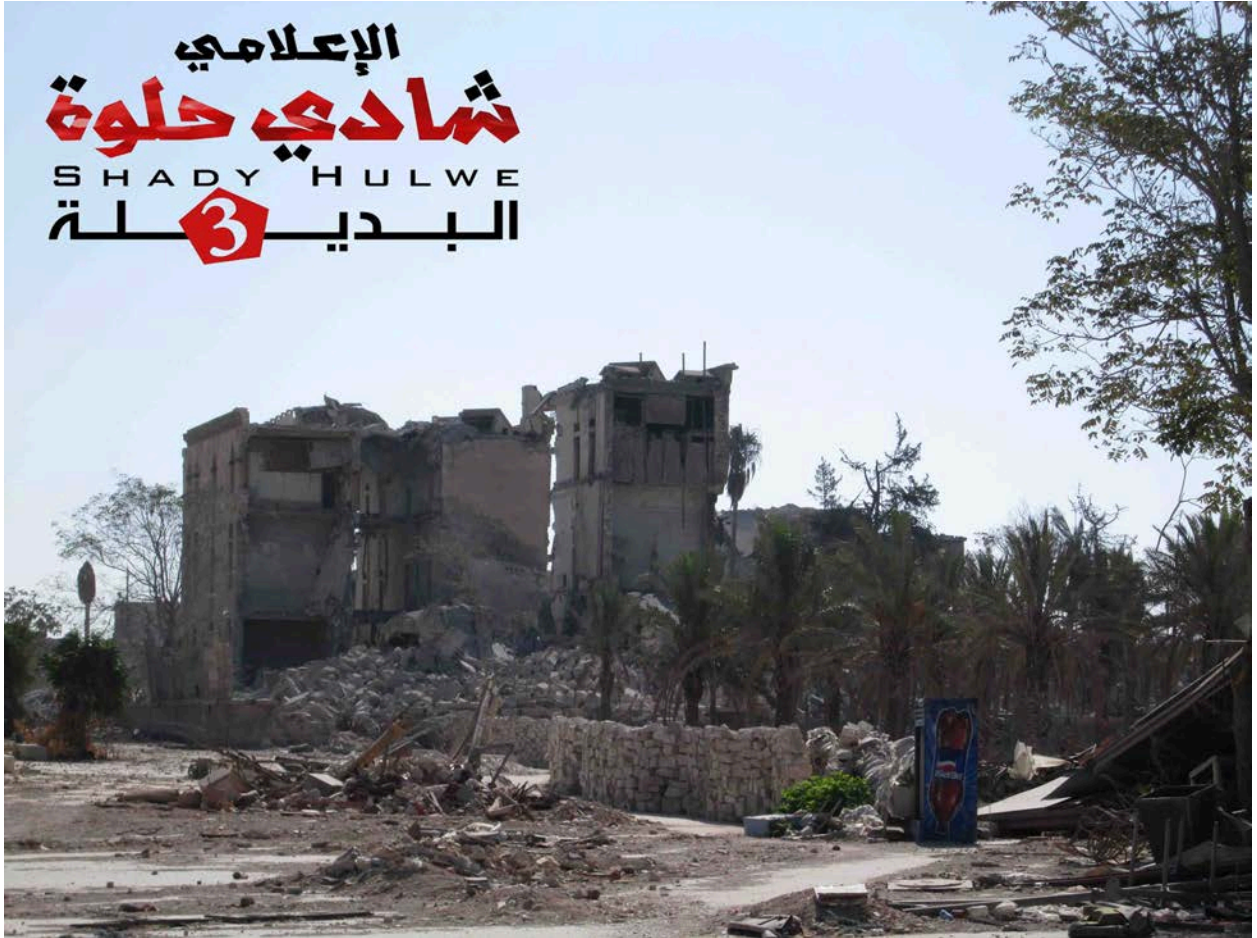
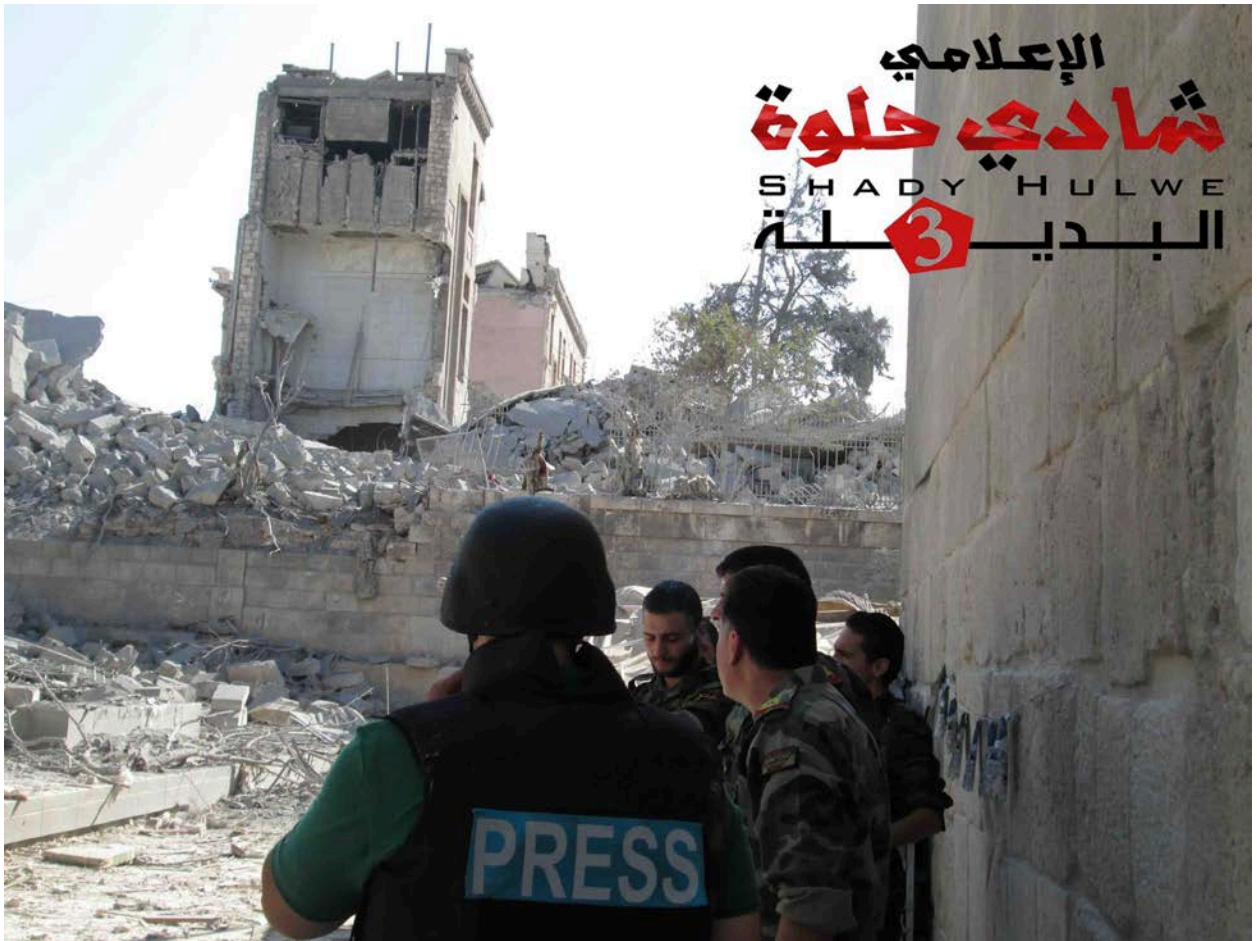
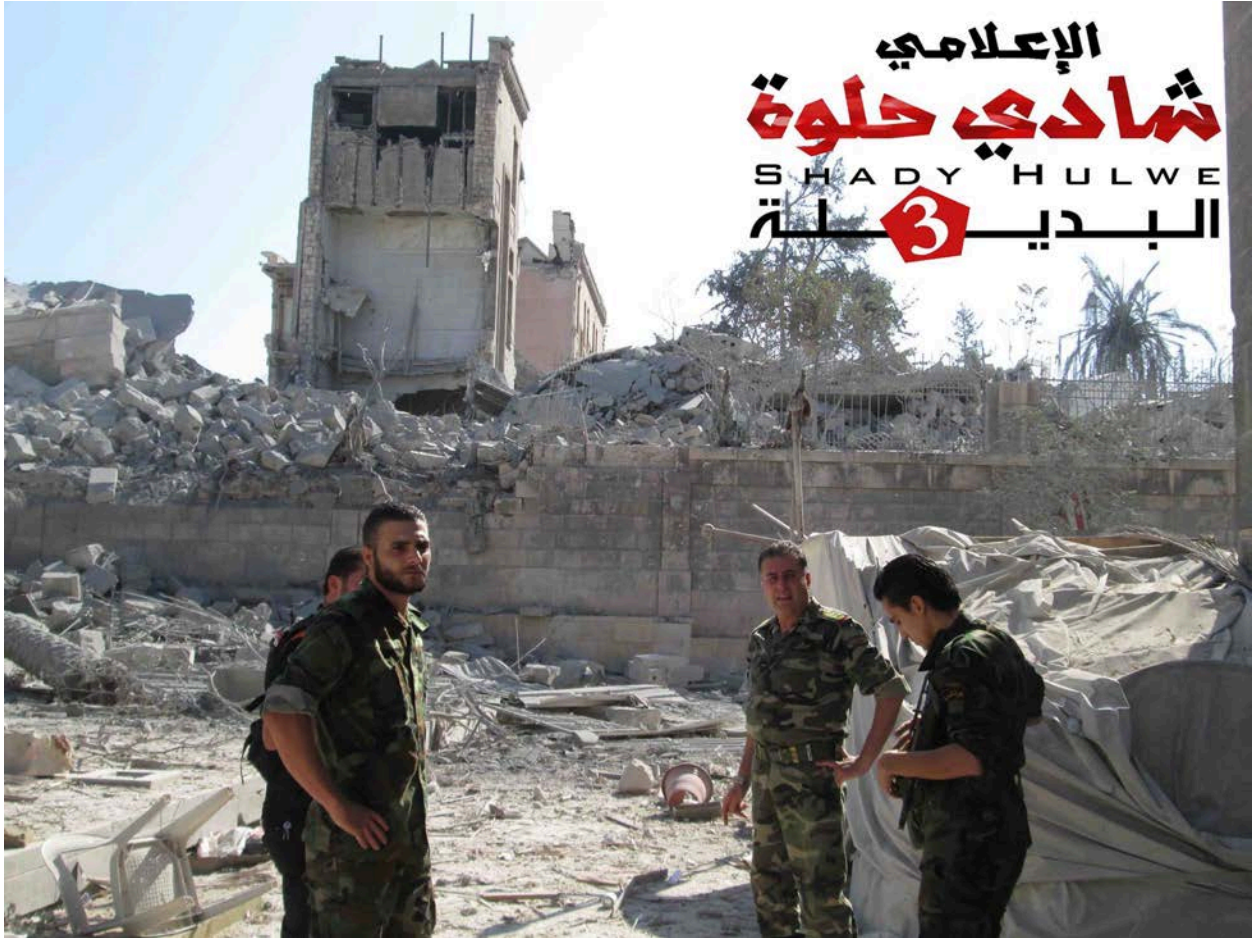
The remains of the Serail in Aleppo on September 3, 2014 (Shady Hulwe).

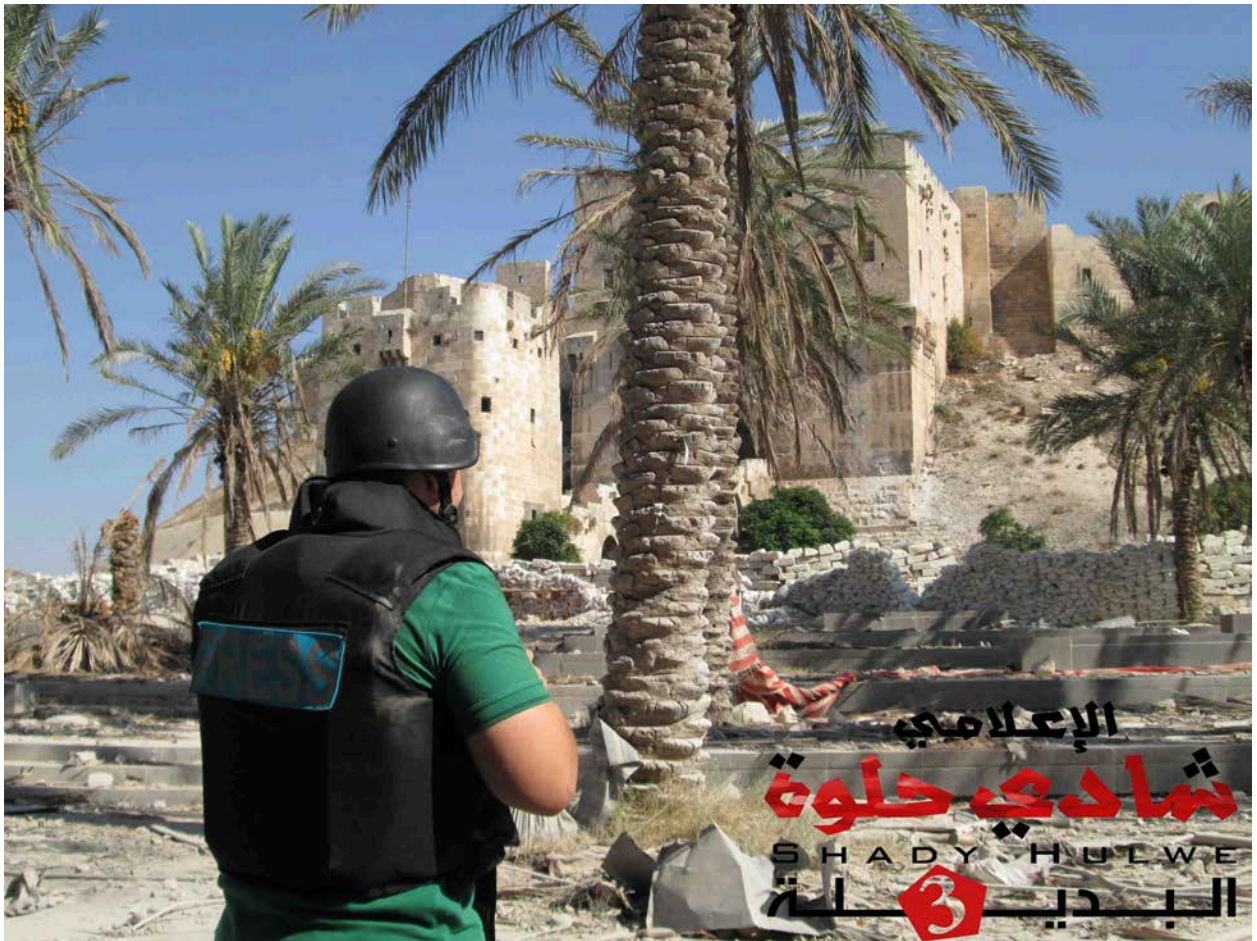
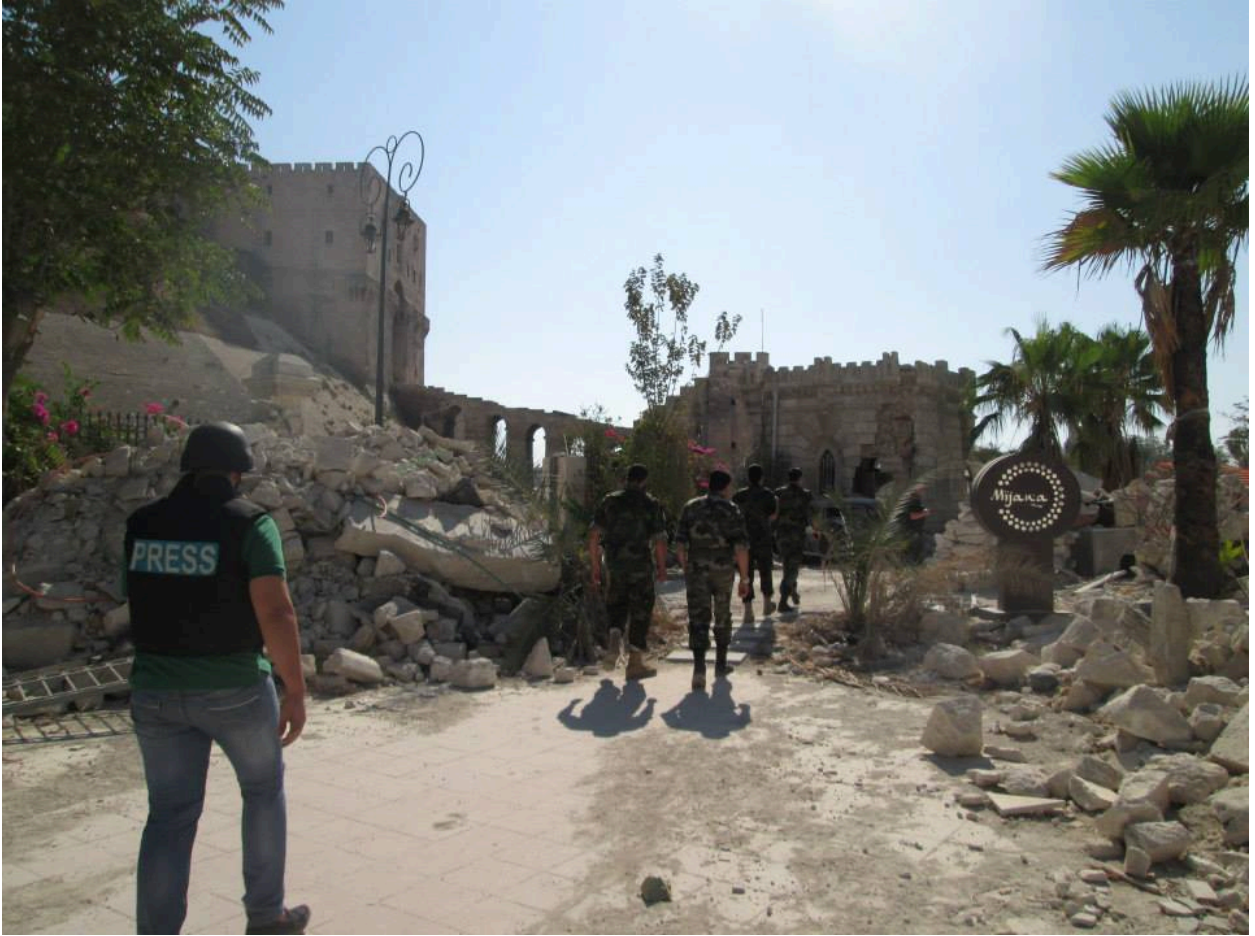
The entrance to the Aleppo Citadel on September 3, 2014 (Shady Hulwe).

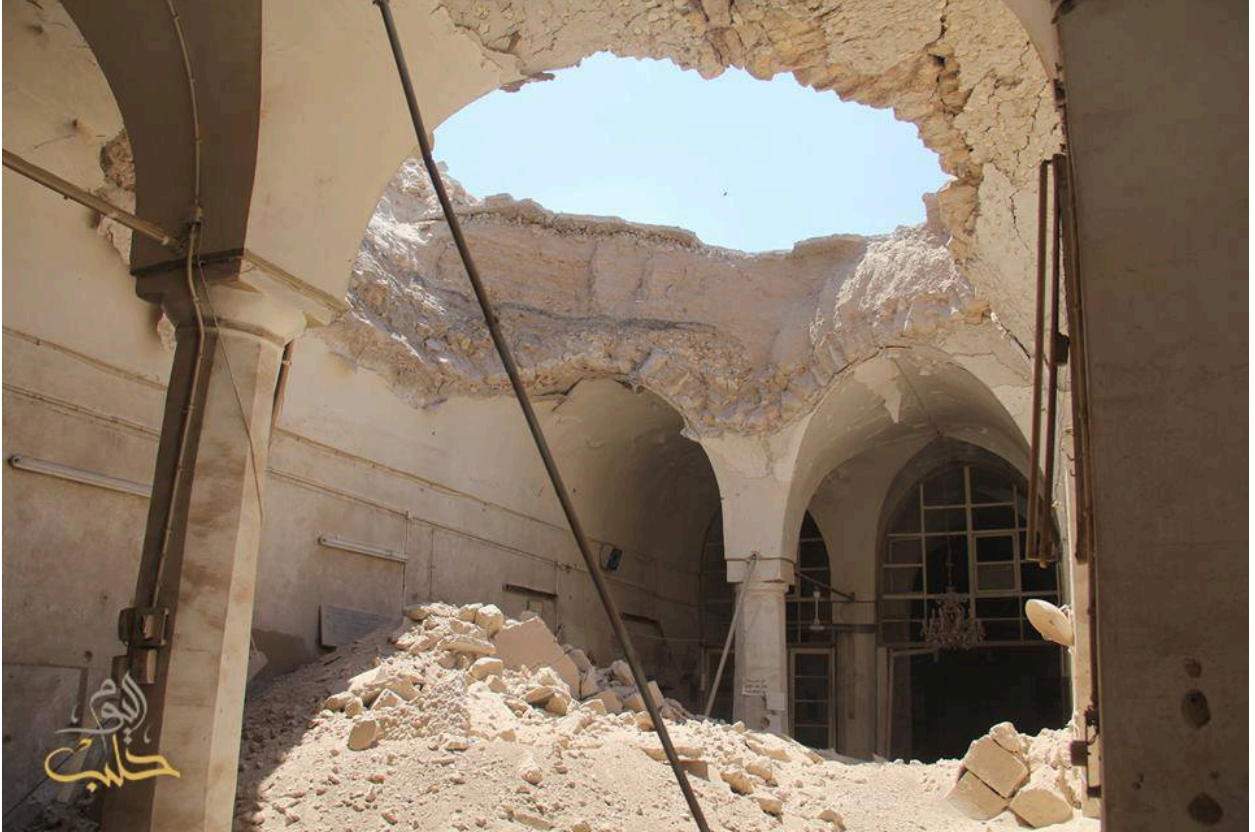
Source of Destruction: Presumably combat damage. The building has been extensively damaged and its main dome has collapsed.

Damage to the Haddadin Mosque in the UNESCO World Heritage Site Ancient City of Aleppo (APSA).

Monitoring Recommendations and Mitigation Measures: The oncoming inclement weather of the cold/rainy season in Syria will cause additional damage to buildings with damaged roofs or those otherwise open to the elements through water intrusion and marked diurnal temperature variations. Efforts should be made to seal these buildings with tarps and plastic sheeting to divert rainwater from interiors.

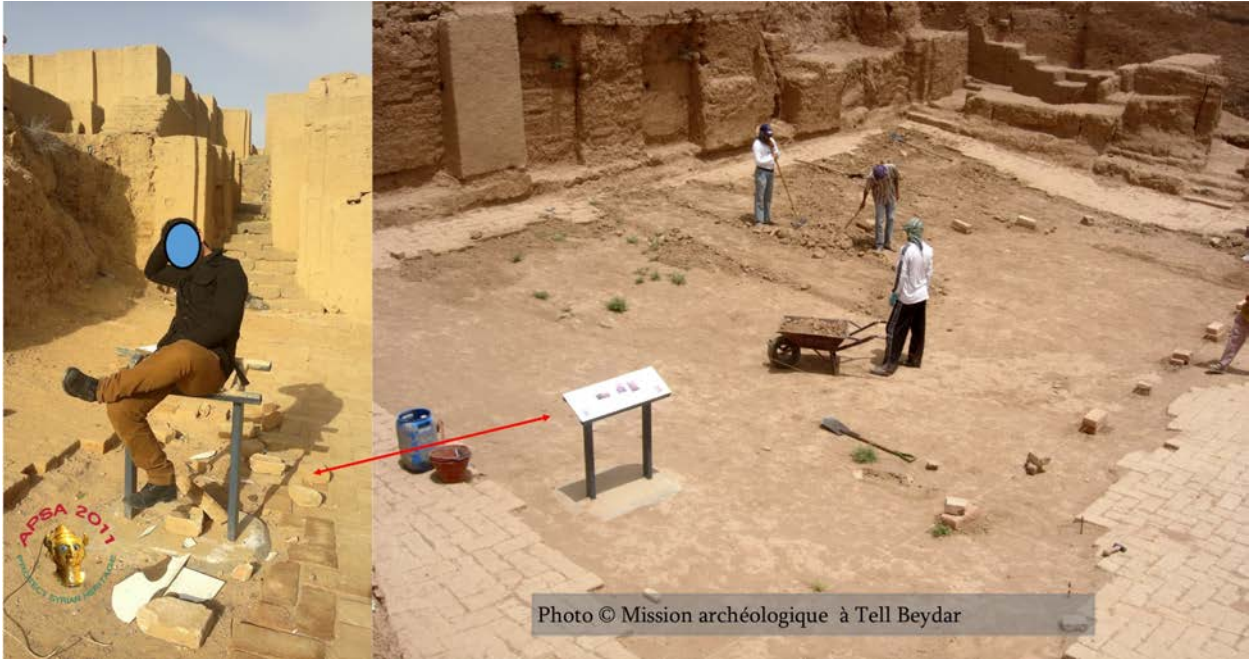
Source of Destruction: Vandals have removed brick paving and have destroyed signage.

Vandalism at Tell Beydar.

Monitoring Recommendations and Mitigation Measures: I note that there is currently no recent satellite imagery available for Tell Beydar — we will be requesting new images. I suspect the vandalism documented at Tell Beydar is typical of most archaeological sites with open excavation areas.
