# ASOR Syrian Heritage Initiative (SHI): Planning for Safeguarding Heritage Sites in Syria<sup>1</sup>

NEA-PSHSS-14-001

Weekly Report 6 – September 15, 2014

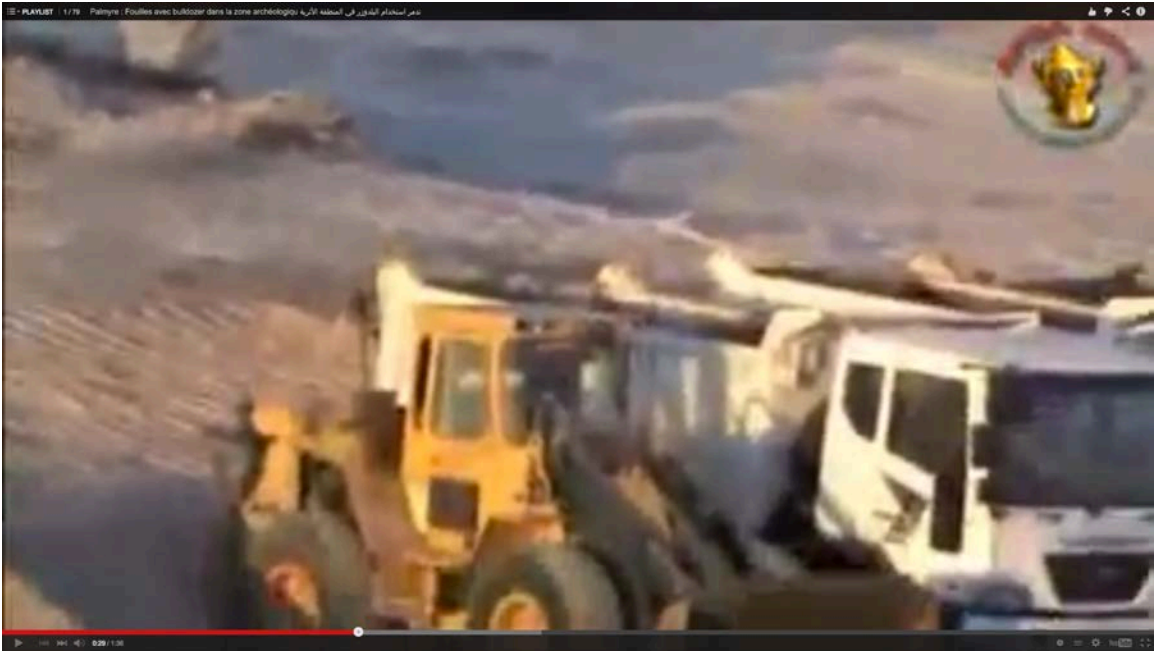
**Source of Destruction:** A video posted by APSA shows a bulldozer and numerous trucks in the archaeological area surrounding the Palmyra citadel.

Screenshot of the ASPA video showing a bulldozer in the archaeological section of Palmyra (APSA).

**Monitoring Recommendations and Mitigation Measures:** Palmyra continues to be one of SHI's key foci for monitoring, mitigation, and preservation projects.

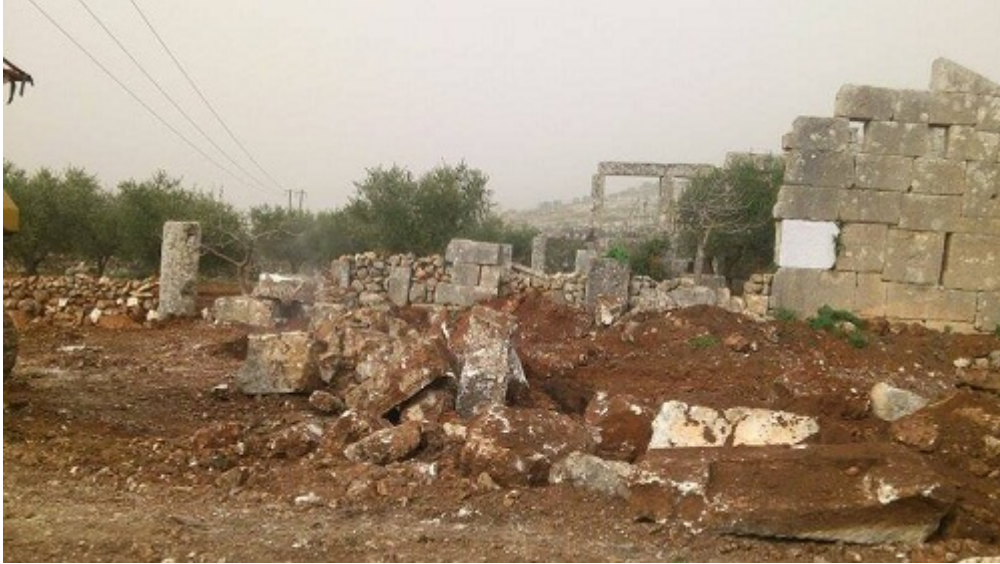
- **St. Simeon Castle** – Clashes caused minor damage to the northern façade.
- **St. Simeon Monastery** – Digging and illegal building are evident at the northern part of the monastery, while illegal construction is also present on the northern wall of the western monastery. Further illegal building is present in the southern shrine of the northeastern part of the monastery, where ancient stones have been mined for building material.

Photograph of the St. Samaan Monastery showing ancient stones broken by bulldozer (DGAM).

**Monitoring Recommendations and Mitigation Measures:** SHI has already prioritized St. Simeon and this region for monitoring and evaluation.

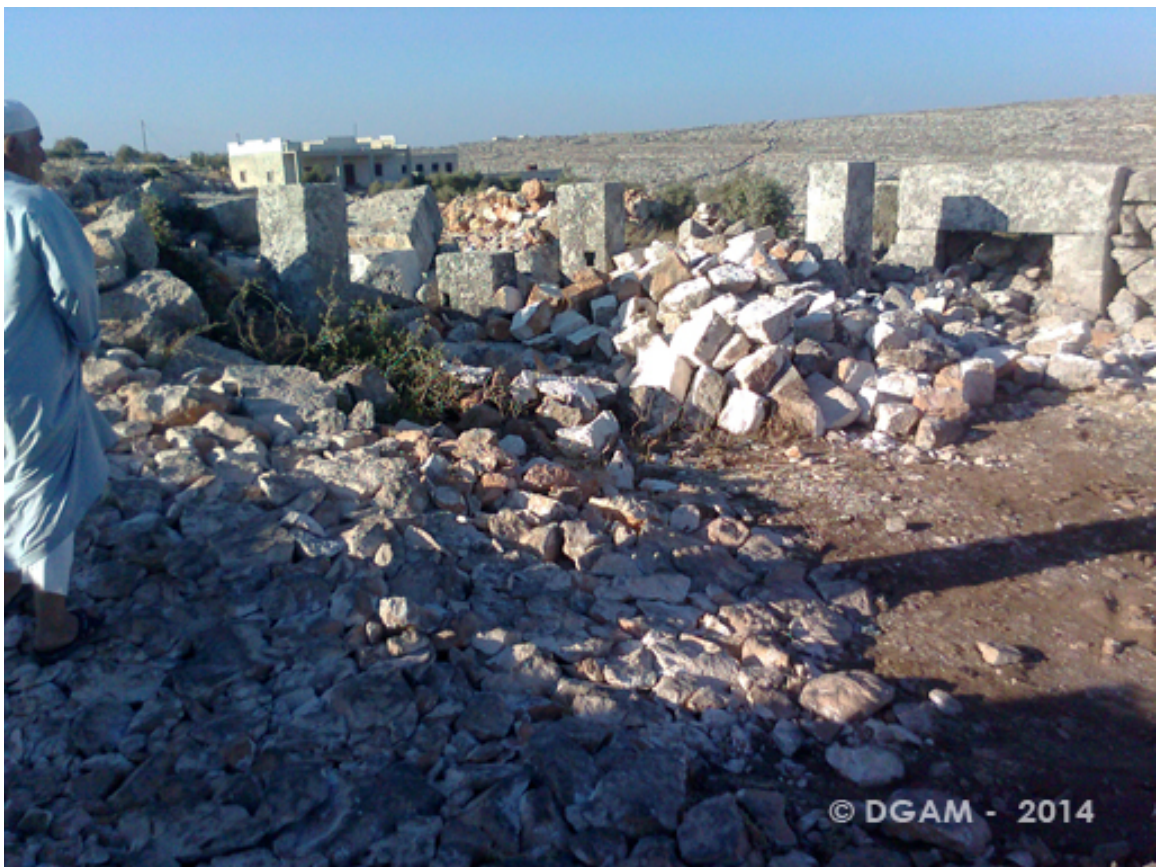
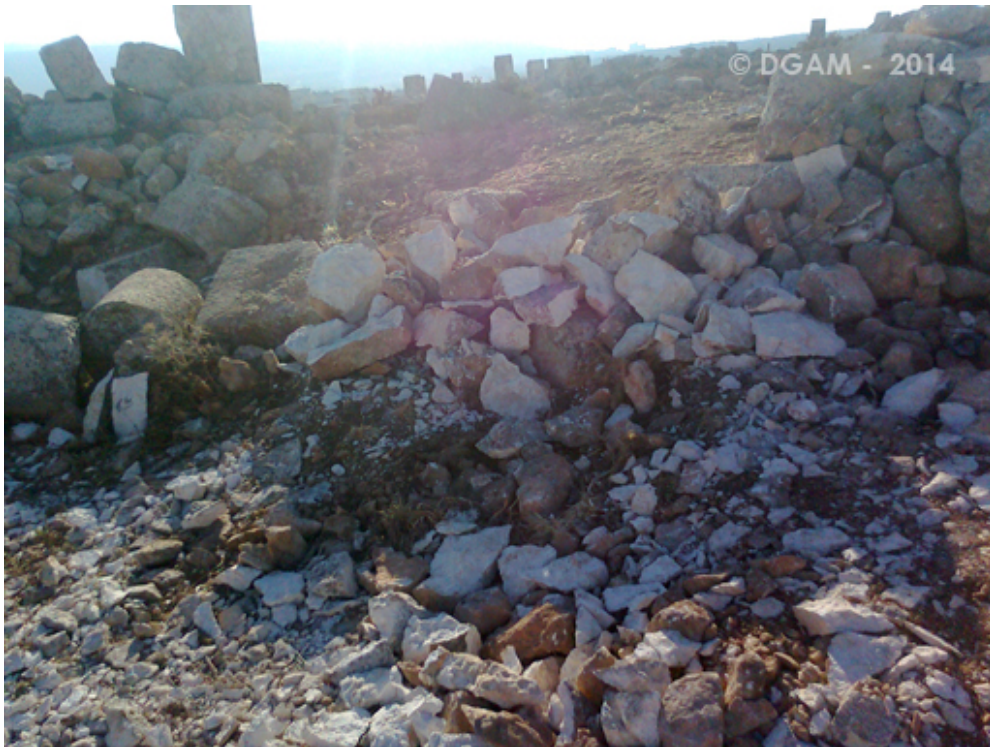
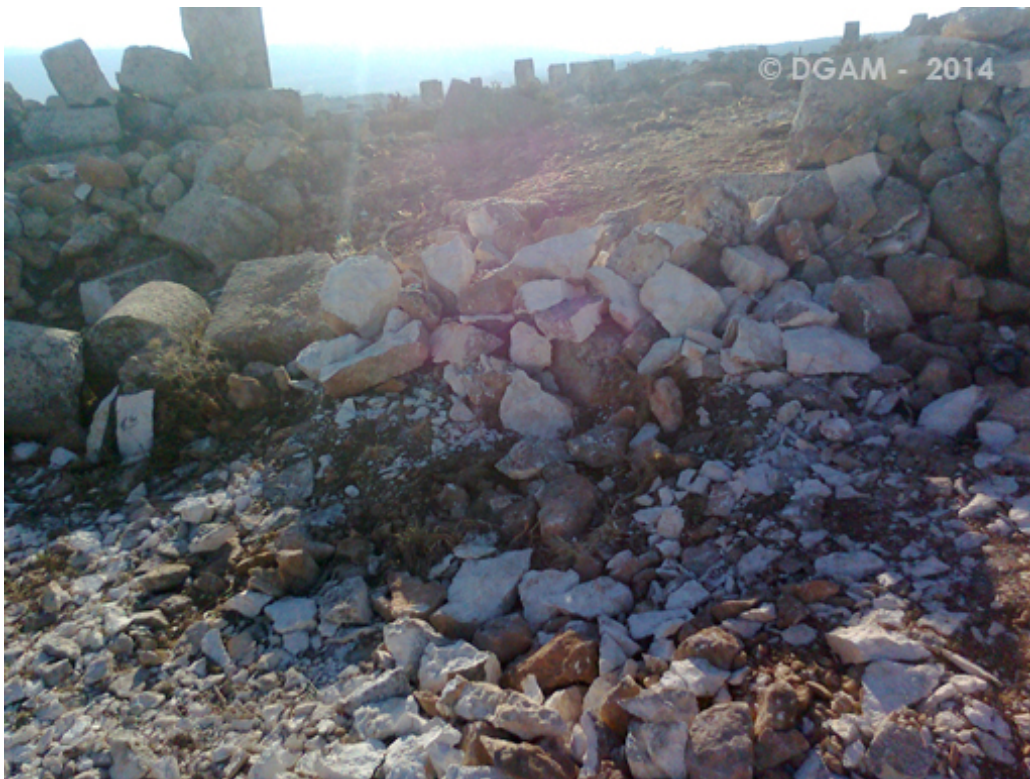
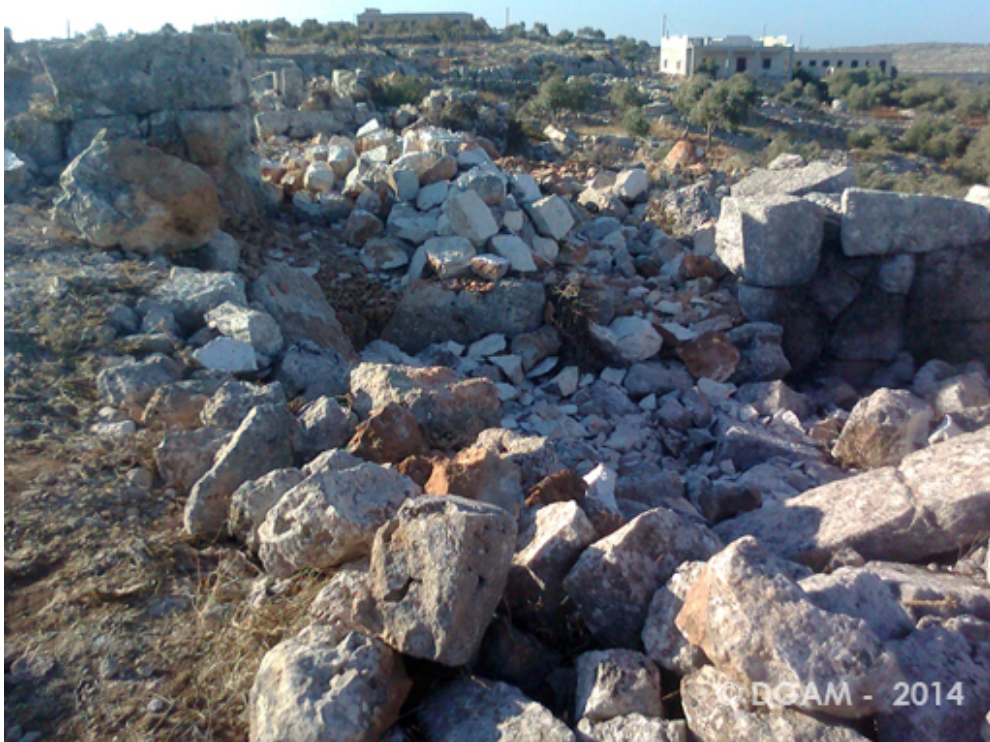
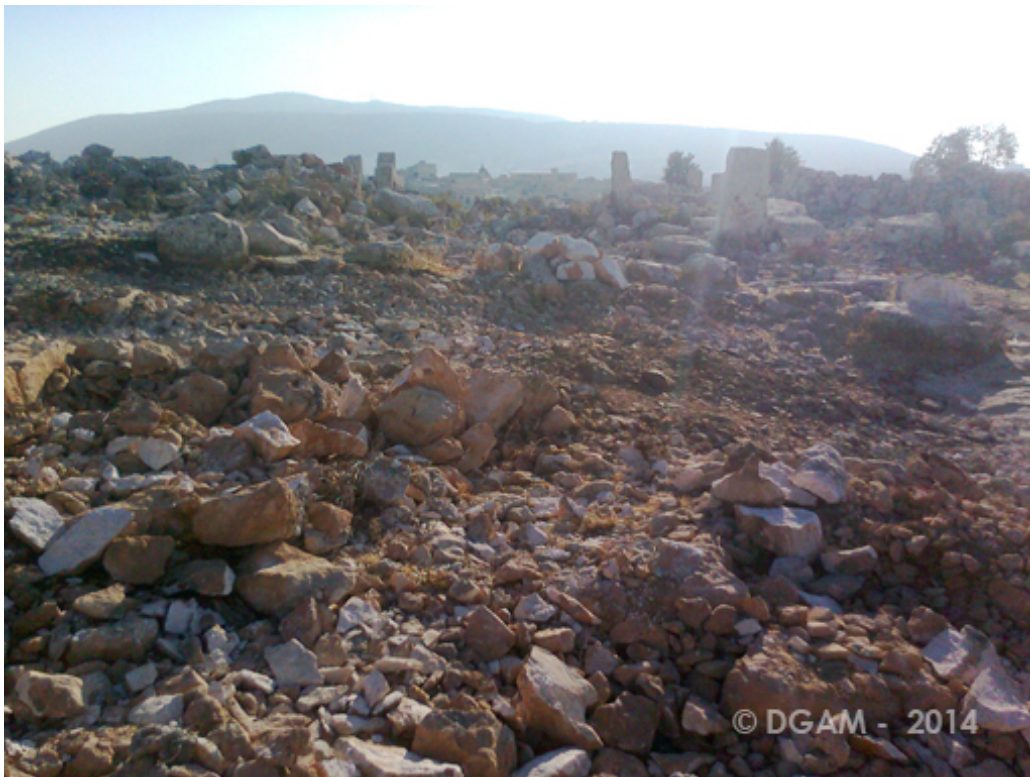
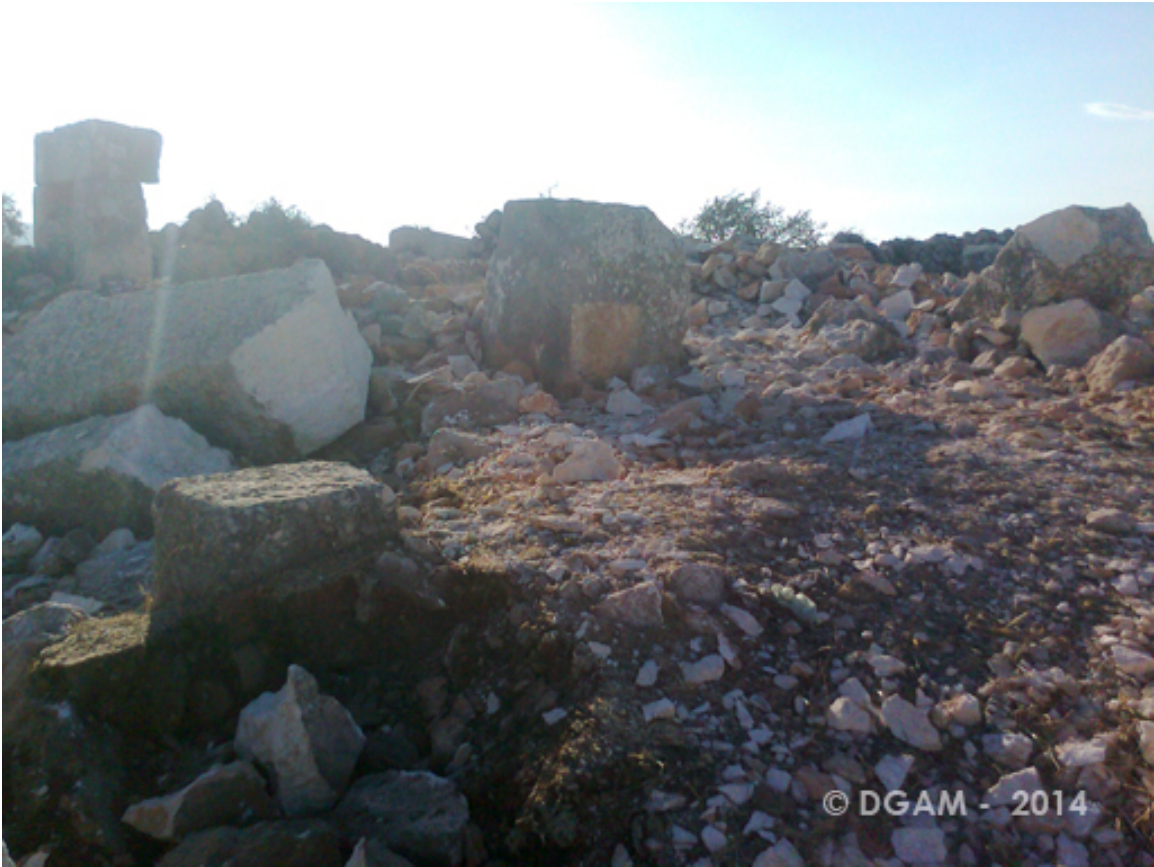
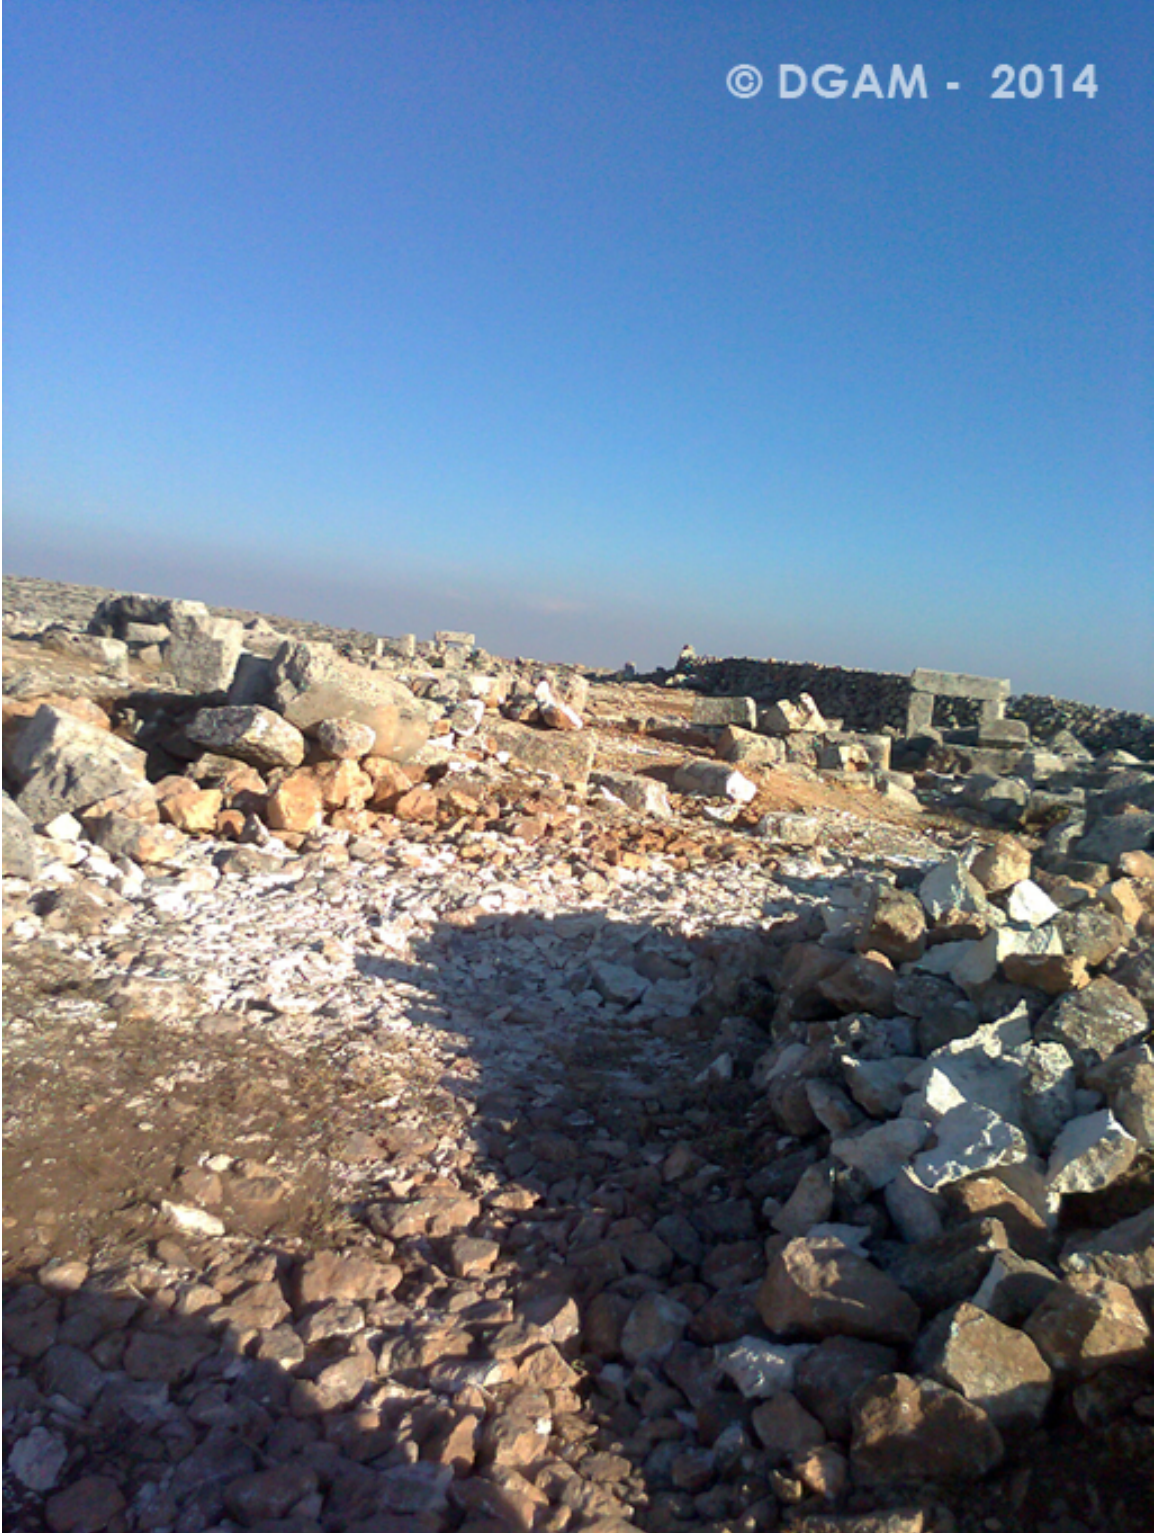
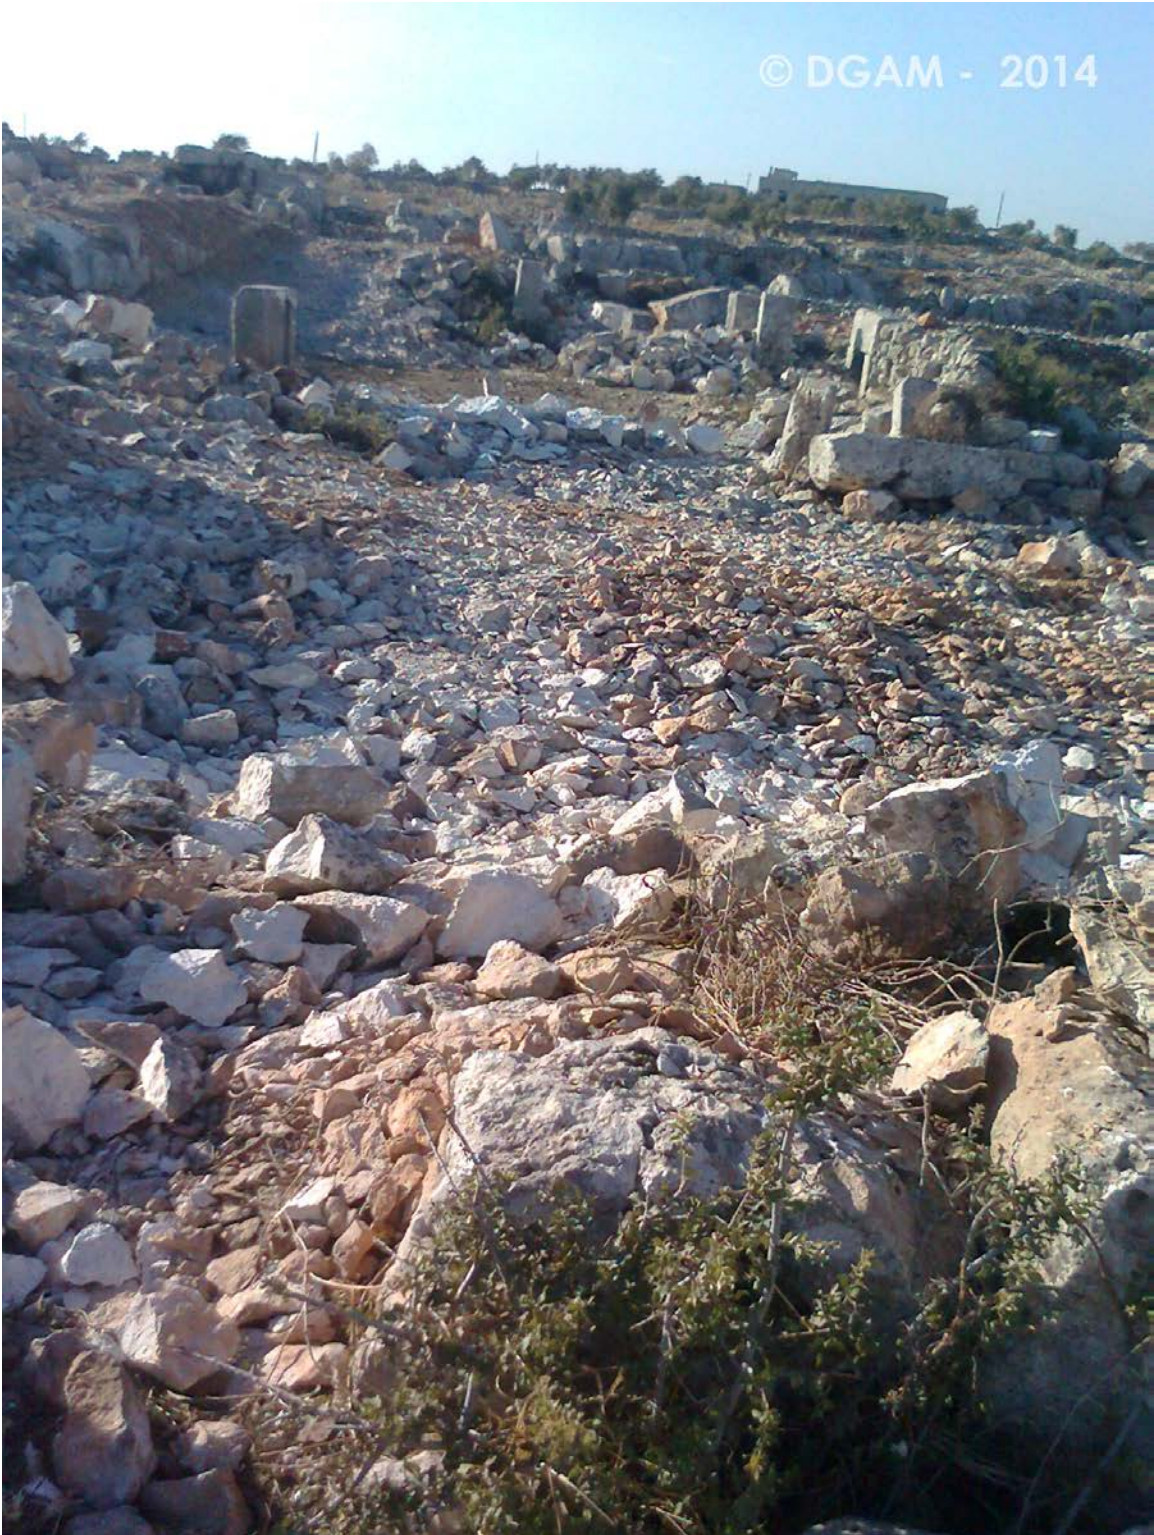
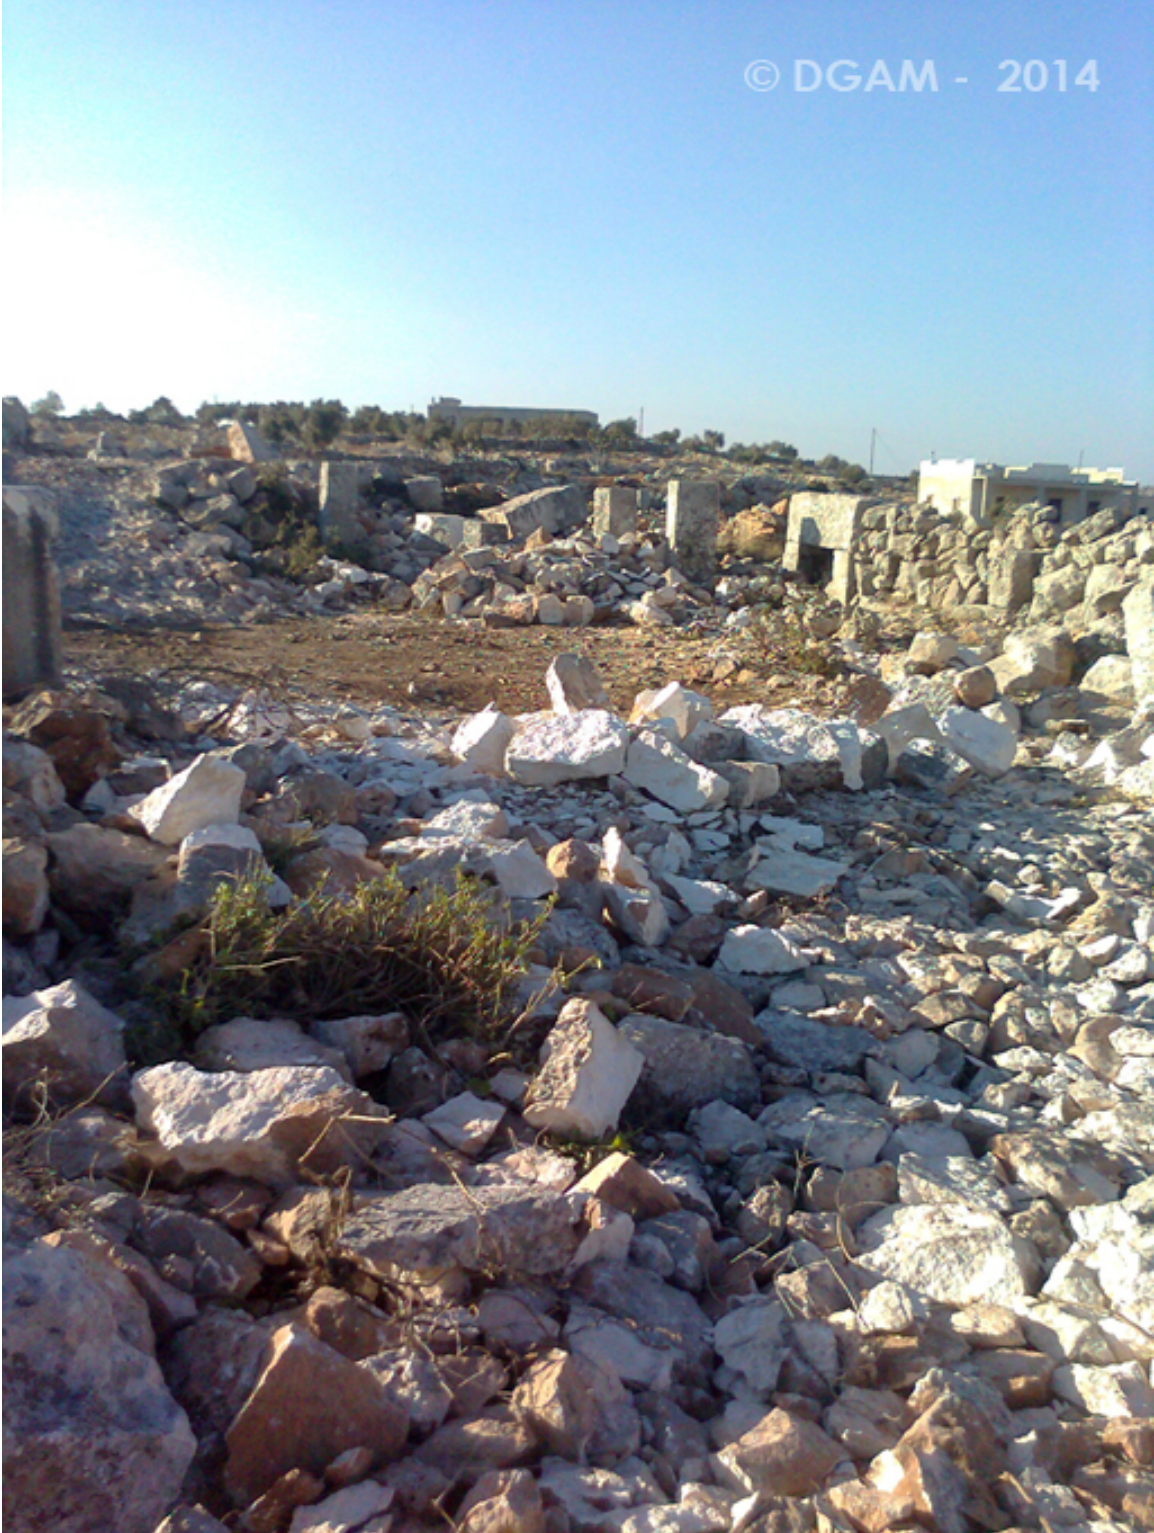
- **The Triumphal Arch** – Evidence of digging and illegal building are also present at the old entrance to the church, which connects the castle with the monastery. Vandals have mined ancient stones for building material, inflicting additional damage on the walls with a bulldozer and drilling, which was used to make space for the illegal shops.

Photograph showing large ancient stones at St. Simeon Castle that have been broken for building material (DGAM).

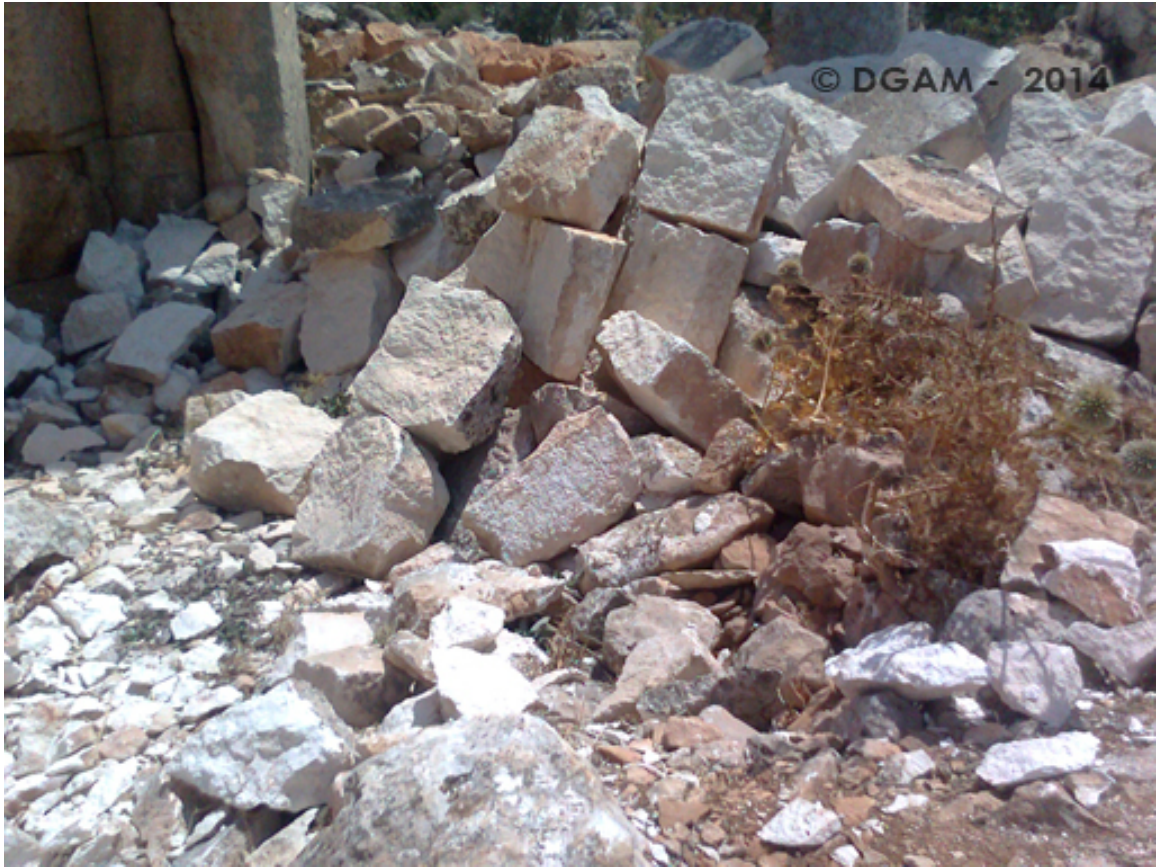
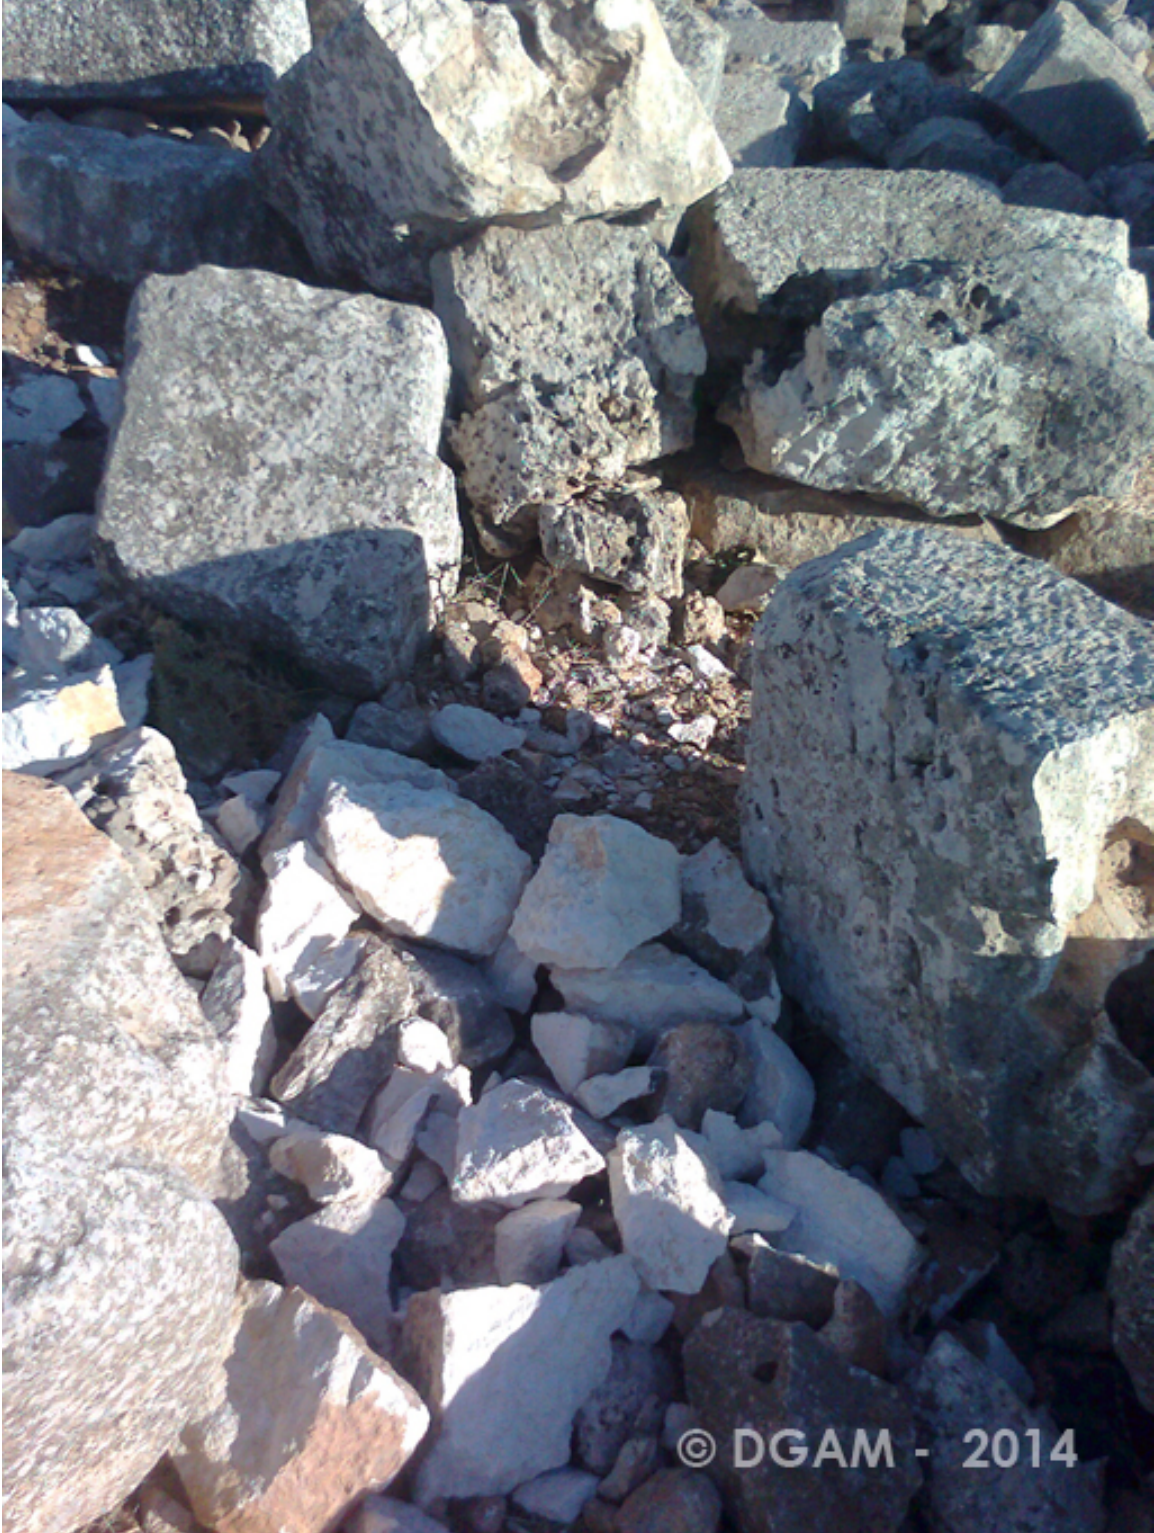
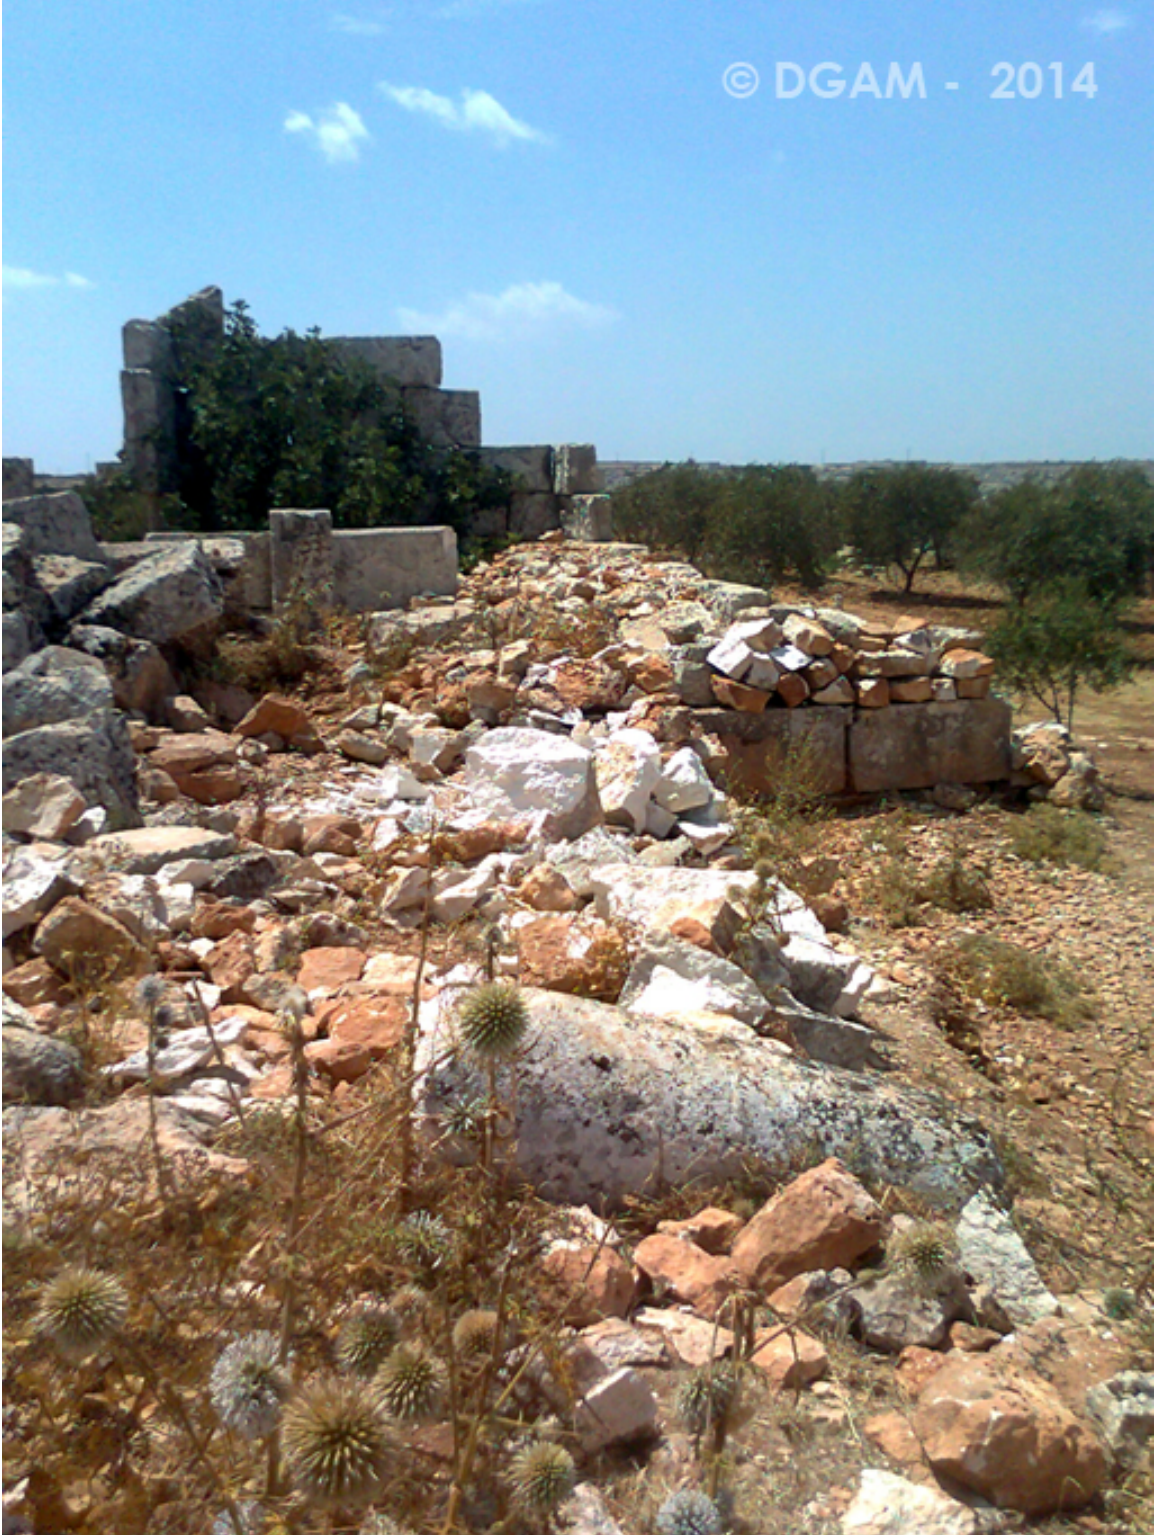
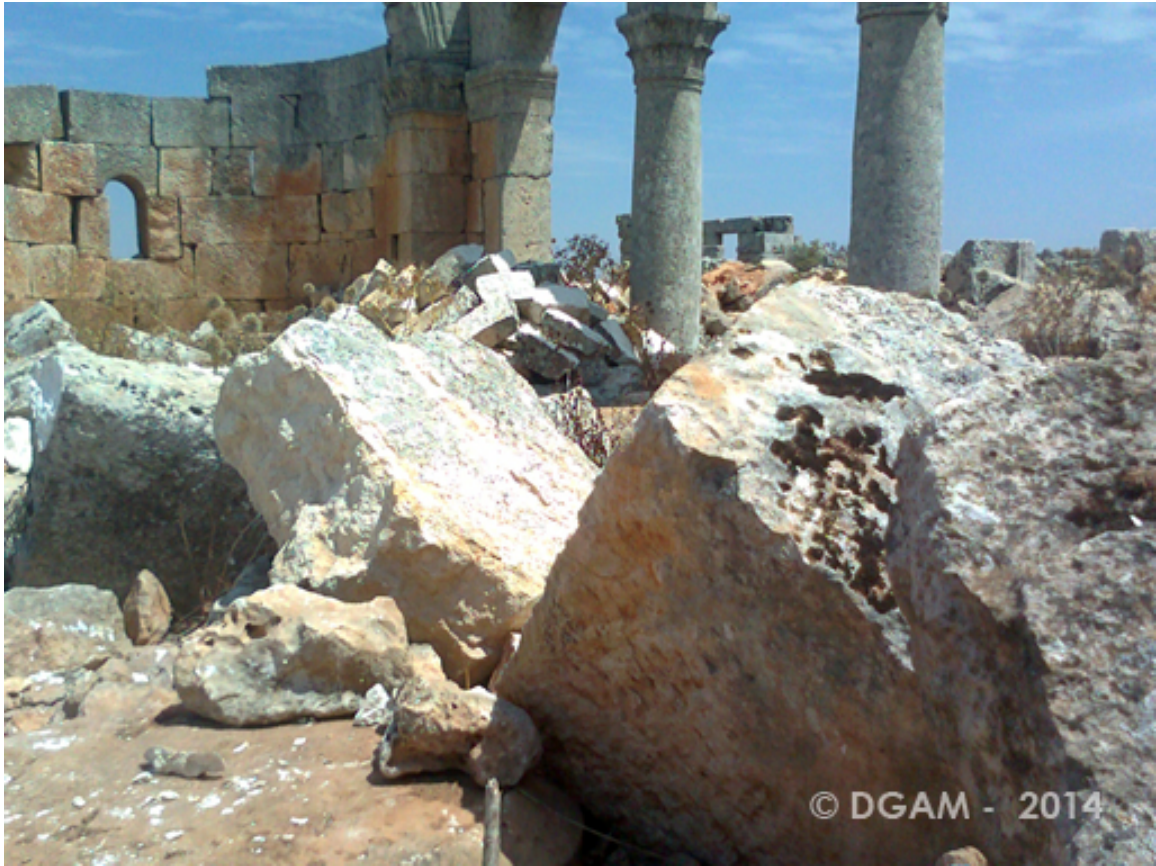
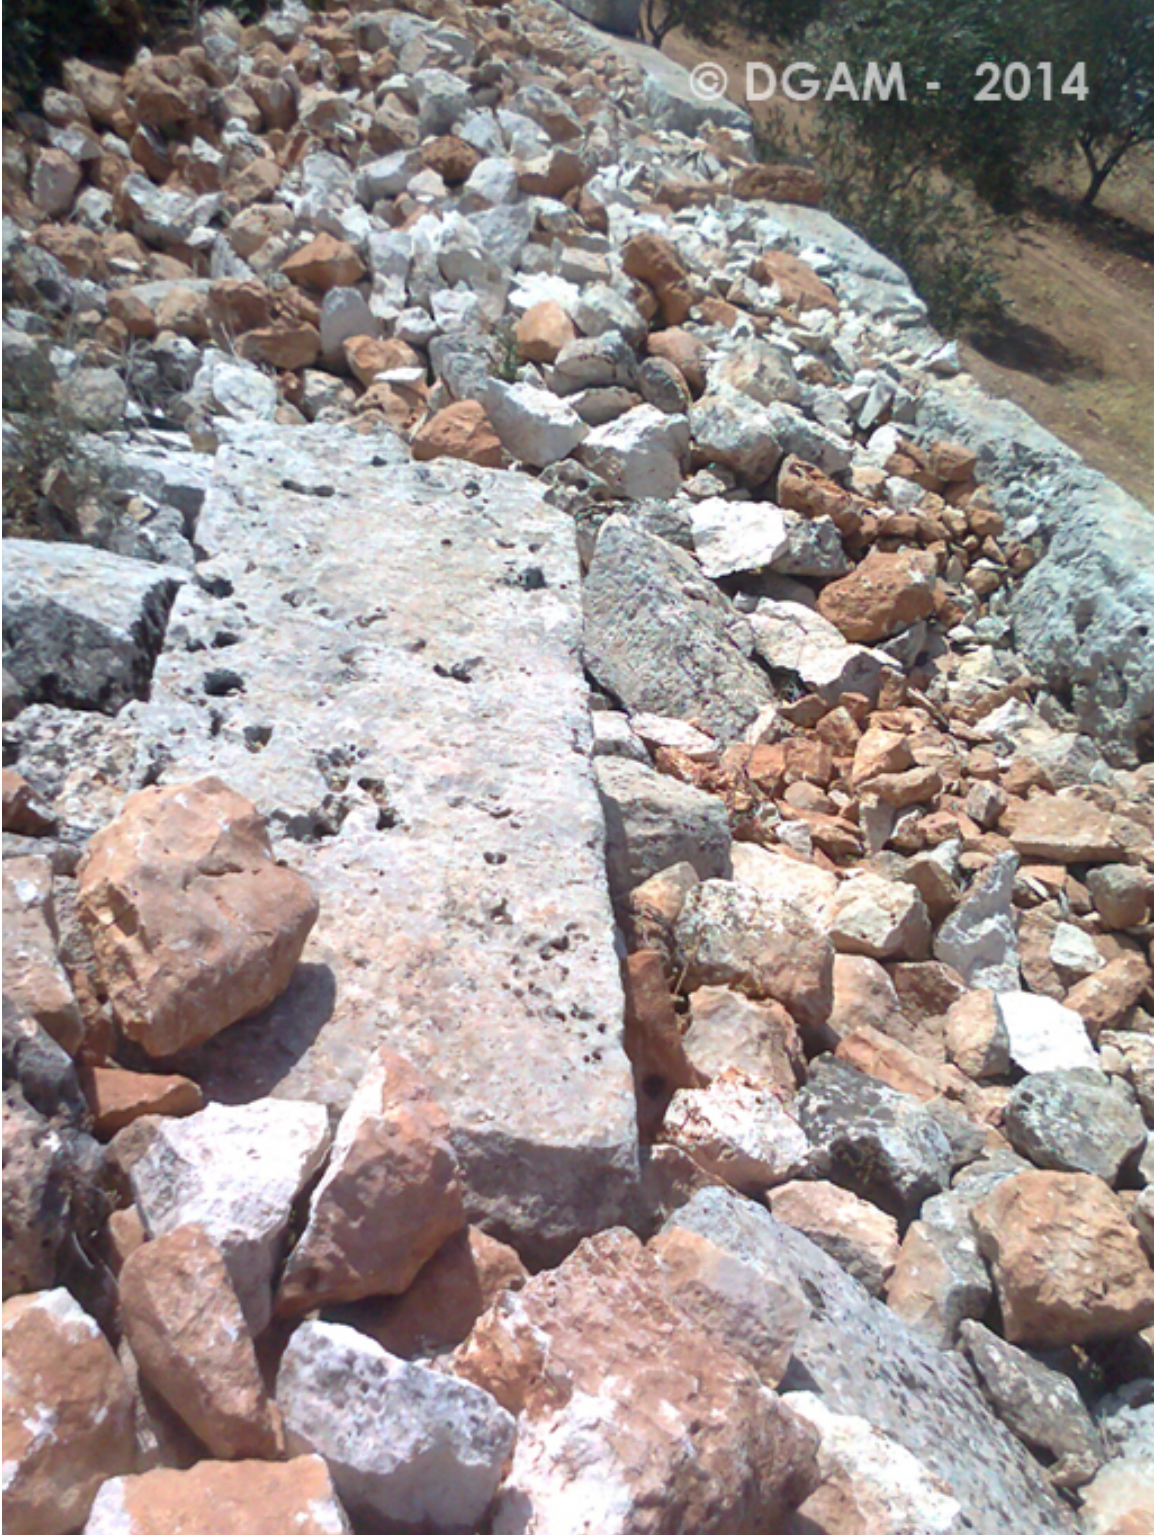
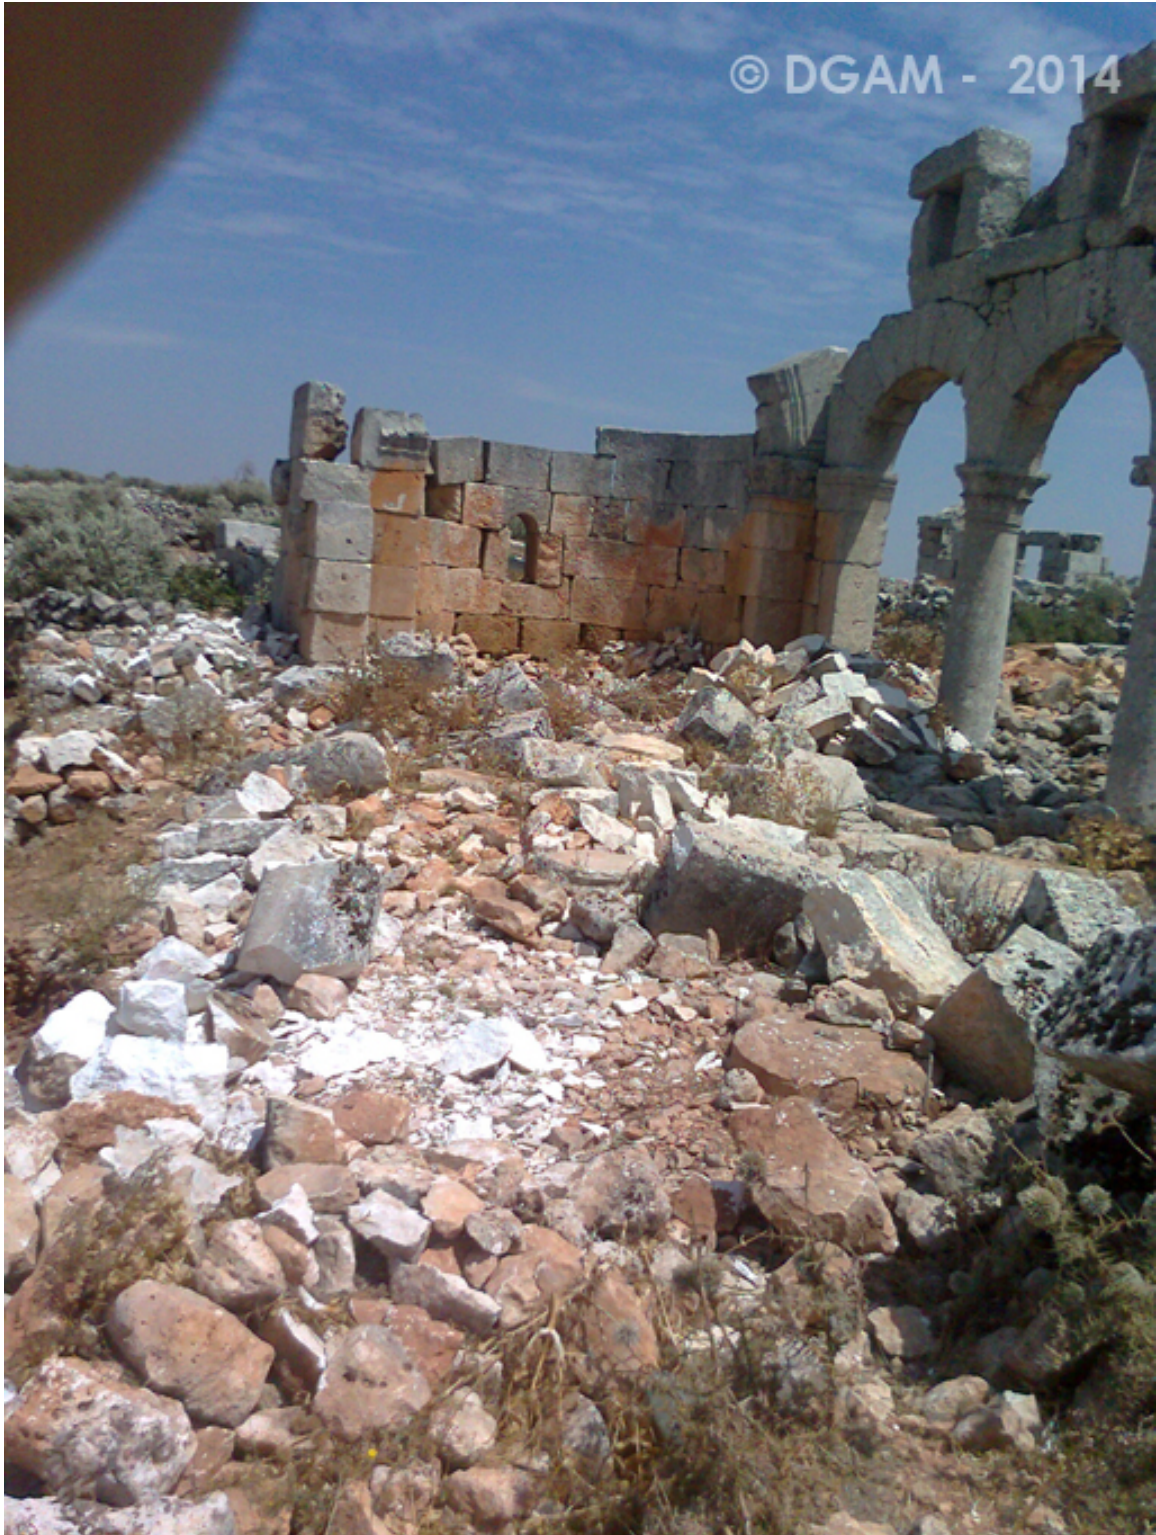
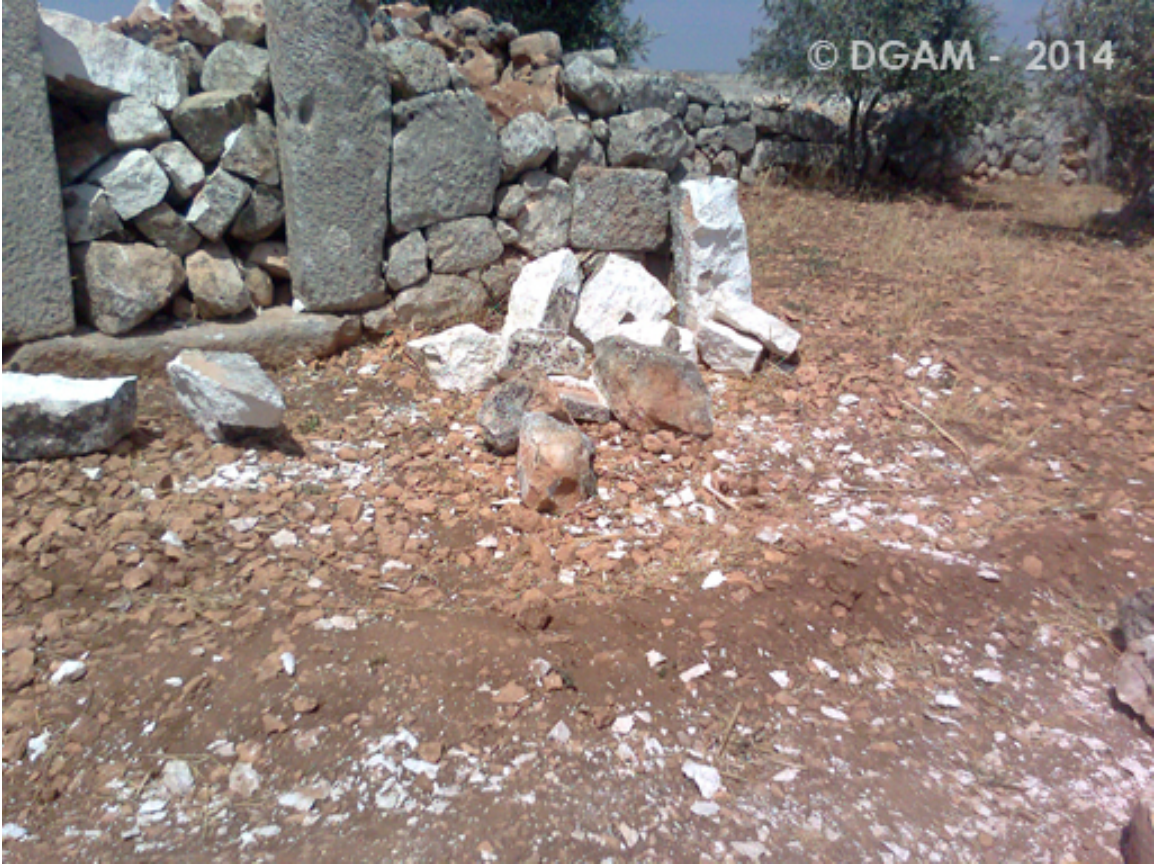
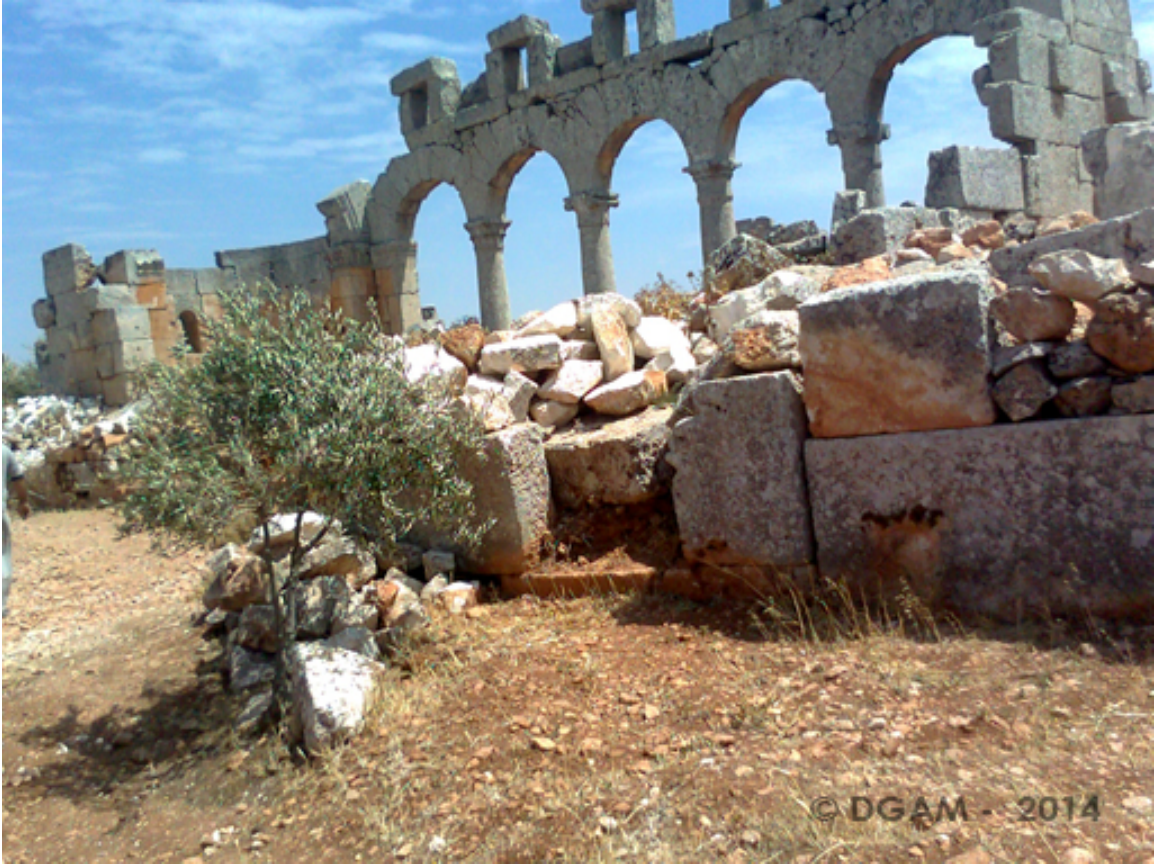
- **Batota** –Large ancient stones have been broken for building material inside and around the church in the western part of the site.

Stones at Batota that have been broken for building material (DGAM).

**Monitoring Recommendations and Mitigation Measures:** SHI has already prioritized St. Simeon and this region for monitoring and evaluation.
