# ASOR Syrian Heritage Initiative (SHI): Planning for Safeguarding Heritage Sites in Syria<sup>1</sup>

NEA-PSHSS-14-001

Weekly Report 6 – September 15, 2014

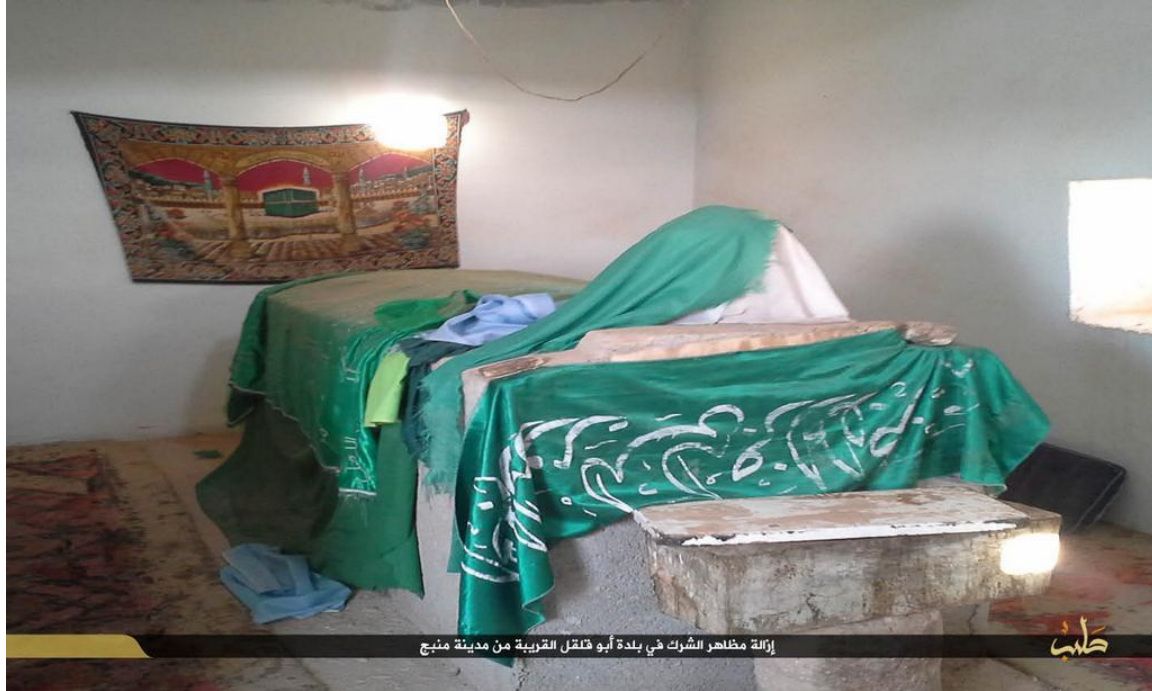
**Source of Destruction:** IS intentionally destroyed a Sufi Meqam and tombs. A photo posted by APSA shows the use of an axe. The original source appears to be an IS-linked site promoting this as an intentional destruction —

The Sufi Maqam in Abu Qalqal/Abu Abrus (APSA)

**Monitoring Recommendations and Mitigation Measures:** SHI is compiling lists of IS intentional destructions of cultural heritage carried out and promoted by IS.

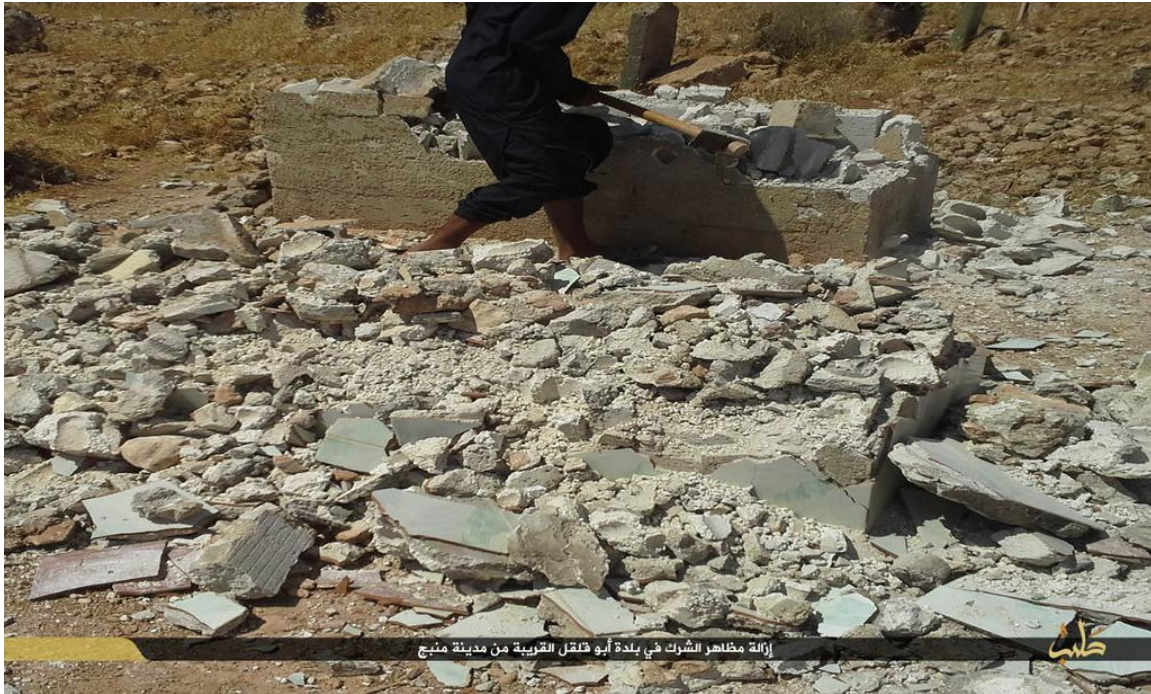
The alleged destruction of the tombs in Abu Qalqal/Abu Abrus (APSA)
