ASOR Syrian Heritage Initiative (SHI): Planning for Safeguarding Heritage Sites in Syria¹

NEA-PSHSS-14-001

Weekly Report 14 – November 10, 2014

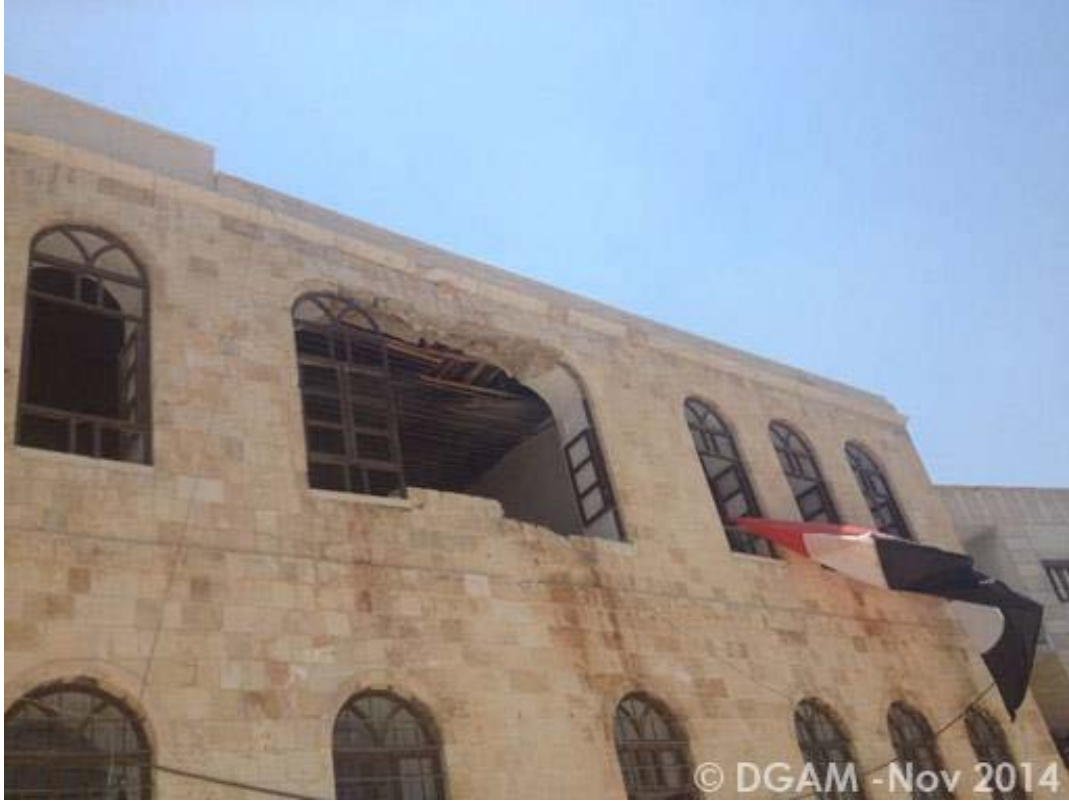
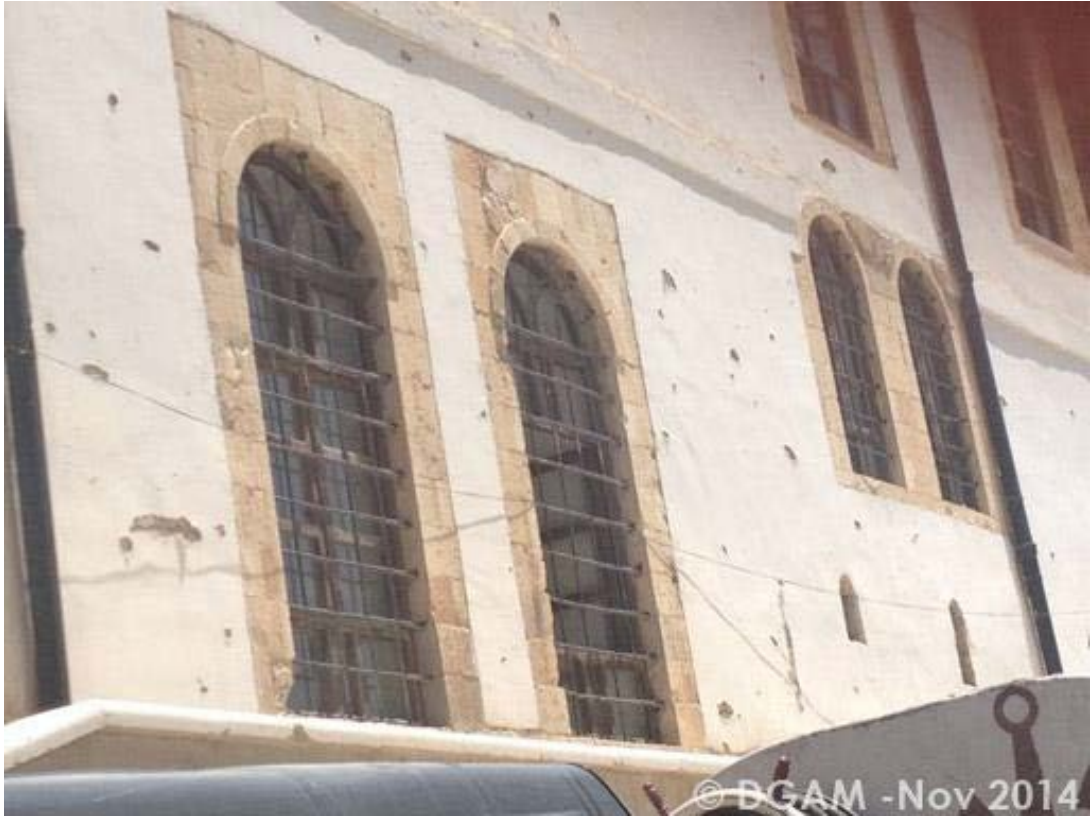
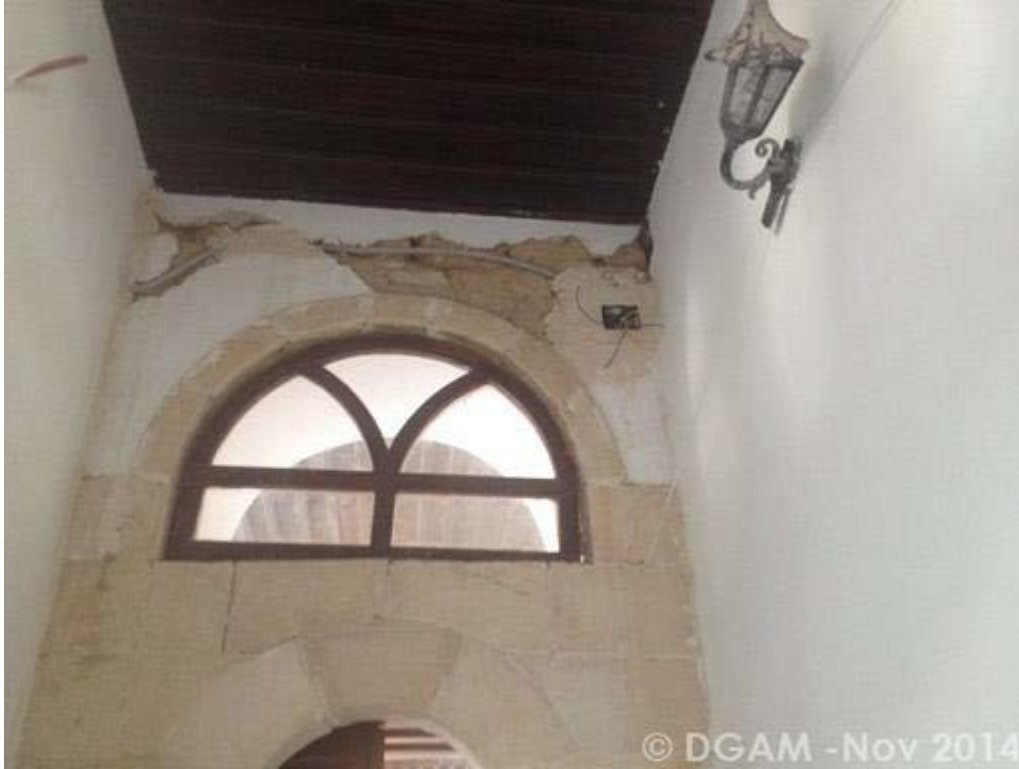
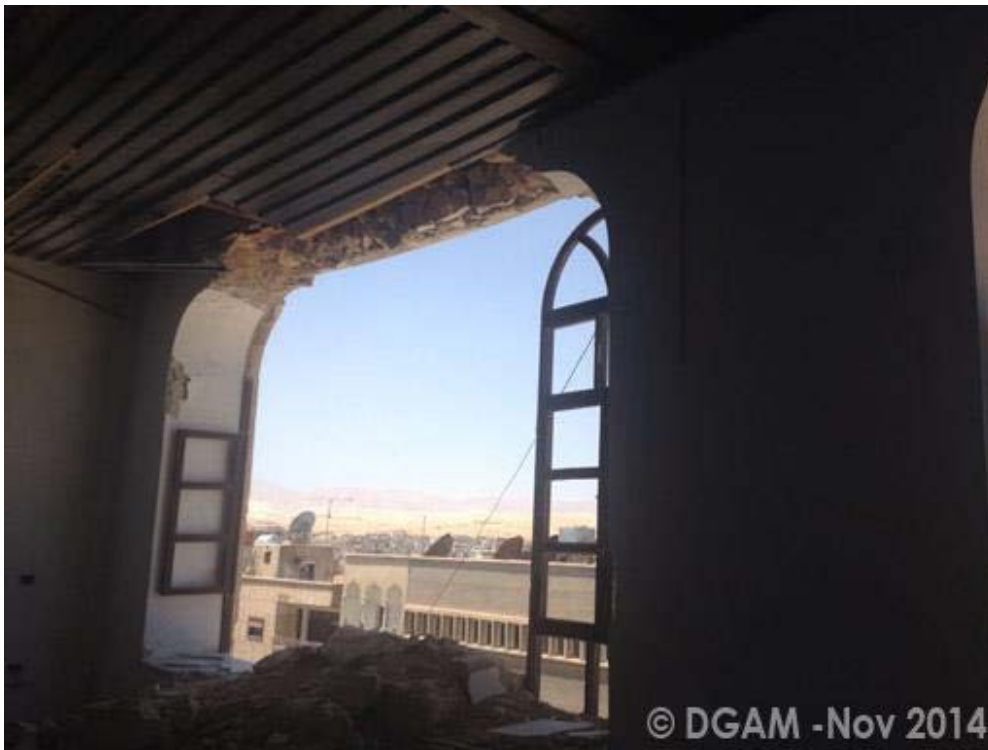
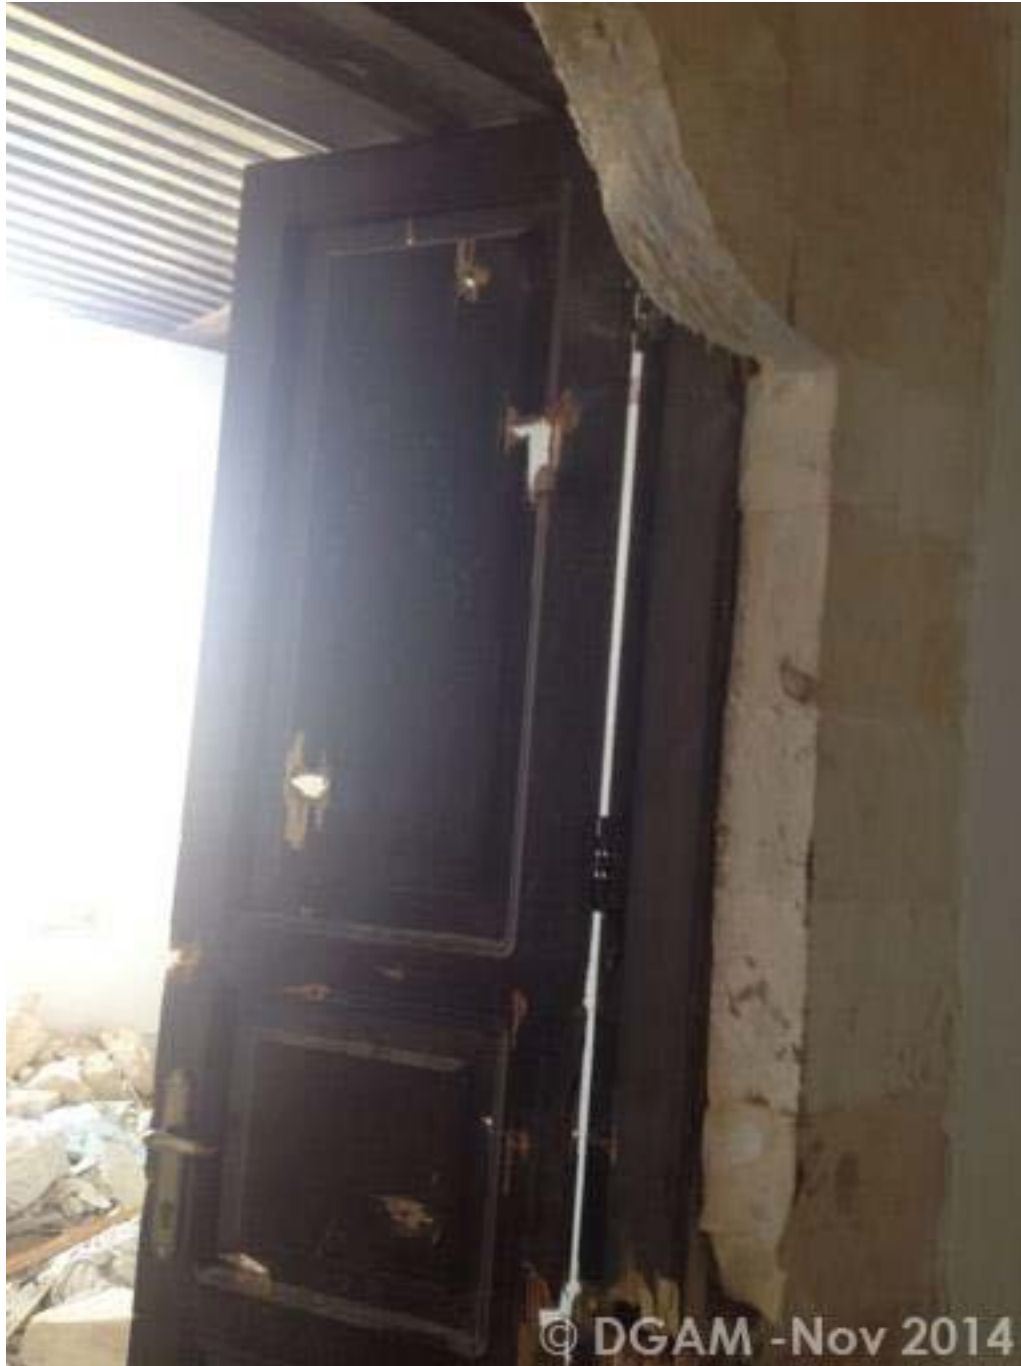
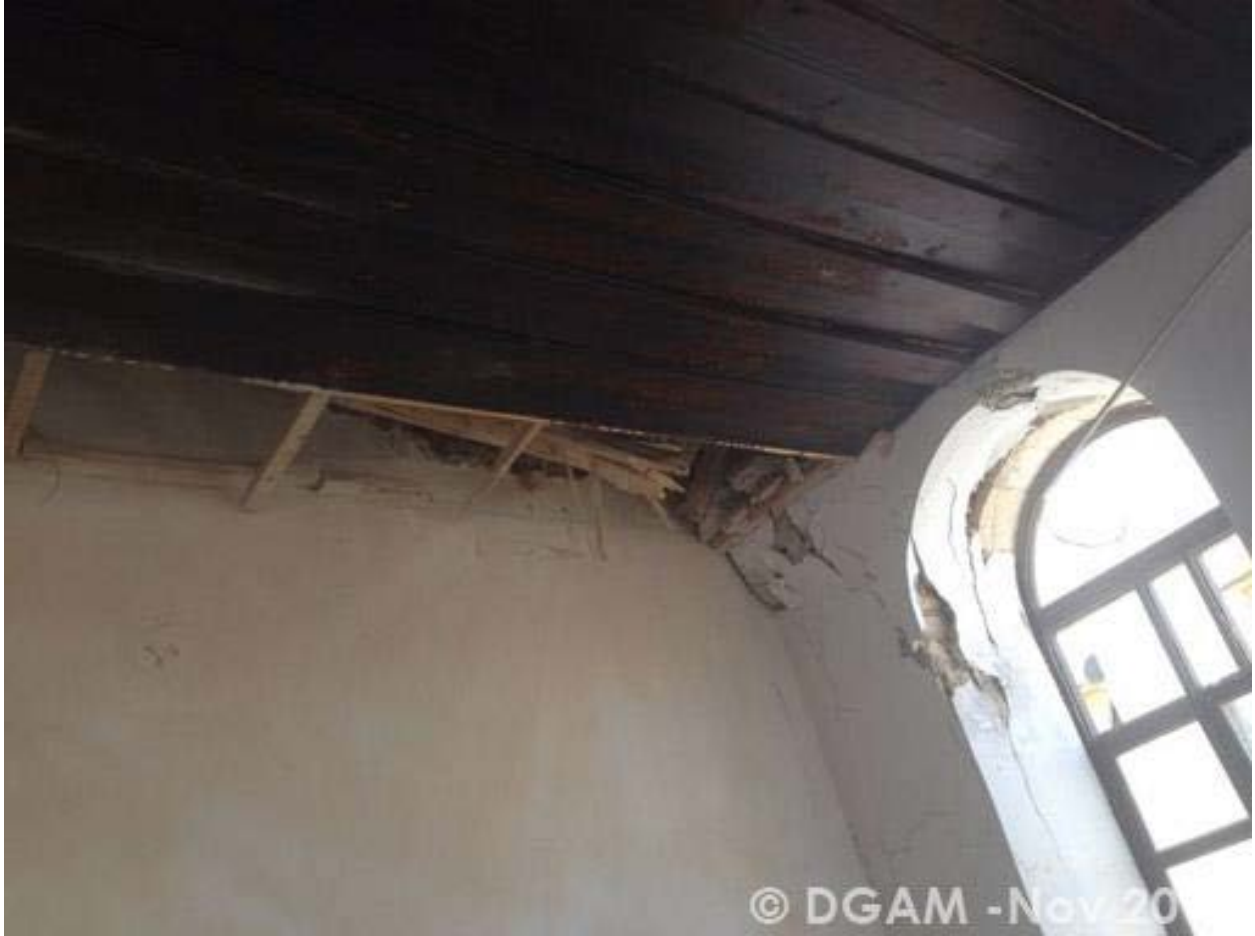
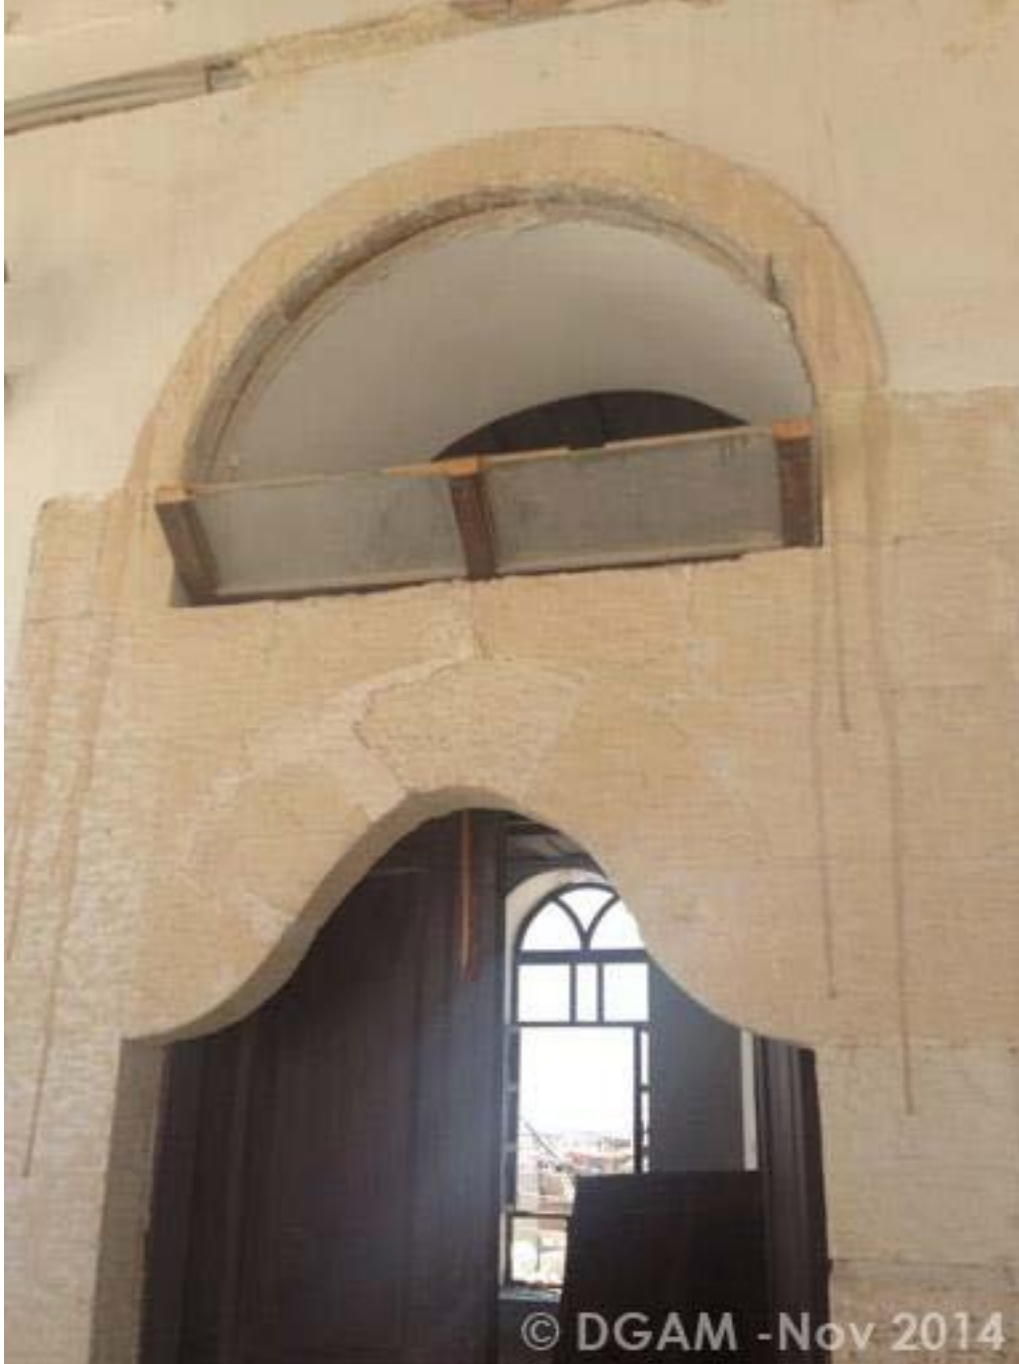
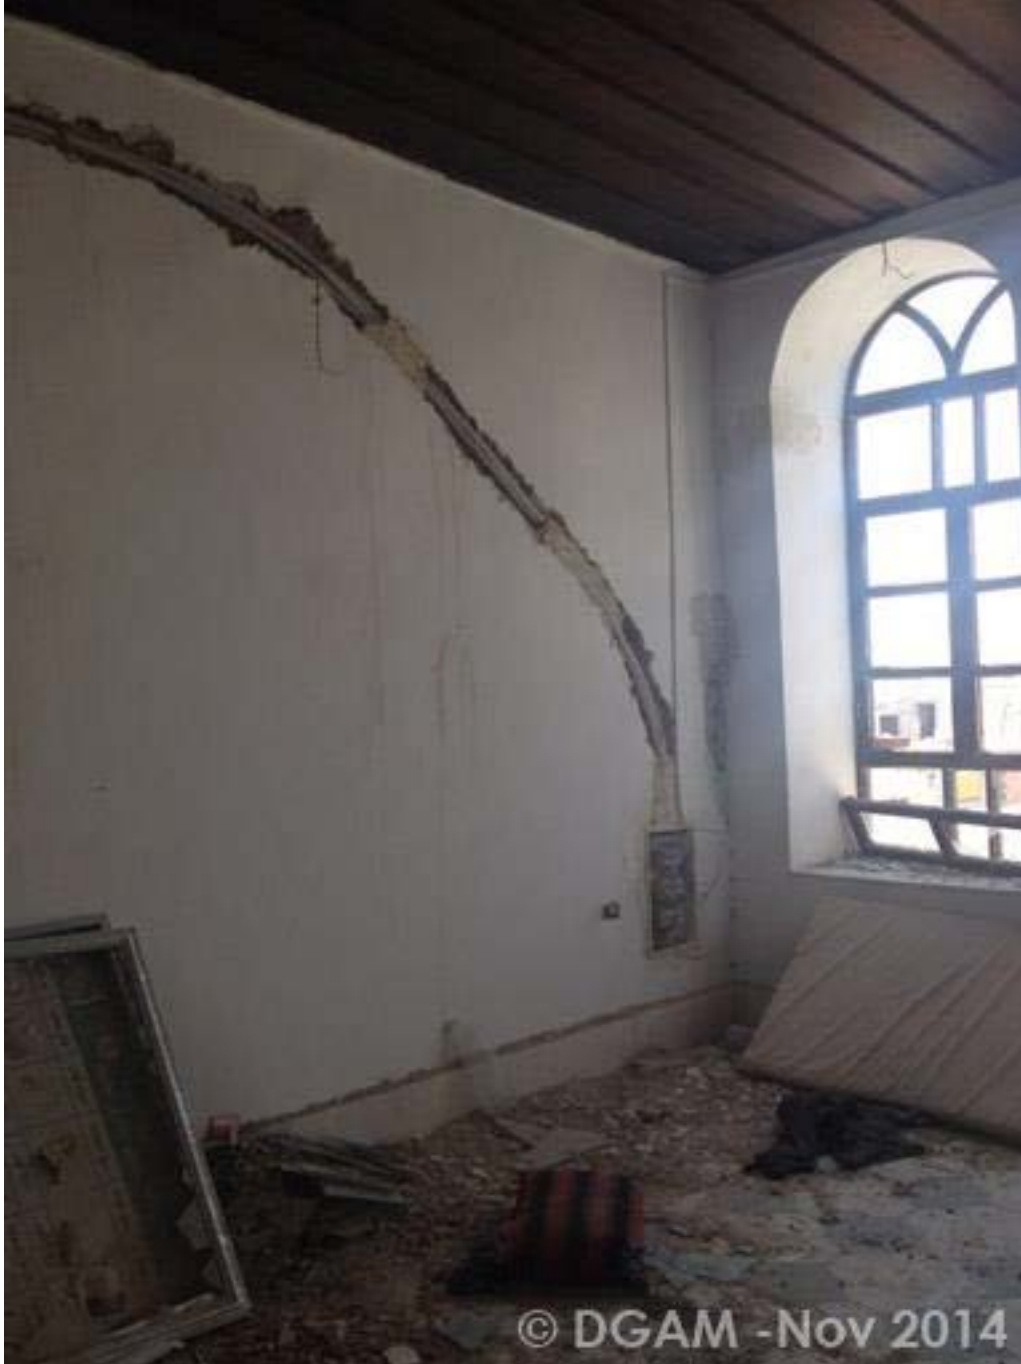
SHI14-074

Source of Destruction: According to the DGAM, the Seray Building in Al-Nabk exhibits broken windows, noticeable cracks on the walls and ceiling, and has been looted.

Pattern: Combat damage

Damage to the Seray Building in Al-Nabk (DGAM).

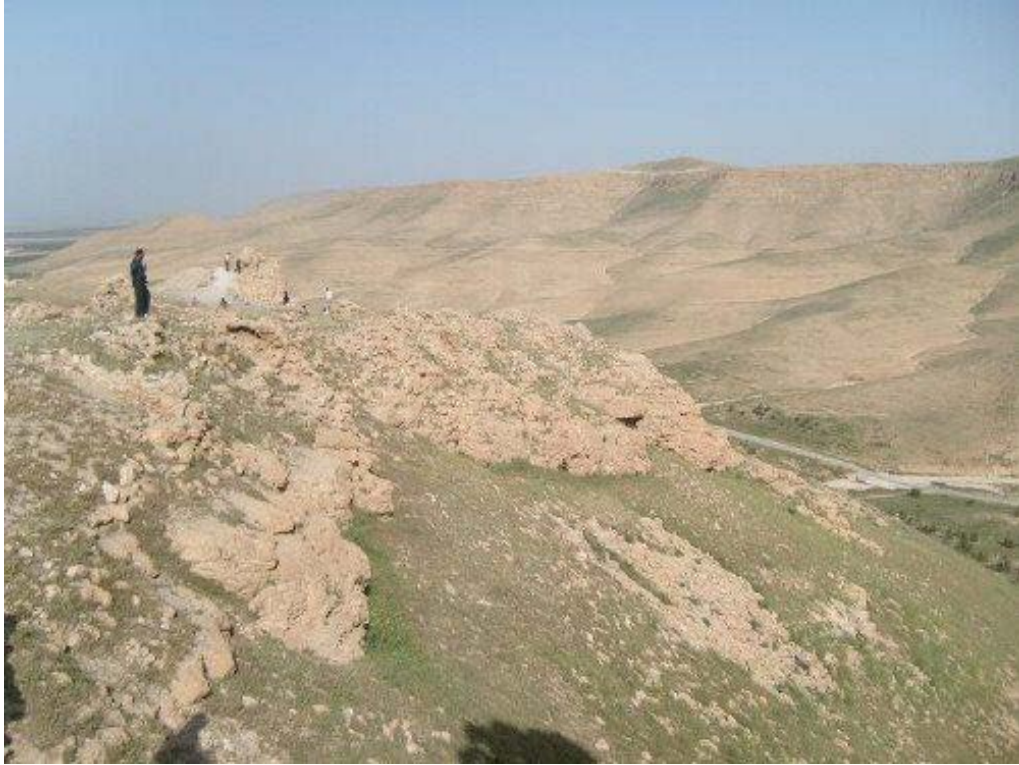
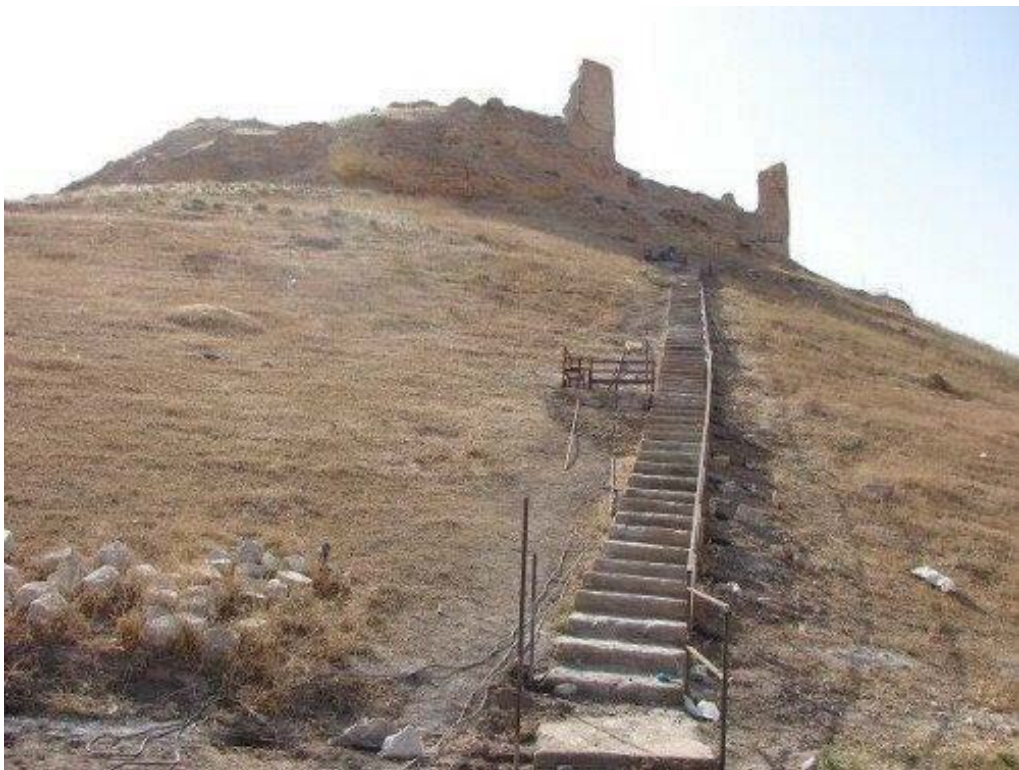
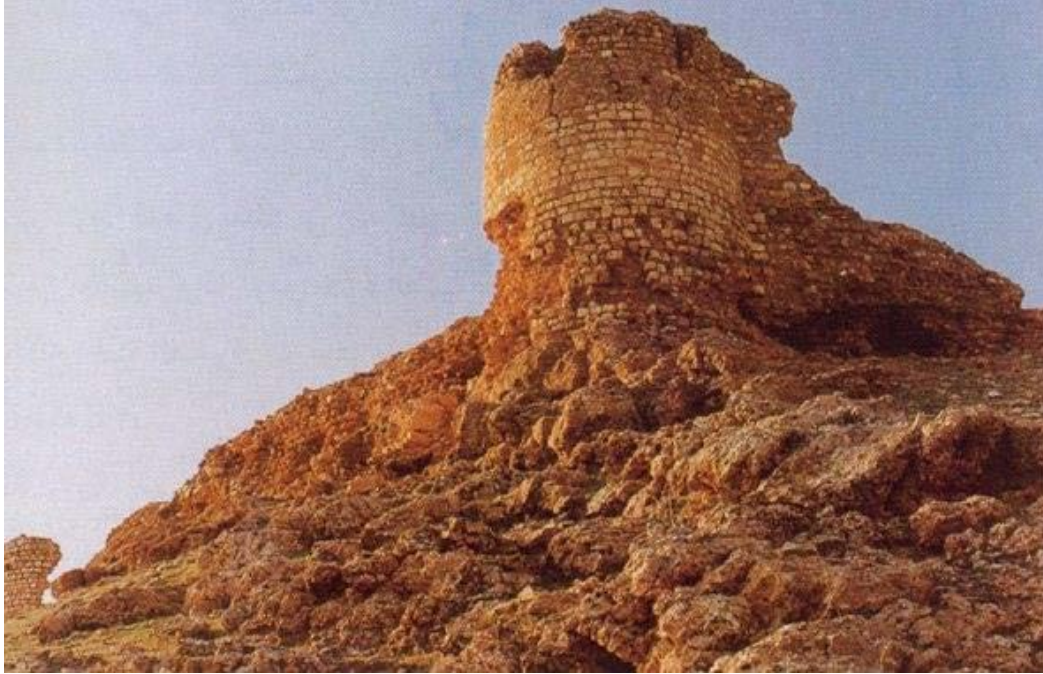
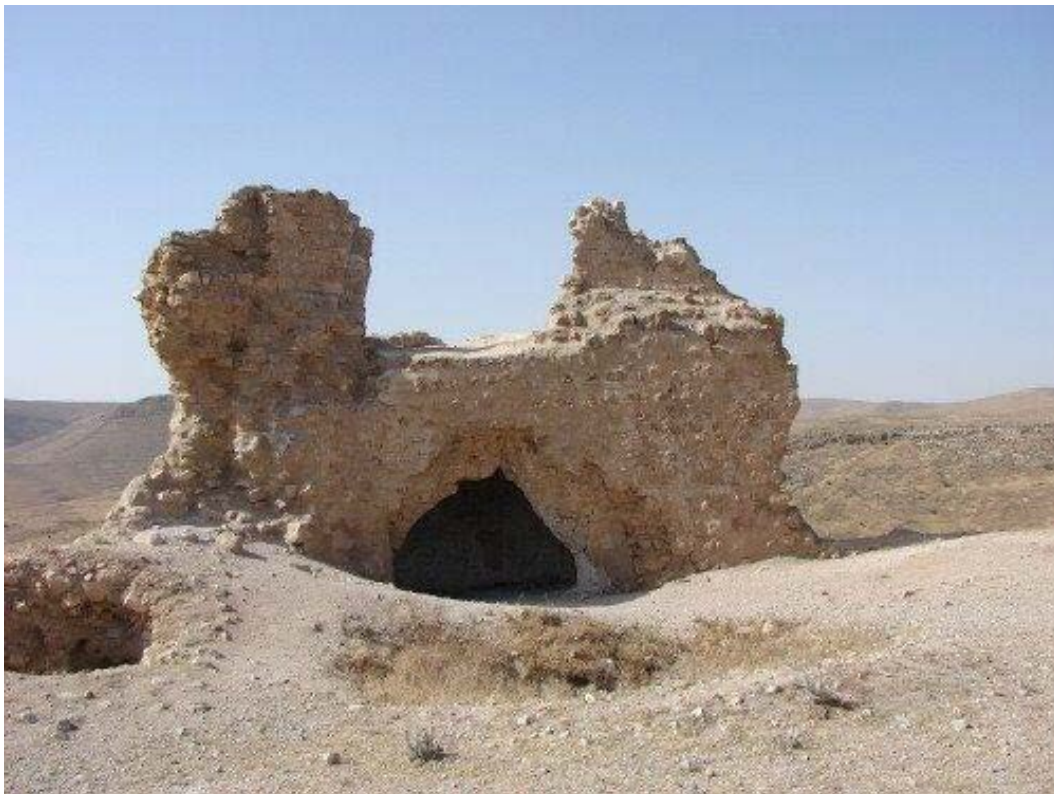
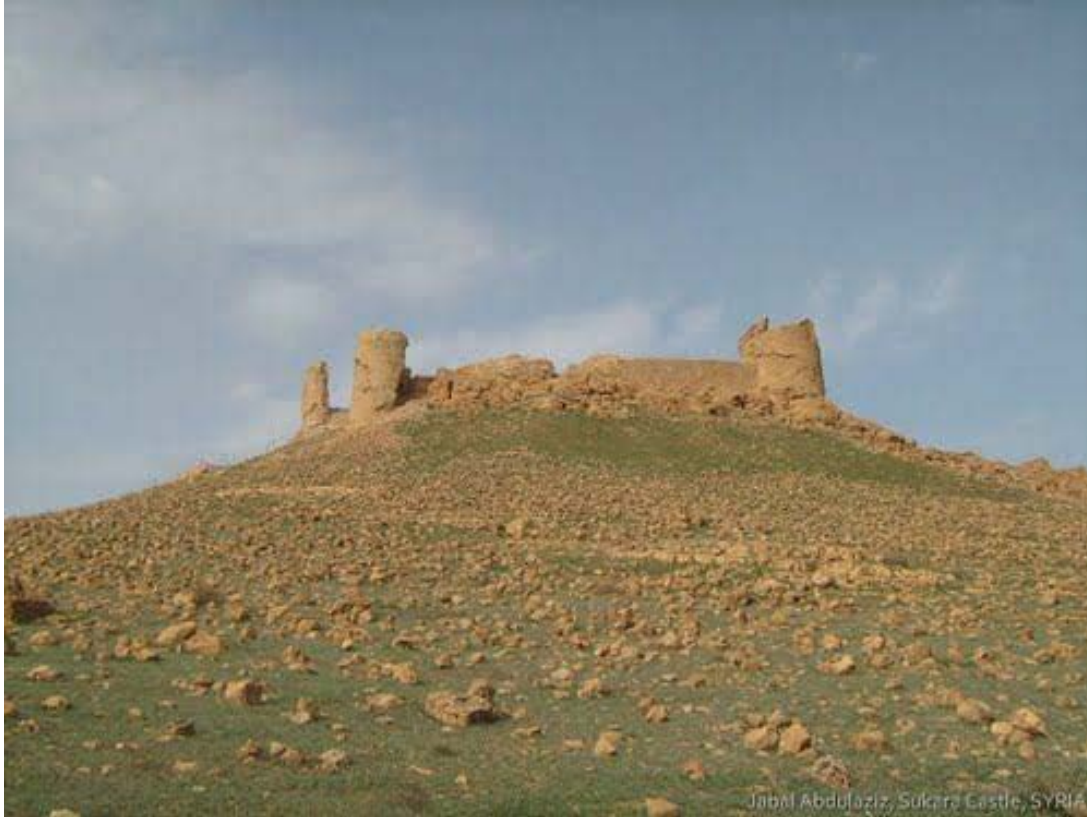
SHI14-075**Report Date:** November 5, 2014**Site Name:** Qal'at Sukkara**Date of Incident:** November 4, 2014**Location:** Jebel 'Abd el-'Aziz, al-Hassakah Governorate**Coordinates:** 36°25'47.64"N 40°25'33.24"E**Site Description:** Stone masonry castle atop a rocky outcropping.**Site Date:** Medieval**Source of Destruction:** According to APSA, airstrikes were conducted against Islamic State militants that were believed to be occupying the site. There are unconfirmed reports of damage to the north side of the castle.**Pattern:** The use of heritage sites for military purposes. Airstrikes on heritage sites.**Monitoring Recommendations and Mitigation Measures:** Airstrikes have occasionally struck archaeological sites used by Islamic State for military purposes, such as the recent airstrike(s) on Tell Sha'ir west of Kobani.**Sources:**

Image of Qal'at Sukkara (APSA).

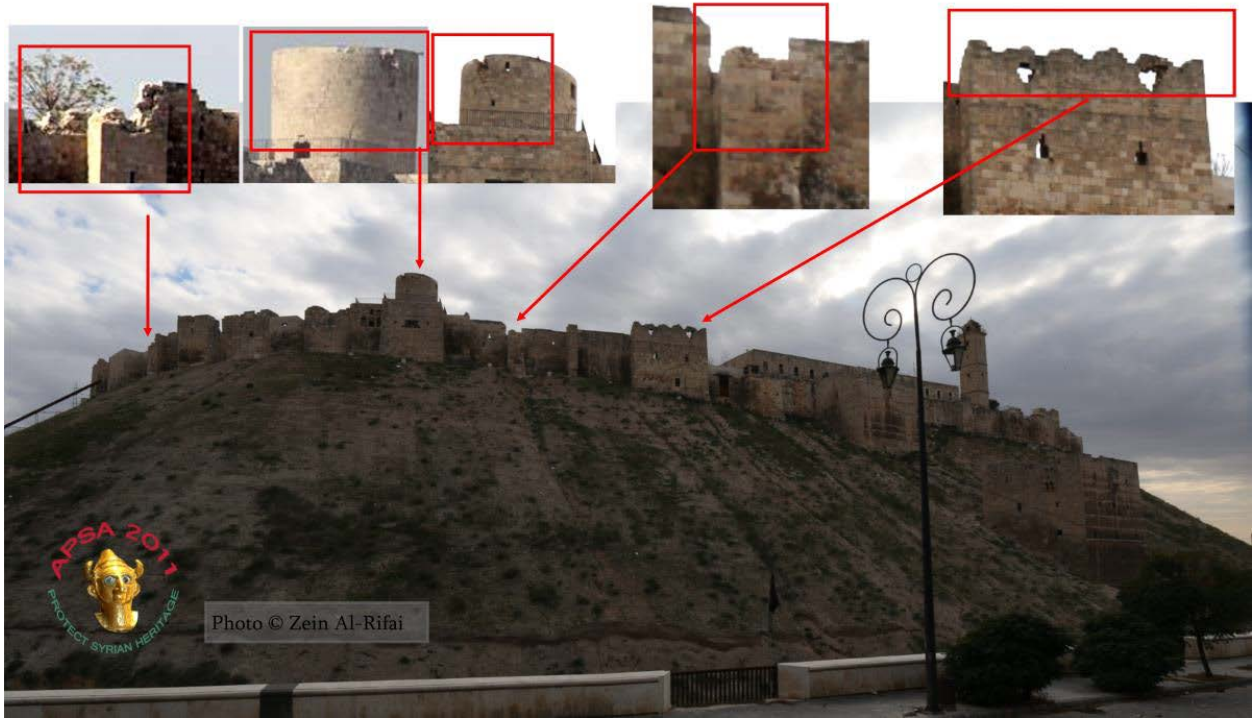
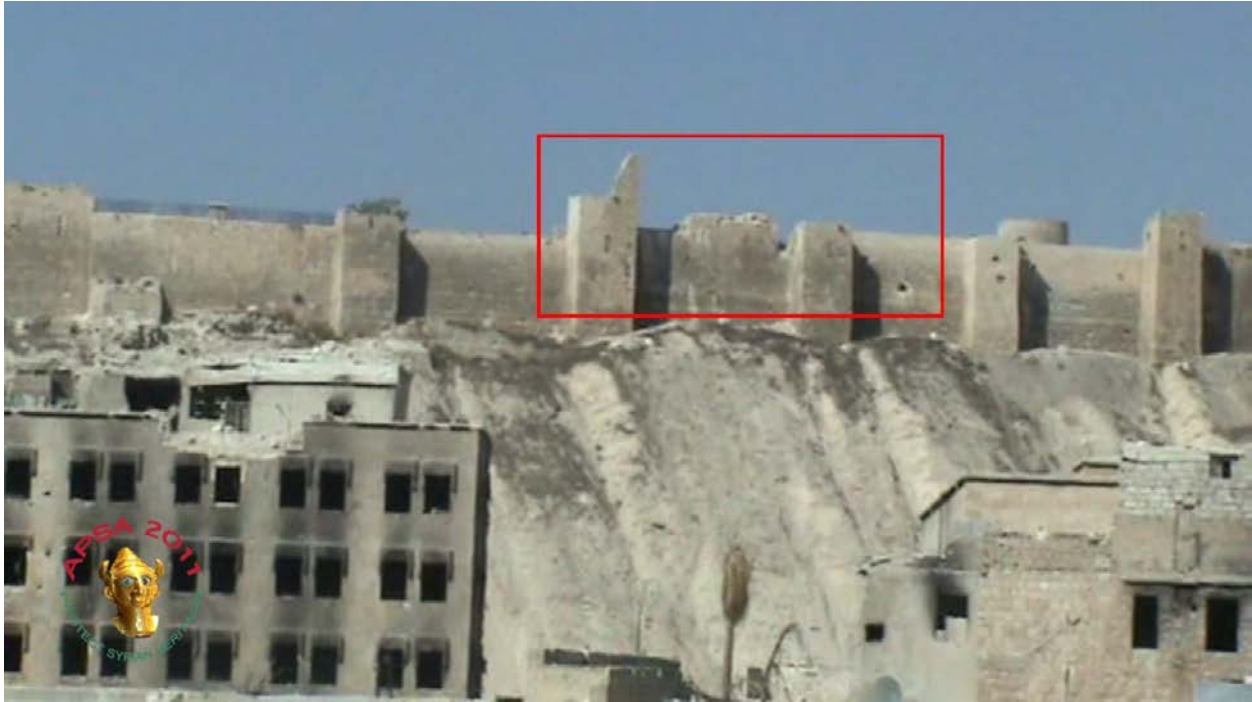
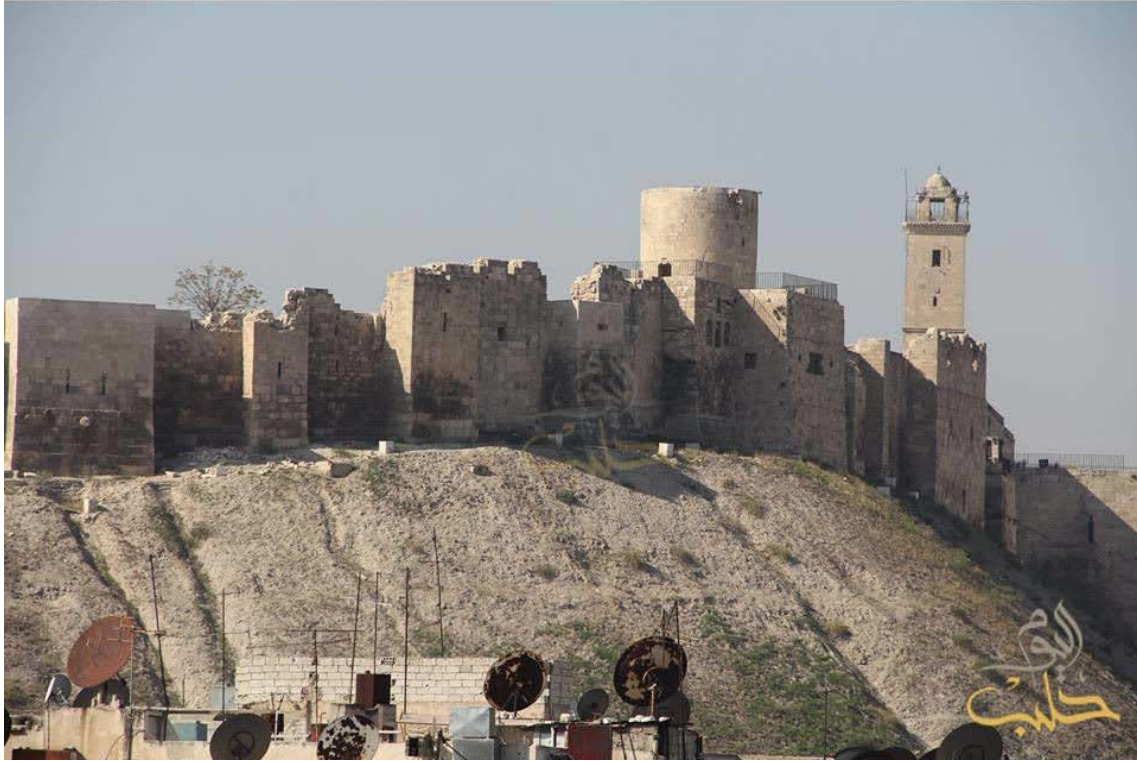
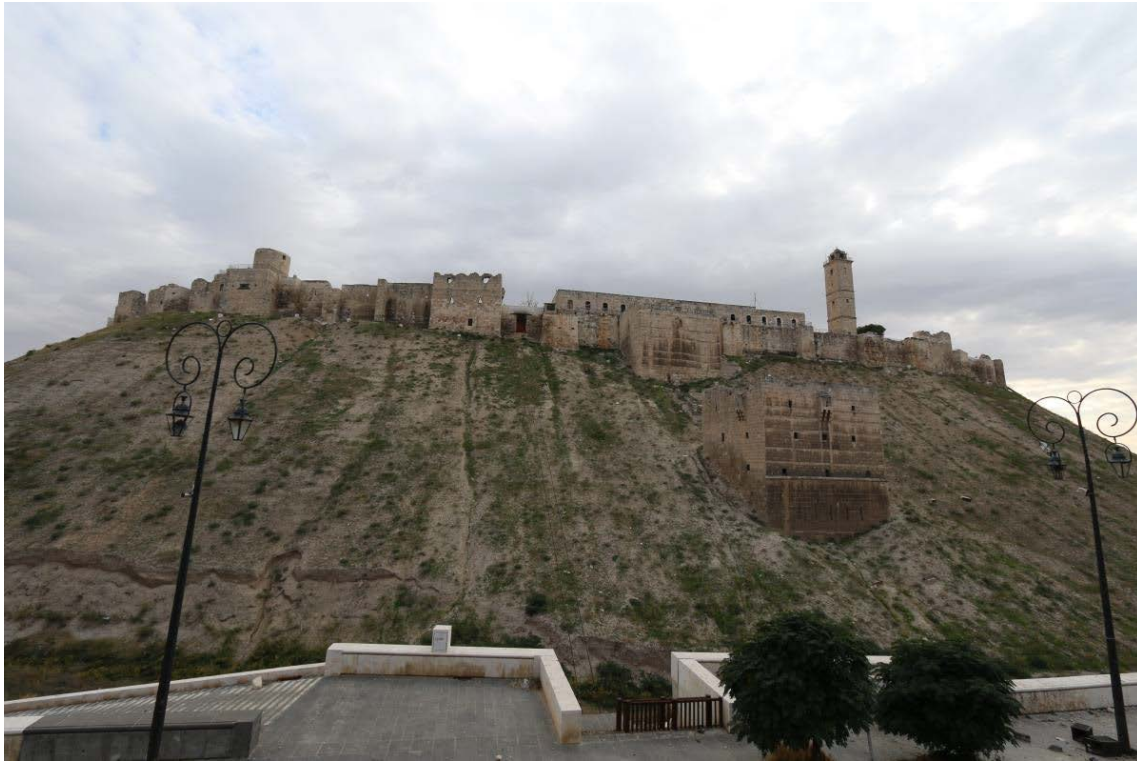
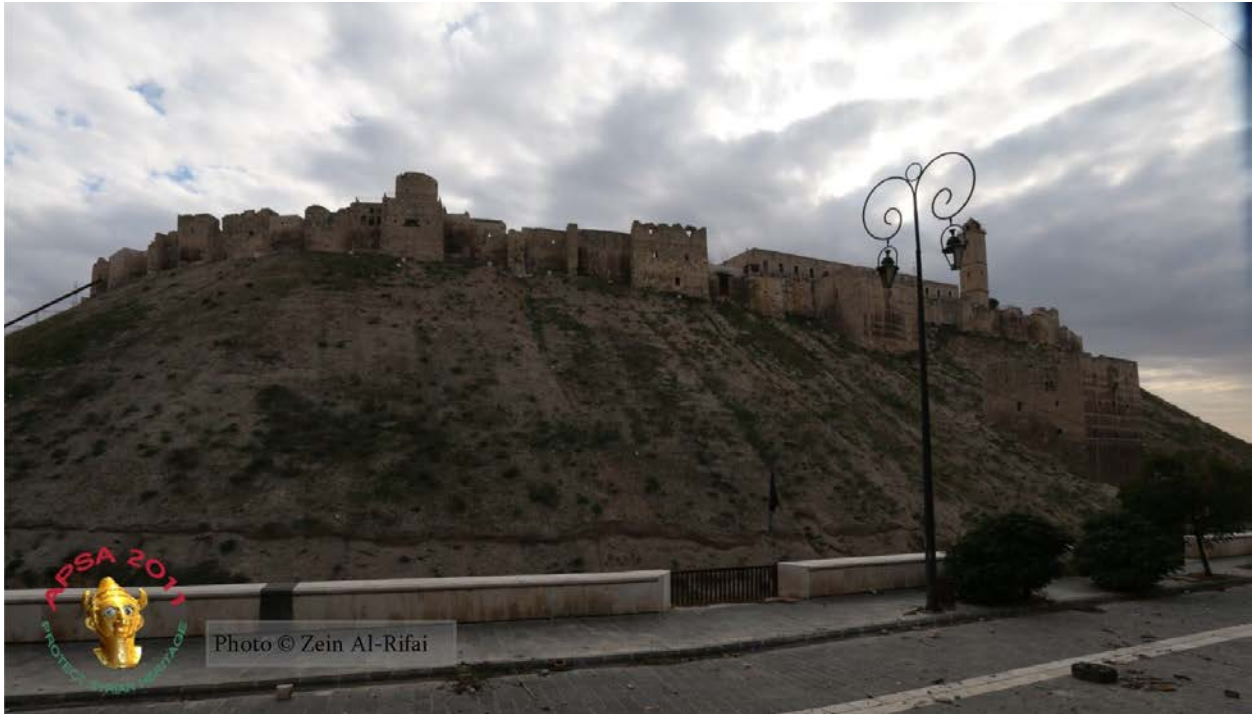
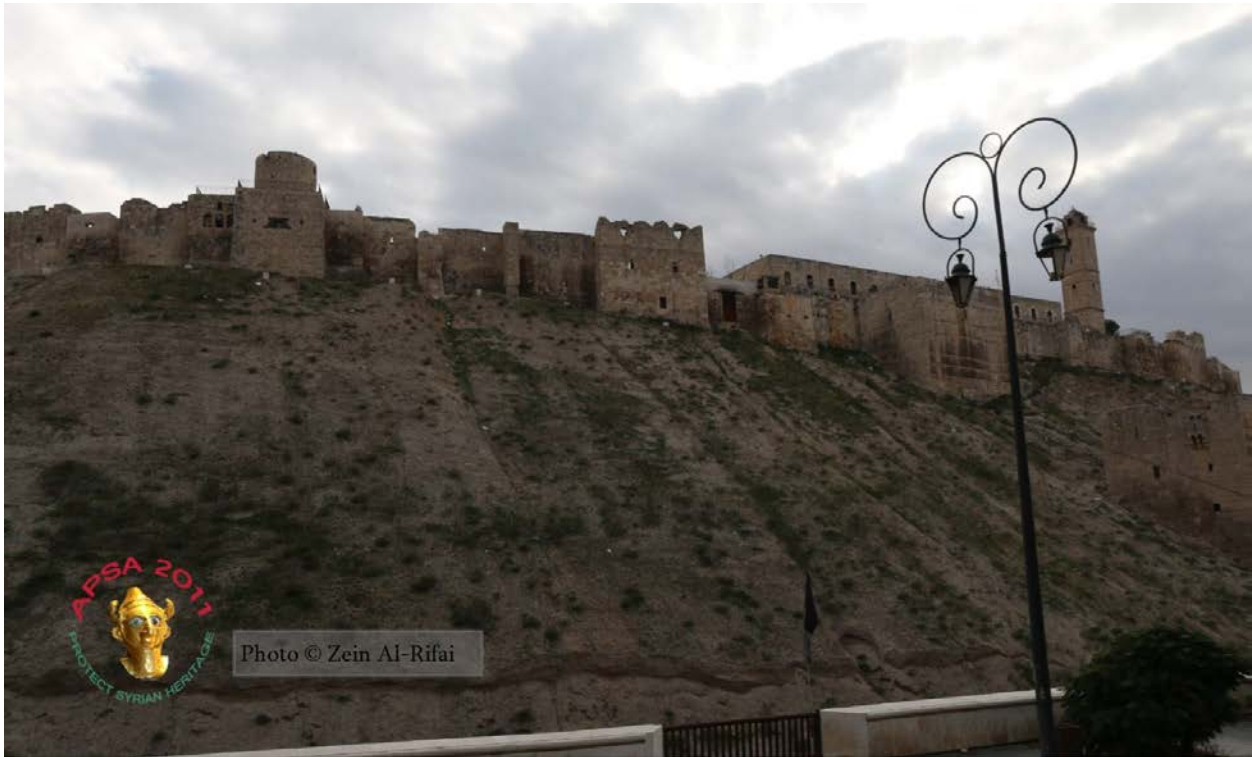
SHI14-076

Source of Destruction: Small arms fire, rockets, mortar rounds, artillery fire.

Pattern: Urban warfare. The destruction of heritage places in the UNESCO World Heritage Site, Ancient City of Aleppo.

Image showing damage to the Aleppo Citadel (APSA).

Monitoring Recommendations and Mitigation Measures: SHI has designated The Old City of Aleppo as a high priority monitoring area, as have other monitoring groups. There is a major humanitarian crisis unfolding in and around the modern city, and there is a desperate need to conduct mitigation and preservation projects on heritage sites in Aleppo.
