Palmyra: Heritage Adrift

Detailed report on all damage done to the archaeological site between February 2012 and June 2015

Cheikhmous ALI *

The Association for the Protection of Syrian Archaeology
www.apsa2011.com

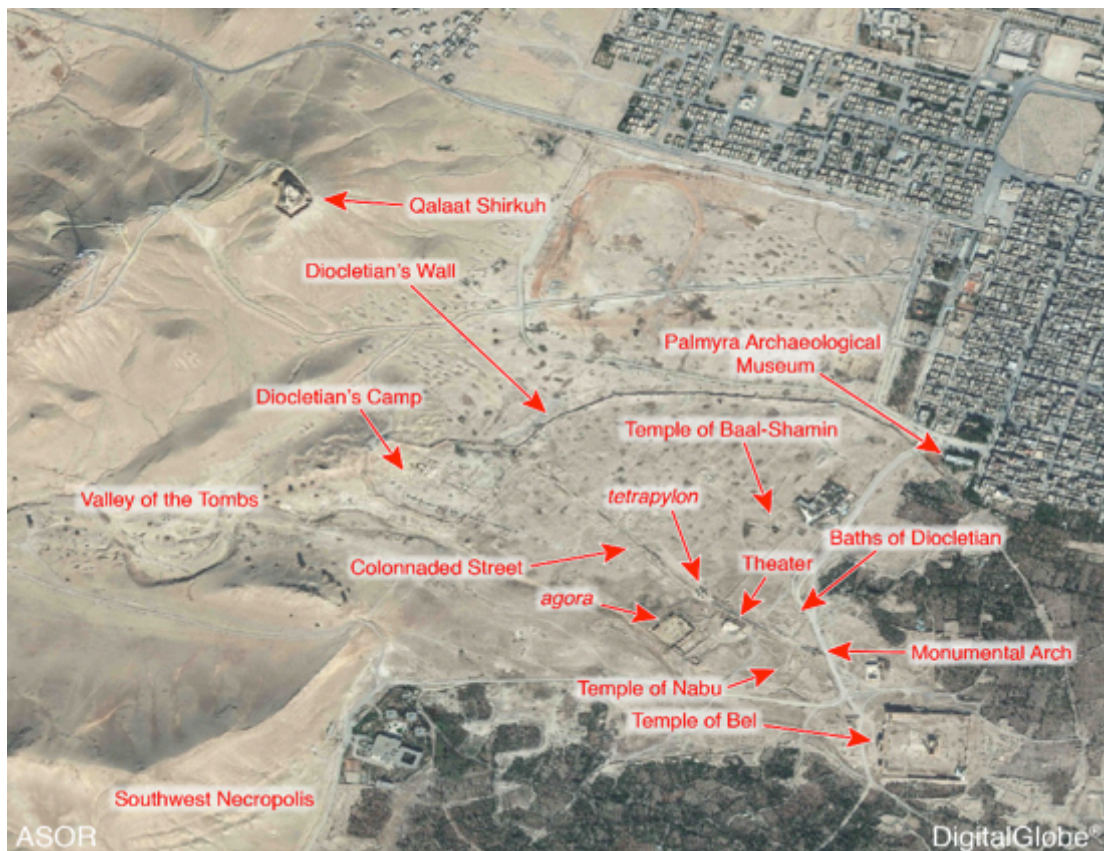
Figure 2: DigitalGlobe satellite of the old town of Palmyra showing some important monuments and archaeological sites (Courtesy of ASOR CHI)

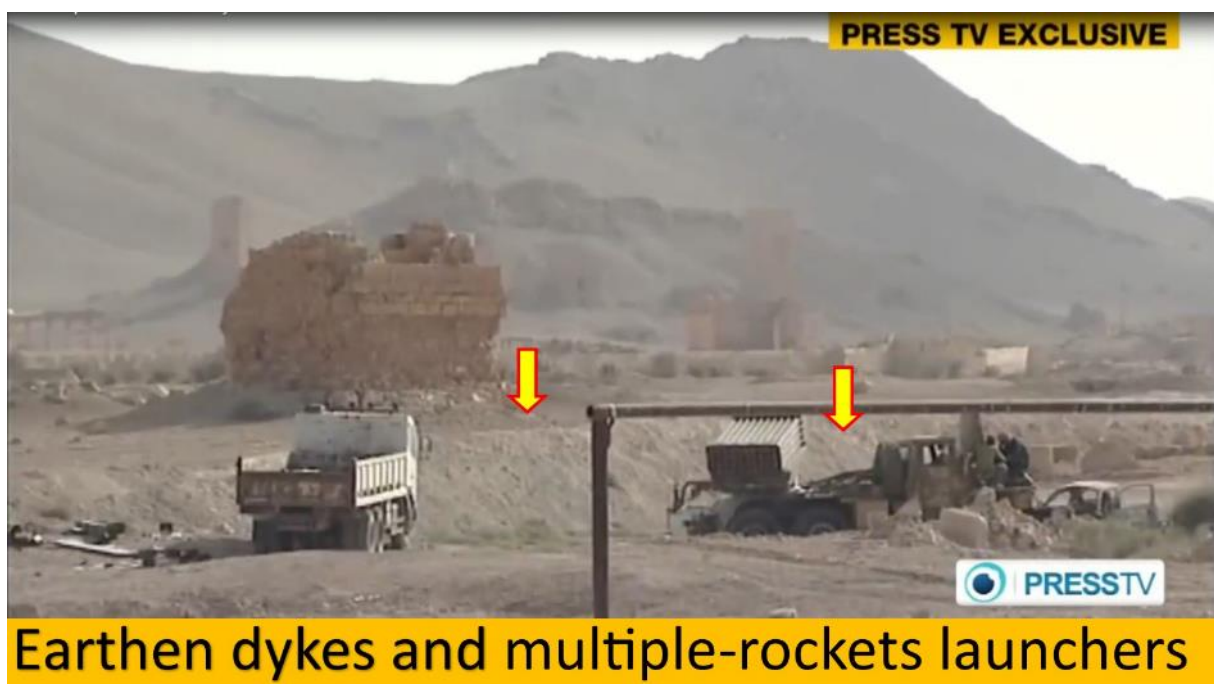
Heavy armaments (e.g. tanks and multiple rocket launchers) were installed at the foot of the mountain on which the citadel sits on hills such as Gabal al-Hysaniyat and Gabal al-Rwissat, and at strategic points within the Northern Necropolis area. The main center of military operations and ammunition depots was built on top of Gabal al-Rwissat next to the telecommunications tower. Surveillance equipment has also been installed on site immediately adjacent to the telecommunications tower. Since 2012, APSA has published several videos and photos concerning this issue, as part of the documentation of damage to the site.²

Figure 3: The installation of heavy weapons and soldiers in the archaeological area (Source: Press TV; May 2015, <https://www.youtube.com/watch?v=35kvAx-smKc>)

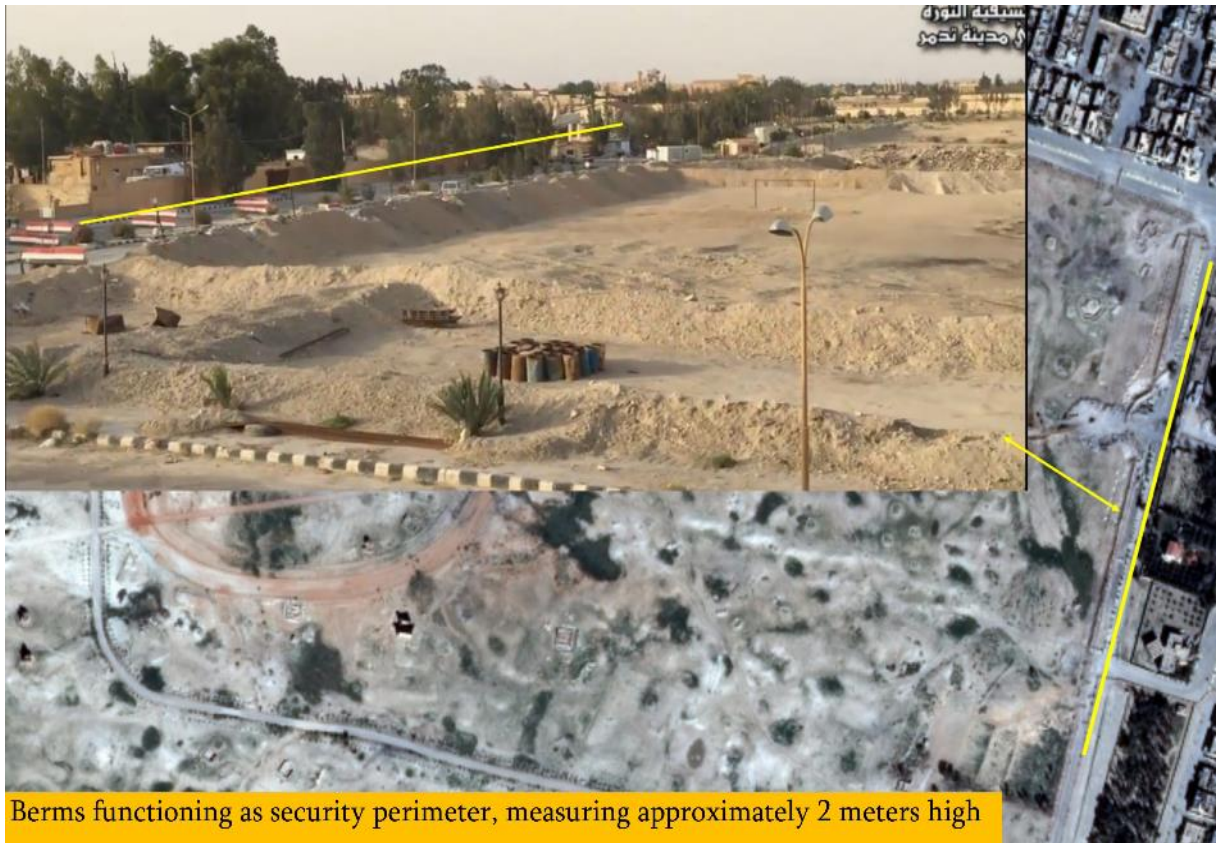
The Syrian army has erected a 2-meter-high levee or earthen dyke. It extends from the northern side of the citadel to the northwest corner of the police station (west-east direction). The levee runs parallel to the main road leading to the modern city and then turns to the south in an irregular and intermittent fashion. (Figures 4, 6–8).

Figure 6: Levee measuring 2 meters in height, created by dredging within the archaeological area opposite the police station (Sources: Coordination of the City of Palmyra [inset] and HRW [aerial])

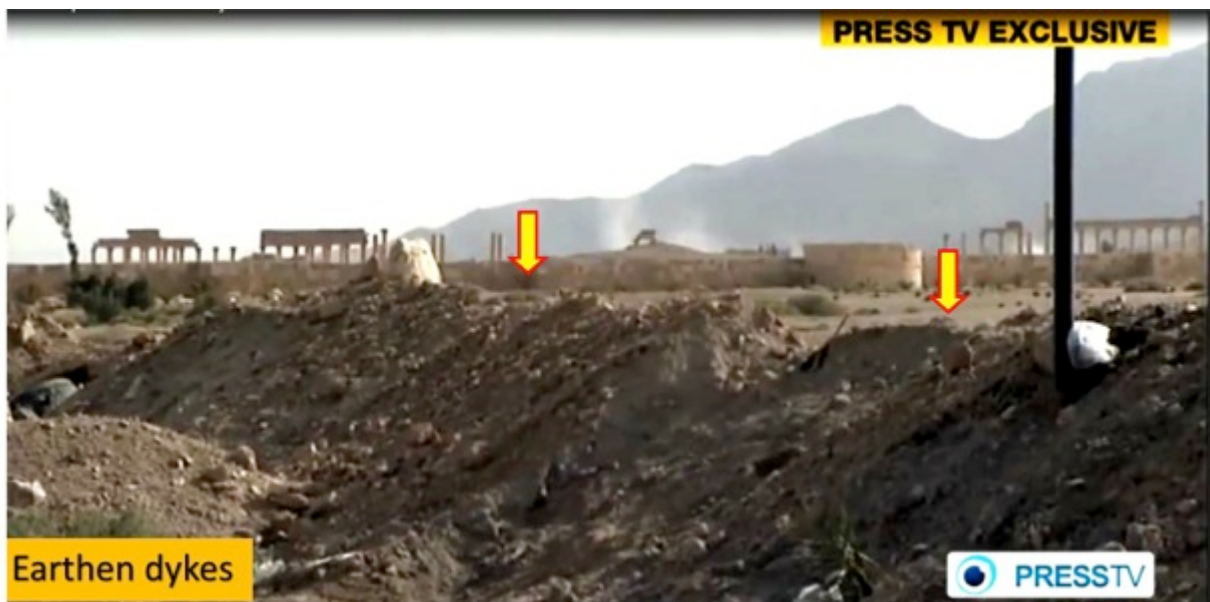
Figure 7: Levee in the archaeological area immediately adjacent to the rampart (Source: Press TV; May 2015, <https://www.youtube.com/watch?v=35kvAx-smKc>)

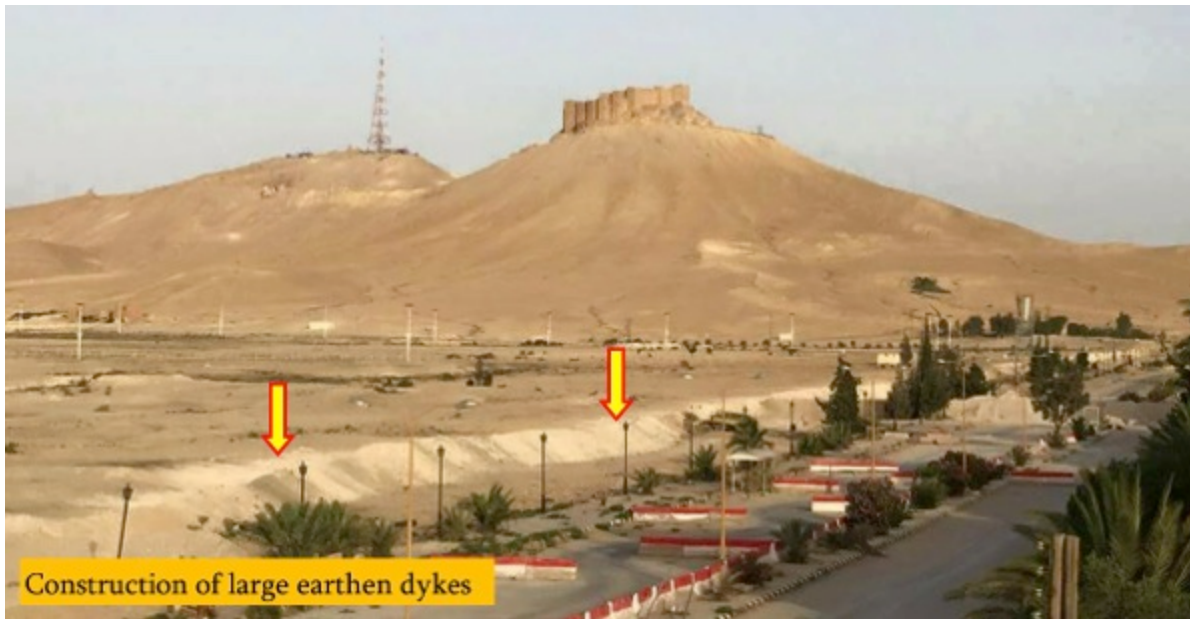
Figure 8: Levee in the archaeological area near the police station (Source: Coordination of the City of Palmyra)

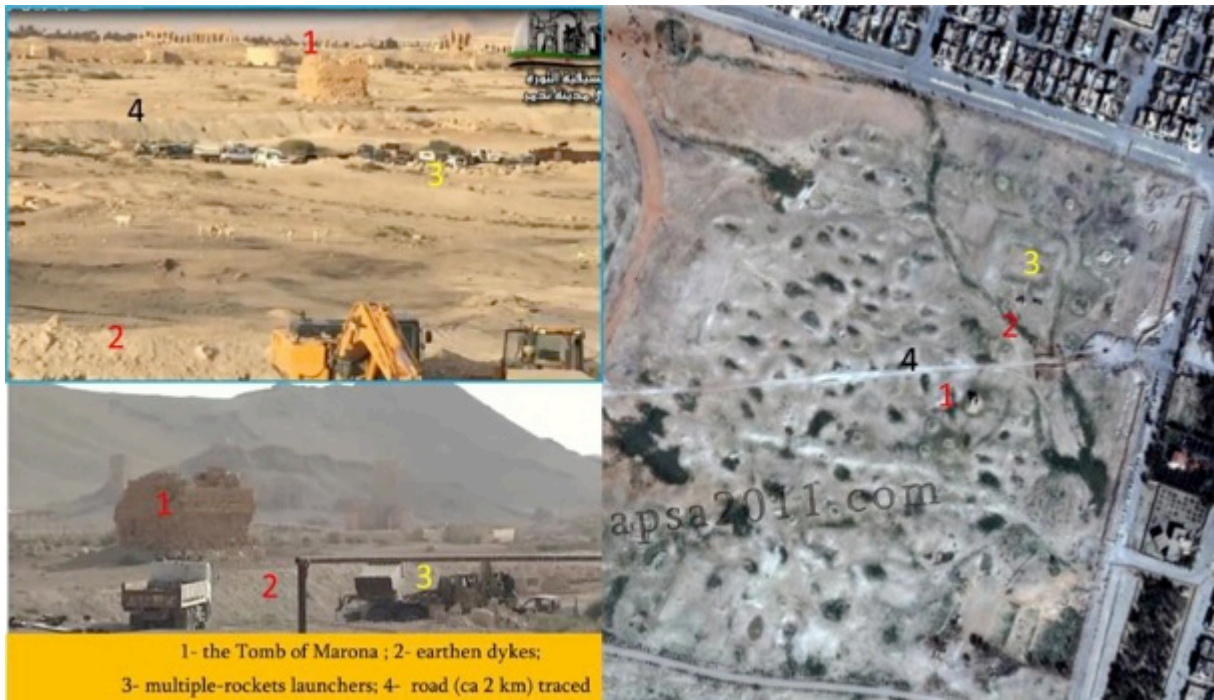
Figure 9: Soil removal in the area of the Marona tomb; creation of a rubble repository and an area for vehicle disposal (Sources: Coordination of the City of Palmyra [left] and HRW [inset])

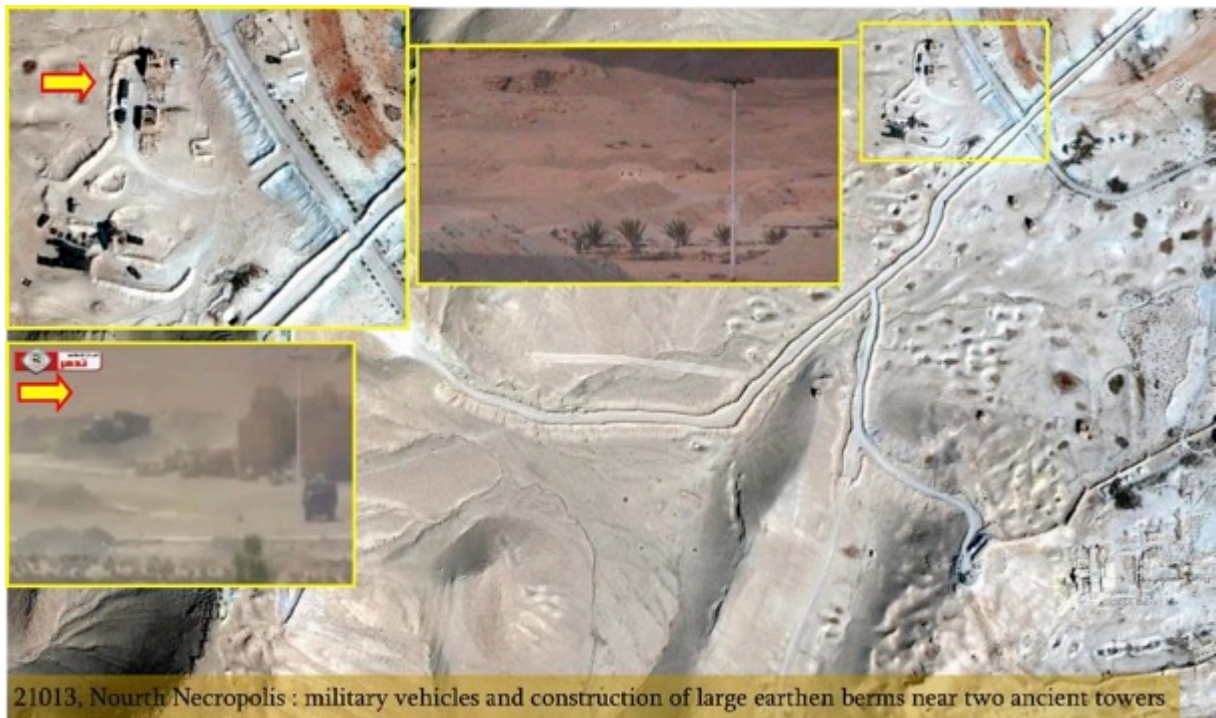
Another dredging operation, involving the construction of high earthen levees, was conducted in a vast area within the northern tombs area. The aim of the operation was the preparation of protected positions for artillery, rocket launchers, and tanks. This equipment was installed west of the tomb of Marona (Qaser Al-Hayaa) and close to several other funerary towers, leading to the complete or partial removal of the foundations of some tombs. On top of al-Gabal Hussiyinat, a vast archaeological area was completely destroyed in order to build a heavy artillery position, other military emplacements, and an ammunition depot.

21013, Nourth Necropolis : military vehicles and construction of large earthen berms near two ancient towers
Figure 10: The position of cannons and rocket launchers near the tower-tombs west of the Marona tomb
 (Sources: APSA; Coordination of the City of Palmyra [insets]; HRW[aerial])

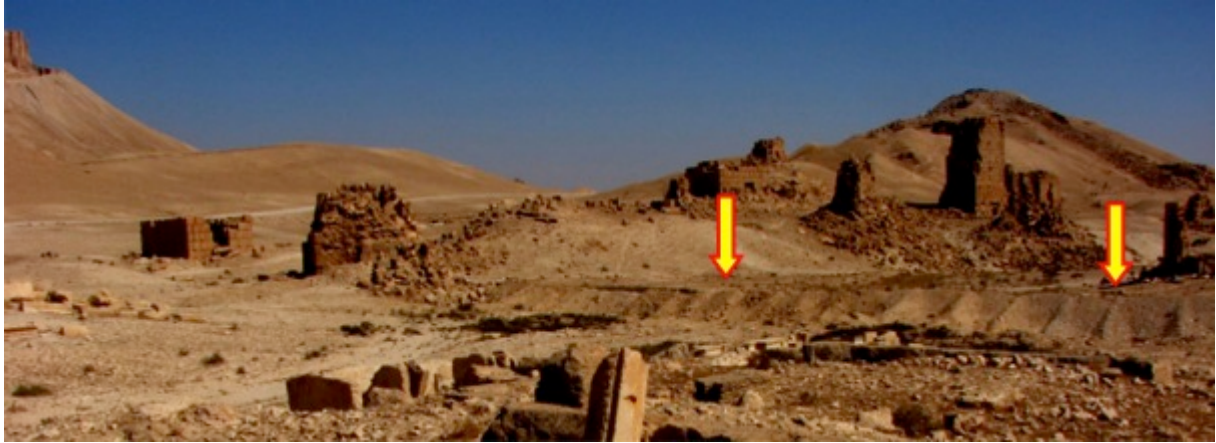
Figure 12: Levees in the Valley of the Tombs area (Source: APSA)

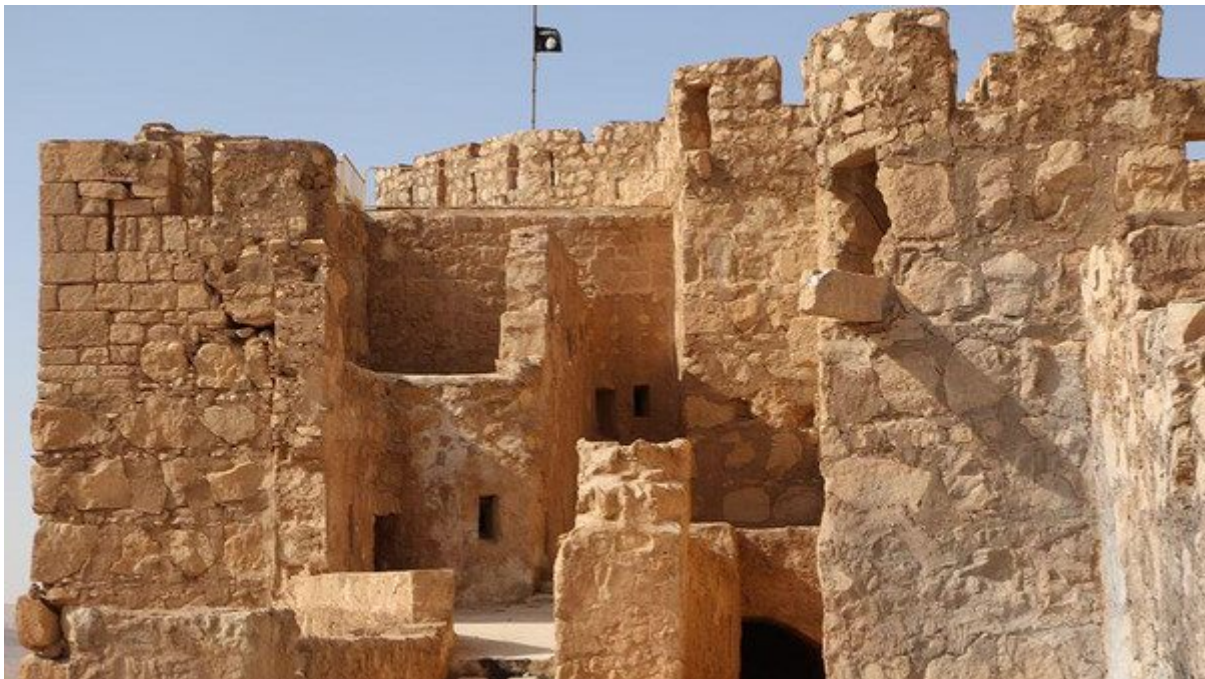
Up to now, there has been no observed damage, according to ground-level observations from local sources and published reports. It should be noted that the area around the citadel was bombed during the fighting between the Syrian army and ISIL that began on May 14, 2015.³

Figure 13: The ancient citadel under the control of ISIL (Source: APSA)

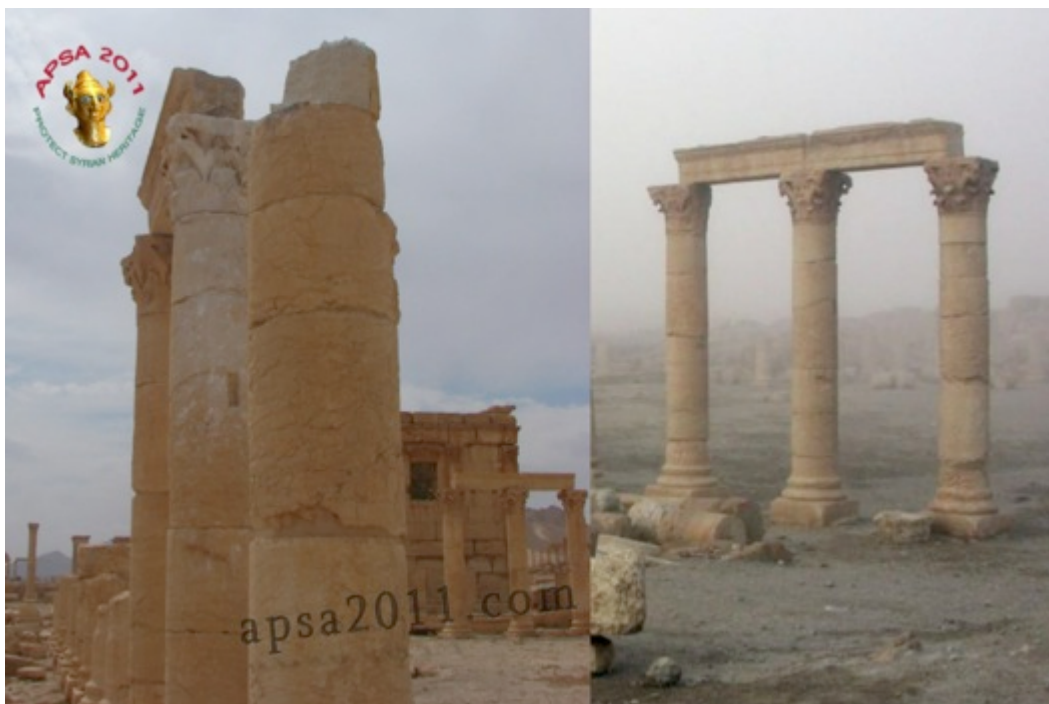
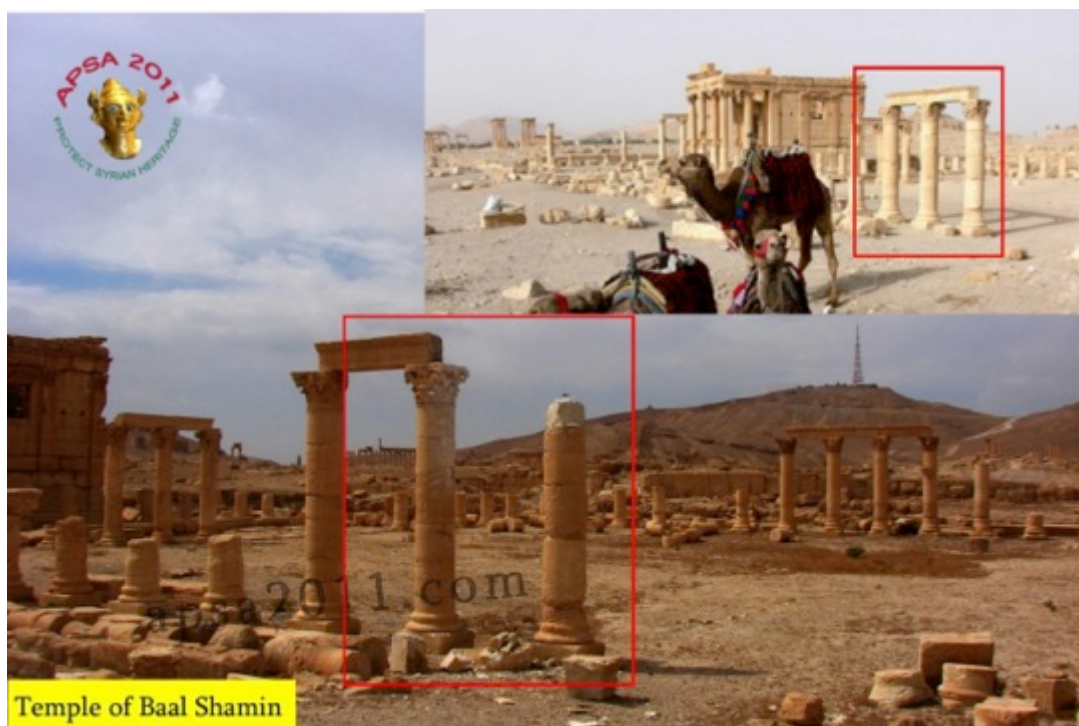
Figure 14: Damage in the portico of the temple of Baal-Shamin. (Sources: APSA and HRW)

Figure 15: Damage in the portico of the temple of Baal-Shamin. (Sources: APSA and HRW)

Figure 16: Damage to the frieze and the column of the eastern portico (Source: APSA)

Figures 14–16 show direct damage to a frieze and a column of the portico, which resulted in the collapse of the damaged part of the frieze and the upper drum and capital of the column.⁴

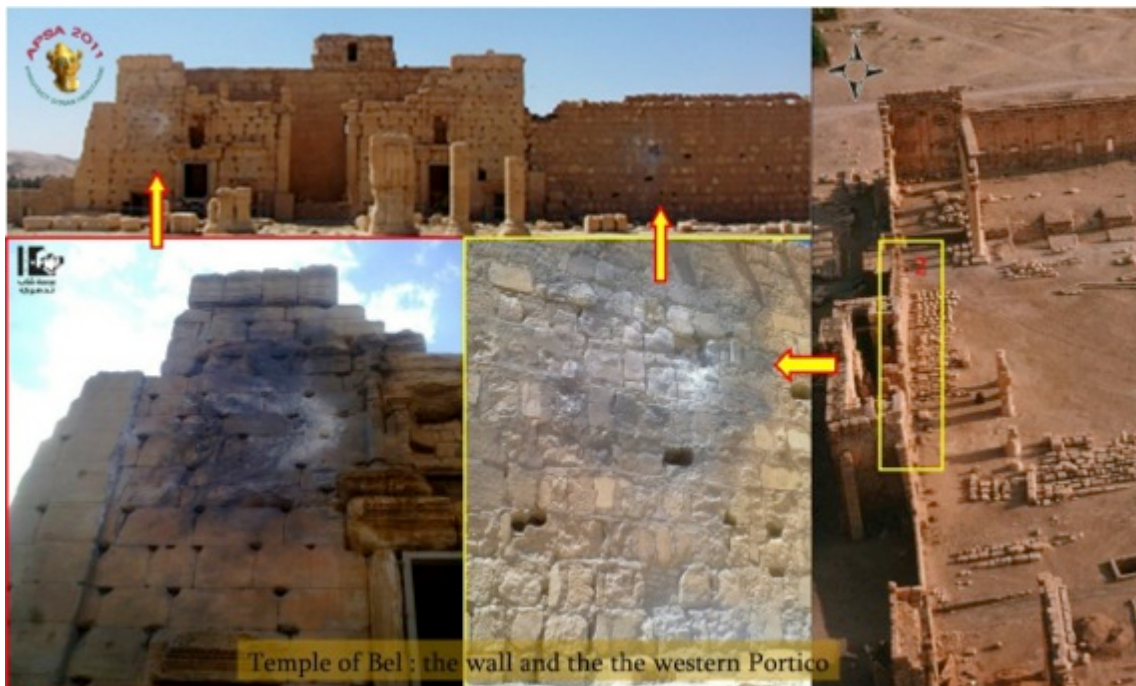
- Traces of a shell that left minor damage on the northwestern corner of the outer wall of the temple (**Figure 18**).
- A few stones from the upper part of the western wall were destroyed by a direct hit (**Figure 19**). The inner facade of the temple was hit by two shells. The damage appears to be light (**Figure 20**).

Figure 20: Damage to the interior facade of the western wall (Source: APSA and Lens Young Tadmouri)

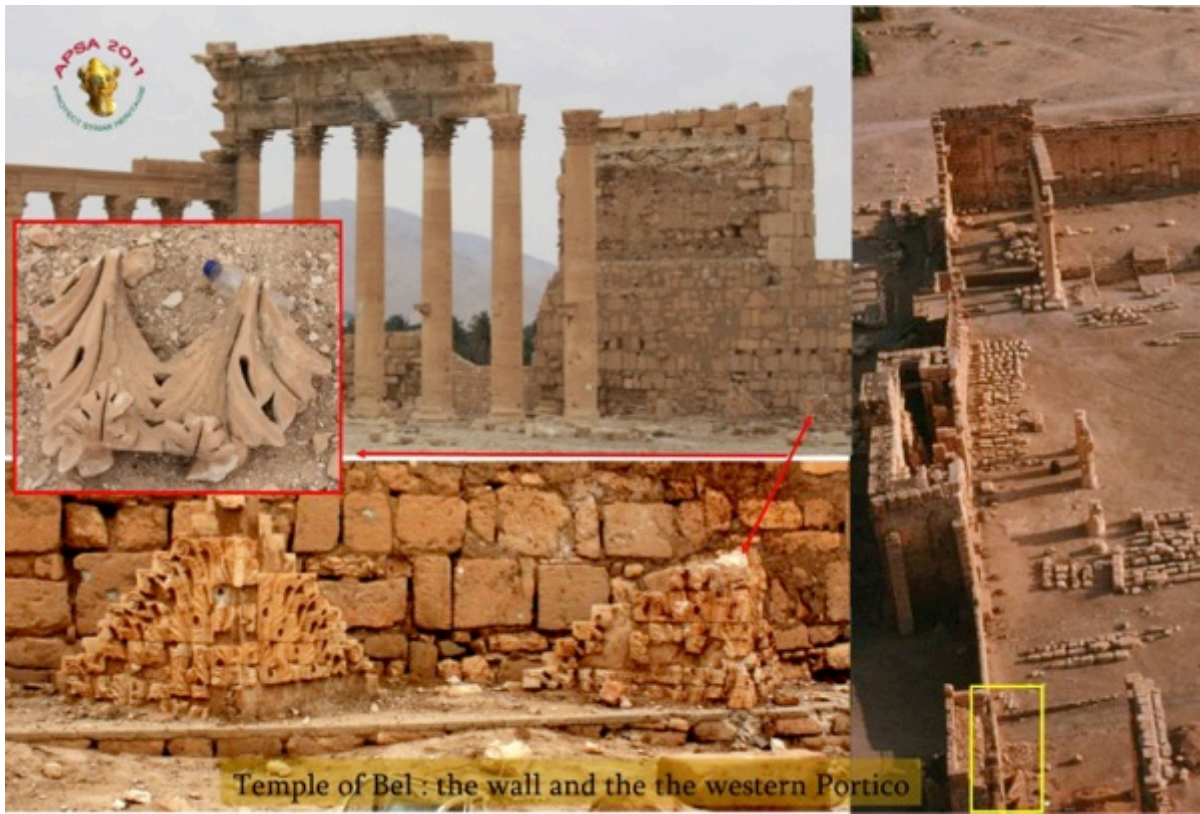
- Part of the capital of a restored column now lies on the ground and has been broken. (**Figure 25**).

Figure 25: Damage to the capital of a column previously restored (Source: APSA)

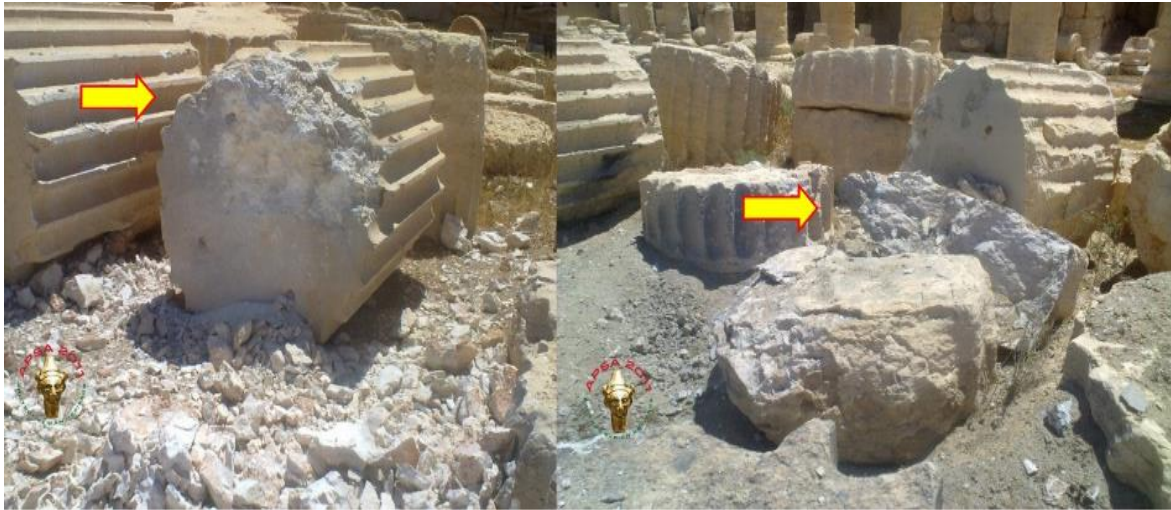
- A direct hit by a shell left a hole in the southern enclosure facing column 3 (**Figure 27**). In addition, some drums and capitals that had been placed on the ground in the southern portico area have crumbled due to shelling. (**Figure 32**).

Figure 32: Shell traces in the south portico area (Source: APSA)

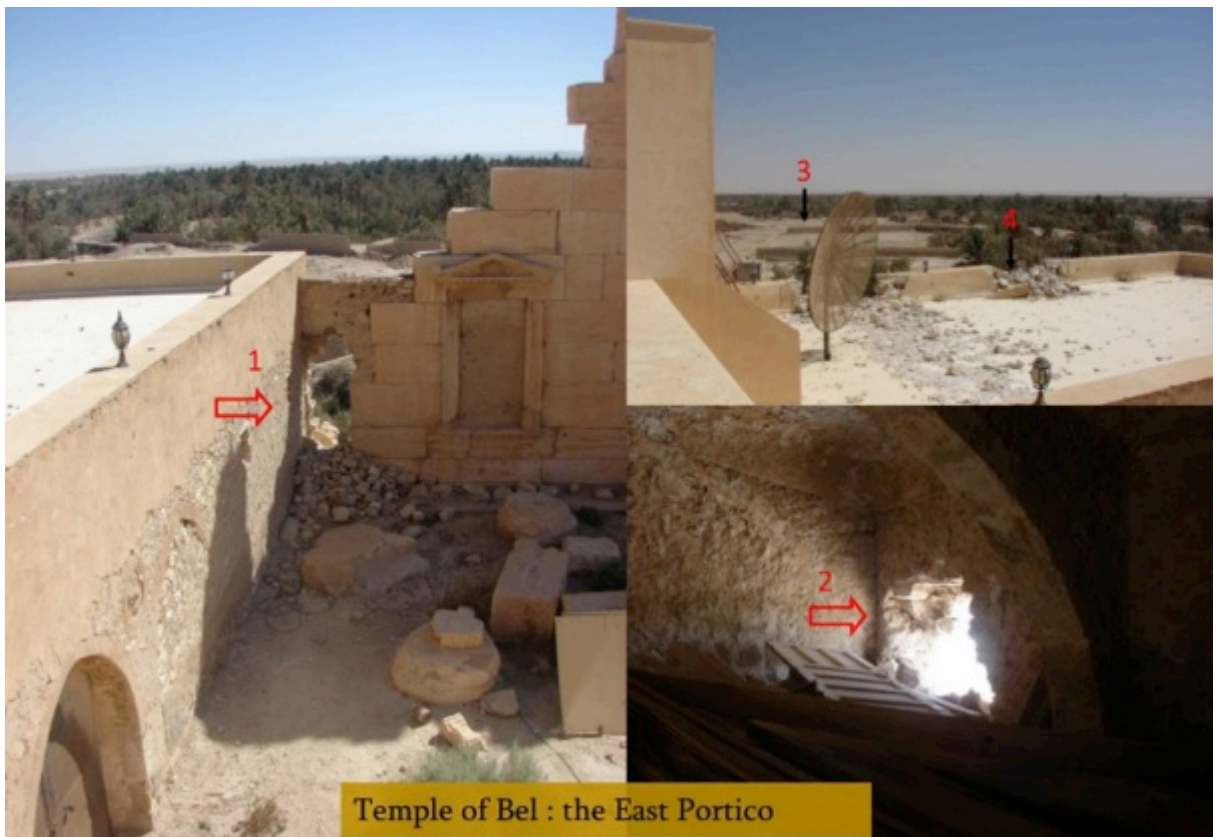
- In the southeastern corner of the temple of Baal, two openings were created by thieves. The first is located in the southern enclosure and measures 2 x 1 meters; the second (1.5 x 1.5 meters) is located in the wall adjacent to the guest house on the southern side (**Figures 34, 35 - points 1-2**).⁶
- The rest of the damage is relatively minor damage to the top of the wall (**Figures 36-37**), including two holes (**Figure 38**).

Figure 35: The two openings created by thieves at the southeastern corner of the enclosure of the temple of Baal (Source: APSA)

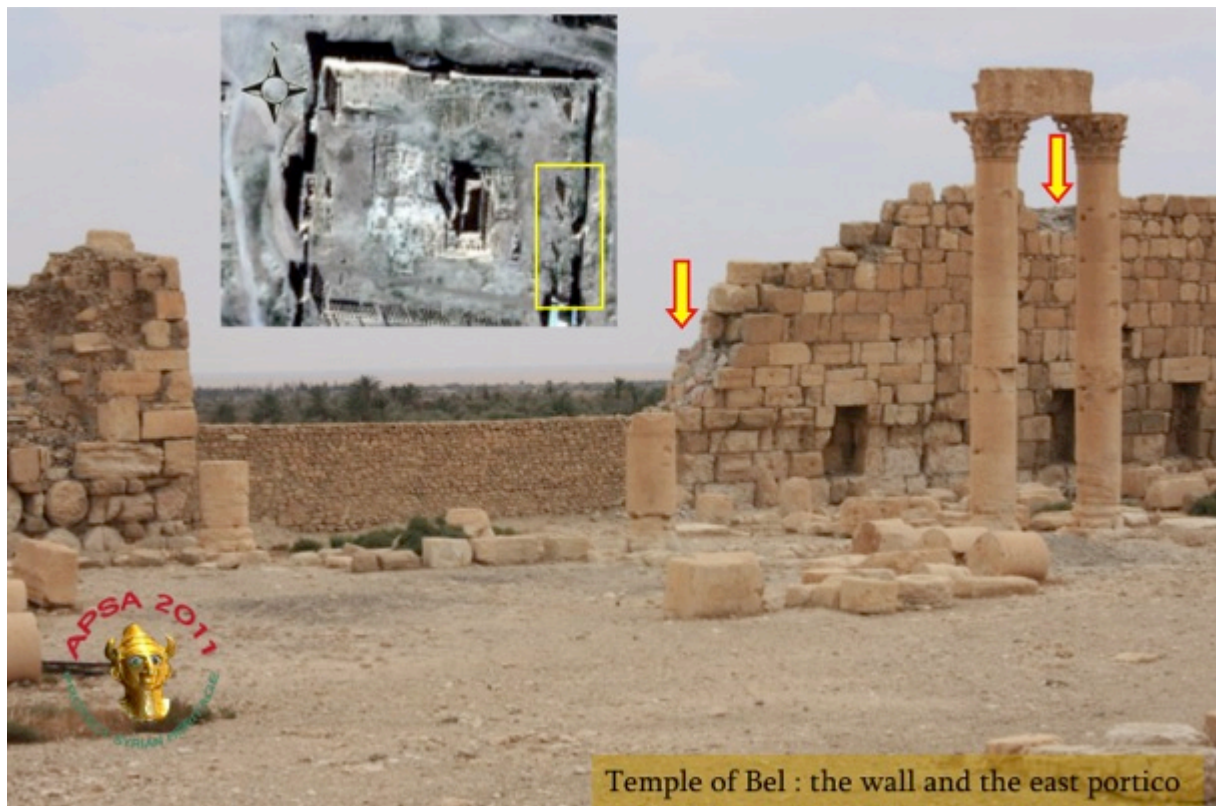
Figure 36: Traces of shrapnel in the eastern wall (Source: APSA)

Figure 37: Traces of shrapnel in the eastern wall (Source: APSA)

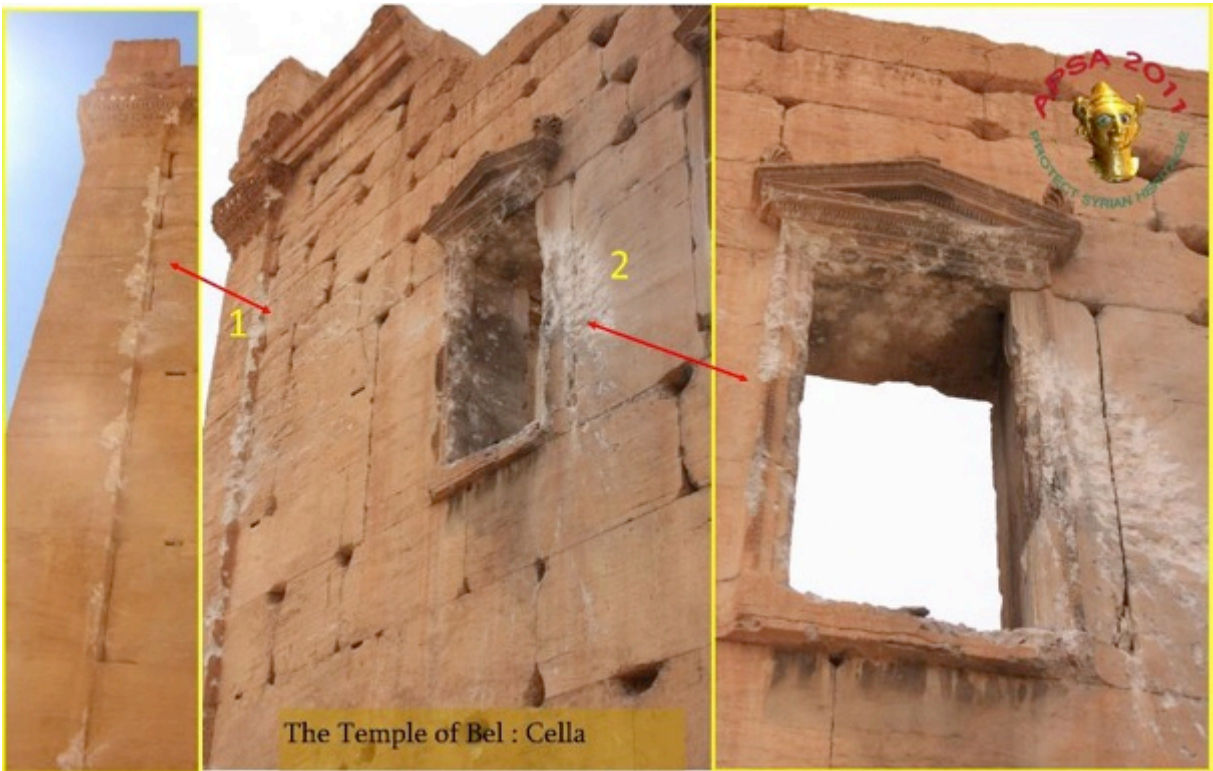
Figure 42: Sanctuary of the temple, damage to the southeastern corner of the eastern wall (Source: APSA)

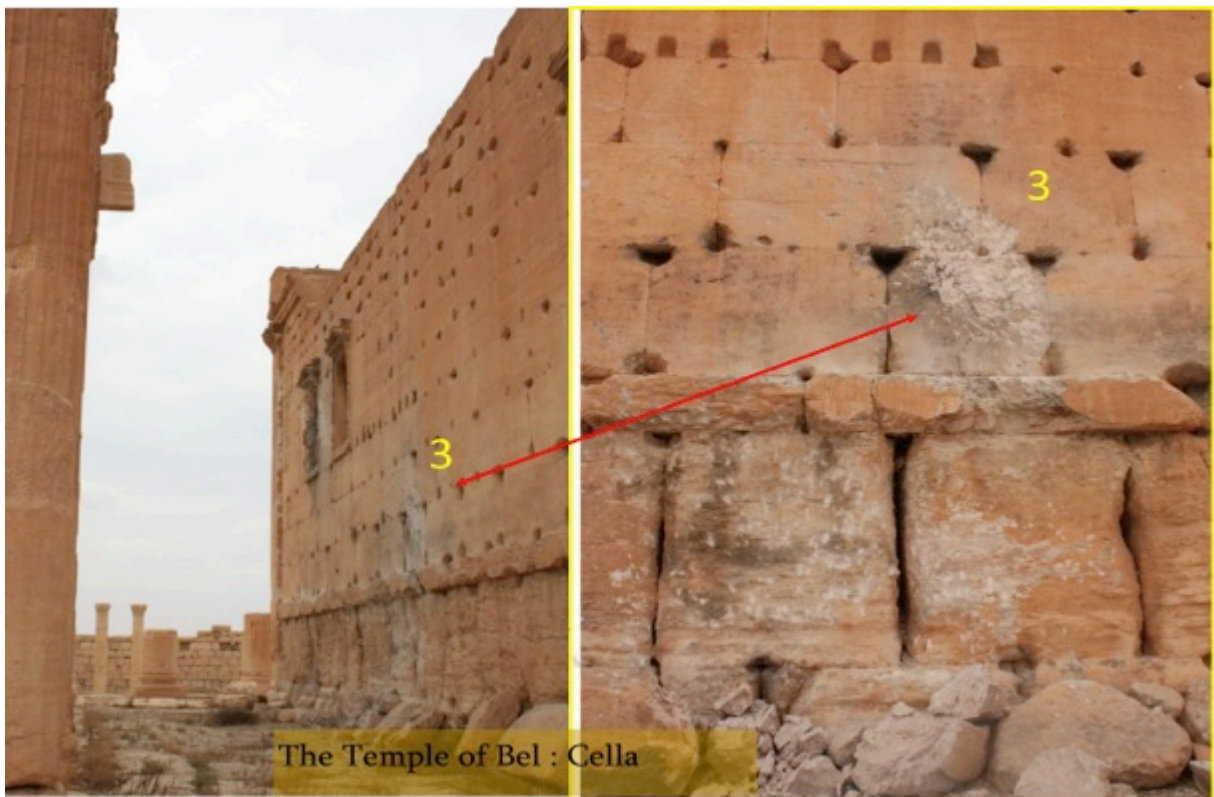
Figure 44: Sanctuary of the temple, shell traces on the outer facade of the eastern wall (Source: APSA)

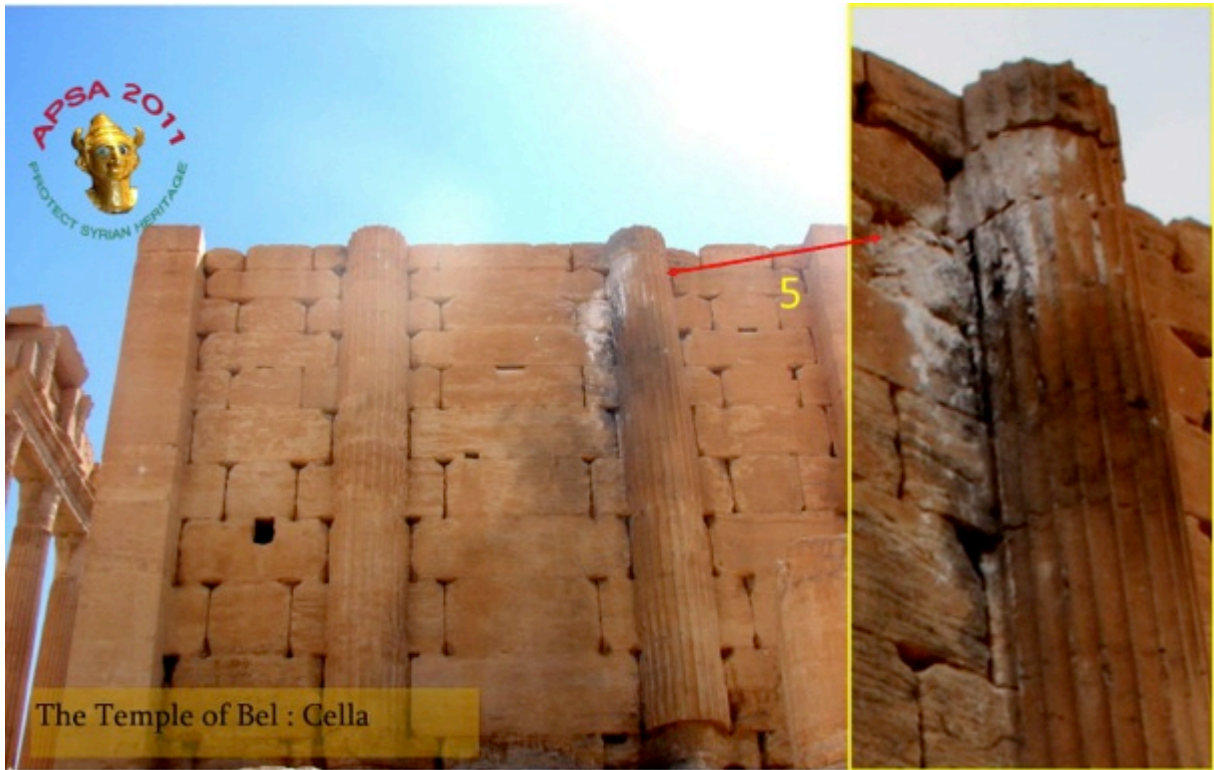
Figure 47: Sanctuary of the temple, crumbling of the upper part of a column and the northern wall, Point no. 5 (Source: APSA)

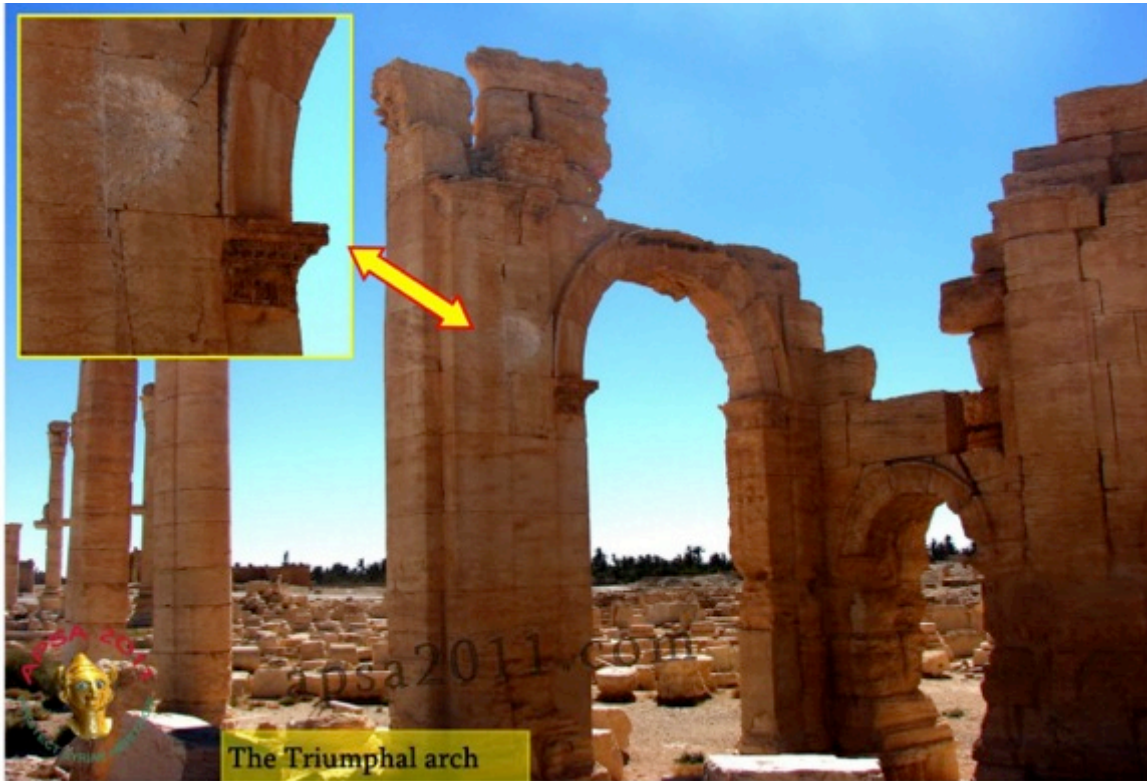
- **Figure 49** shows that the facade of the small northeastern arch next to the triumphal arch has suffered some damage due to a shelling.
- Four columns situated 200 meters west of the tetrapylon and near basilica I (**Figure 50**) were subject to a direct hit. This caused the collapse of three columns and their frieze, while a drum of the fourth column was shifted without collapsing completely (**Figures 51-52**).

Figure 49: Shell damage to facade of the small northeastern arch next to the triumphal arch (Source: APSA)

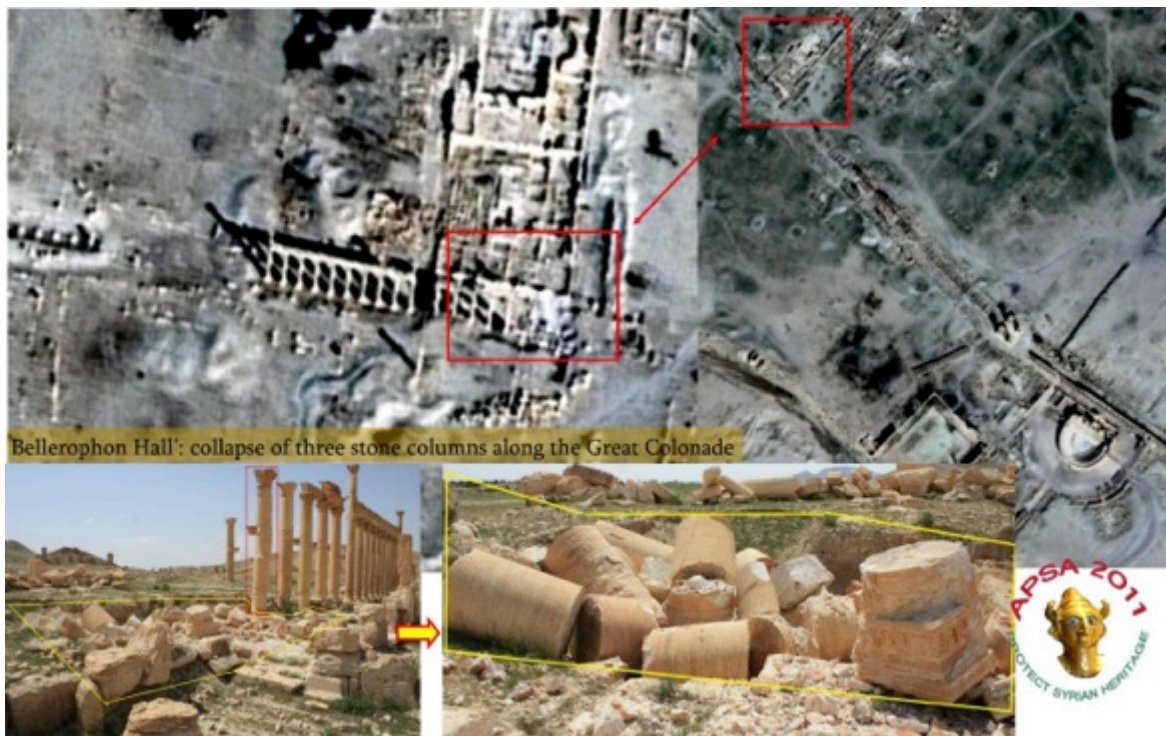
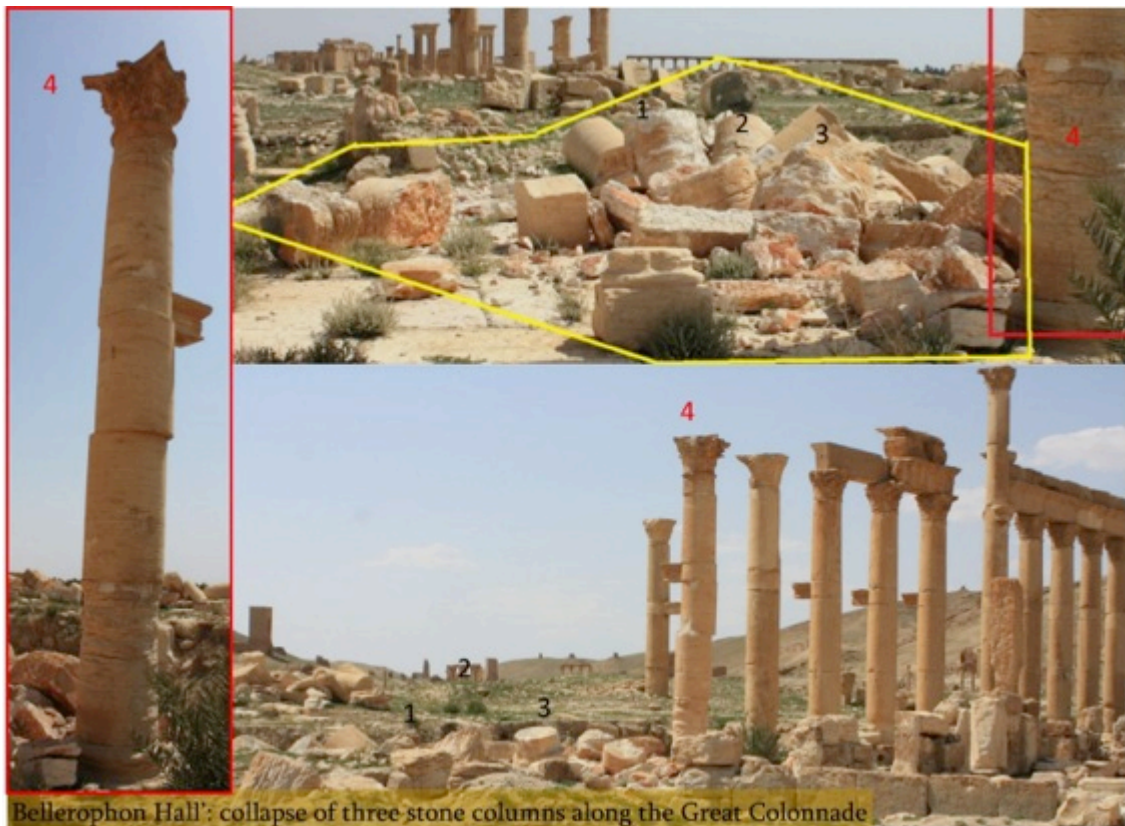
Figure 50: The colonnaded street; damage to three columns and the shifting of a drum of the fourth column (Sources: APSA and HRW)

Figure 51: The colonnaded street; damage to three columns and the shifting of a drum of the fourth column (Source: APSA)

Figure 52: The colonnaded street; damage to three columns and the shifting of a drum of the fourth column (Source: APSA)

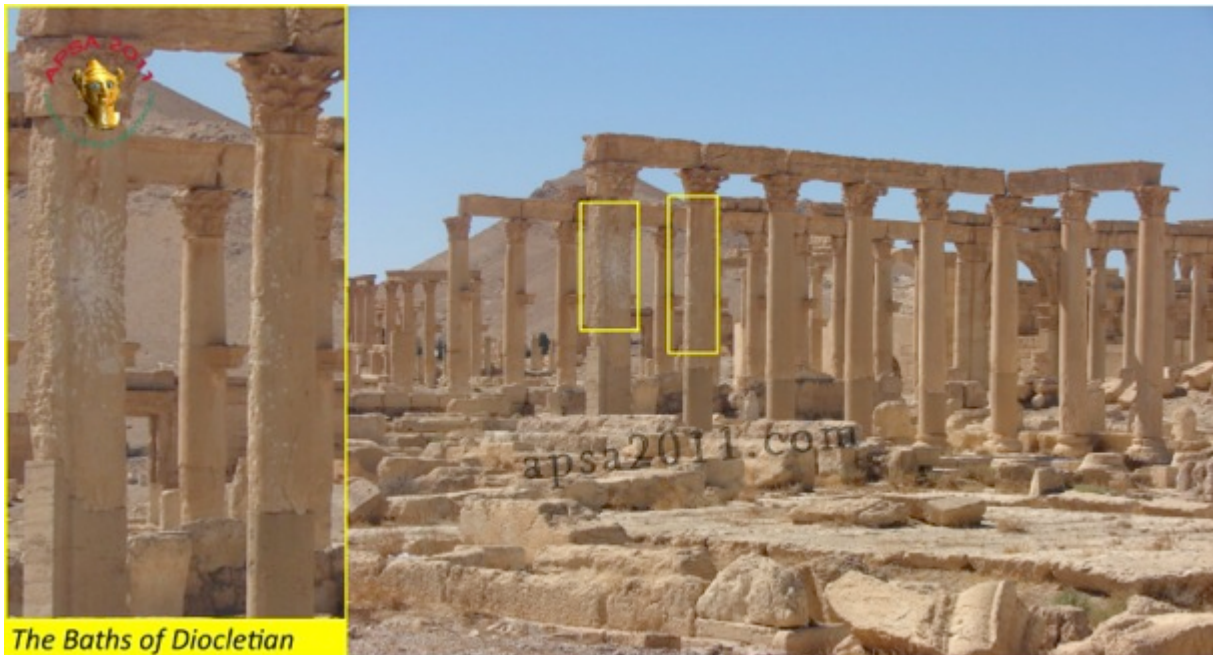
- Two columns belonging to the Diocletian hammam were damaged with minor crumbling in the structure (**Figure 54**).
- The area of the Diocletian camp was subject to bulldozer work, which resulted in heavy damage to the archaeological deposits (**Figures 55-56**).

Figure 54: The Baths of Diocletian (Source: APSA)
