Palmyra: Heritage Adrift

Detailed report on all damage done to the archaeological site between February 2012 and June 2015

Cheikhmous ALI *

The Association for the Protection of Syrian Archaeology
www.apsa2011.com

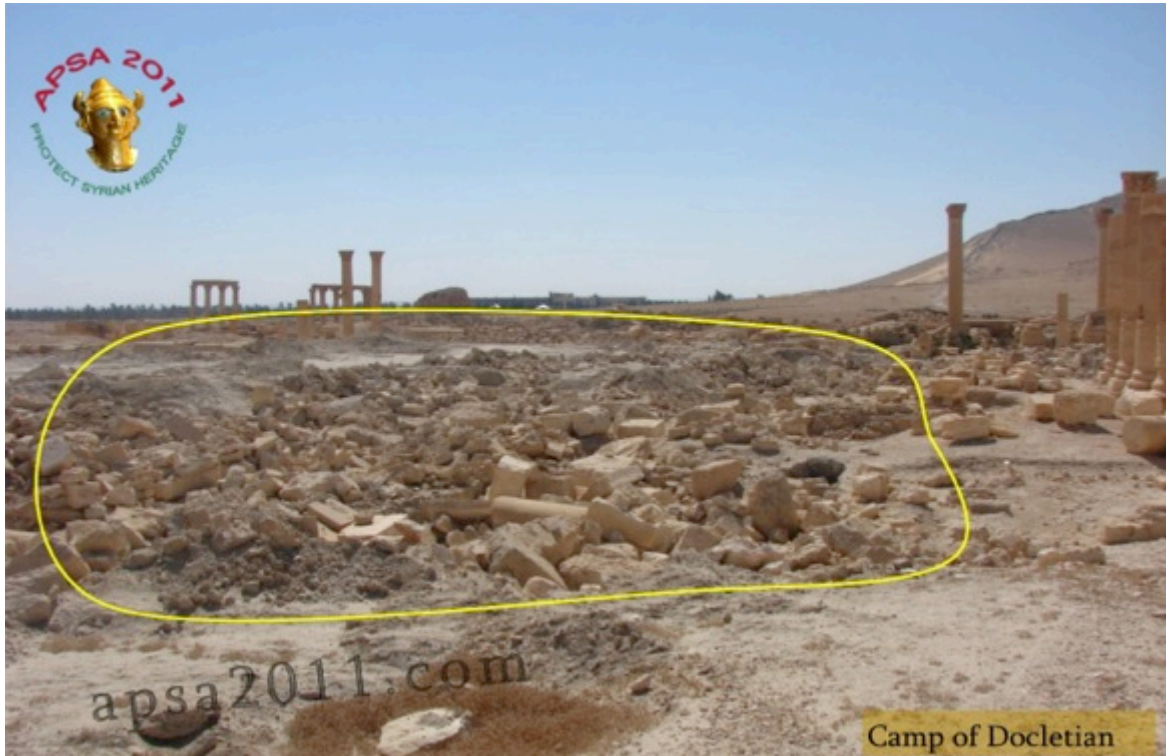
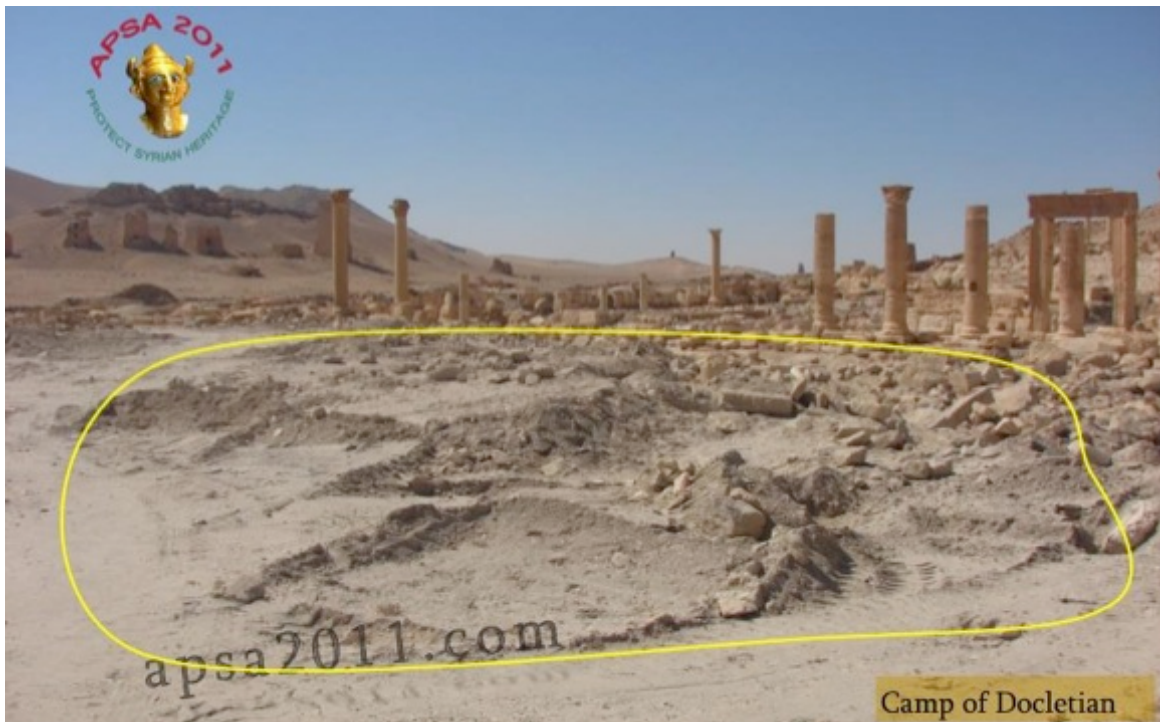
- Two columns belonging to the Diocletian hammam were damaged with minor crumbling in the structure (**Figure 54**).
- The area of the Diocletian camp was subject to bulldozer work, which resulted in heavy damage to the archaeological deposits (**Figures 55-56**).

Figure 55: Bulldozer work in the area of the camp of Diocletian, resulting in heavy damage to the archaeological deposits (Source: APSA)

Figure 56: Bulldozer work in the area of the camp of Diocletian, resulting in heavy damage to the archaeological deposits (Source: APSA)

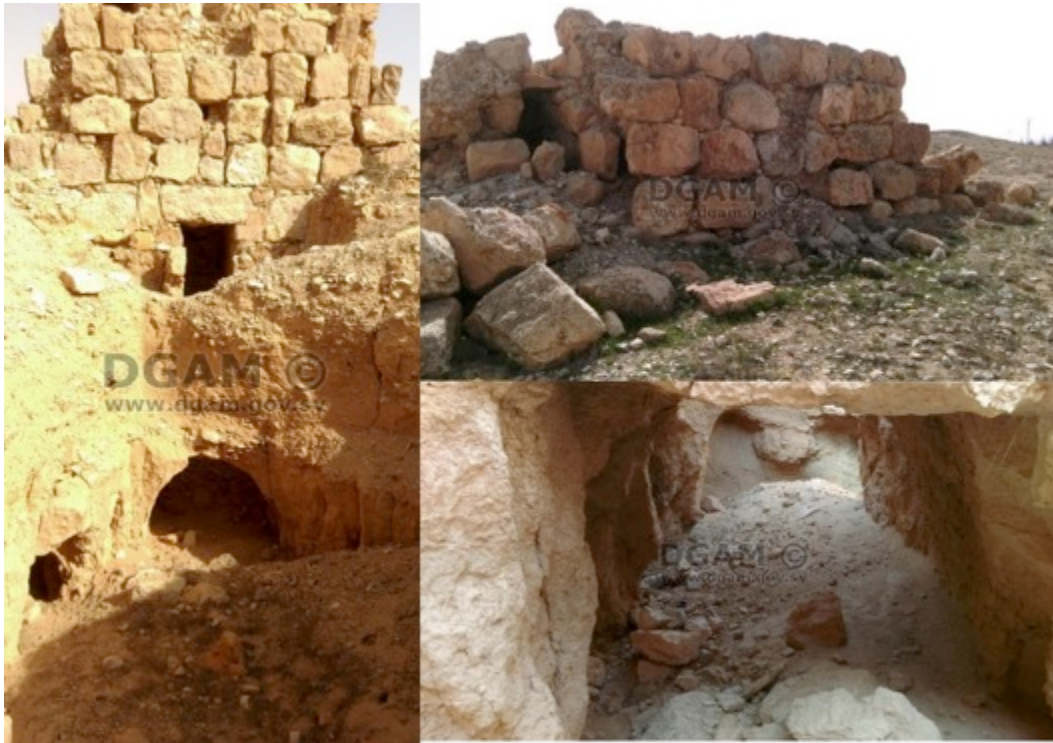
The southern tombs area has suffered massive illegal excavations by looters, most often using bulldozers, particularly in the palm fields and especially in those located near the tombs and the rampart. This area was bombed, and archaeological deposits were destroyed by bulldozers for military purposes. On March 25, 2015, the DGAM published photos showing damage in the southeastern tombs area and the Valley of the Tombs area.¹⁰

Figure 58: Illegal excavation in the Valley of the Tombs (Source: DGAM)

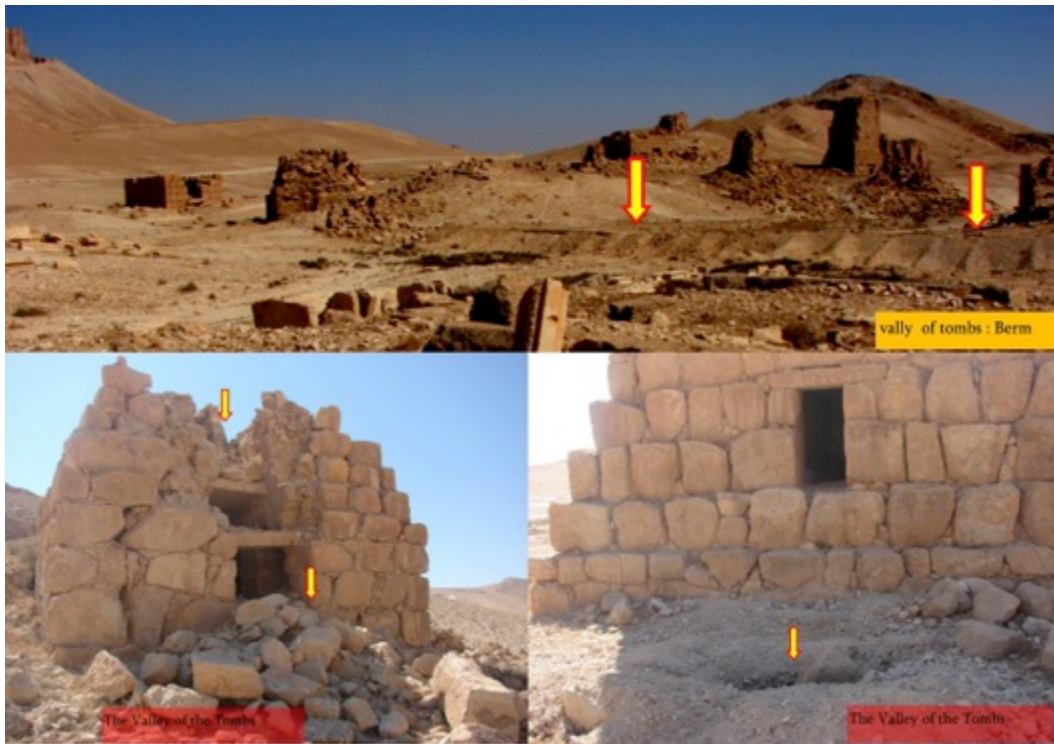
Figure 59: Some damage in the area of Valley of the Tombs area (Source: APSA)

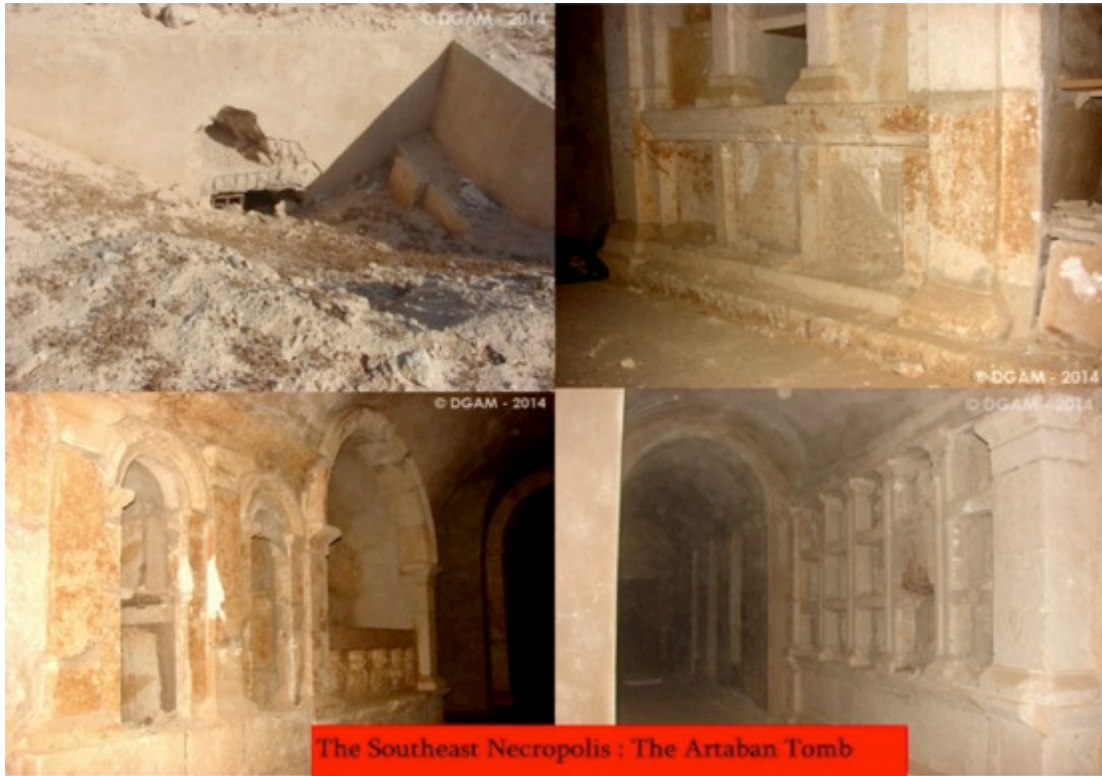
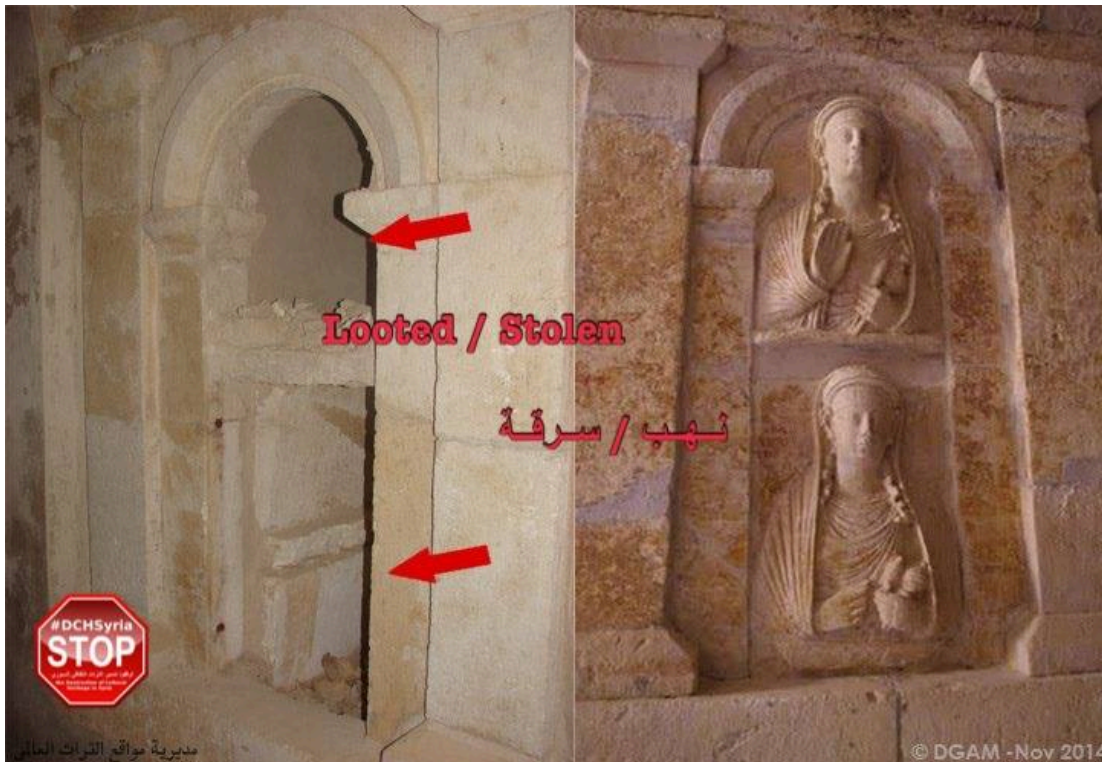
Figure 60: The tomb of Artaban before and after the looting (Source: Palmyra History and Civilization)

Figure 61: The tomb of Artaban before and after the looting (Source: Archaeology in Syria)

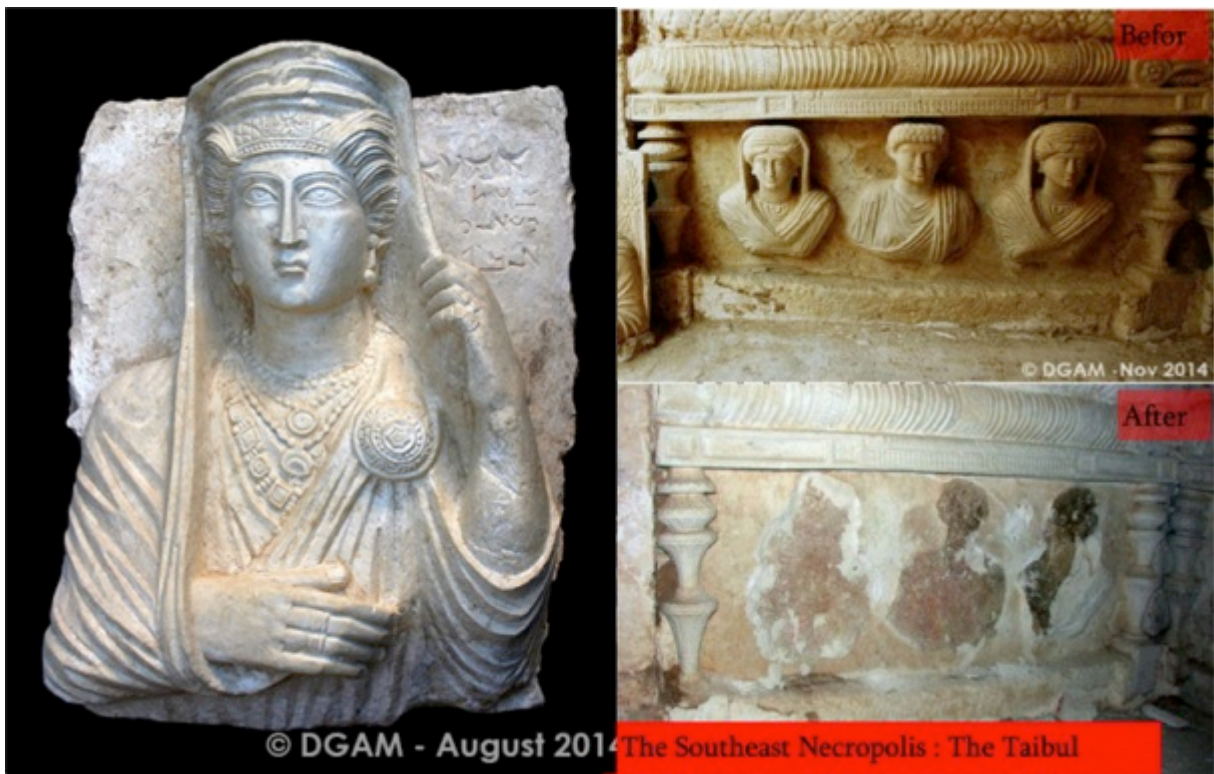
On November 22, 2014, the DGAM announced that the authorities had confiscated funerary statues looted from the tomb. The confiscated items are statue busts made of limestone; two of them are women, while the third is a man, all dressed in clothing typical of Palmyra (**Figure 63**).¹³

Figure 63: Busts of funerary statues of the tomb of Tybul, confiscated and deposited in the Department of Archaeology of Palmyra (Source: DGAM and Palmyra History and Civilization)

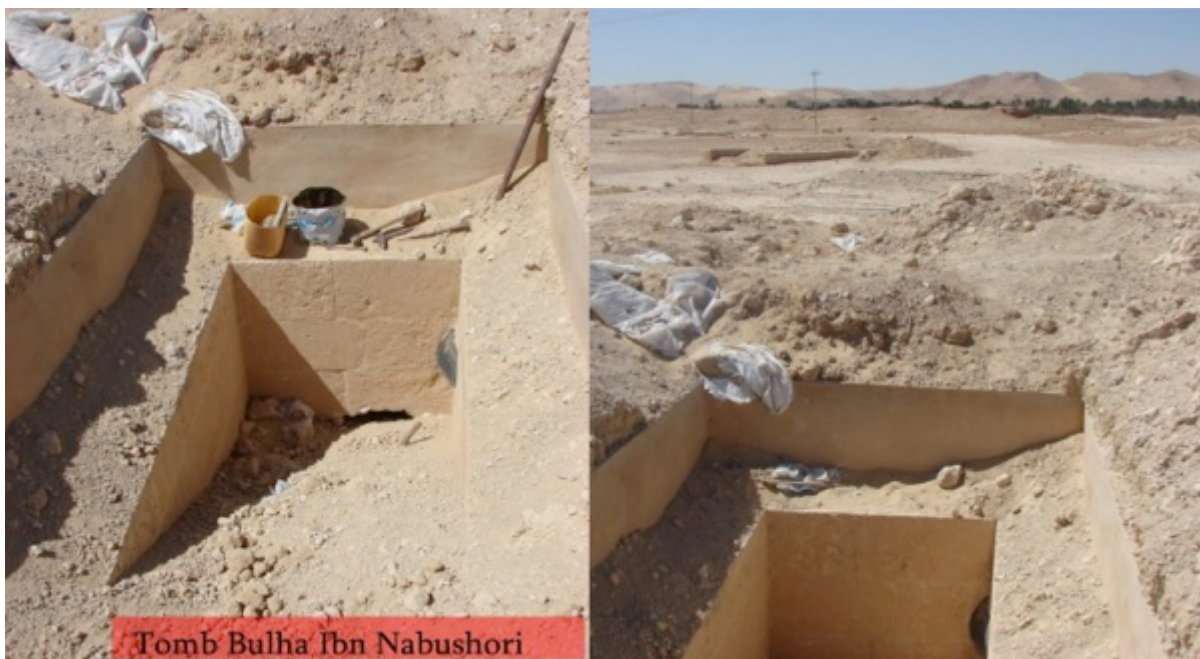
Figure 64: The entrance of the tomb of Bulha Ibn Nabushori after the looting (Source: APSA)

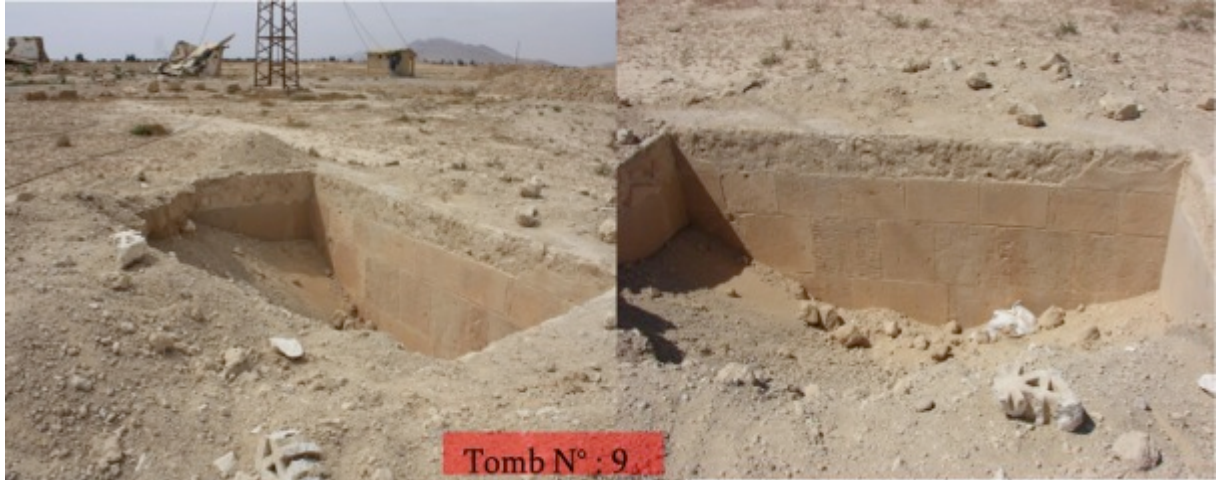
Figure 66 shows that tomb 9 has also suffered looting, but we have no information about the number and nature of objects looted from the tomb.

Figure 66: Illicit excavations at the entrance of tomb 9 (Source: APSA)

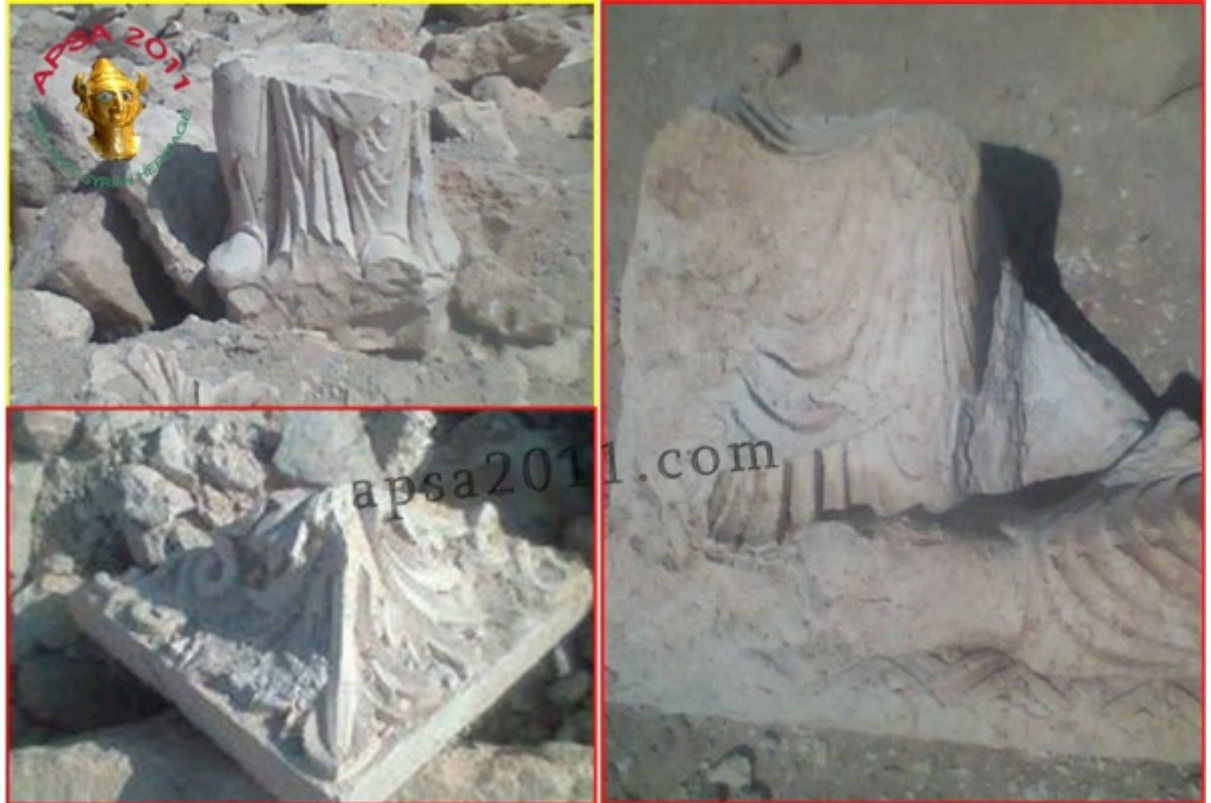
Figure 72: Fragments of statues looted in Palmyra (Source: APSA)

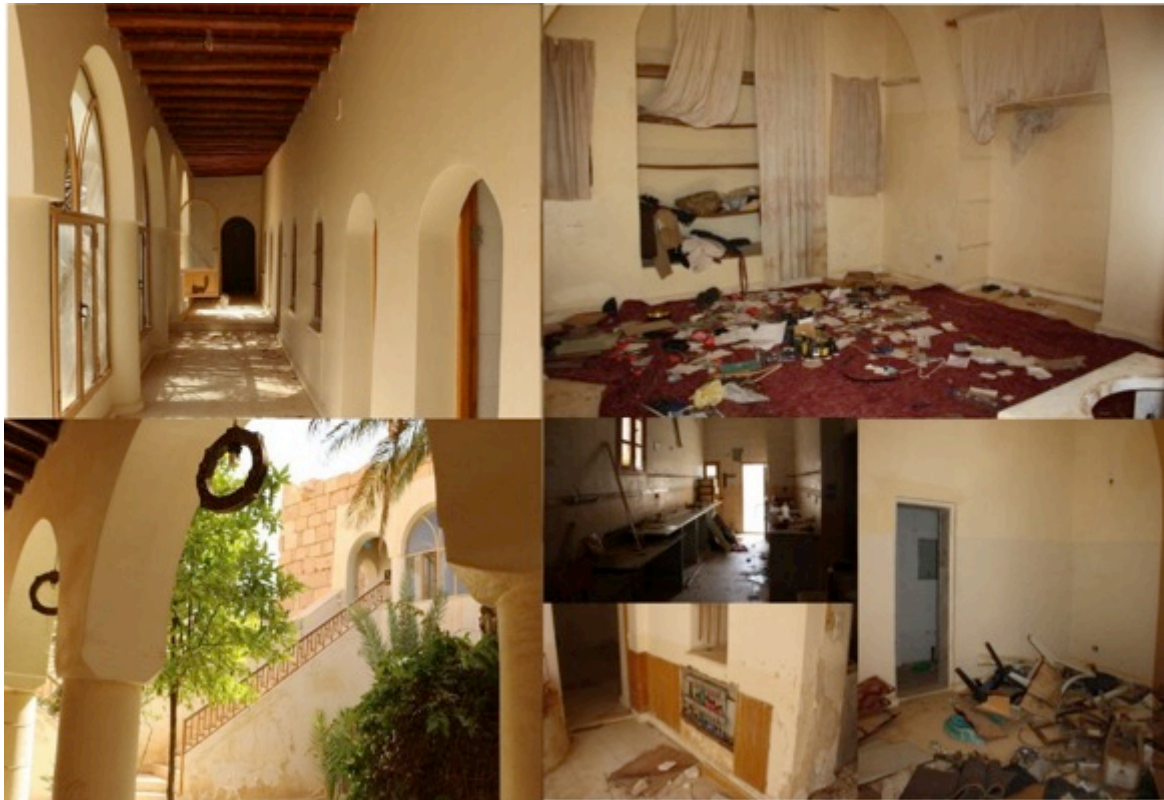
Much of the guesthouse furniture, located in the temple of Baal, was sacked, and some was damaged.²⁹

Figure 73: The Guesthouse in the temple of Baal (source: APSA and DGAM)

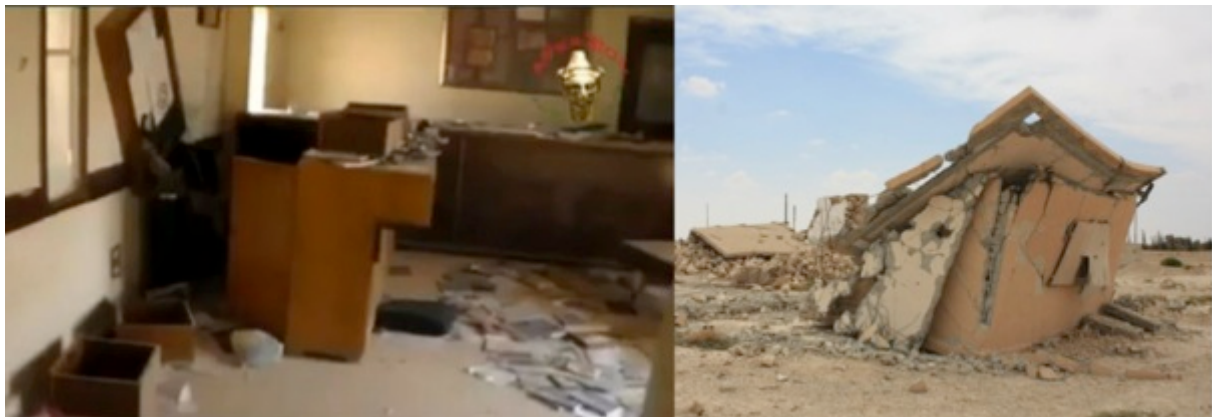
Several amenities, such as toilets at the service of tourists and rooms allocated to guards in the southeastern tombs area, were destroyed. In 2013–2014, ticket sales offices (for example, at the theatre and the temple of Baal) were also looted.³⁰

Figure 74: The ticket sales office of the Baal temple after looting and a security room in the southeastern area of tombs destroyed (Source: APSA)

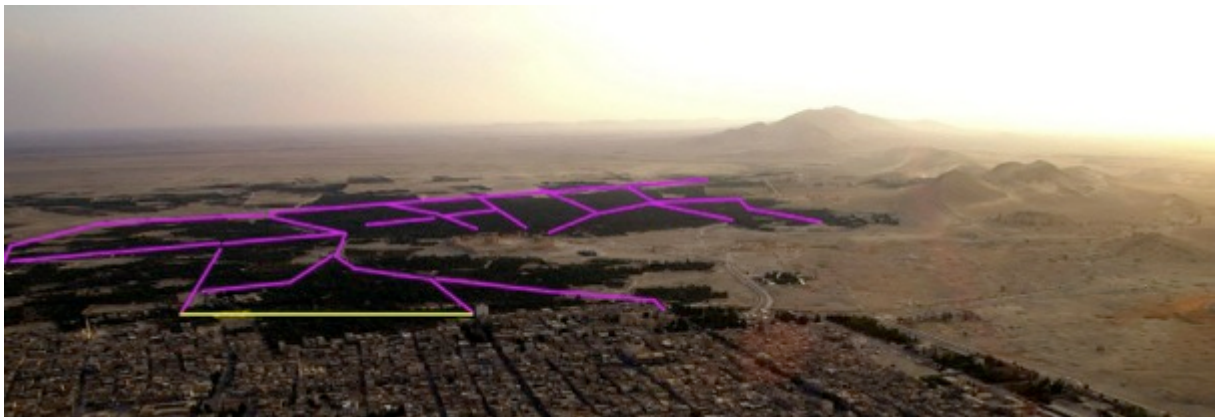
Finally, it should be noted that the areas around the spring of Afqa, the Meridien Hotel, and the palm fields have suffered damage due to work carried out by the Syrian army bulldozers for the purpose of building roads and levees. Moreover, a large part of the fields were burned. For example, the fields in the area around the hotel Dedeman and the spring of Afqa were damaged, and farmers' shelters were destroyed when the army built roads and levees for the purpose of strengthening the defenses of the hotel, which has become a national Defense Forces Centre in Palmyra.^{31 32}

Figure 75: Roads built in the palm field area in Palmyra (Source: APSA)
