ASOR Cultural Heritage Initiatives (CHI): Planning for Safeguarding Heritage Sites in Syria and Iraq¹

Weekly Report 209-212 — October 1–31, 2018

Incident Reports: Syria

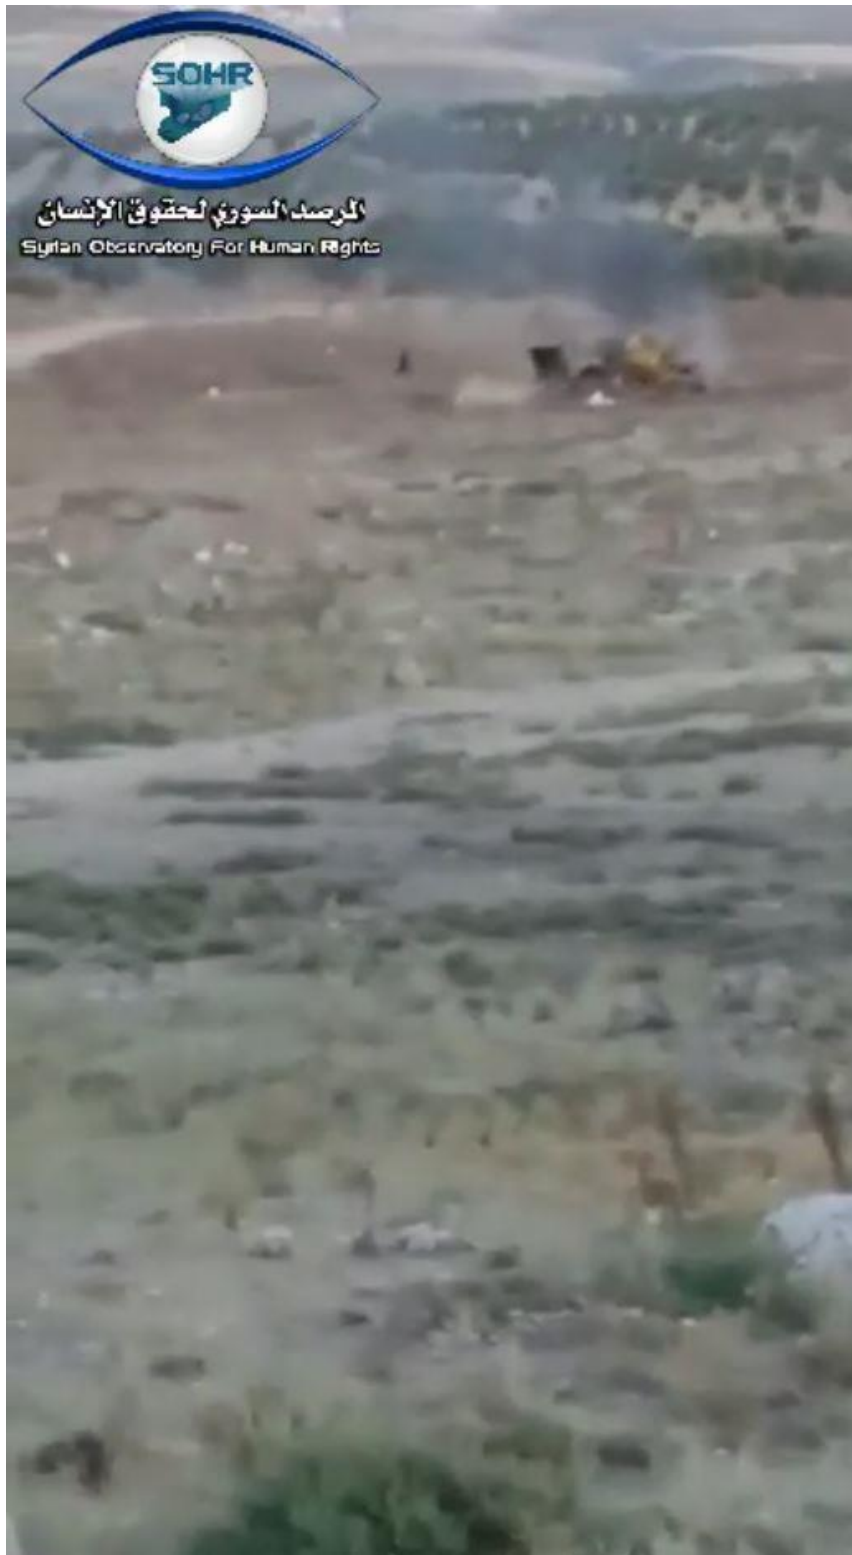
Video still of an earth mover working on the area southeast of the Roman Theater at Cyrrhus (SOHR; October 2, 2018)

Incident Source and Description: On October 2, 2018 the Syrian Observatory for Human Rights (SOHR) posted a video that shows the use of an earth mover in illegal excavations located southeast of the Roman Theater at Cyrrhus.¹⁹ SOHR attributed this activity to members of the First Legion of the Syrian National Army, under the control of Colonel Moataz Raslan (On October 5, 2018, معتمر رسلان).²⁰ The Center for Documenting Violations in Northern Syria (CDVNS) posted photographs of looting in Afrin that likely show some of these illegal excavations.²¹

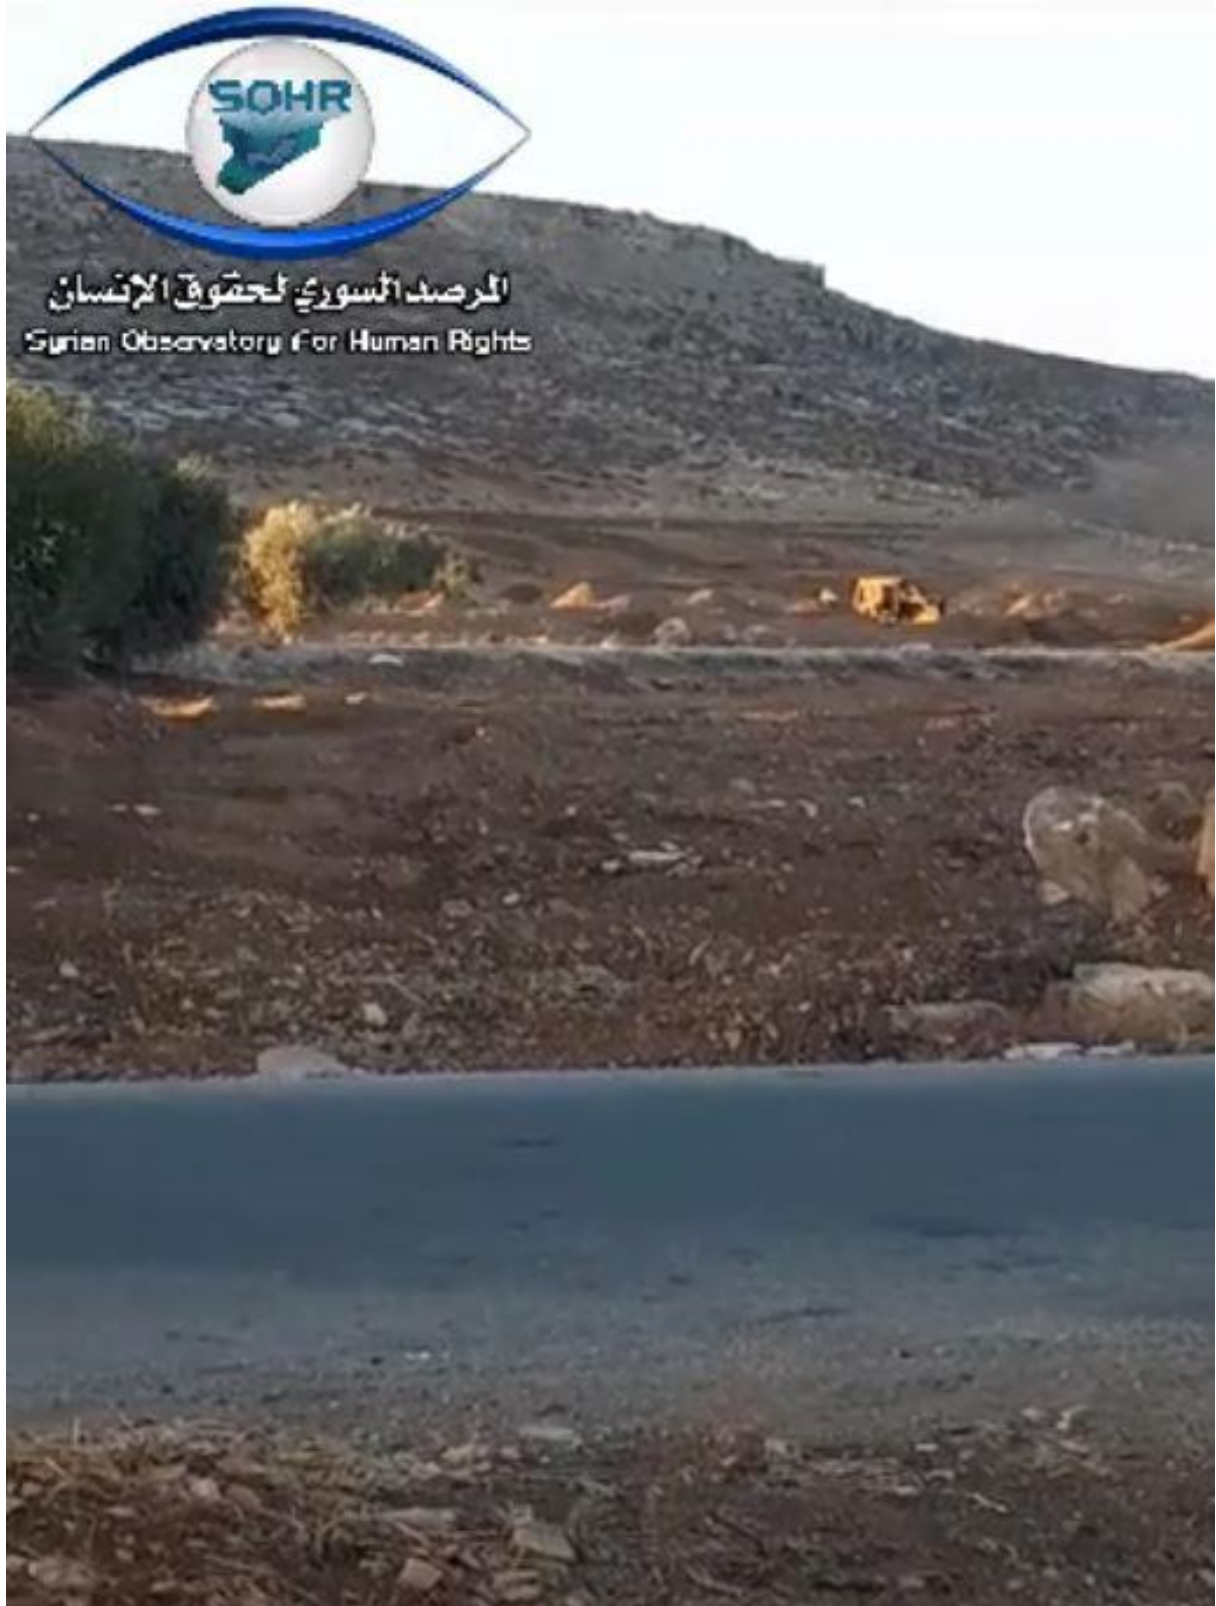
Video still of an earth mover working on the archaeological site of Cyrrhus (SOHR; October 2, 2018)

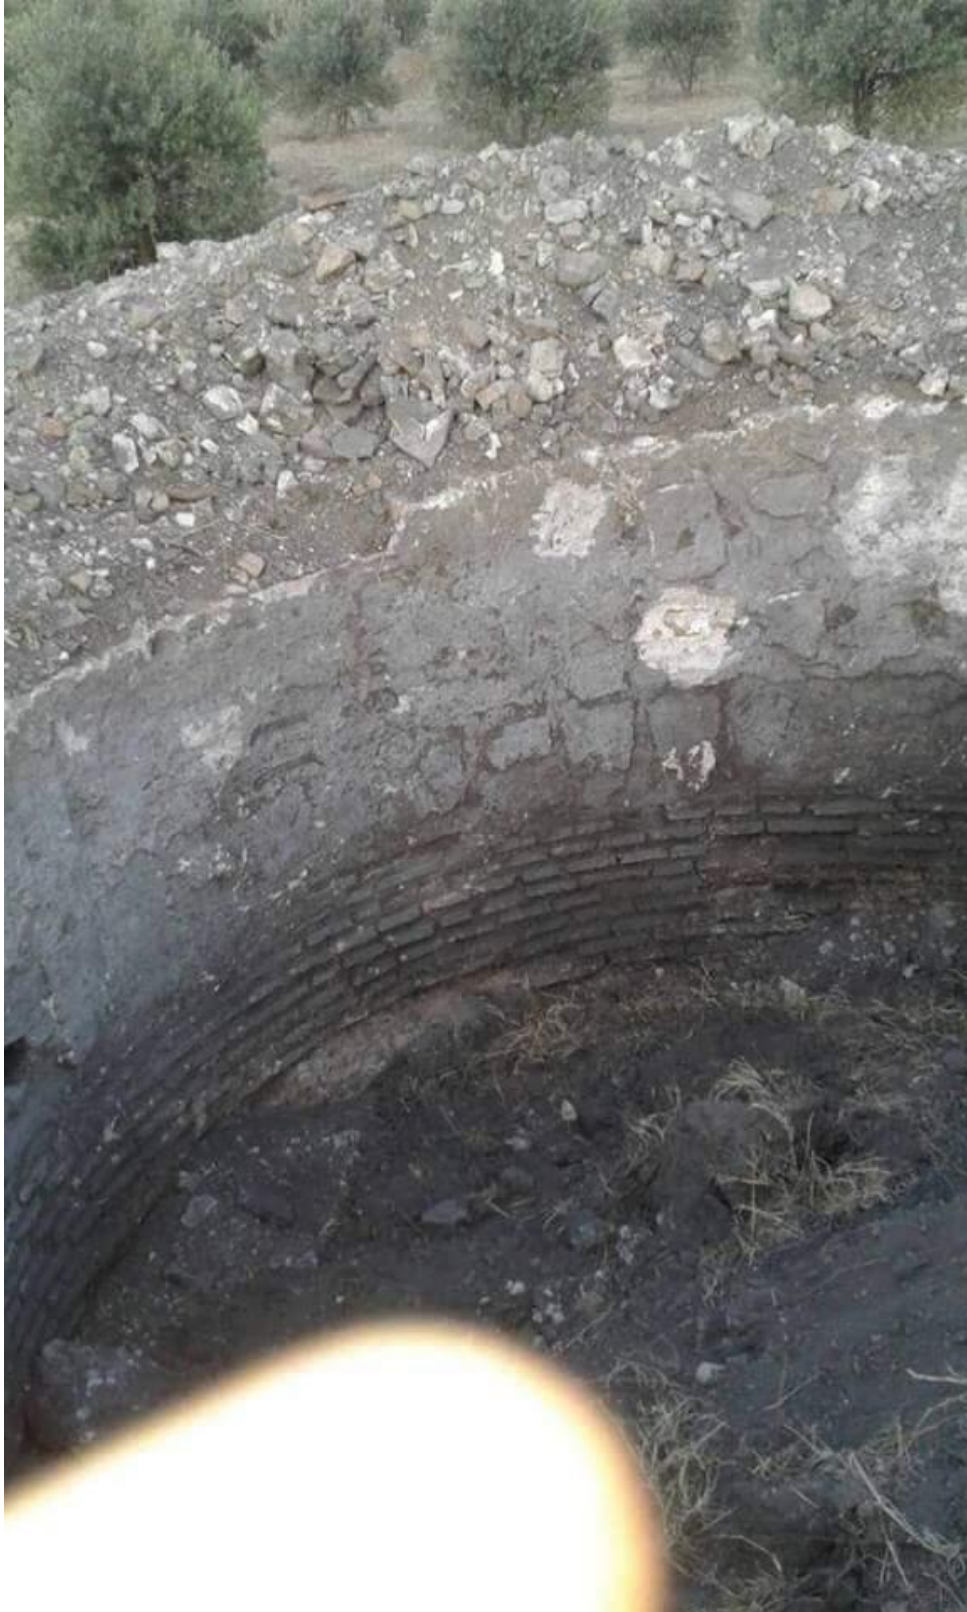
Architecture exposed by illegal excavation, probably at Cyrrhus (CDVNS; October 5, 2018)

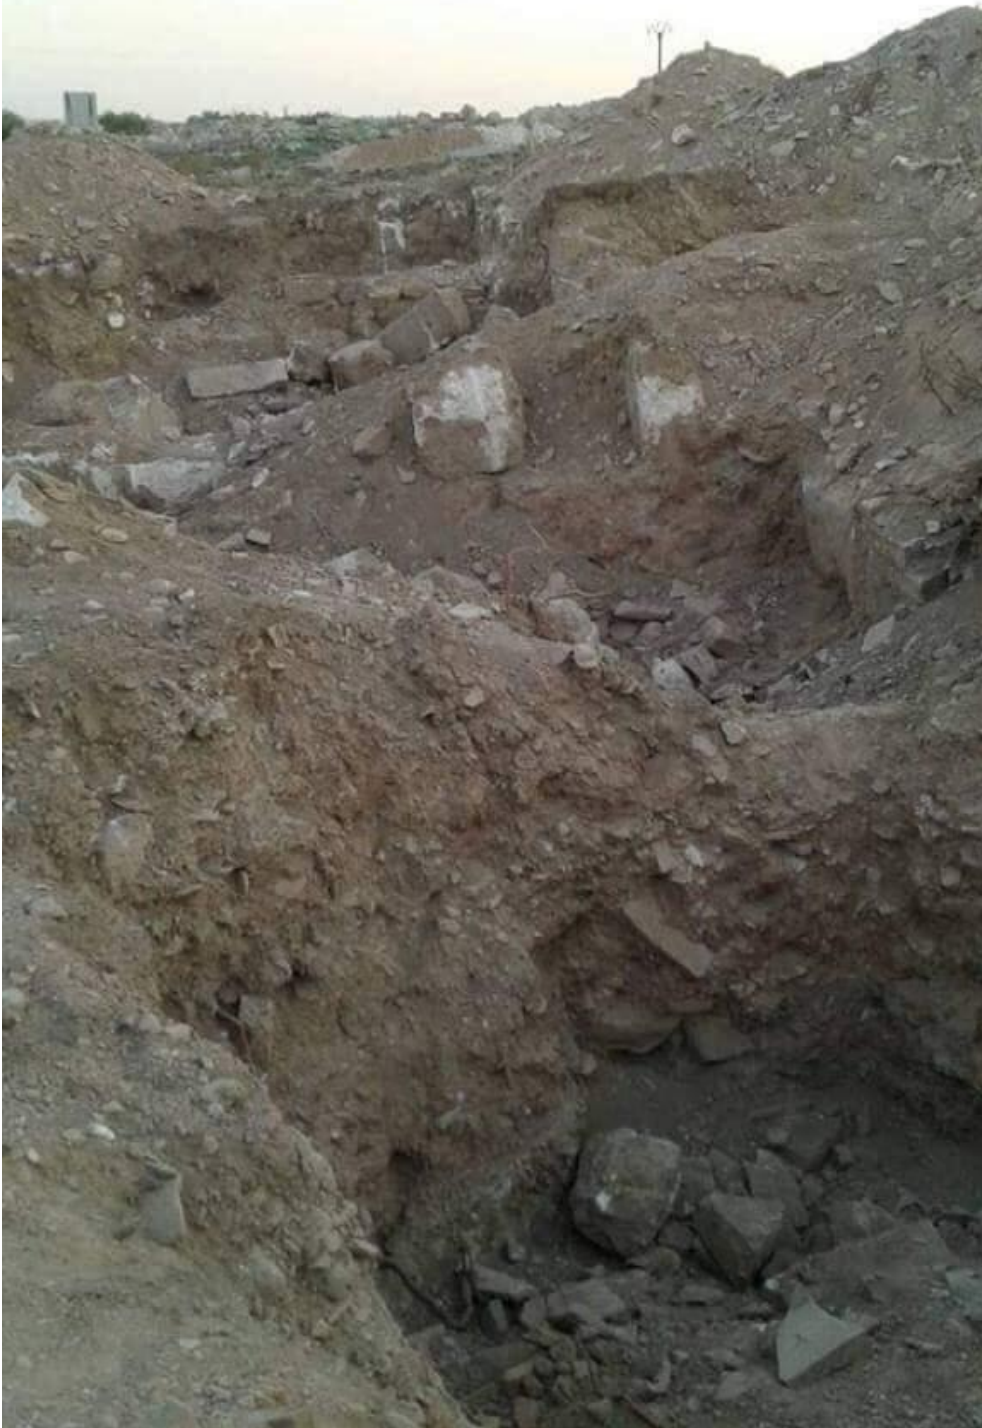
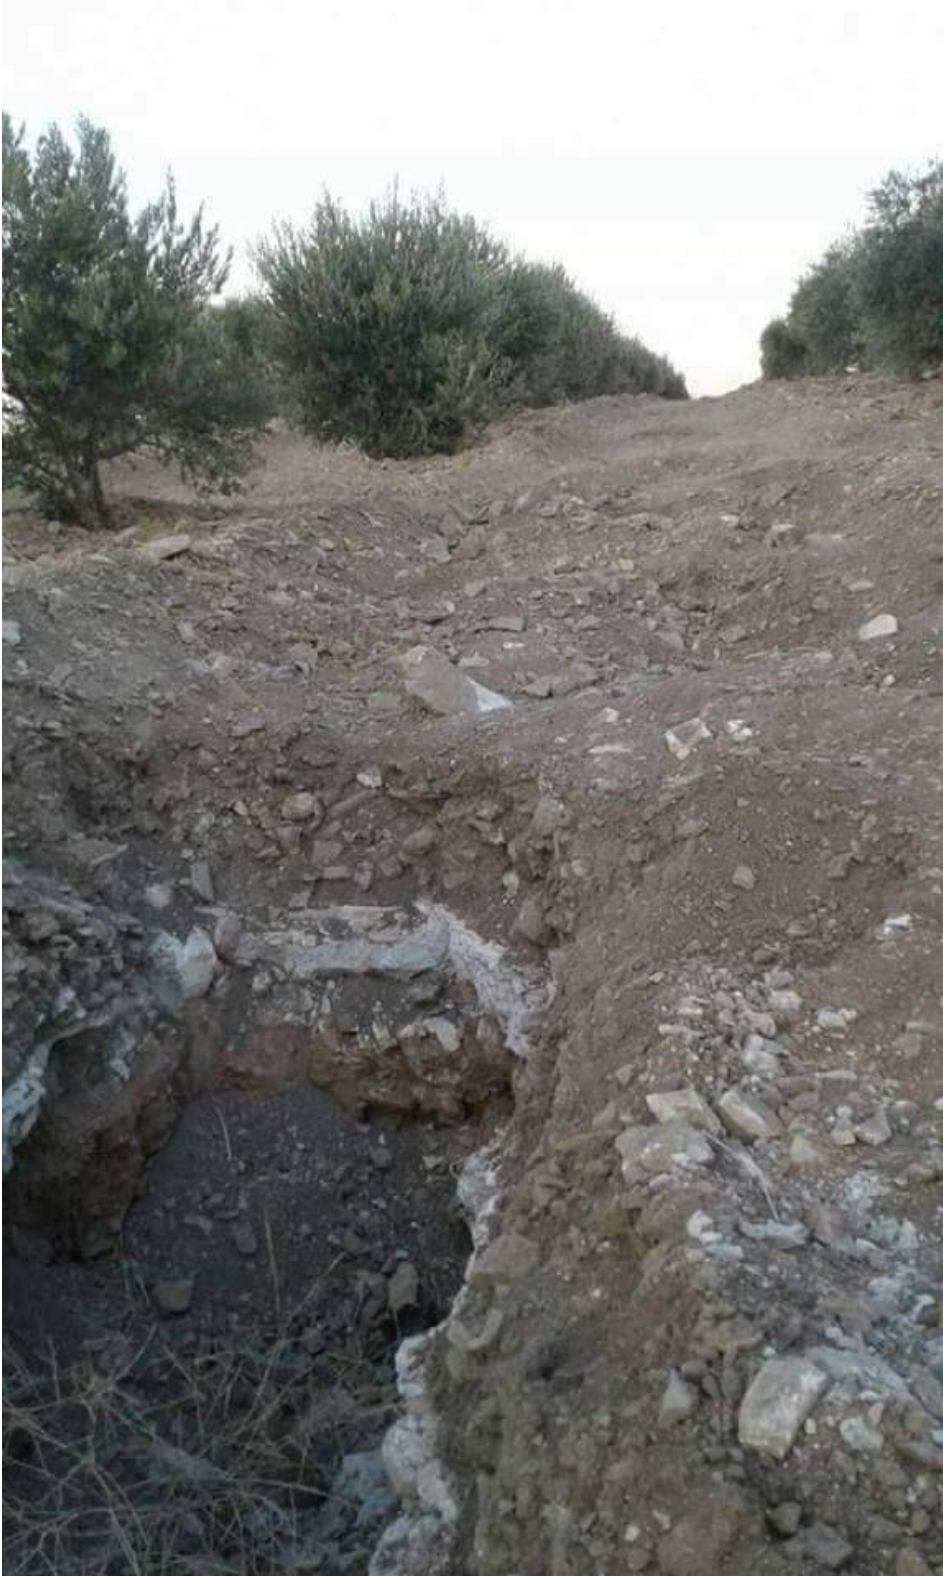
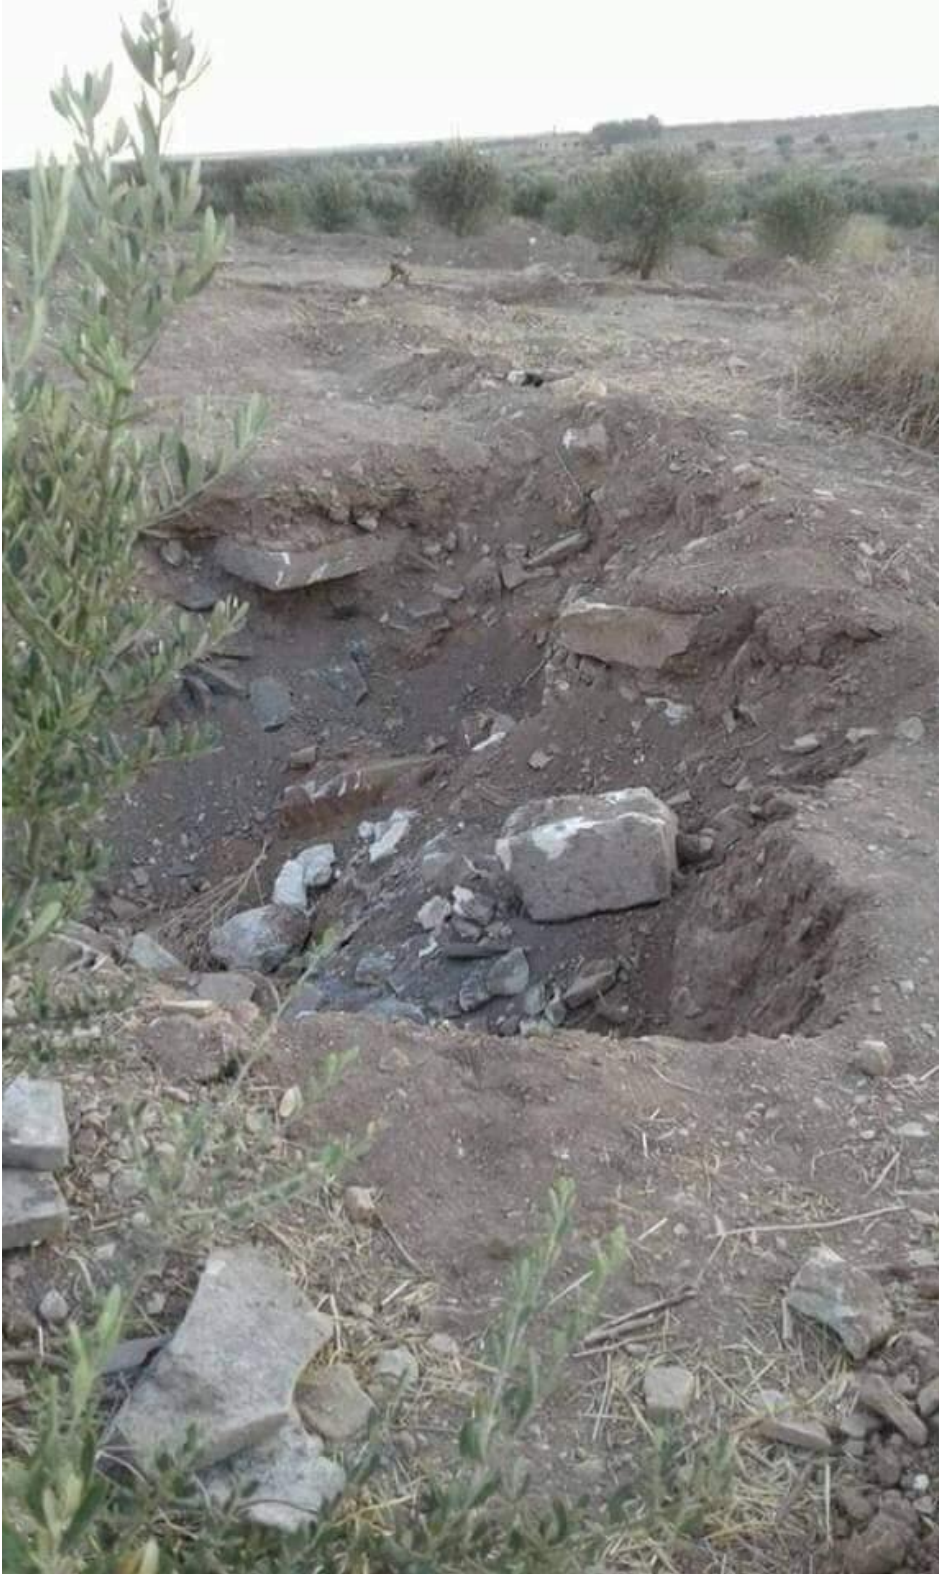
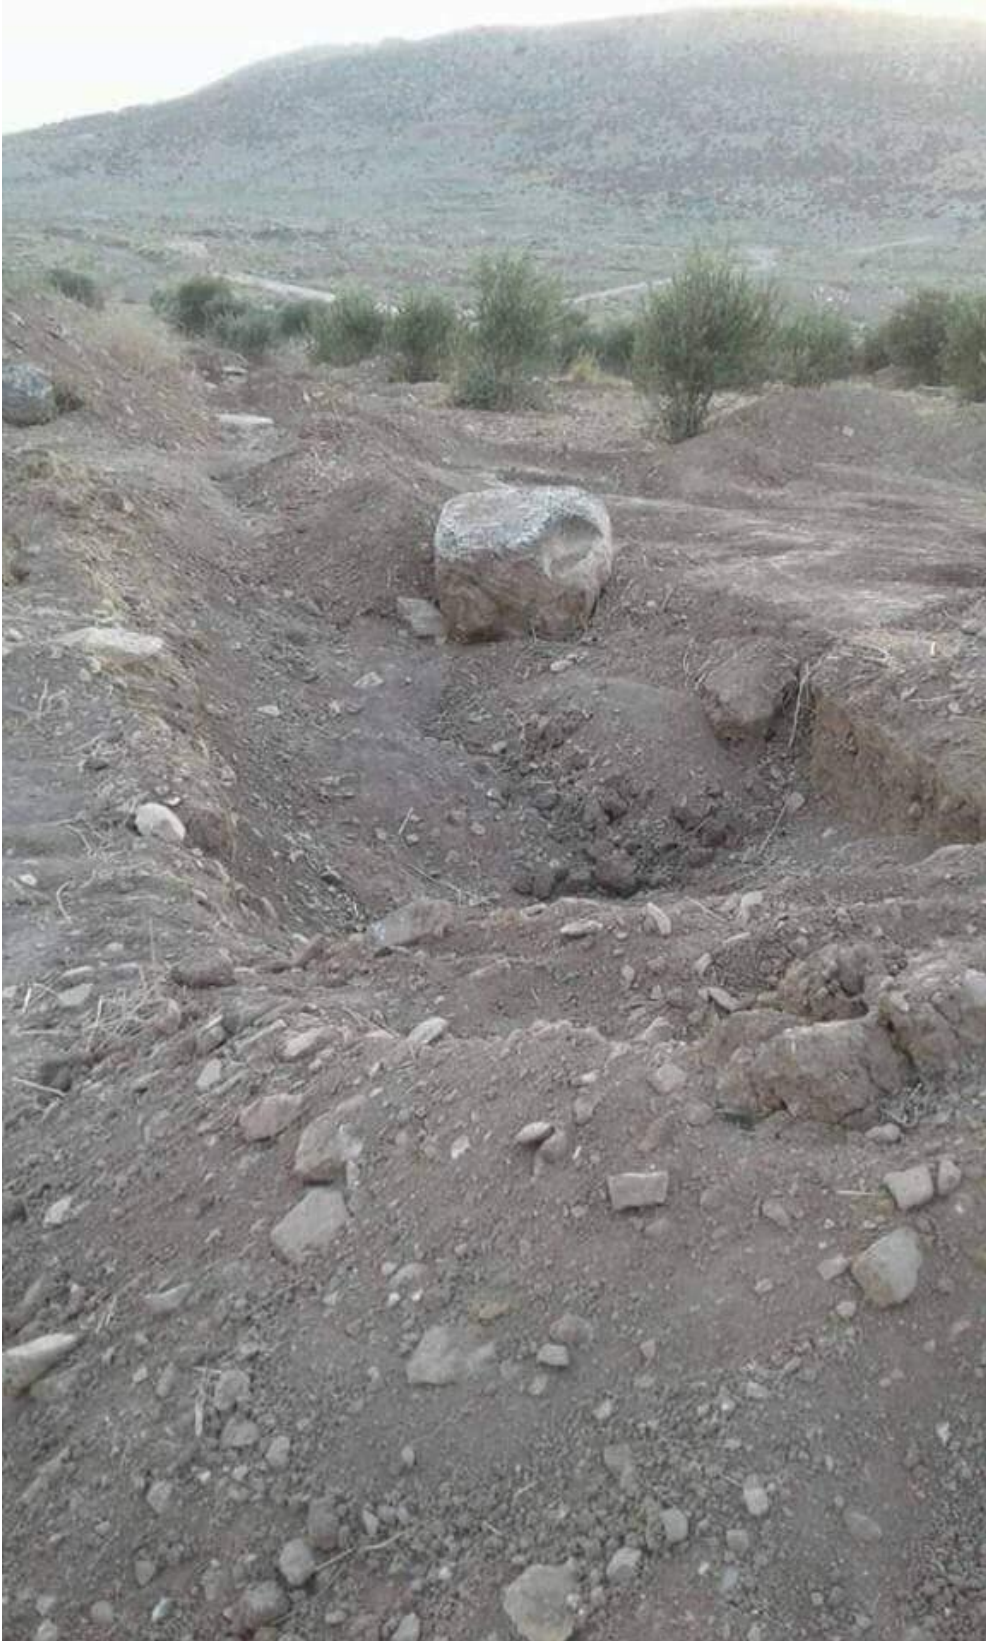
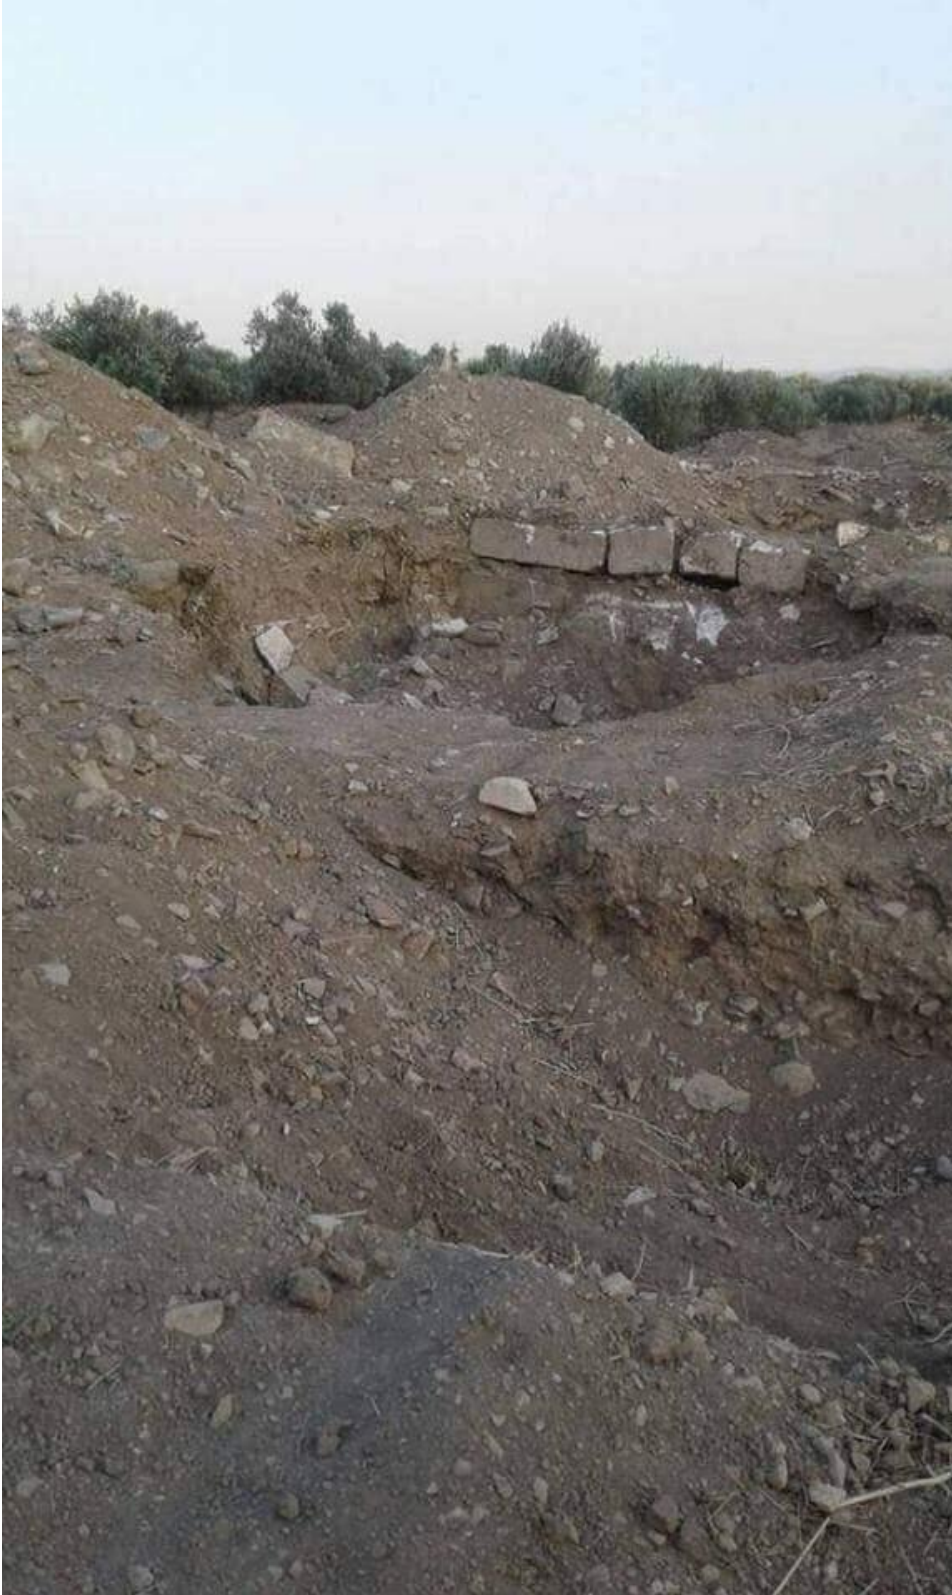
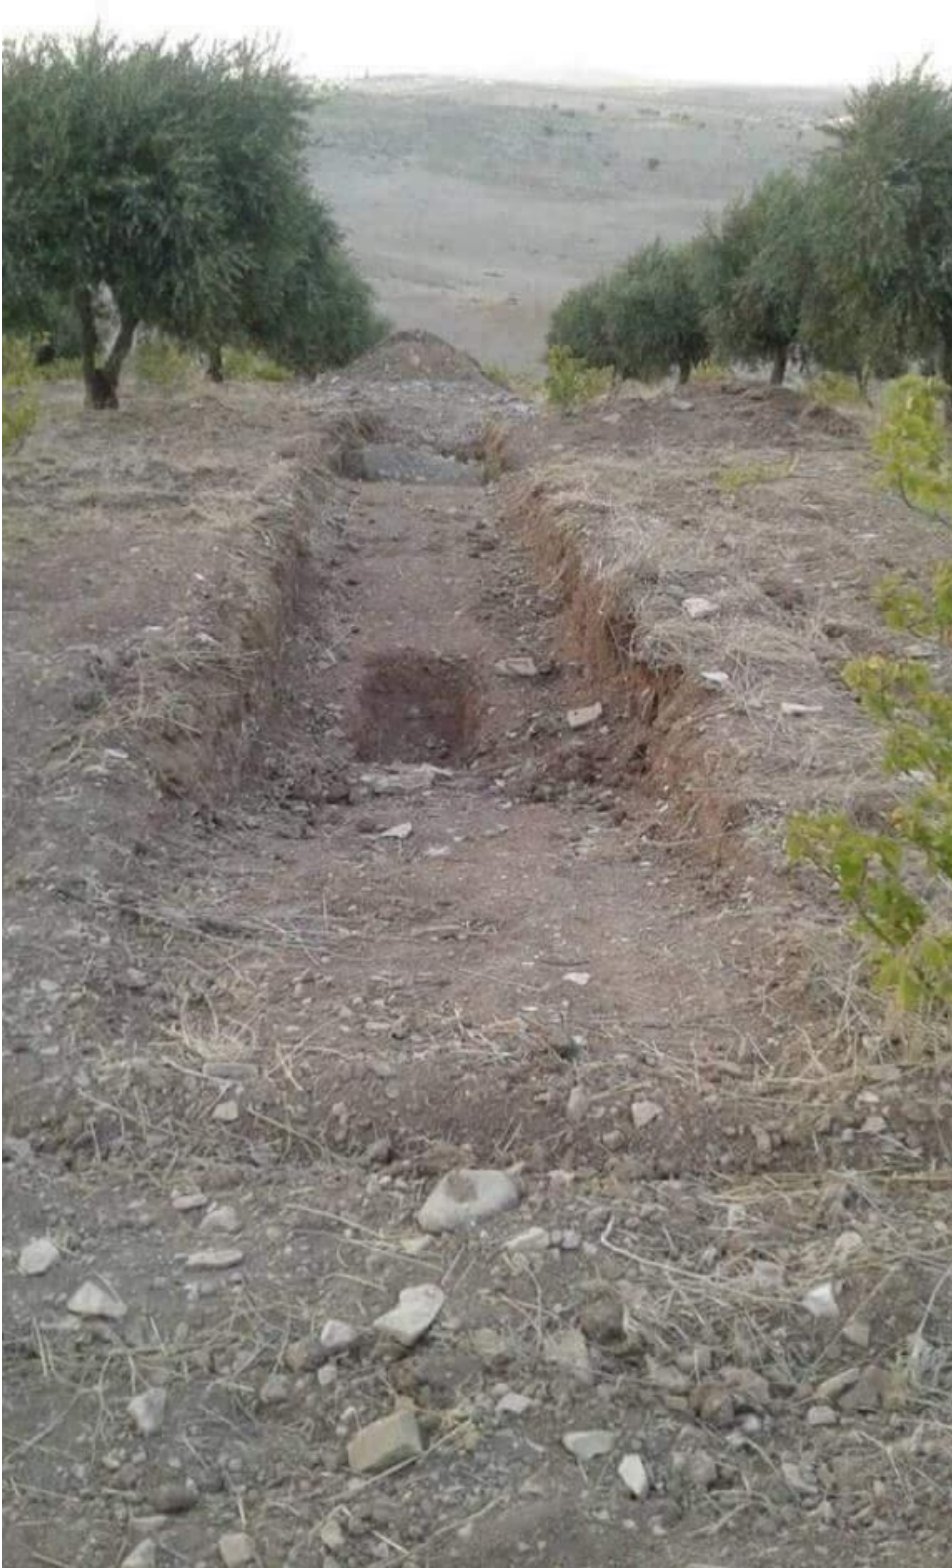
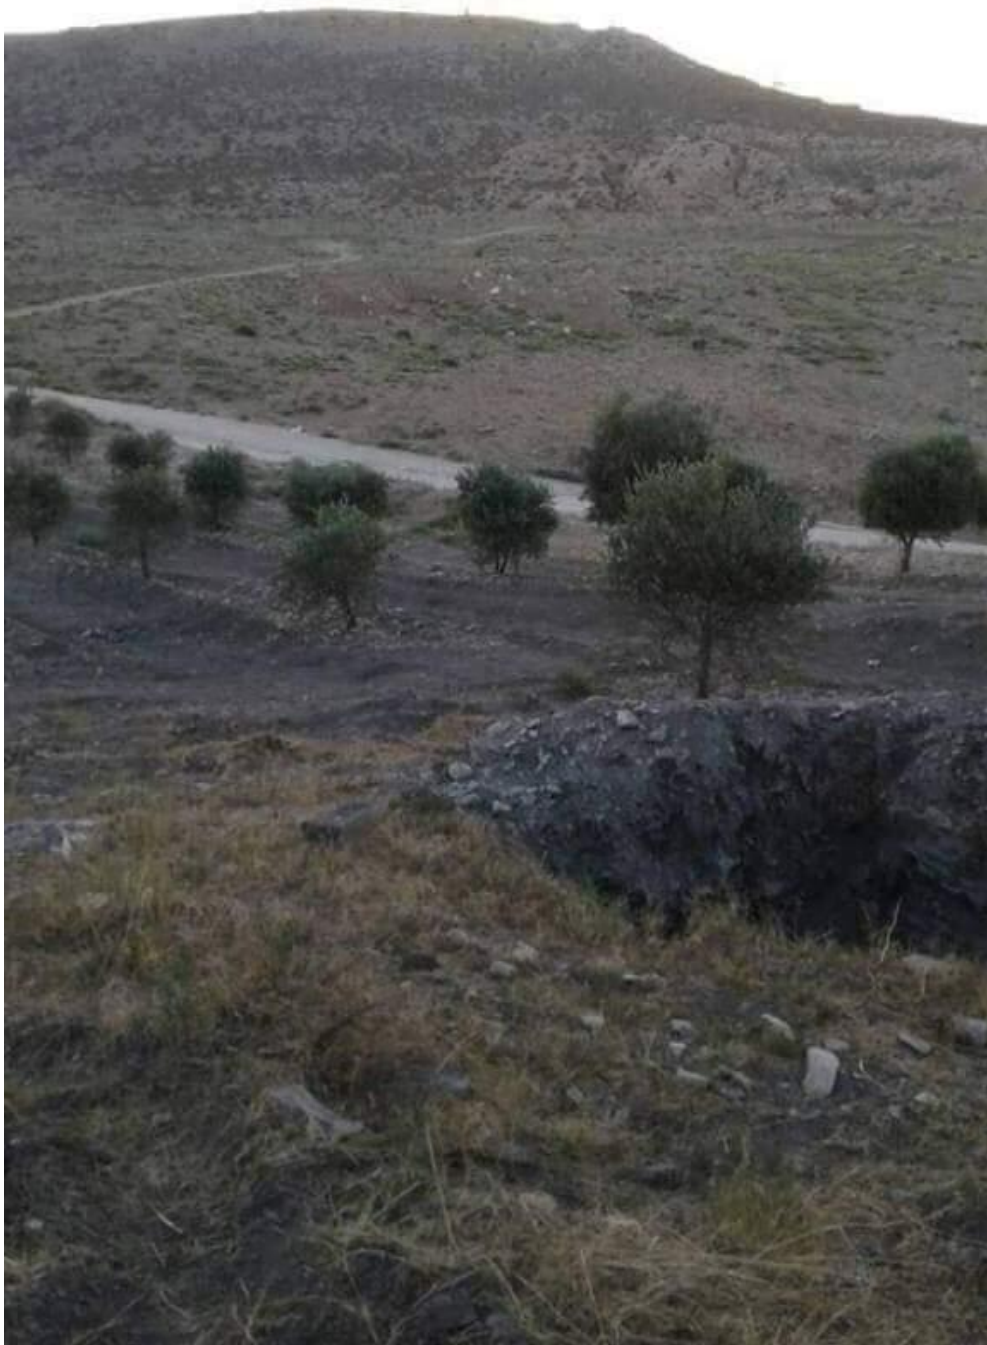
Illegal excavation, probably at Cyrrhus (CDVNS; October 5, 2018)

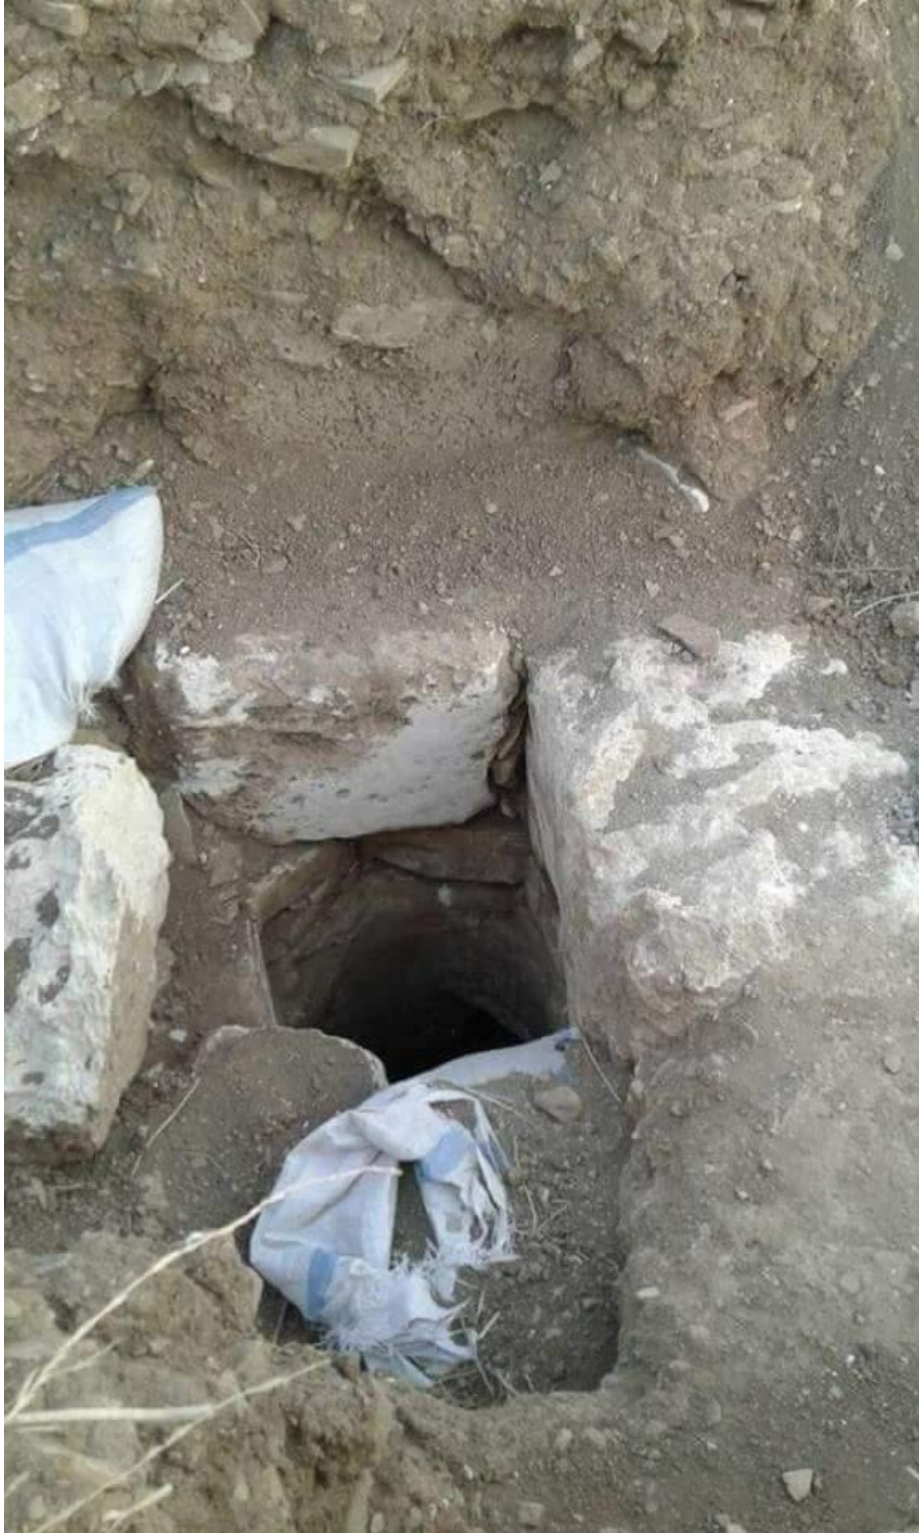
Architecture exposed by illegal excavation, probably at Cyrrhus (CDVNS; October 5, 2018)

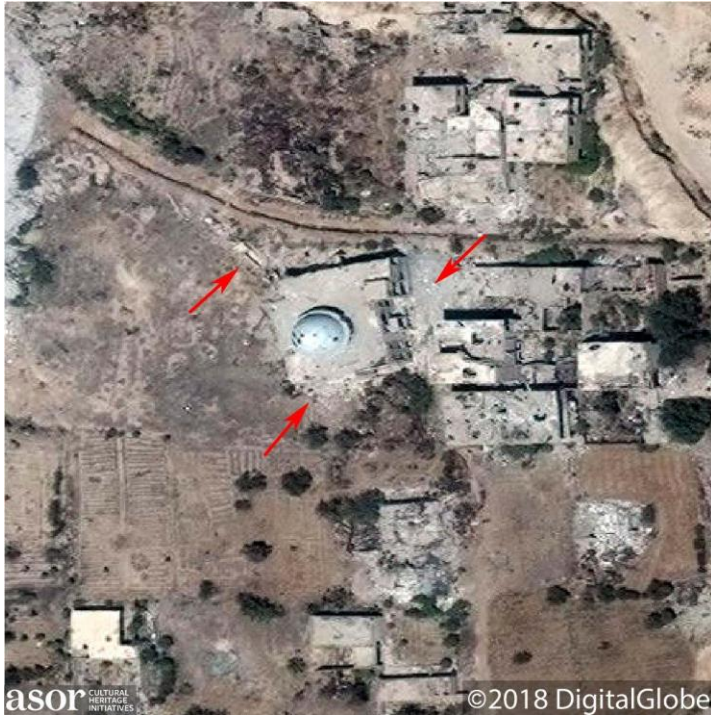
al-Rahma Mosque (جامع الرحمة)

Al-Rahma mosque with prior visible damage from heavy shelling visible on all sides of the mosque, as well as to the dome (Imagery courtesy of DigitalGlobe; August 29, 2018)

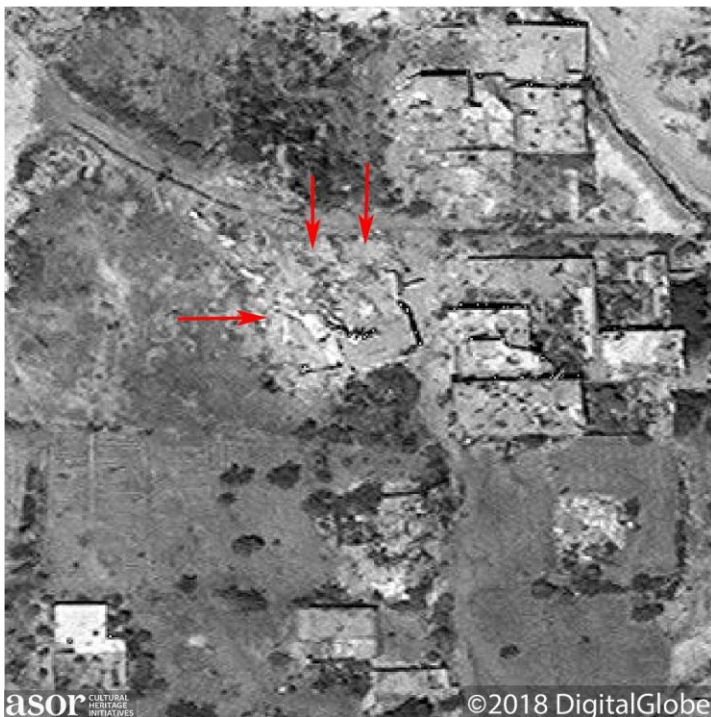
Al-Rahma mosque is almost entirely destroyed, likely the result of an airstrike based on the extensive damage to the main portion of the structure (Imagery courtesy of DigitalGlobe; August 8, 2018)

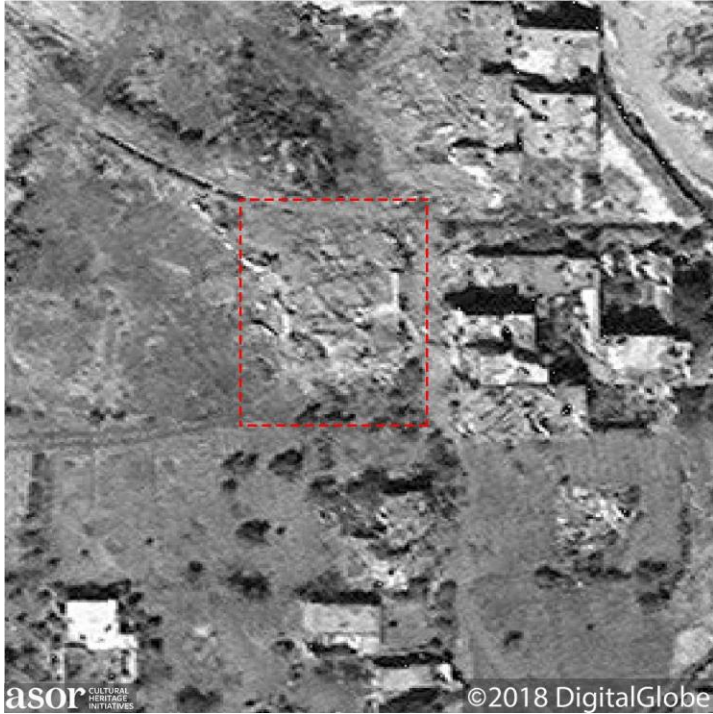
The remains of al-Rahma mosque, shown within the red square, are bulldozed, along with other destroyed buildings in the area (Imagery courtesy of DigitalGlobe; September 11, 2018)

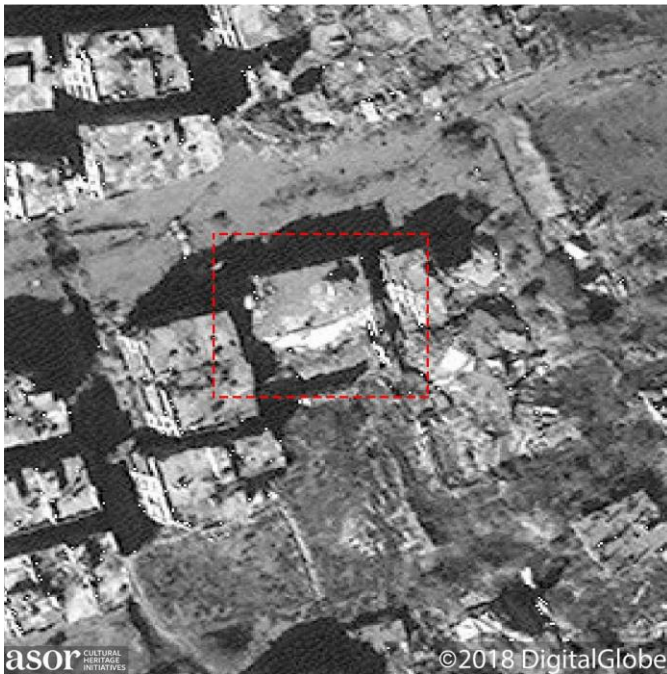
Gazwet Badr Mosque (جامع غزوة بدر)

Gazwet Badr Mosque, as of October 28, 2018, is still standing, although has been damaged as a result of heavy shelling (Imagery courtesy of DigitalGlobe; October 28, 2018)

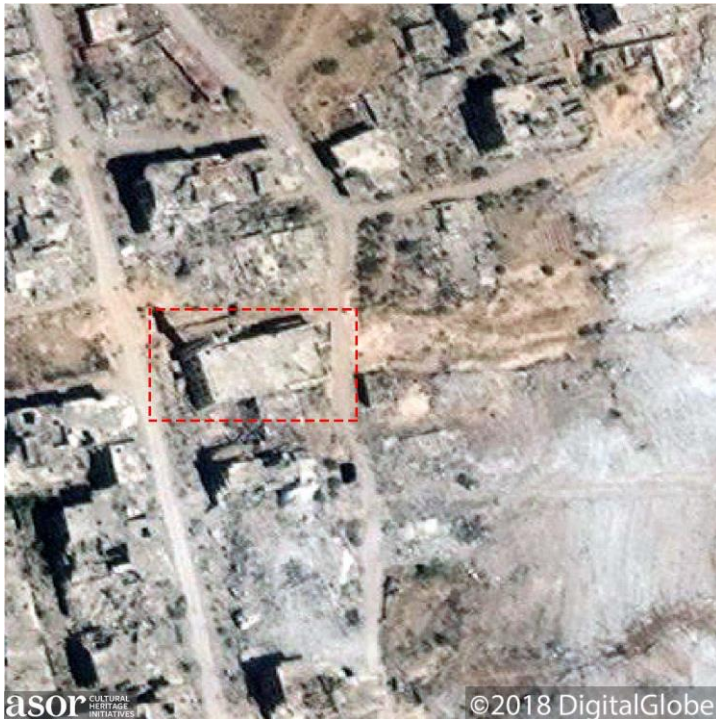
al-Taqwa Mosque (جامع التقوى)

Al-Taqwa mosque prior to destruction; bulldozer scars are clearly visible east and southeast of the mosque (Imagery courtesy of DigitalGlobe; August 27, 2018)

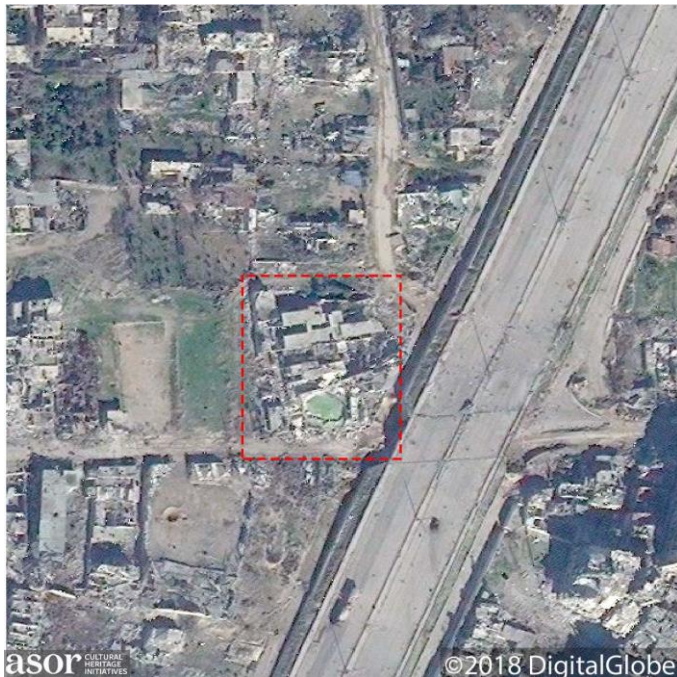
Harmala ibn al-Waleed Mosque (جامع حرملة ابن الوليد)

Harmala ibn al-Waleed Mosque was initially damaged by explosives between November 6, 2012 and December 23, 2014. The result of this severe damage is shown within the red square (Imagery courtesy of DigitalGlobe; December 23, 2014)

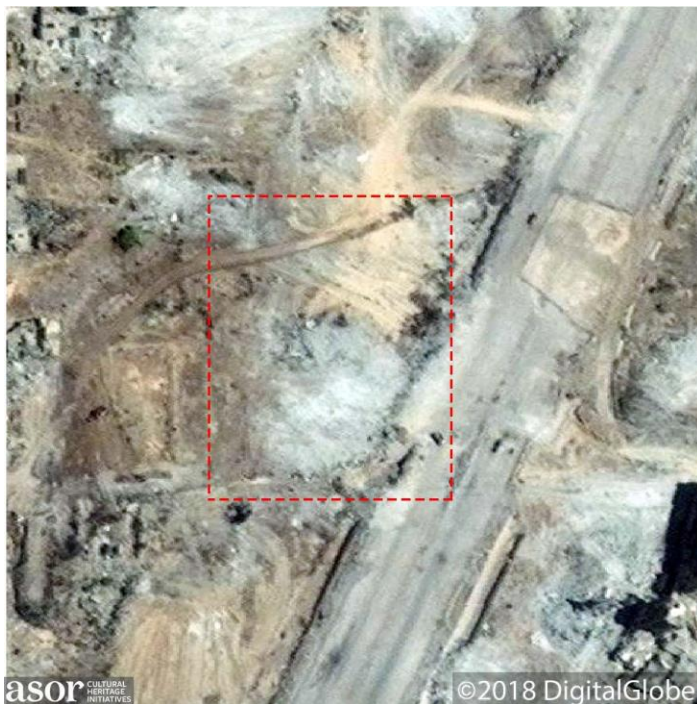
The area surrounding Harmala ibn al-Waleed was bulldozed between July 15, 2018 and July 18, 2018, and again between August 5, 2018 and August 8, 2018. The results of this demolition are visible within the red square (Imagery courtesy of DigitalGlobe; August 8, 2018)

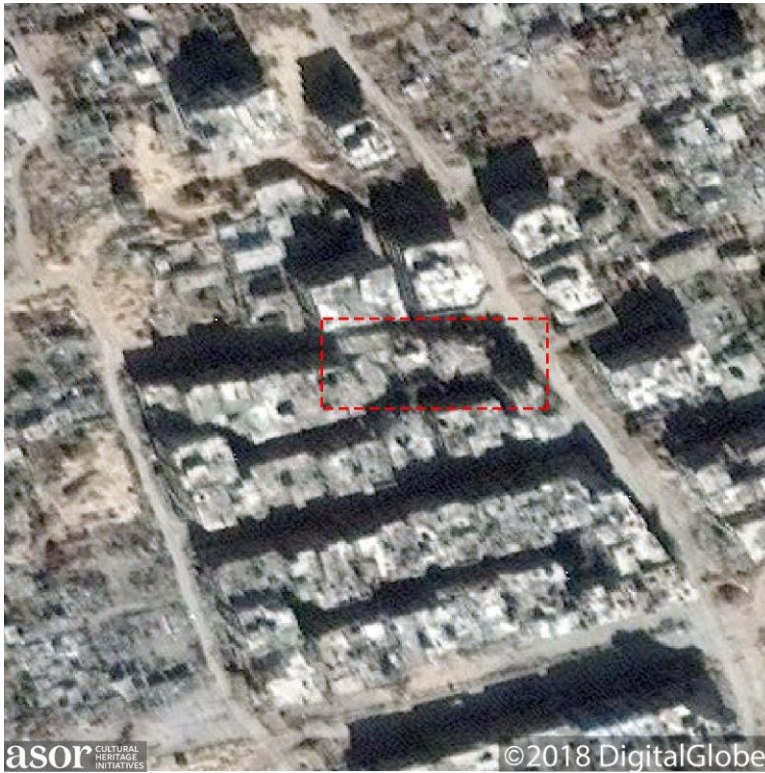
al-Qbani Mosque (جامع القباني)

Approximately half of the al-Qbani Mosque initially collapsed between September 13, 2018 and October 8, 2017. The mosque appears to be in the same condition in the most recently available imagery, shown within the red square (Imagery courtesy of DigitalGlobe; October 31, 2018)

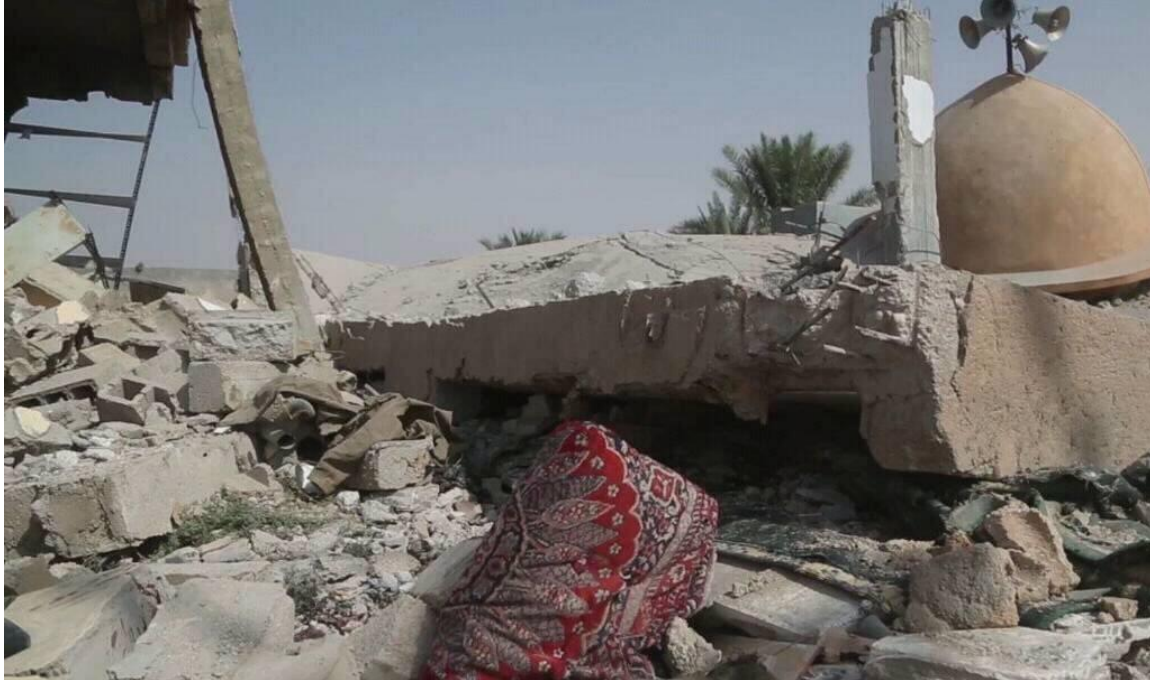
Incident Source and Description: On October 18, 2018 the US-led Coalition conducted an airstrike on Ammar bin Yasser Mosque.²⁸ The strike caused most of the mosque to collapse; only an annex on the western side of the building remains standing. DigitalGlobe satellite imagery from October 30, 2018 confirms this damage.

A view of the collapsed Ammar bin Yasser Mosque with the dome present in the background (SNHR; October 21, 2018)

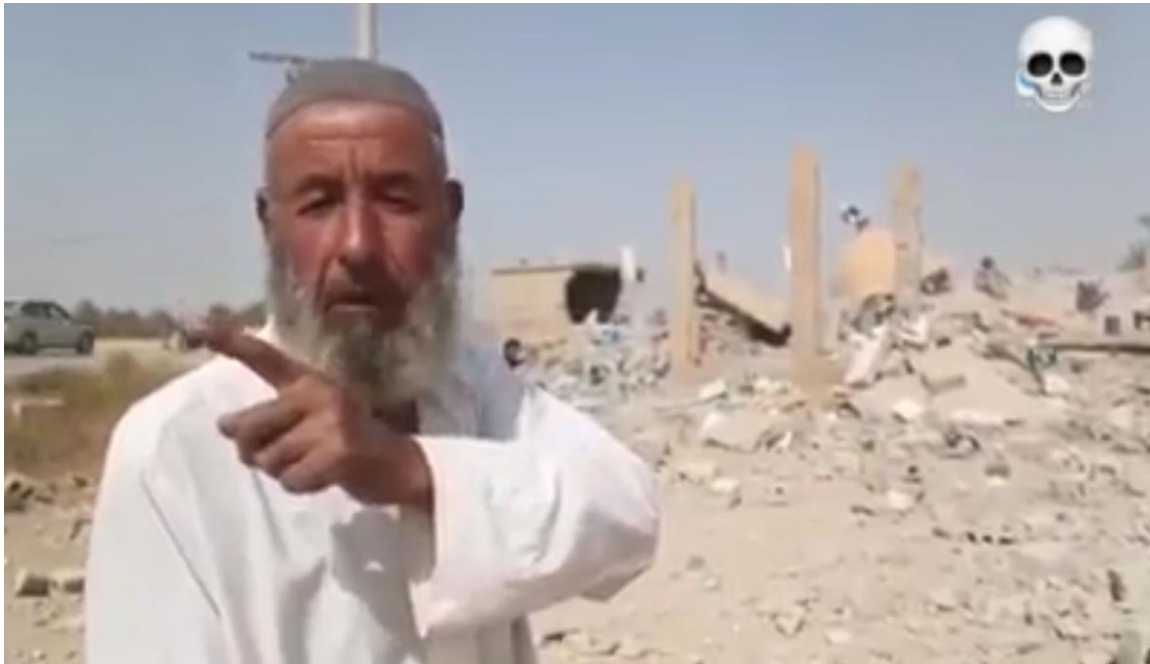
Video still of Ammar bin Yasser Mosque, seen from the southeast (Ahmad Abu al-Kheir; October 20, 2018)
