ASOR Cultural Heritage Initiatives (CHI): Planning for Safeguarding Heritage Sites in Syria and Iraq¹

Weekly Report 209-212 — October 1–31, 2018

Incident Reports: Syria

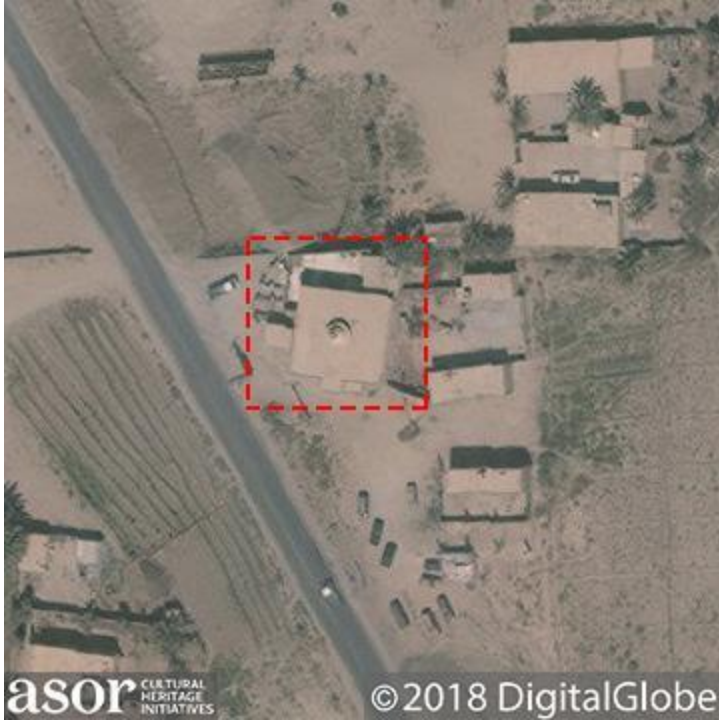
Ammar bin Yasser Mosque prior to damage (Imagery courtesy of DigitalGlobe; September 10, 2018)

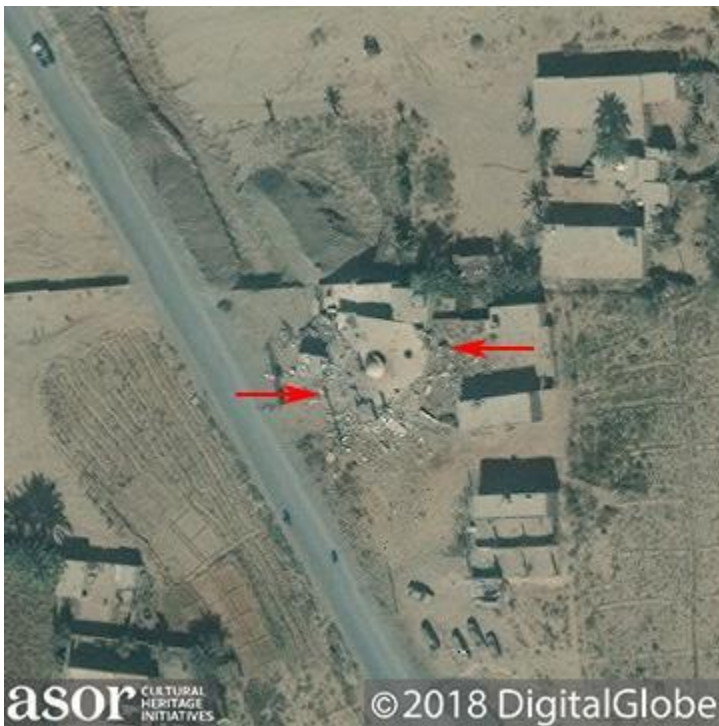
The western side of Ammar bin Yasser Mosque has collapsed (Imagery courtesy of DigitalGlobe; October 30, 2018)

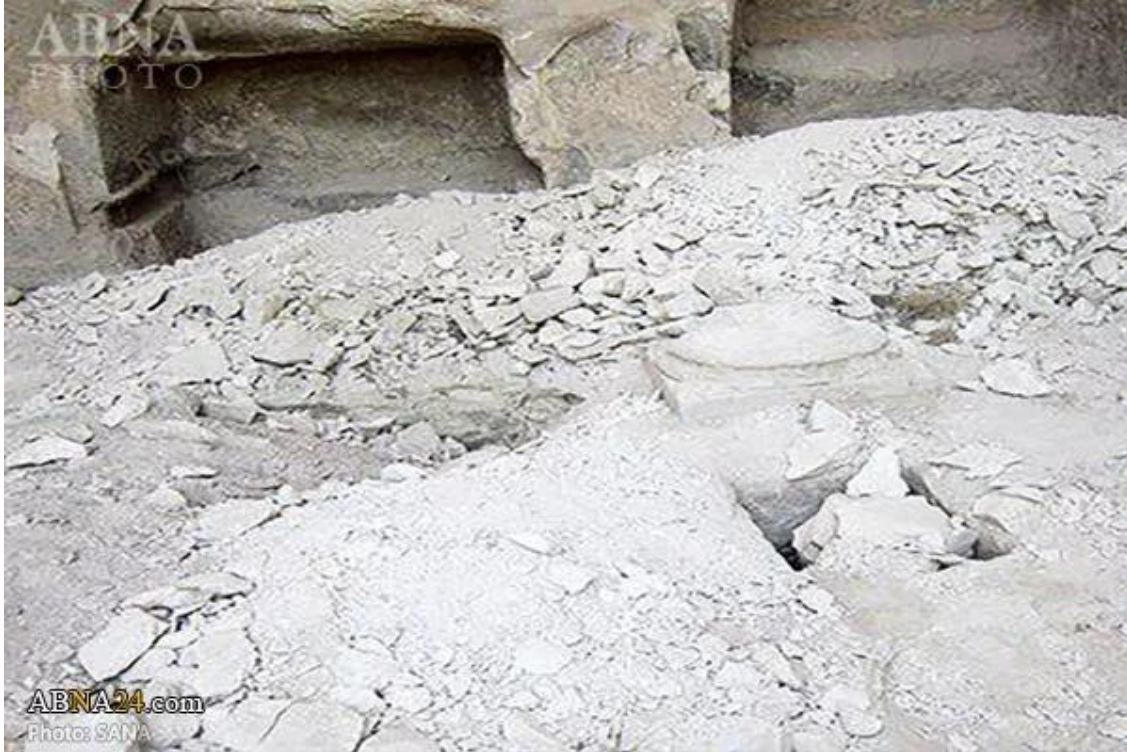
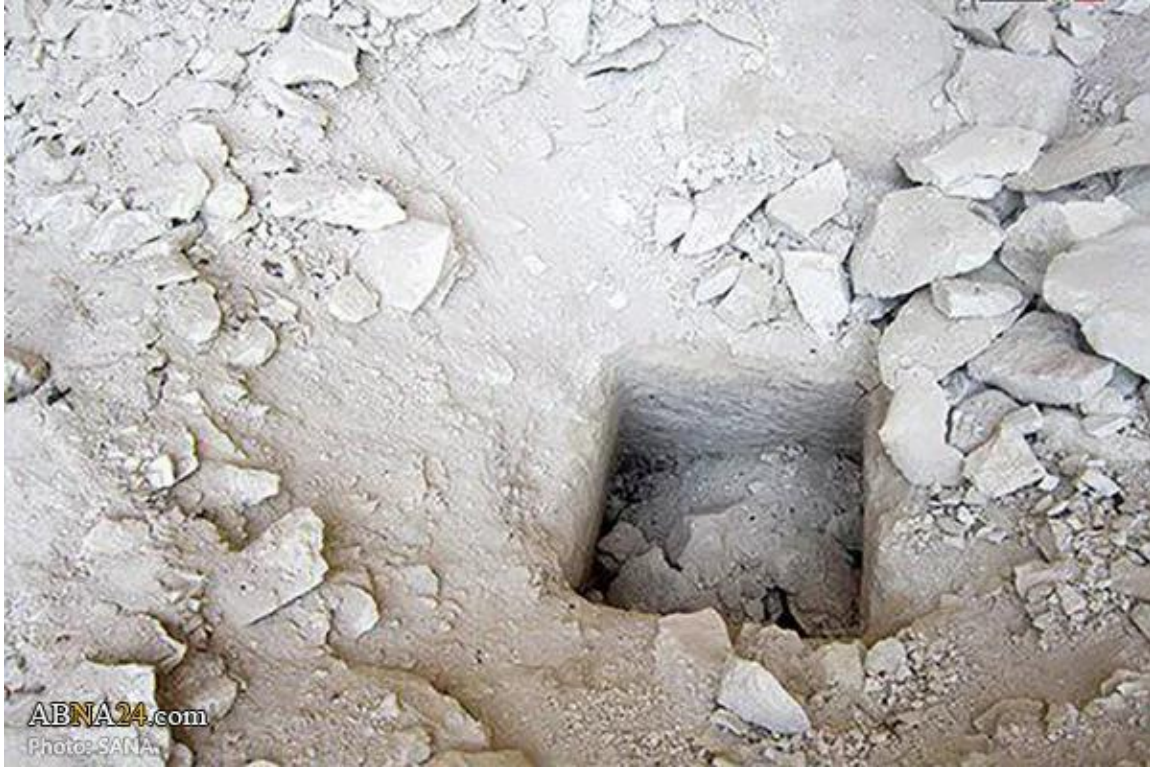
Close-up of a possible looting pit in Shash Hamdan tomb (ABNA; October 18, 2018)

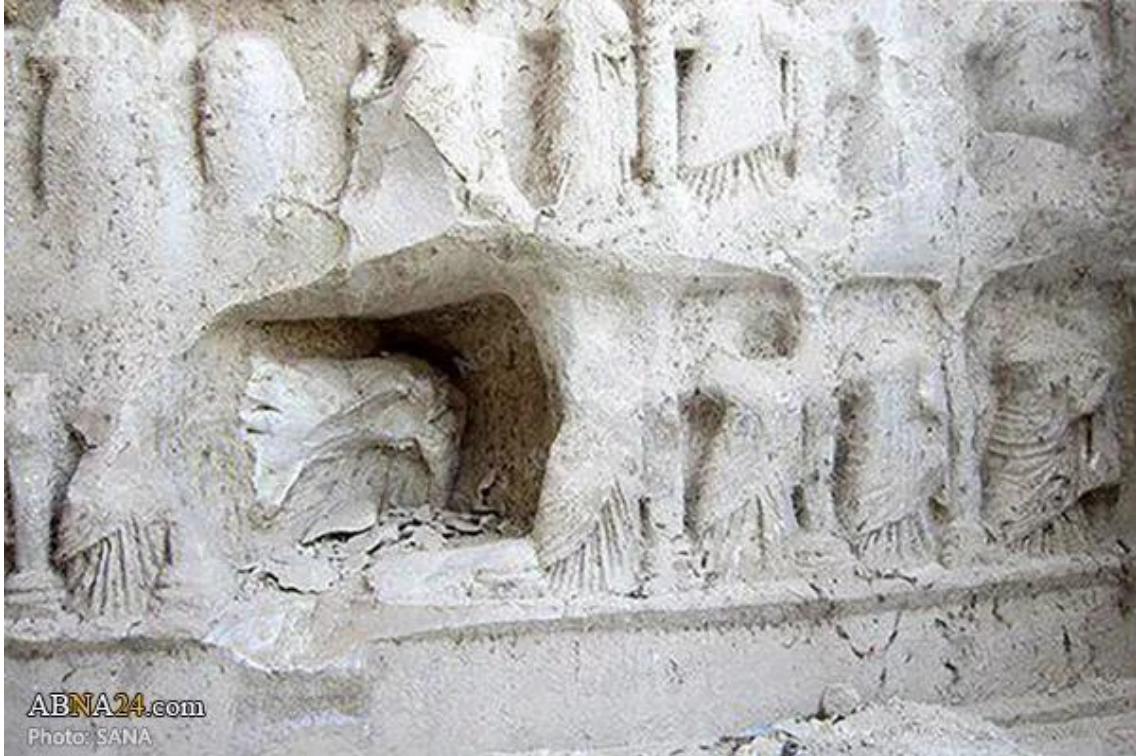
Photograph that shows damage to the bull relief (ABNA; October 18, 2018)

In 2014, Patrick Coburn reported in *The Independent* that ISIS had vandalized the Shash Hamdan tomb.⁴² In a report to UNESCO in 2014, the DGAM claimed that the carved reliefs at Shash Hamdan were deliberately targeted by gunfire and smashed into fragments.⁴³ The DGAM yearly report for 2013, published in January 2014, detailed the condition of Shash Hamdan as damage being present to a statue of a bull carved on the northern wall and two deer on the western side, destruction of the altar, digging in the northeastern corner, and theft of the metal gate.⁴⁴

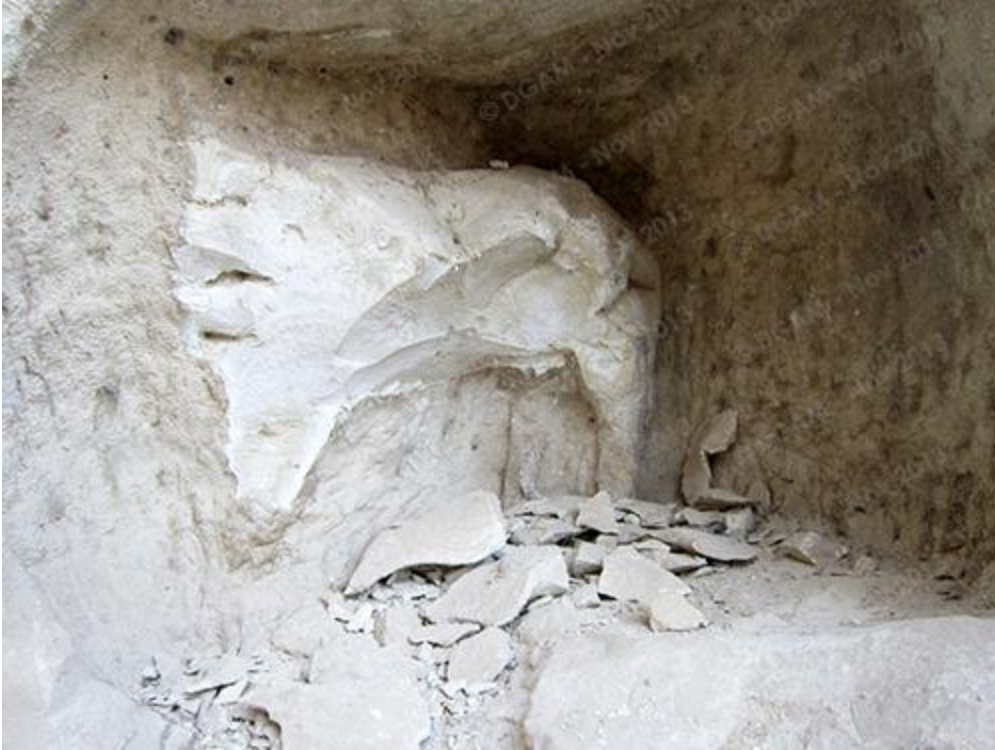
Close-up of the damage to the bull (DGAM; November 17, 2013)

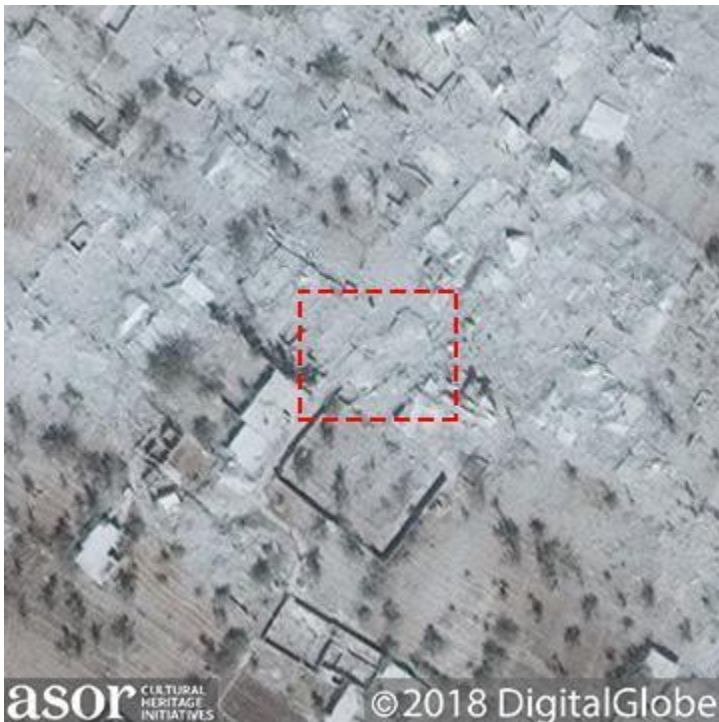
Khalid bin al-Walid or al-Afandi Mosque after the area had been bulldozed (Imagery courtesy of DigitalGlobe; September 29, 2018)

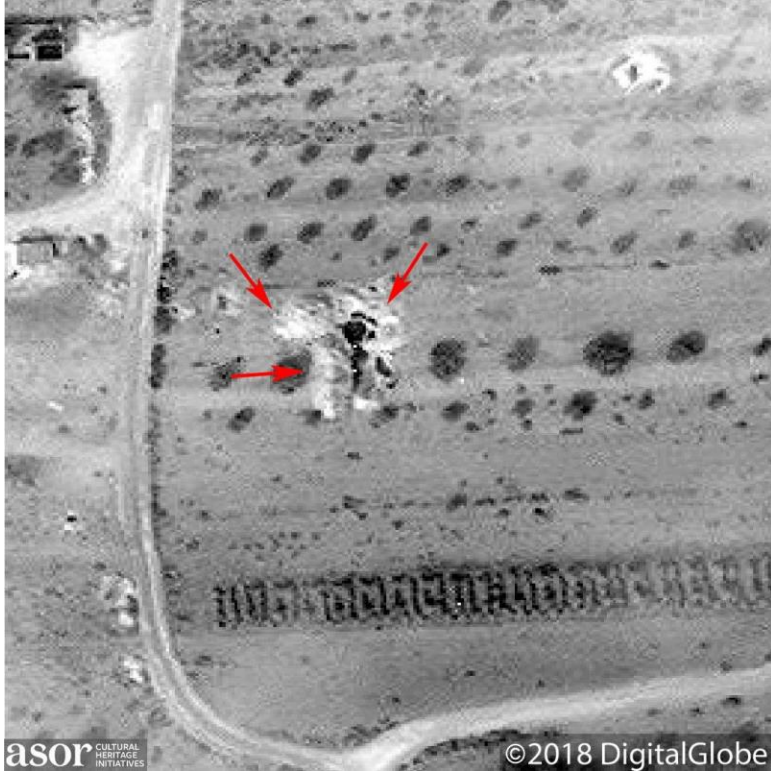
Earth piles from illicit digging are visible surrounding the mausoleum, as well as several looting pits along the northeastern and eastern edge of the mausoleum (Imagery courtesy of DigitalGlobe; October 7, 2018)

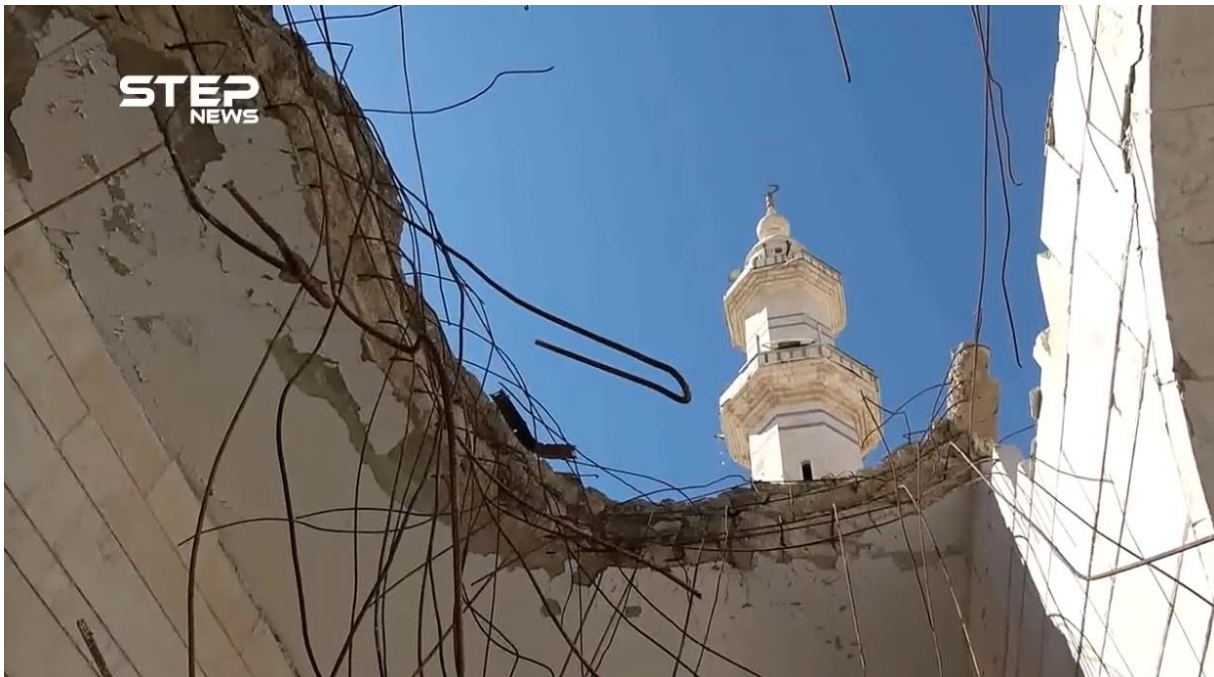
Video still of the hole in the roof of Abu Bakr al-Sidiq Mosque (STEP News Agency; October 6, 2018)
