ASOR Cultural Heritage Initiatives (CHI): Planning for Safeguarding Heritage Sites in Syria and Iraq¹

Weekly Report 161–164 — October 1–31, 2017

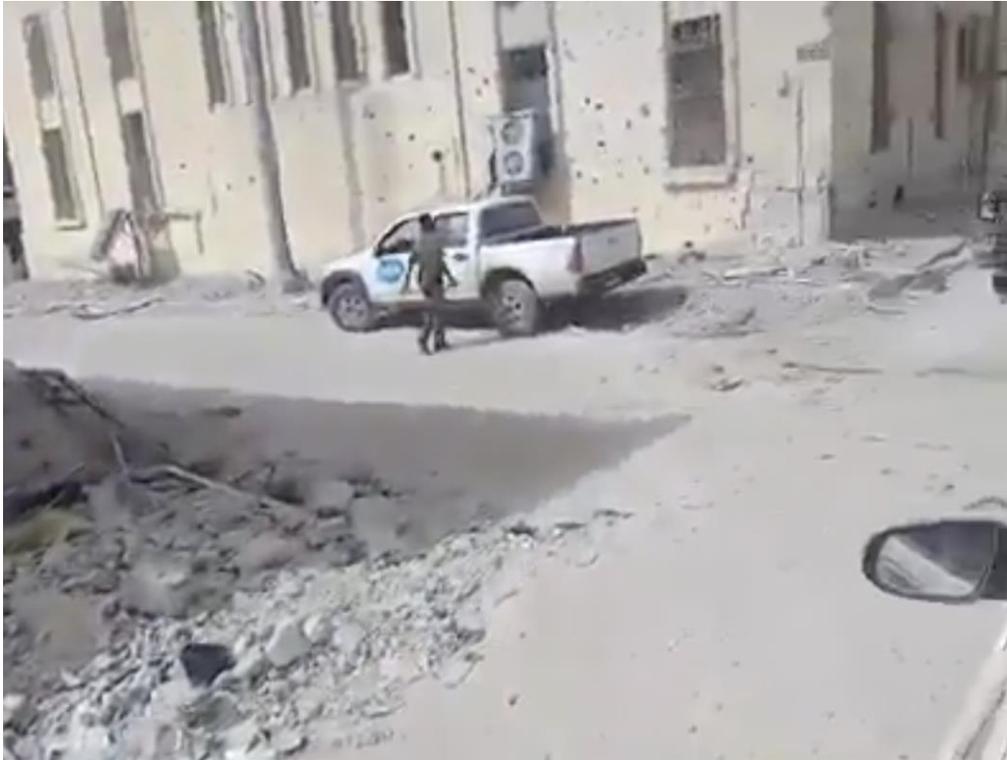
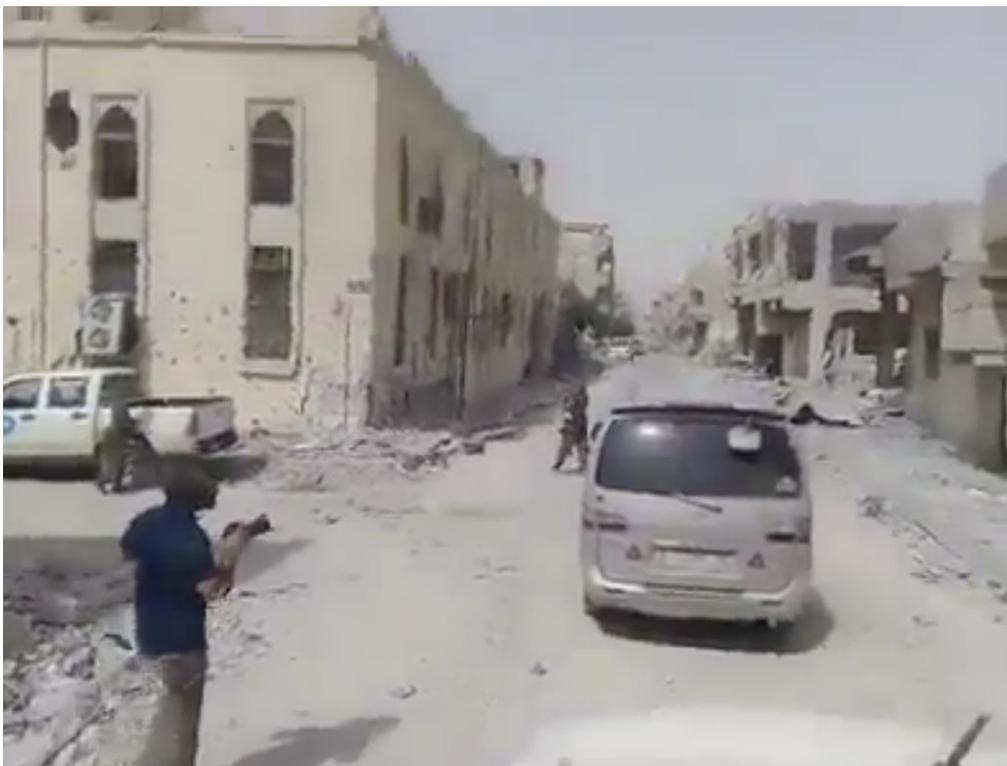
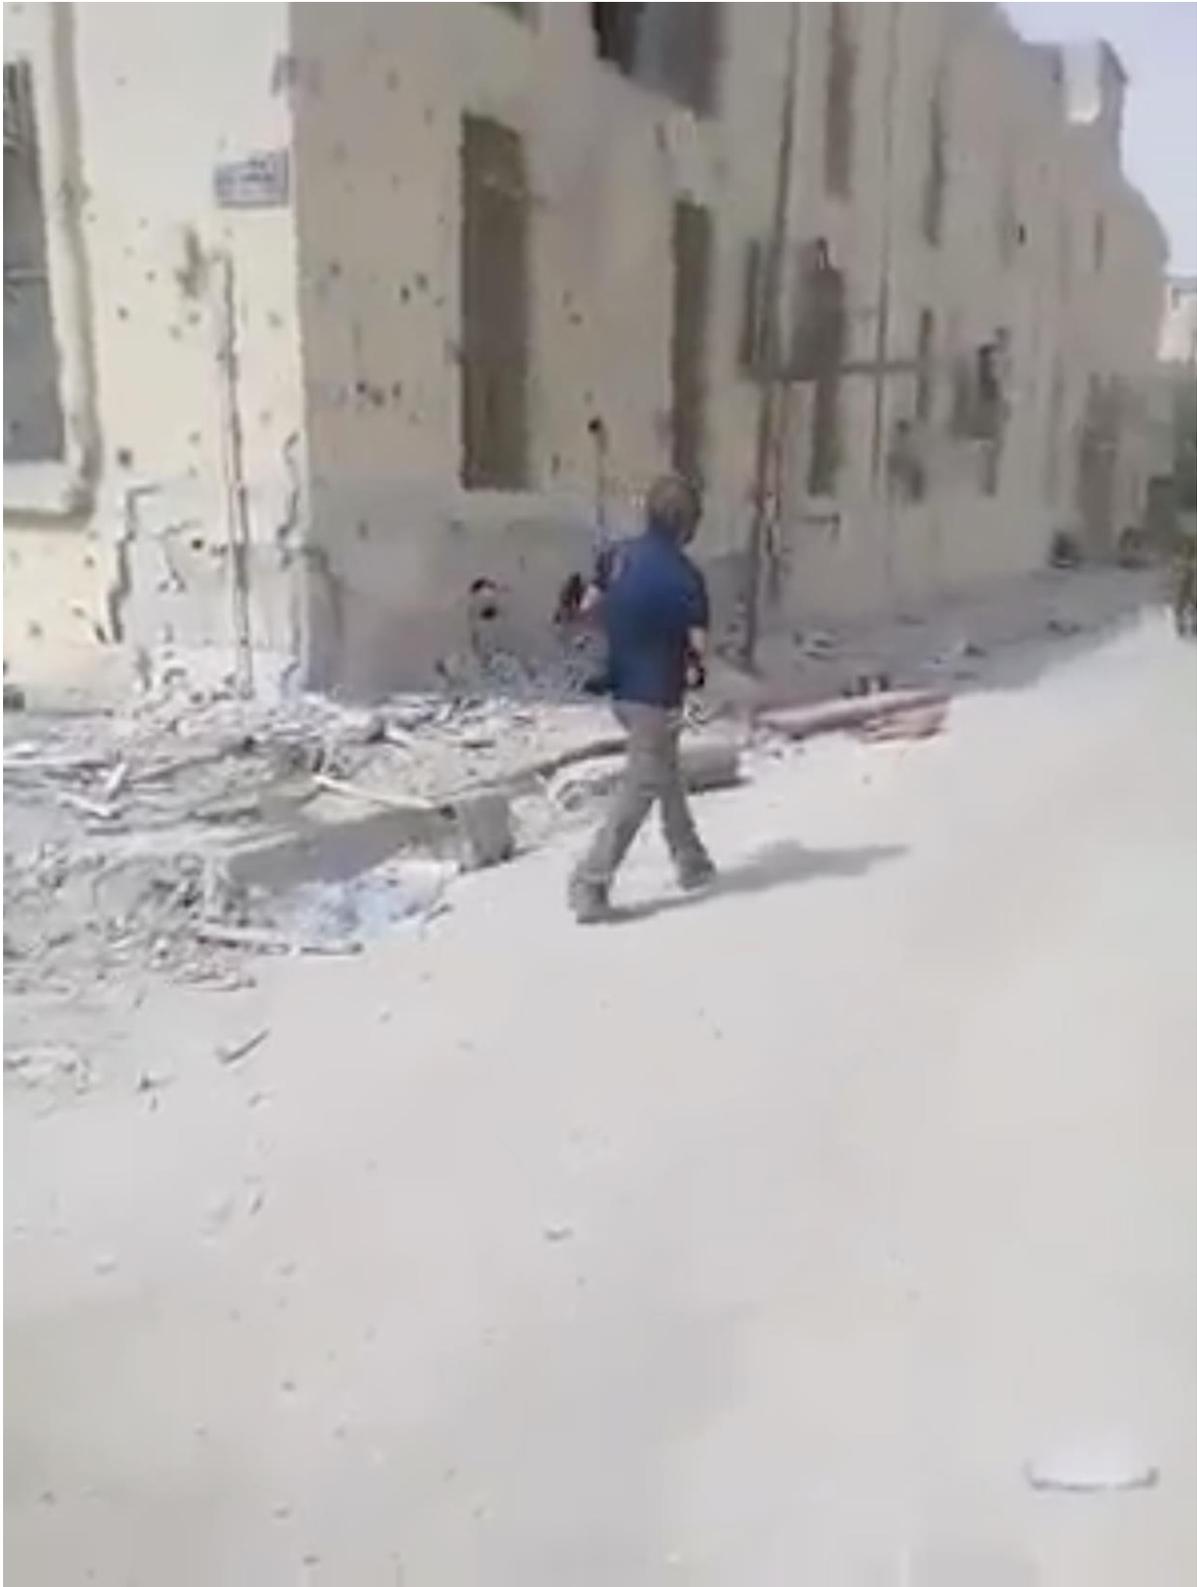
Incident Source and Description: On October 4, 2017 Raqqa is Being Slaughtered Silently (RBSS) posted a video showing previously unreported damage to al-Hinni Mosque.⁷⁷ Small-arms fire has damaged the southern and eastern facades of the mosque. This damage is concentrated near the southeastern corner of the building. Additionally, a large hole in the second story of the southern facade suggests the use of heavier weaponry.

Video still of damage from small-arms fire, seen from the south (RBSS; October 4, 2017)

Video still of damage from small-arms fire, seen from the south. Note the larger hole near the second story window (RBSS; October 4, 2017)

Video still of damage from small-arms fire, seen from the southeast (RBSS; October 4, 2017)

Monitoring Recommendations and Mitigation Measures: ASOR CHI will continue to monitor the condition of al-Hinni Mosque, as well as the condition of other heritage sites located in regions subject to intense military activity.

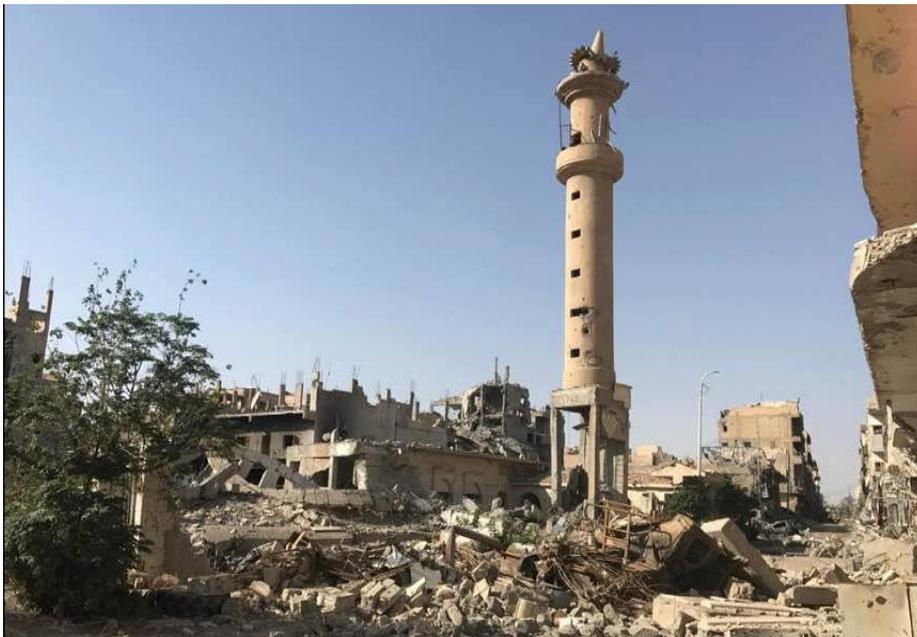
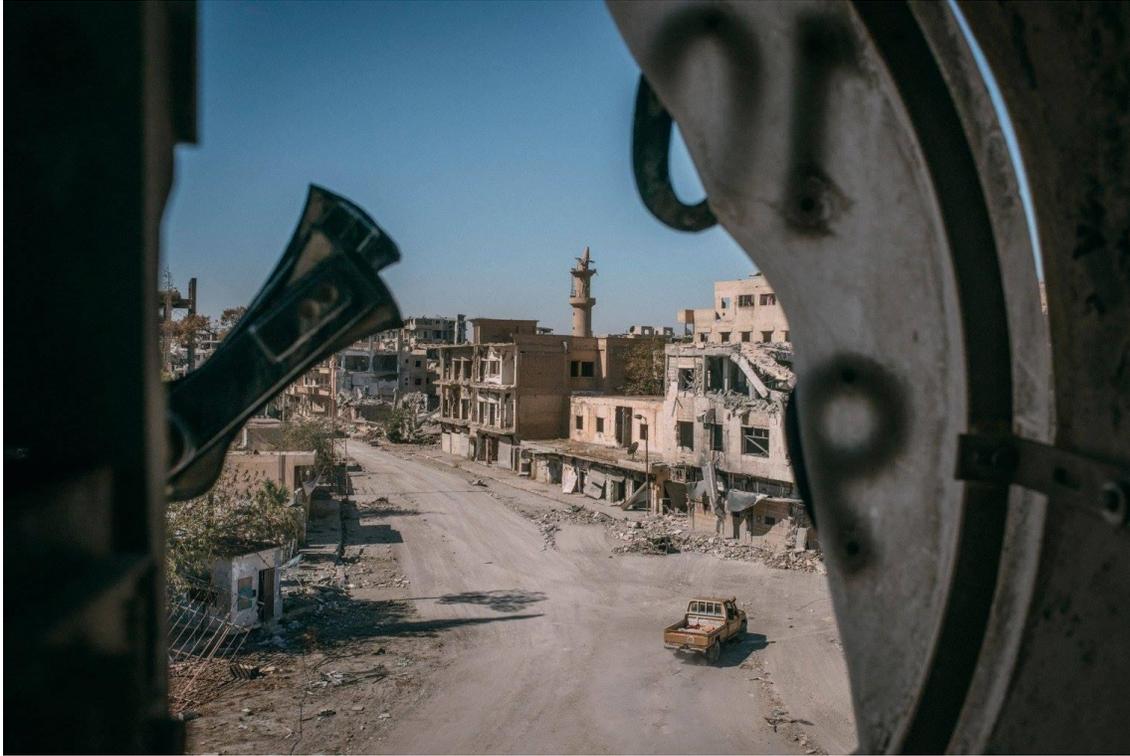
Incident Source and Description: On October 19 and 20, 2017 Raqqa is Being Slaughtered Silently (RBSS) published photographs showing the destruction of the Circassian Mosque for the first time.⁷⁸ These photographs confirm the complete destruction of the mosque building, as well as damage to the top of the minaret.

Destruction of the Circassian Mosque and damage to minaret (RBSS; October 19, 2017)

Damage to minaret of the Circassian Mosque (RBSS; October 20, 2017)

Monitoring Recommendations and Mitigation Measures: ASOR CHI will continue to monitor the condition of the Circassian Mosque, as well as the condition of other heritage sites located in regions subject to intense military activity.

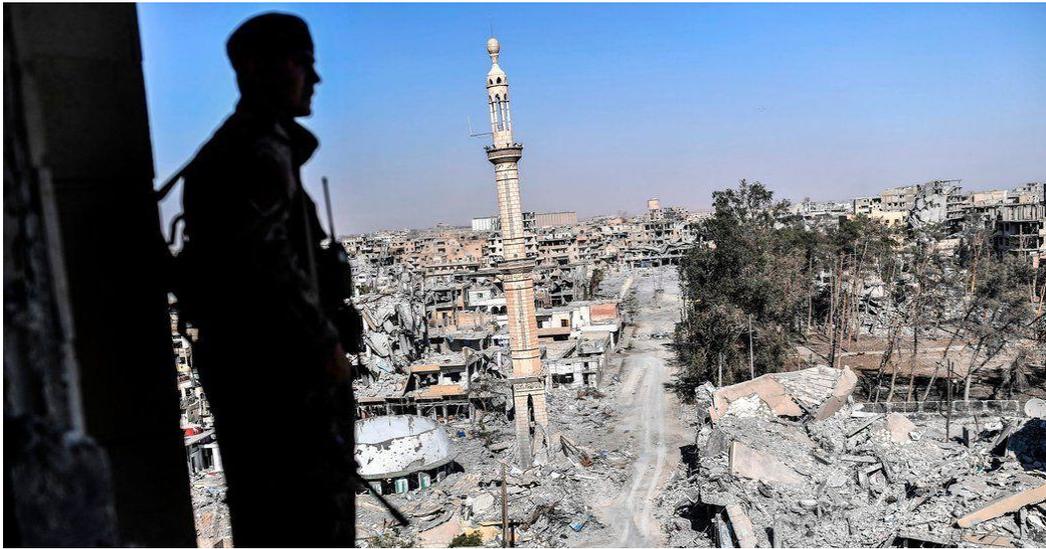
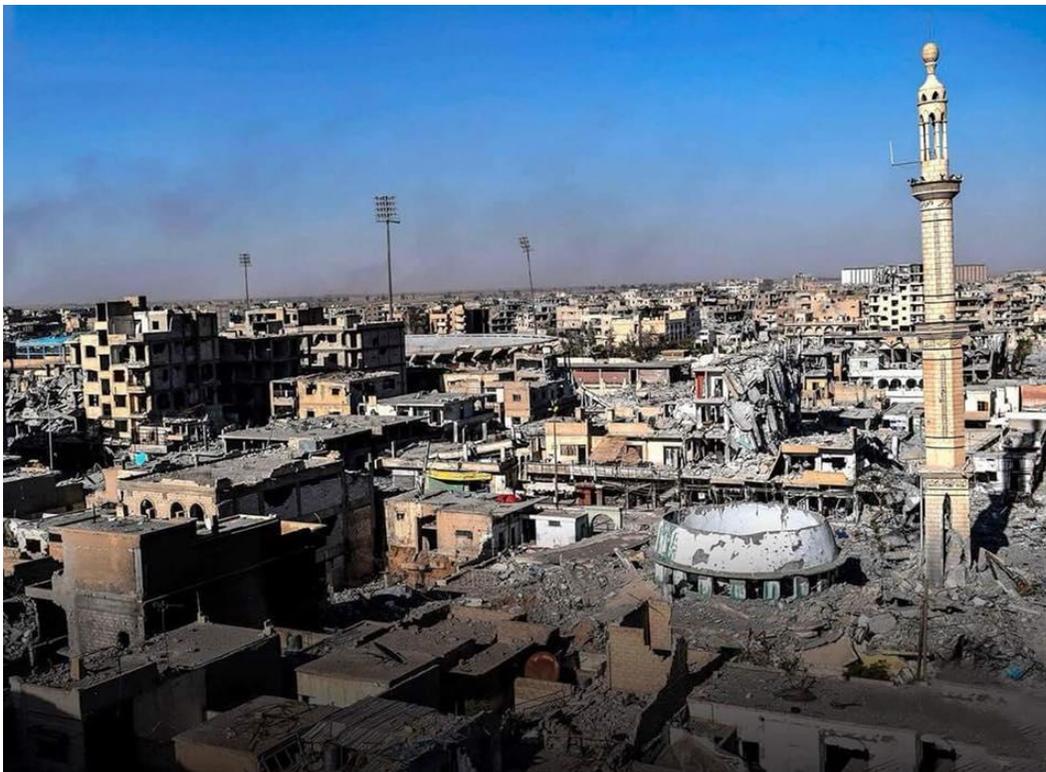
Incident Source and Description: On October 17, 2017 Raqqa is Being Slaughtered Silently (RBSS) and the Center for Civilians in Conflict (CIVIC) published photographs of damage to al-Firdous Mosque.⁸¹ The mosque had previously been reported as destroyed by a US-led Coalition airstrike on September 11, 2017 by RBSS.⁸² DigitalGlobe satellite imagery confirmed severe damage to the mosque as a result of airstrikes between September 6, 2017 and September 19, 2017 but photographs were unavailable at the time. The minaret is still standing but the dome of the mosque has collapsed, rendering the structure unusable.

Damage to al-Firdous Mosque (CIVIC; October 17, 2017)

Damage to al-Firdous Mosque (RBSS; October 17, 2017)

Monitoring Recommendations and Mitigation Measures: ASOR CHI will continue to monitor the condition of al-Firdous Mosque, as well as the condition of other heritage sites located in regions subject to intense military activity.

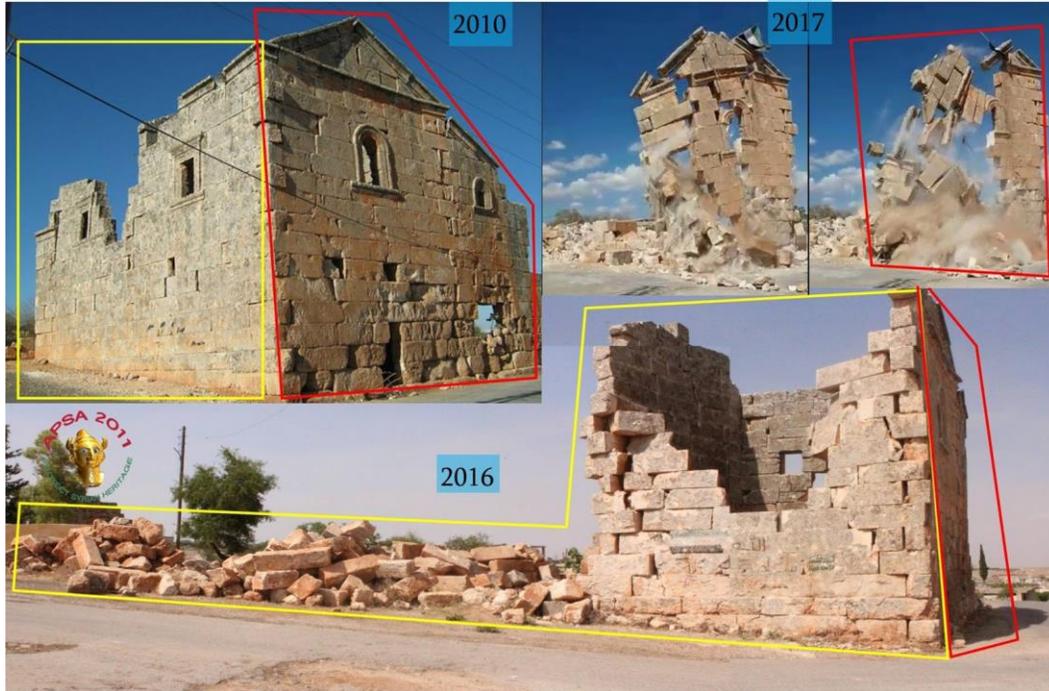
The Association for the Protection of Syrian Archaeology (APSA) published a series of photographs from 2010, 2016, and 2017 showing various stages of damage to the monument.⁸⁸ The 2010 photograph shows no damage. The 2016 photograph shows the northern room of the structure and the western wall of the southern room collapsed, possibly as the result of an earlier airstrike. There is also graffiti and a Syrian flag painting on the western wall. In the 2017 photograph and the video, only the southern wall of the structure is still standing.

Photographs of the destroyed monument from 2010, 2016, and 2017 (APSA; October 4, 2017)

Monitoring Recommendations and Mitigation Measures: ASOR CHI will continue to monitor the condition of the Deir Sunbul, as well as the condition of other heritage sites located in regions subject to intense military activity.

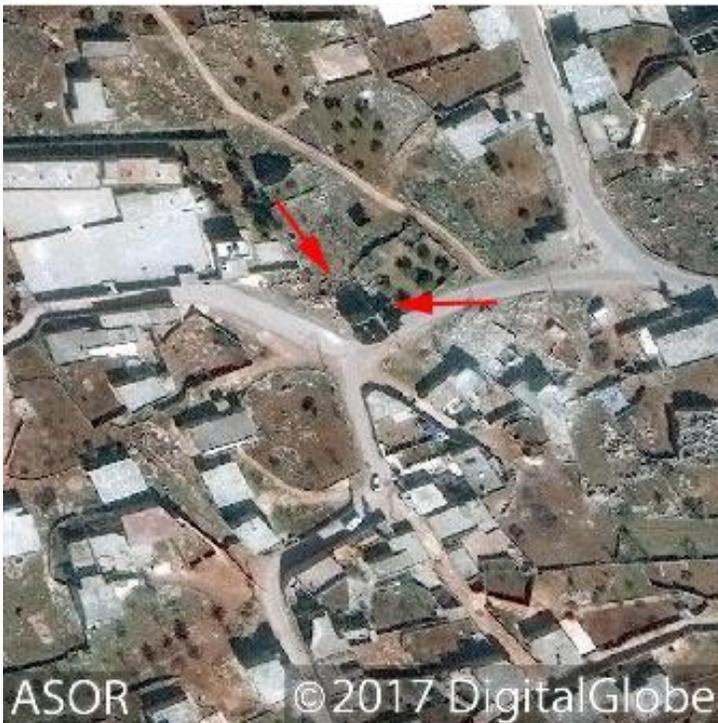
Severe damage to the northern part of villa indicated by red arrows (DigitalGlobe NextView License; February 21, 2017)

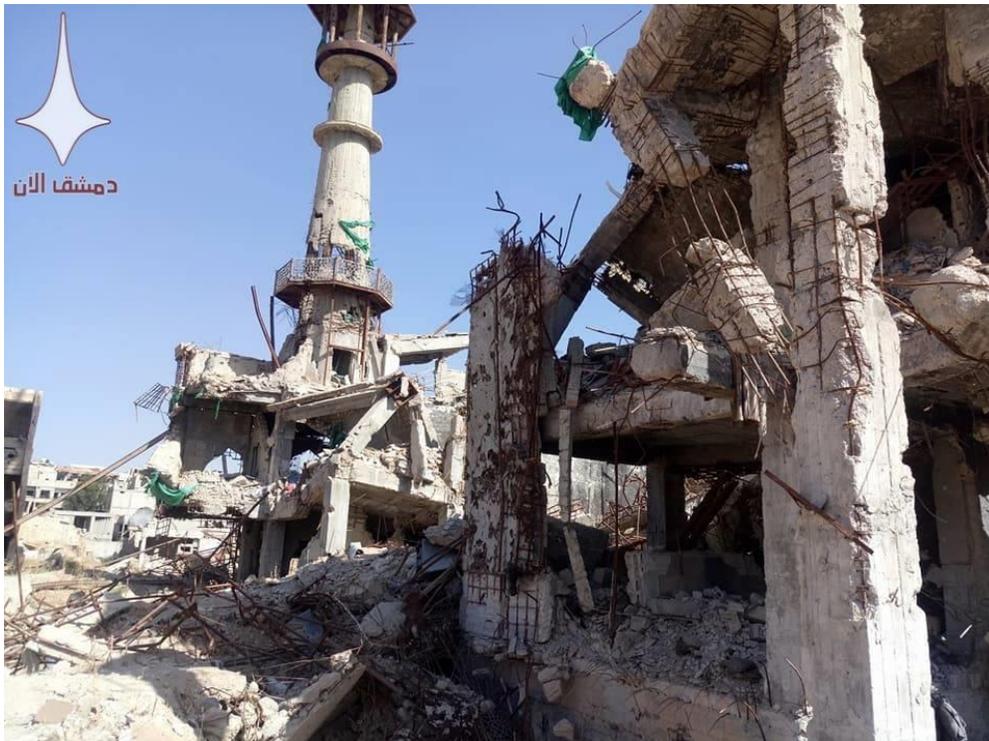
Photograph of damage to the front of the shrine (Private Facebook Account; October 8, 2017)

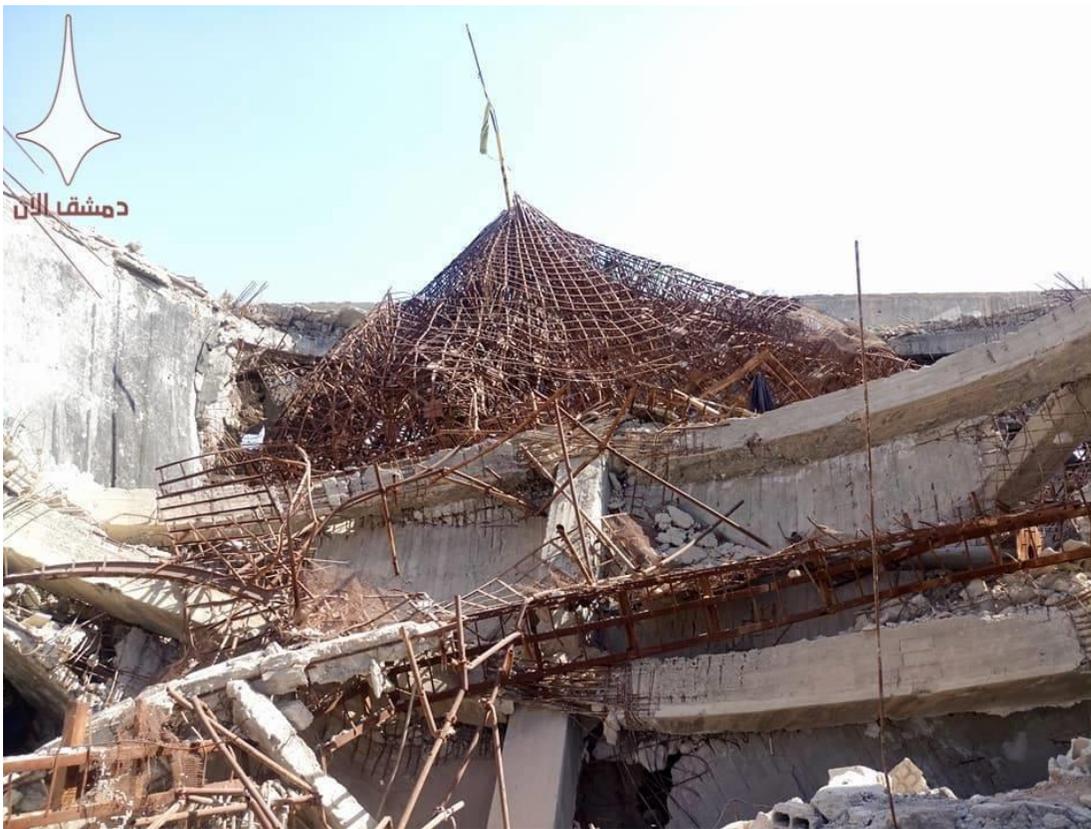
Photograph of damage to the shrine, with remnants of the destroyed dome in foreground (Private Facebook Account; October 8, 2017)

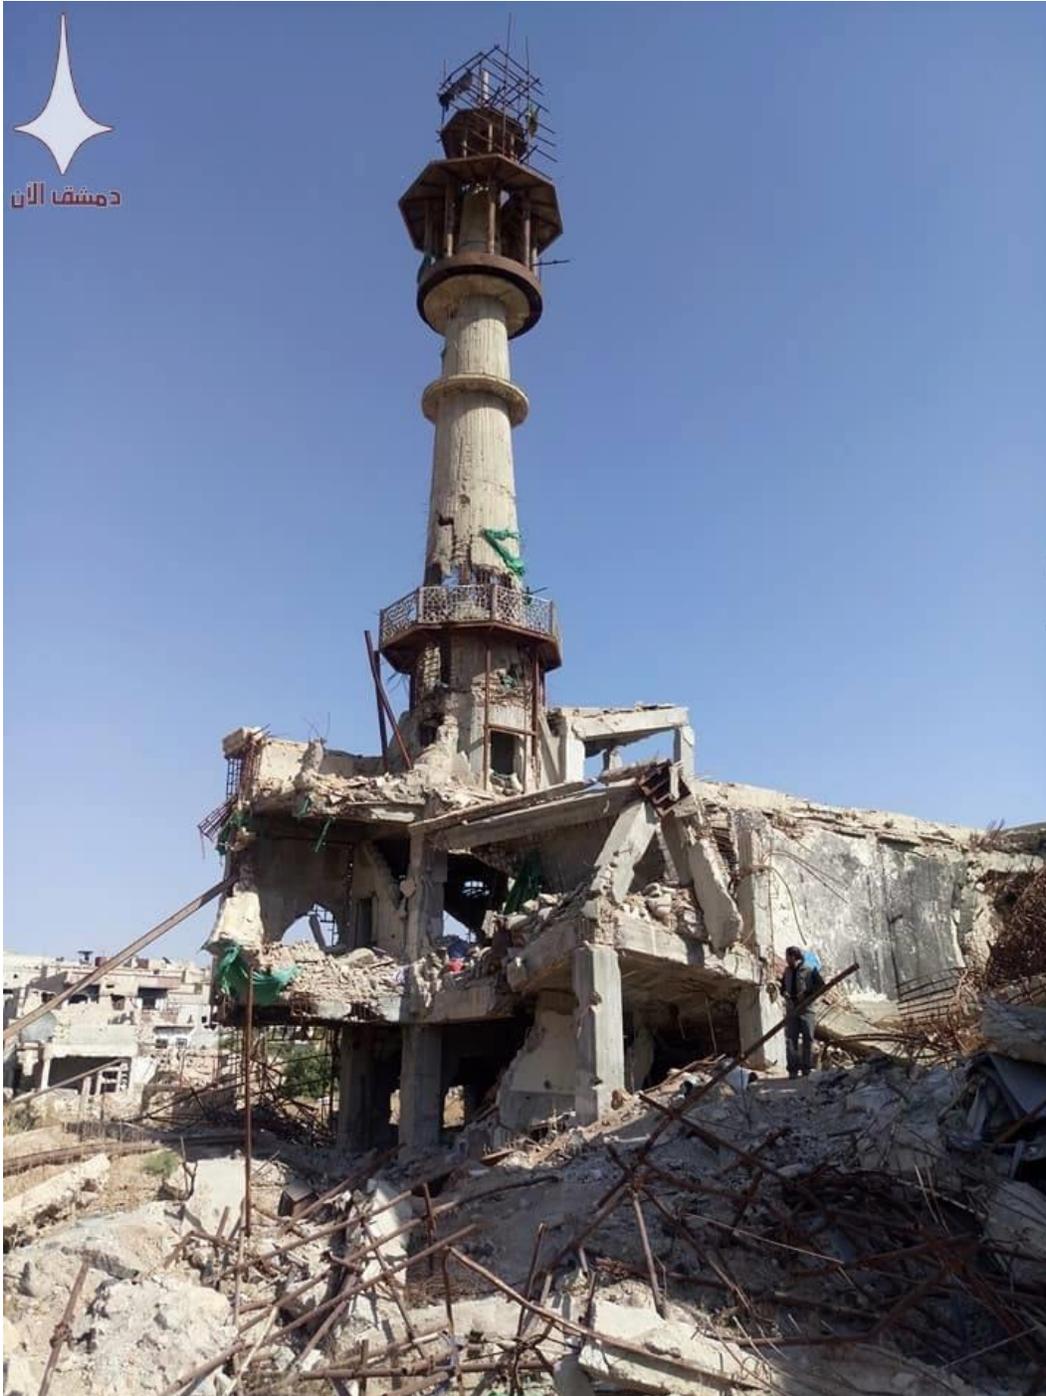
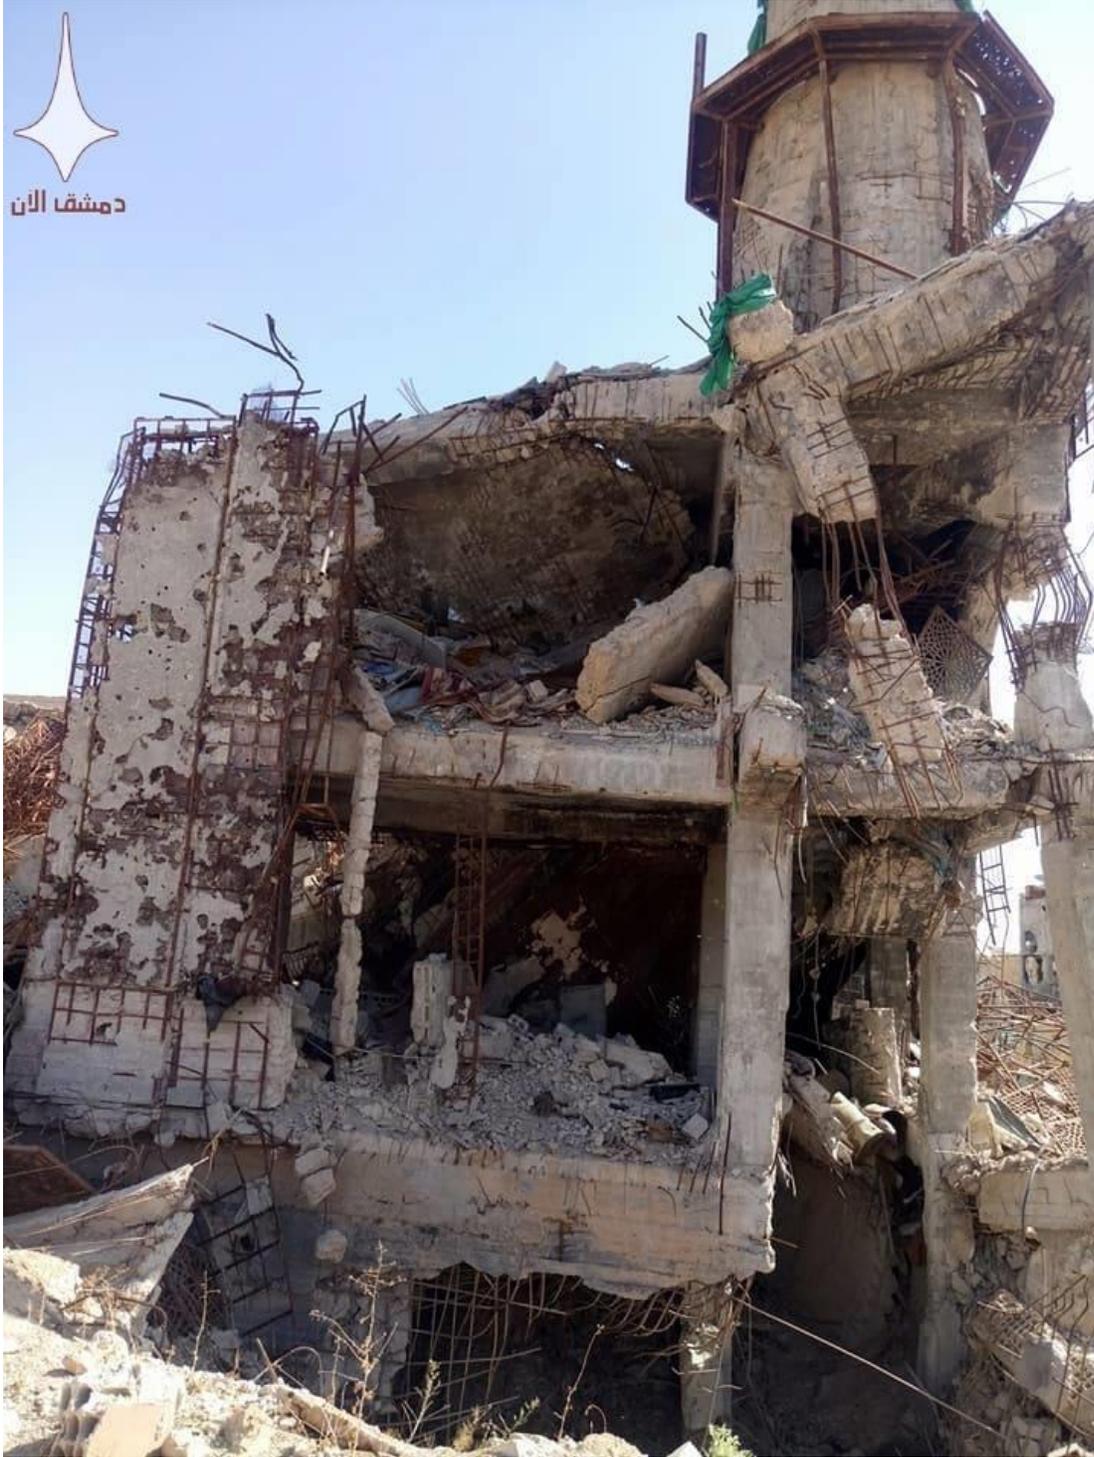
Photograph of damage to the shrine's minaret (Private Facebook Account; October 8, 2017)

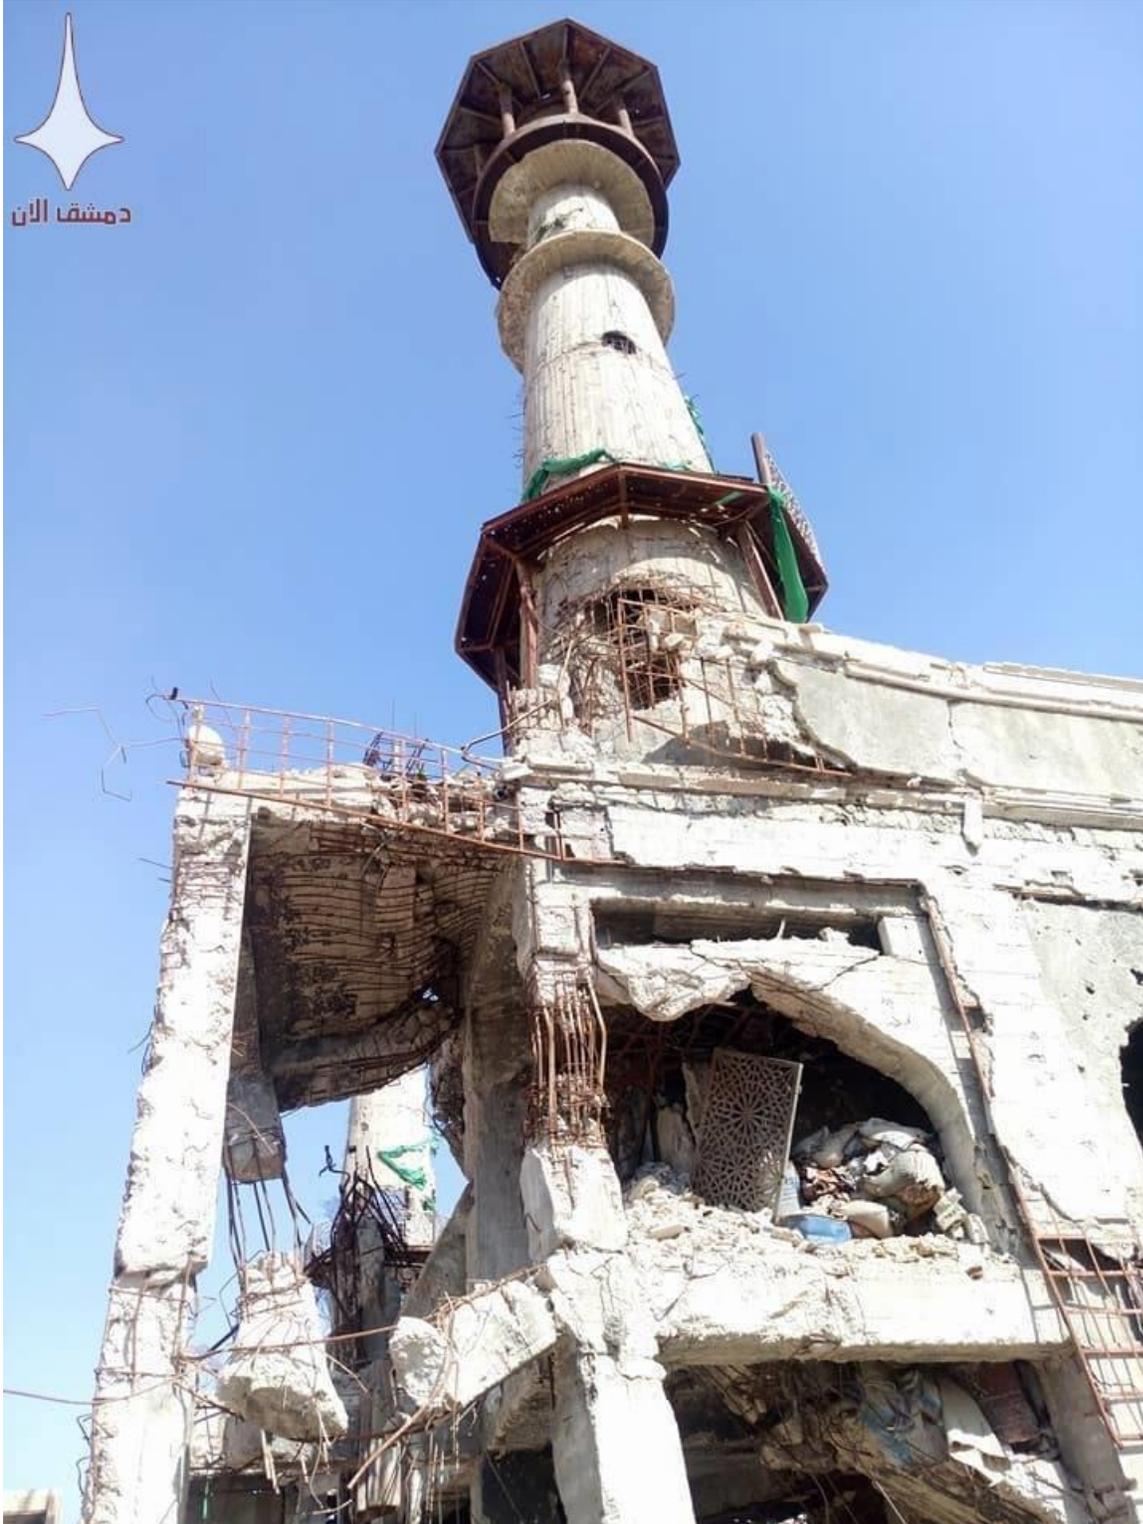
Photograph of damage to the shrine below the minaret (Private Facebook Account; October 8, 2017)

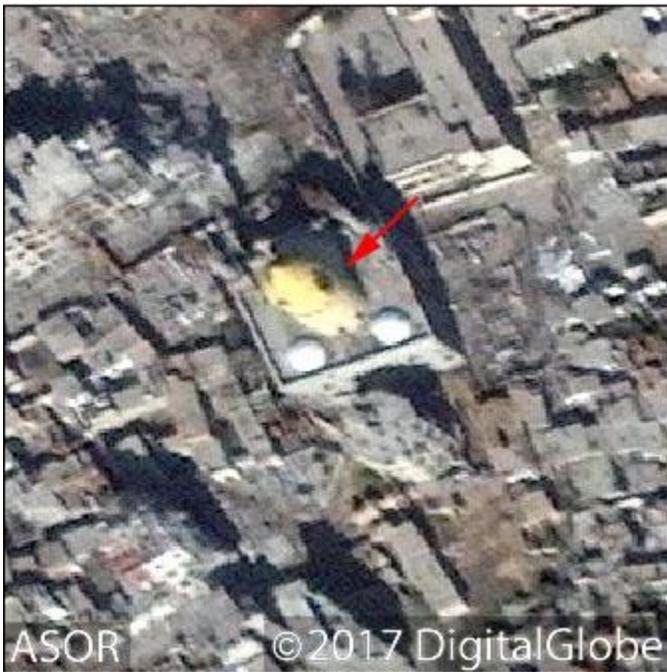
Initial damage to the dome of the shrine as indicated by the red arrow, possibly from an airstrike (DigitalGlobe NextView License; November 20, 2013)

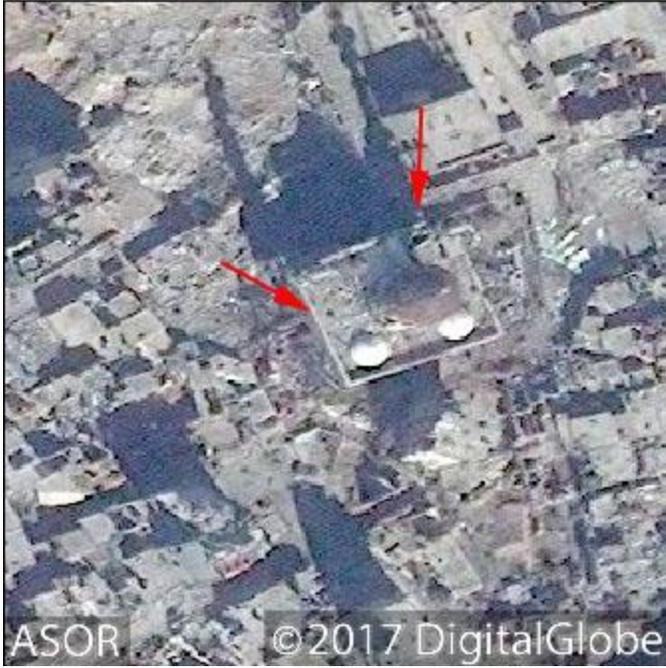
Increased damage to the roof of the shrine in the form of holes, possibly from airstrikes, indicated by red arrows (DigitalGlobe NextView License; December 23, 2014)

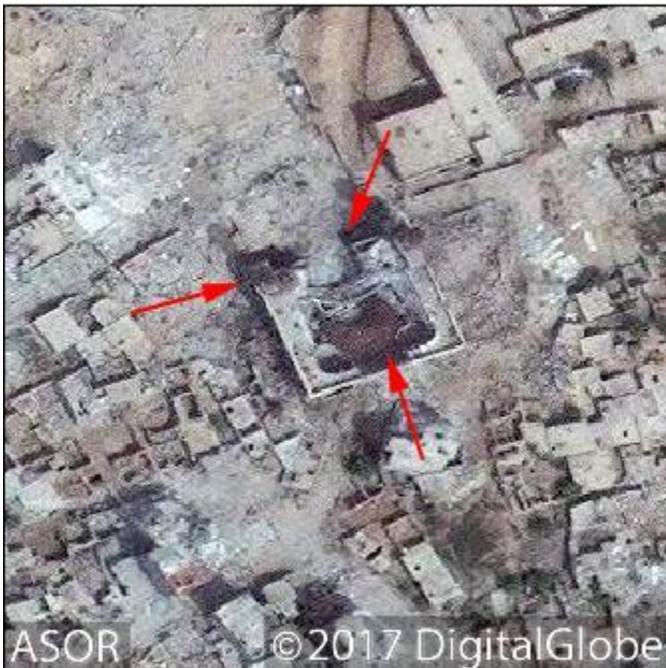
Extreme damage to the shrine, indicated by red arrows. The central dome of the shrine has collapsed, along with much of the central portion of the building (DigitalGlobe NextView License; April 17, 2015)

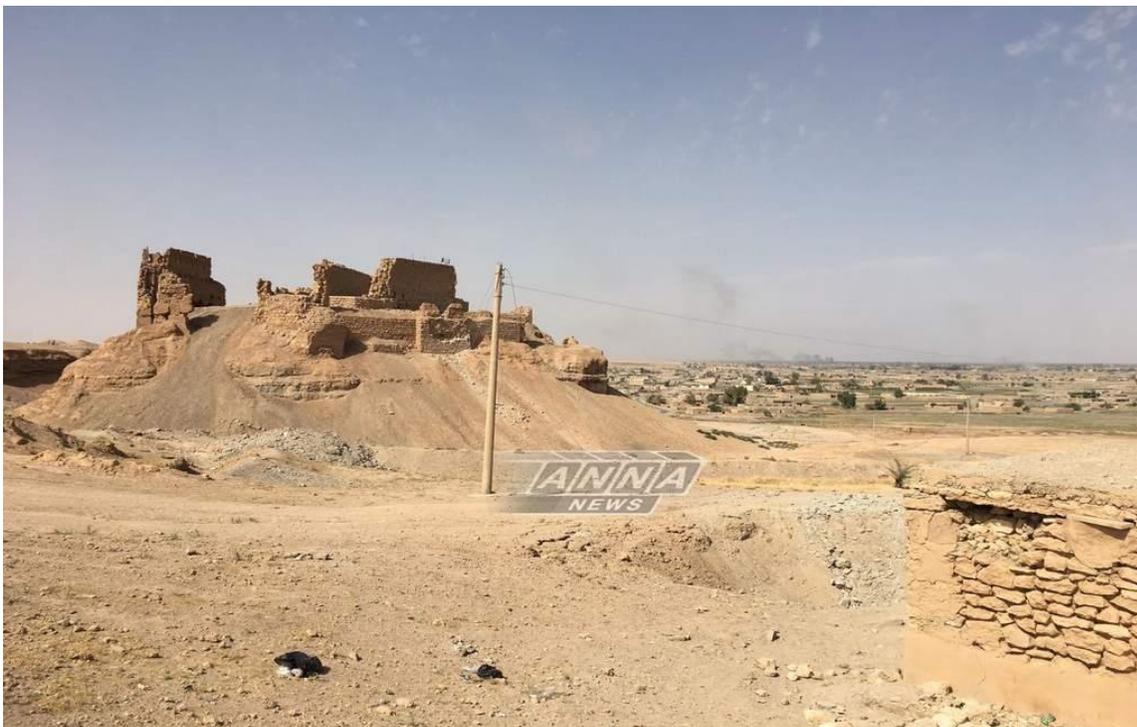
Qalaat Rahba, seen from the southeast. The soil discoloration along the left side of the image is likely the result of foot traffic into the site's interior (ANNA News; October 8, 2017)

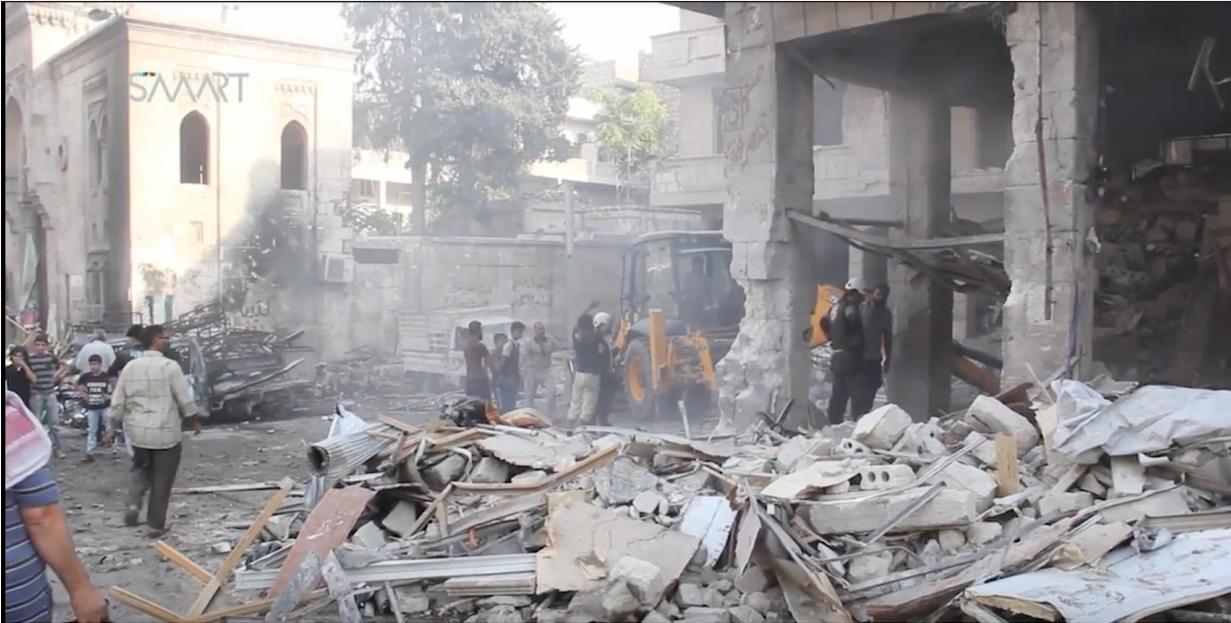
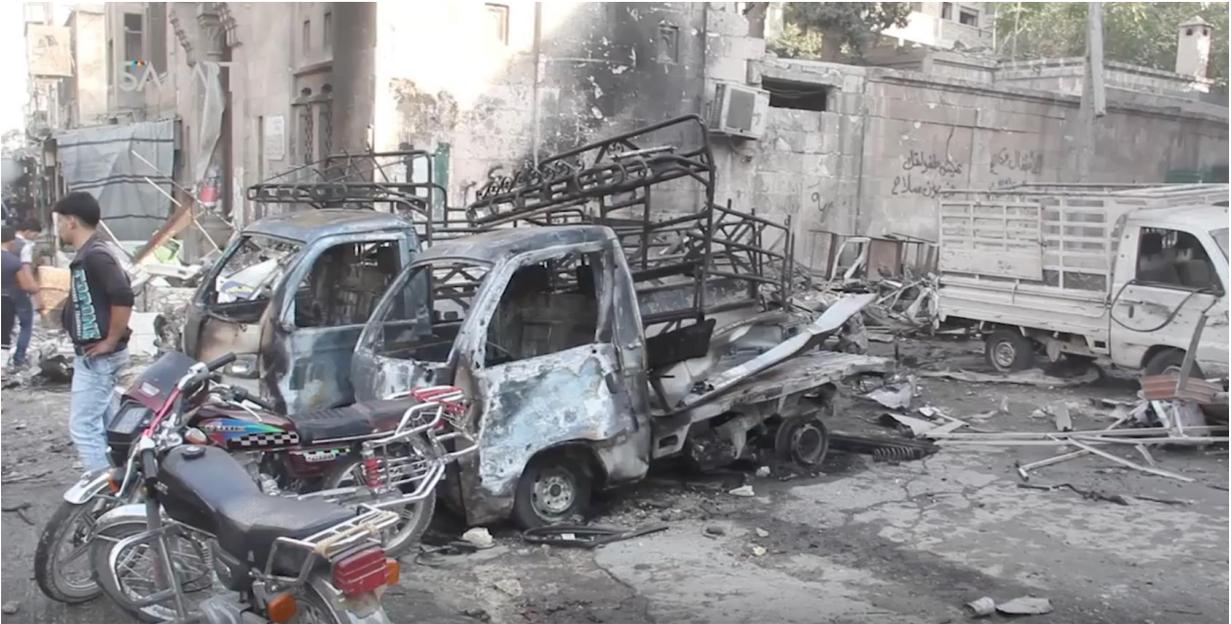
Video still showing damage to eastern side of cultural center in top left (SMART; October 8, 2017)

Video still showing damage to eastern side of cultural center (SMART; October 8, 2017)

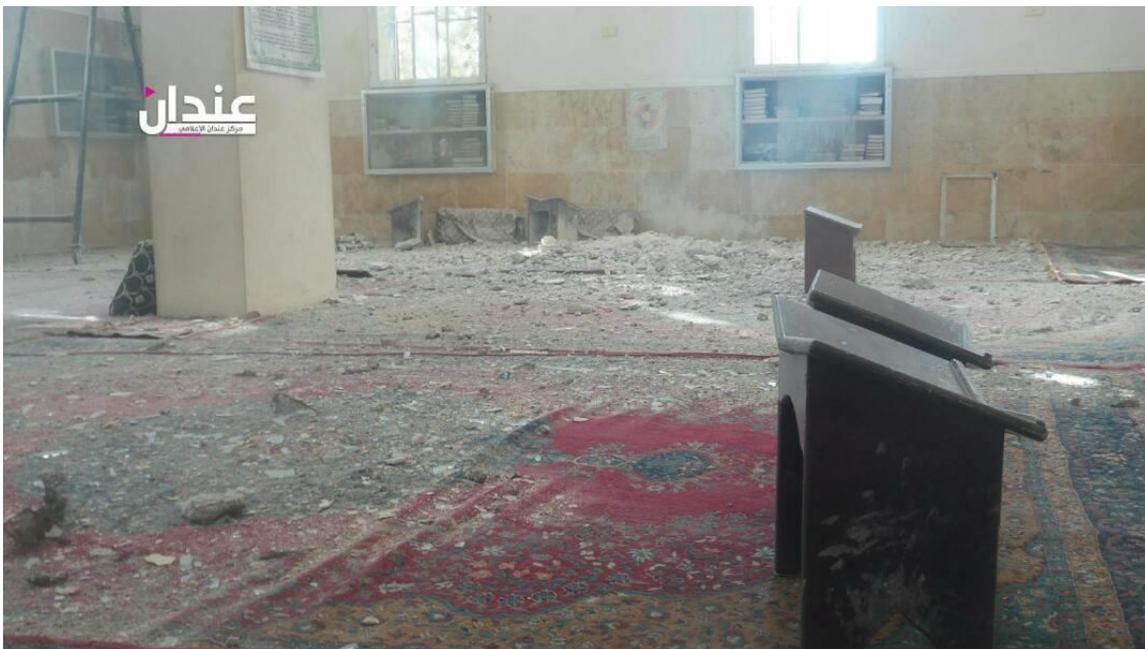
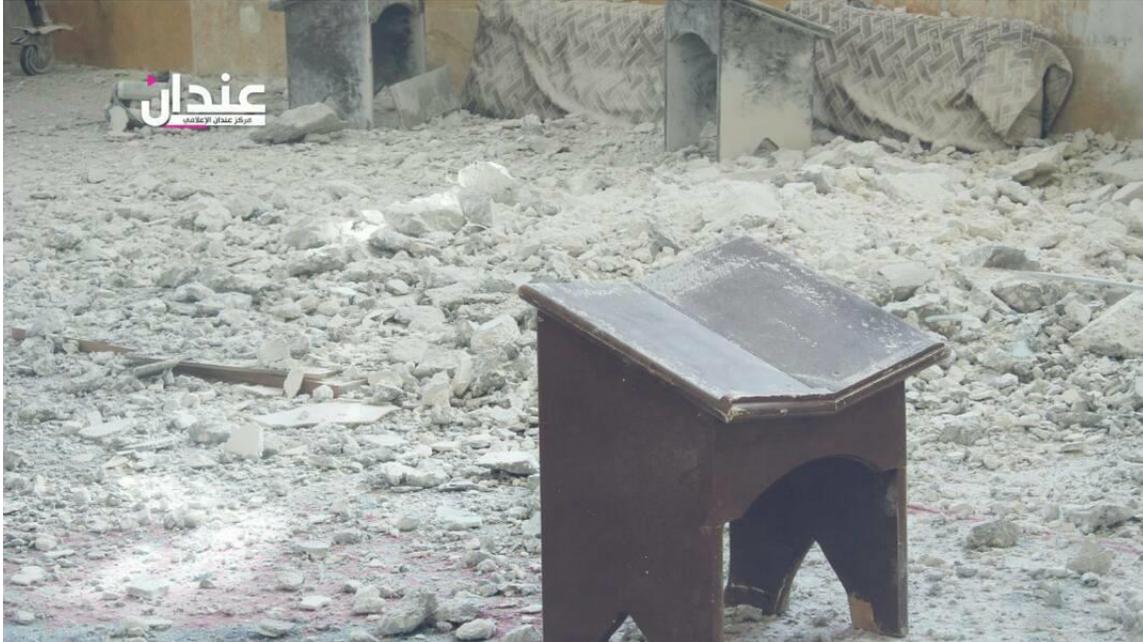
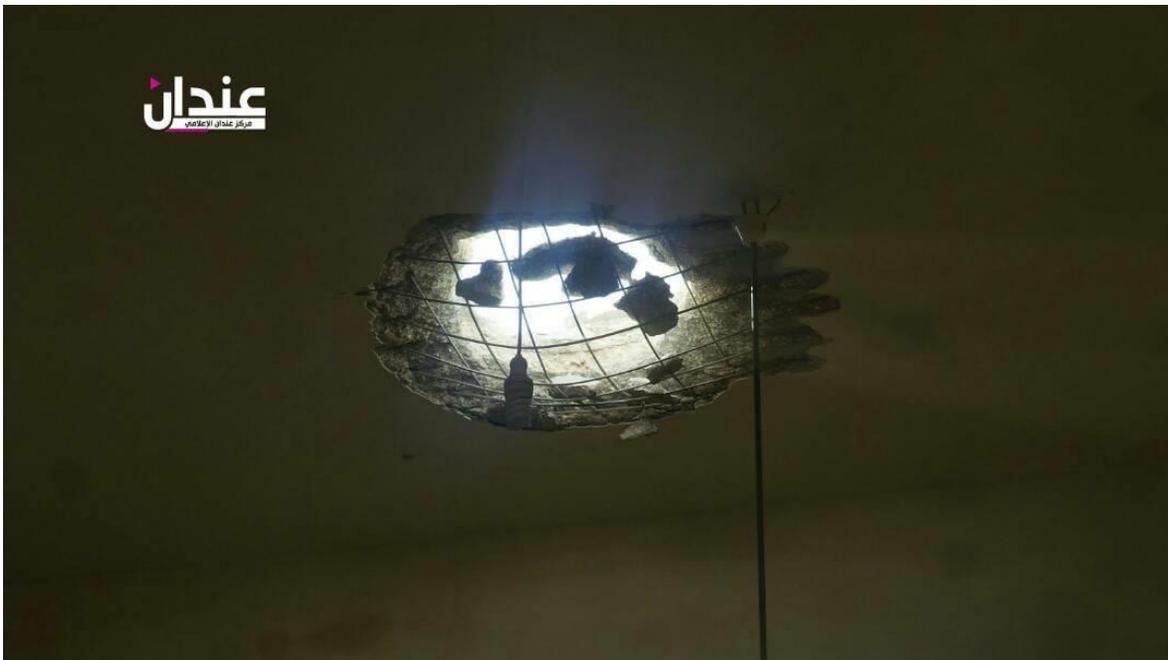
Damage to the interior of Abu Bakr al-Siddiq Mosque (Anadan Media Center; October 11, 2017)

Rubble in mosque interior (Anadan Media Center; October 12, 2017)

Damage to mosque ceiling (Anadan Media Center; October 12, 2017)

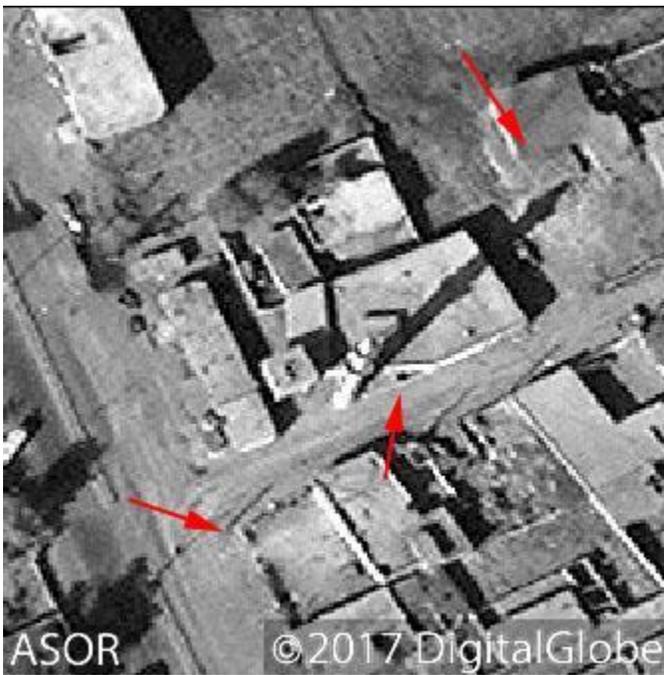
A hole visible in the southern roof of the mosque just east of the minaret is indicated by a red arrow. Nearby damage is indicated by red arrows (DigitalGlobe NextView License; October 15, 2017)

Monitoring Recommendations and Mitigation Measures: ASOR CHI will continue to monitor the condition of this mosque, as well as the condition of other heritage sites located in regions subject to intense military activity.

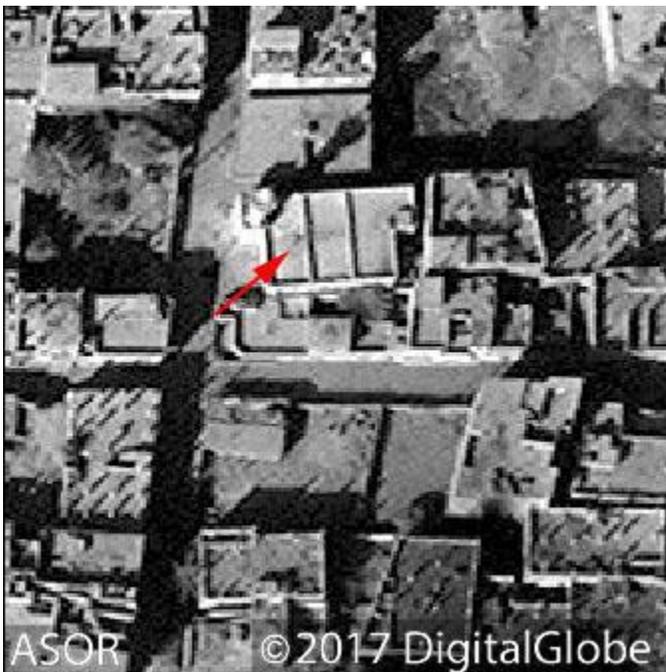
A hole in the roof of the mosque indicated by a red arrow (DigitalGlobe NextView License; October 15, 2017)

Monitoring Recommendations and Mitigation Measures: ASOR CHI will continue to monitor the condition of the Unnamed Mosque, as well as the condition of other heritage sites located in regions subject to intense military activity.

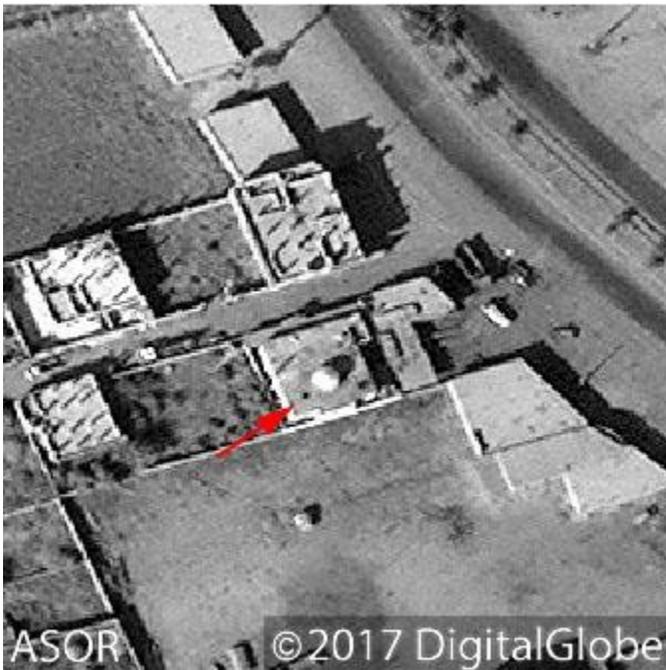
A new hole in the roof of the mosque indicated by a red arrow (DigitalGlobe NextView License; October 15, 2017)

Monitoring Recommendations and Mitigation Measures: ASOR CHI will continue to monitor the condition of this mosque, as well as the condition of other heritage sites located in regions subject to intense military activity.
