ASOR Cultural Heritage Initiatives (CHI): Planning for Safeguarding Heritage Sites in Syria and Iraq¹

Weekly Report 161–164 — October 1–31, 2017

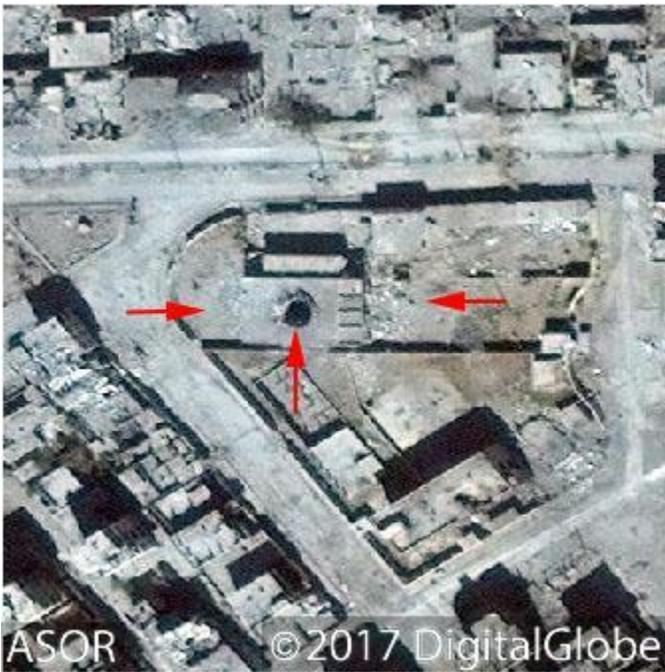
Damage to the dome of the mosque as well as to the surrounding area of the mosque as indicated by red arrows (DigitalGlobe NextView License; October 19, 2017)

Monitoring Recommendations and Mitigation Measures: ASOR CHI will continue to monitor the condition of al-Shuhada Mosque, as well as the condition of other heritage sites located in regions subject to intense military activity and illegal excavation.

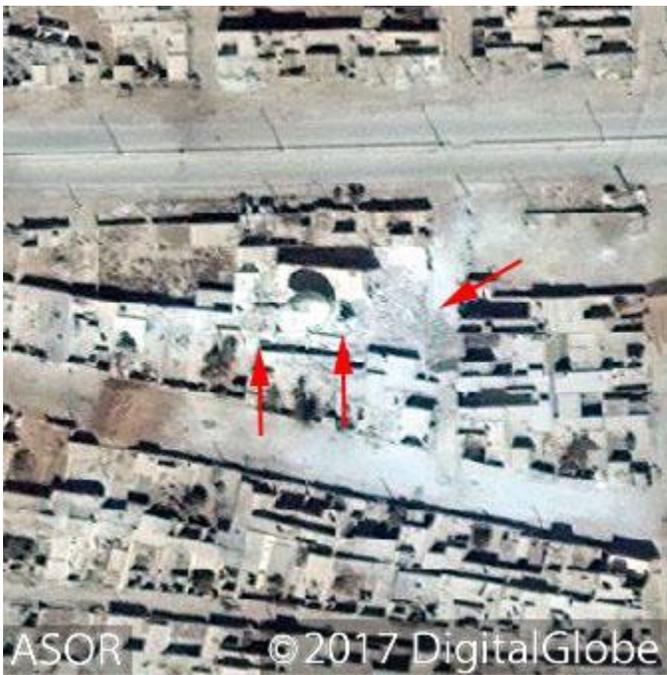
The southern half of the mosque is severely damaged likely by an airstrike, as indicated by the red arrows (DigitalGlobe NextView License; September 30, 2017)

Monitoring Recommendations and Mitigation Measures: ASOR CHI will continue to monitor the condition of the Unnamed Mosque, as well as the condition of other heritage sites located in regions subject to intense military activity and illegal excavation.

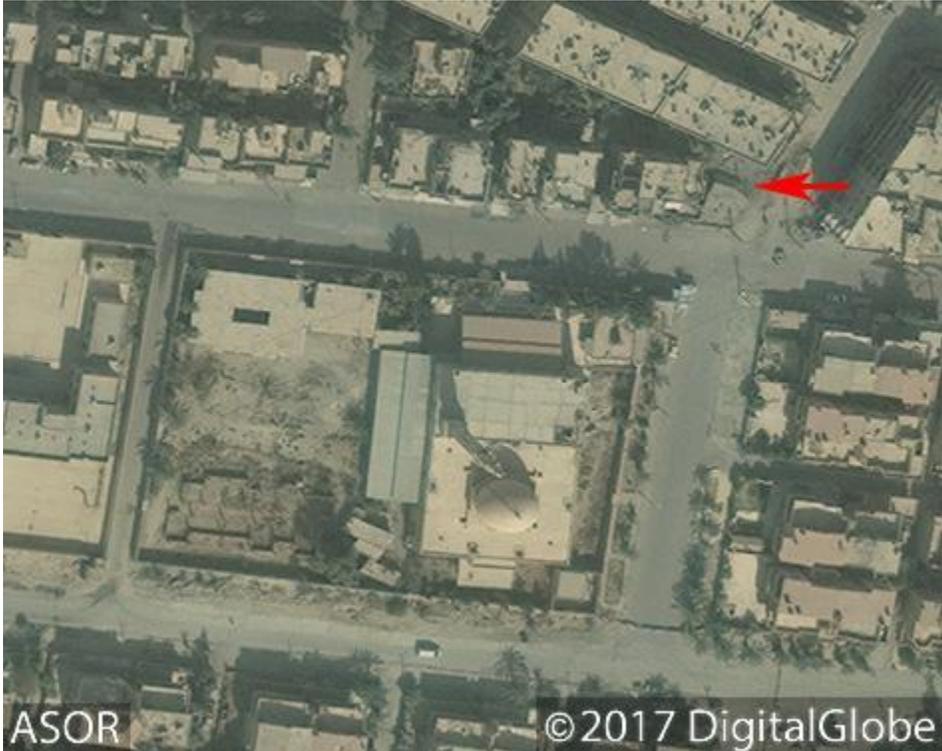
Damage to building close to al-Fateh Mosque after reports of shelling (DigitalGlobe NextView License; October 27, 2017)

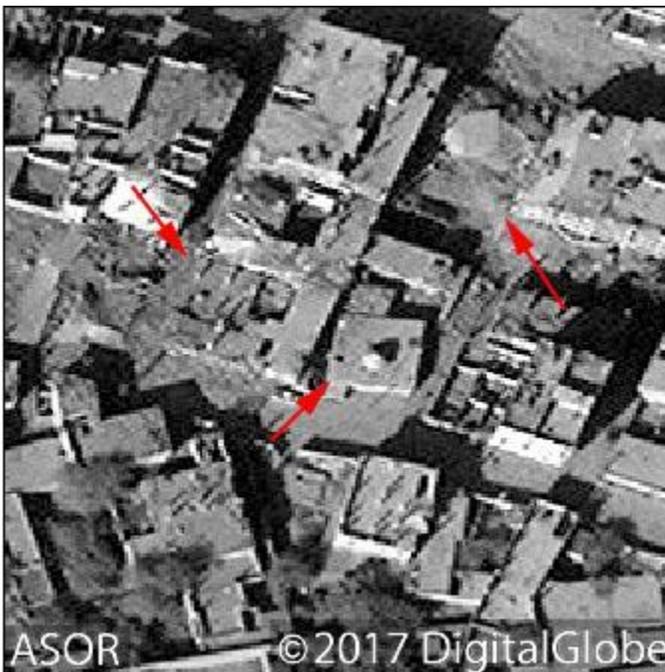
An arrow indicates the hole in the roof of the mosque. Other arrows indicate damage in surrounding area (DigitalGlobe NextView License; October 15, 2017)

Monitoring Recommendations and Mitigation Measures: ASOR CHI will continue to monitor the condition of this mosque, as well as the condition of other heritage sites located in regions subject to intense military activity.

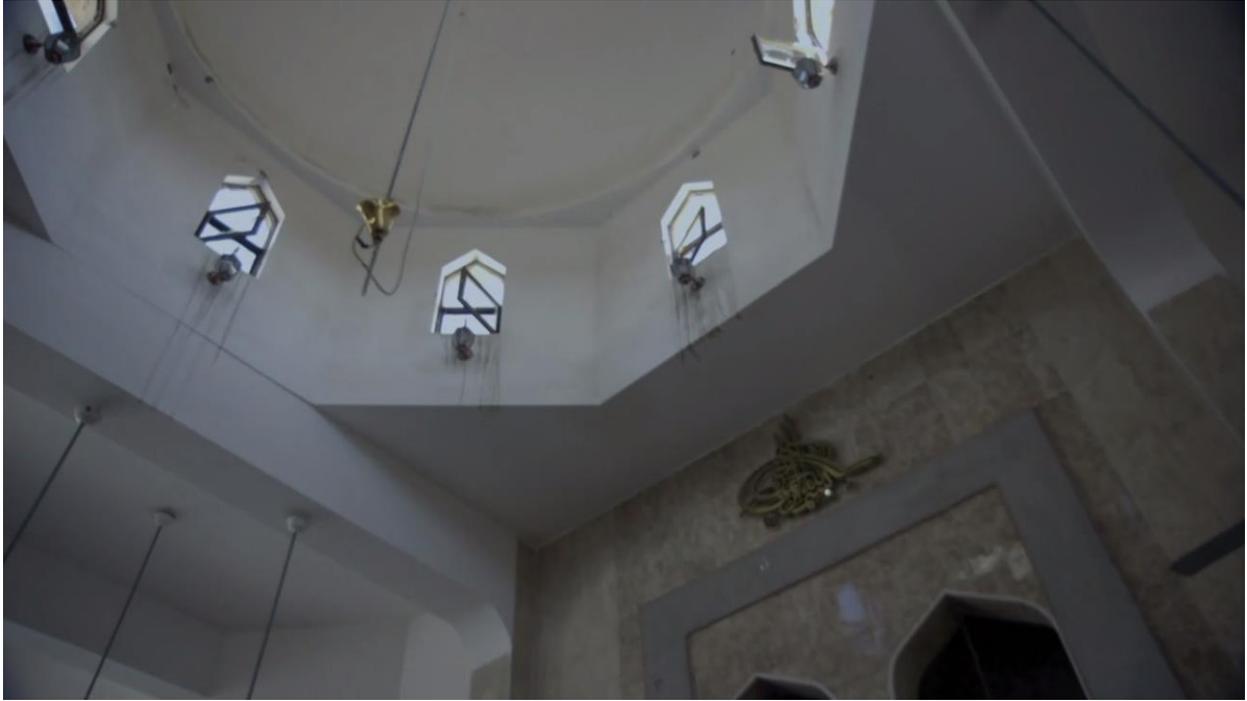
Video still of the mosque's interior. Note the water damage near the open windows (VICE News; October 13, 2017)

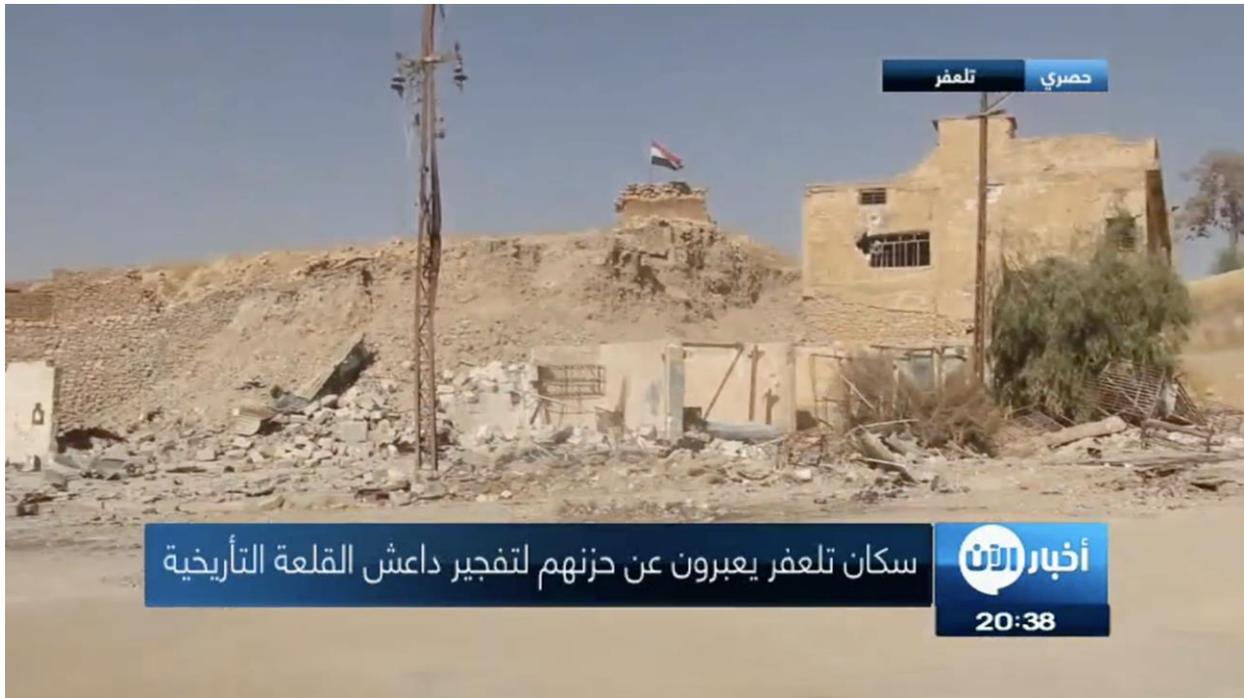
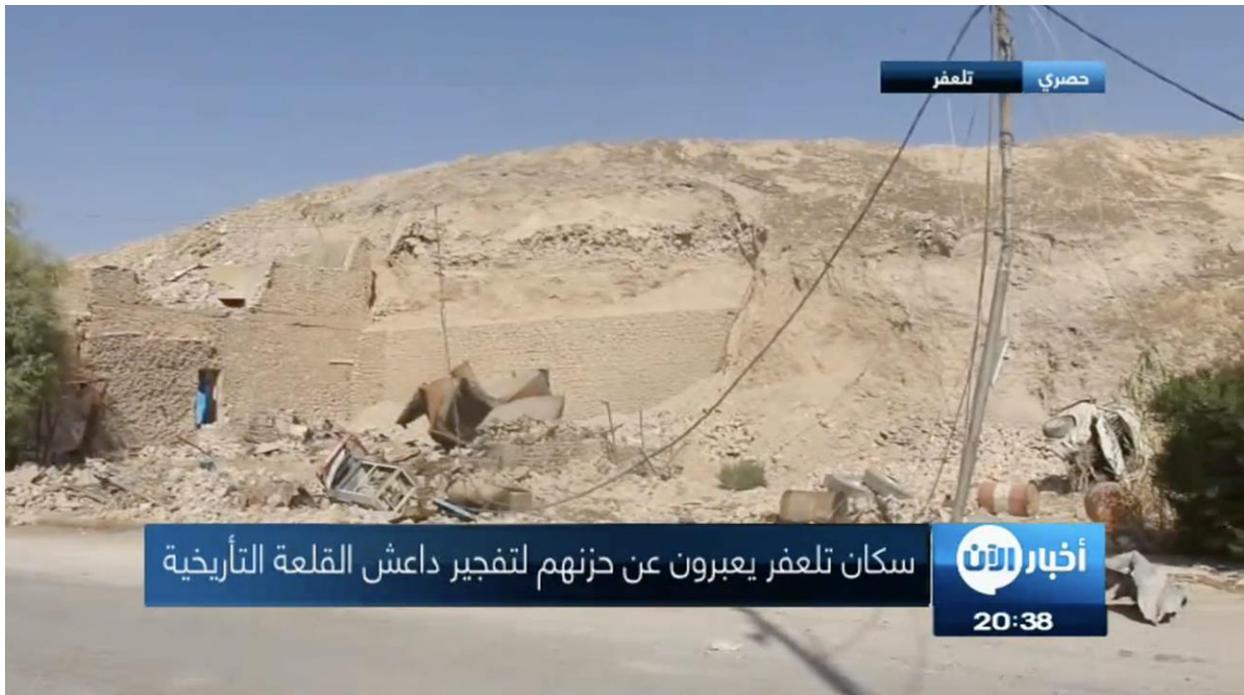
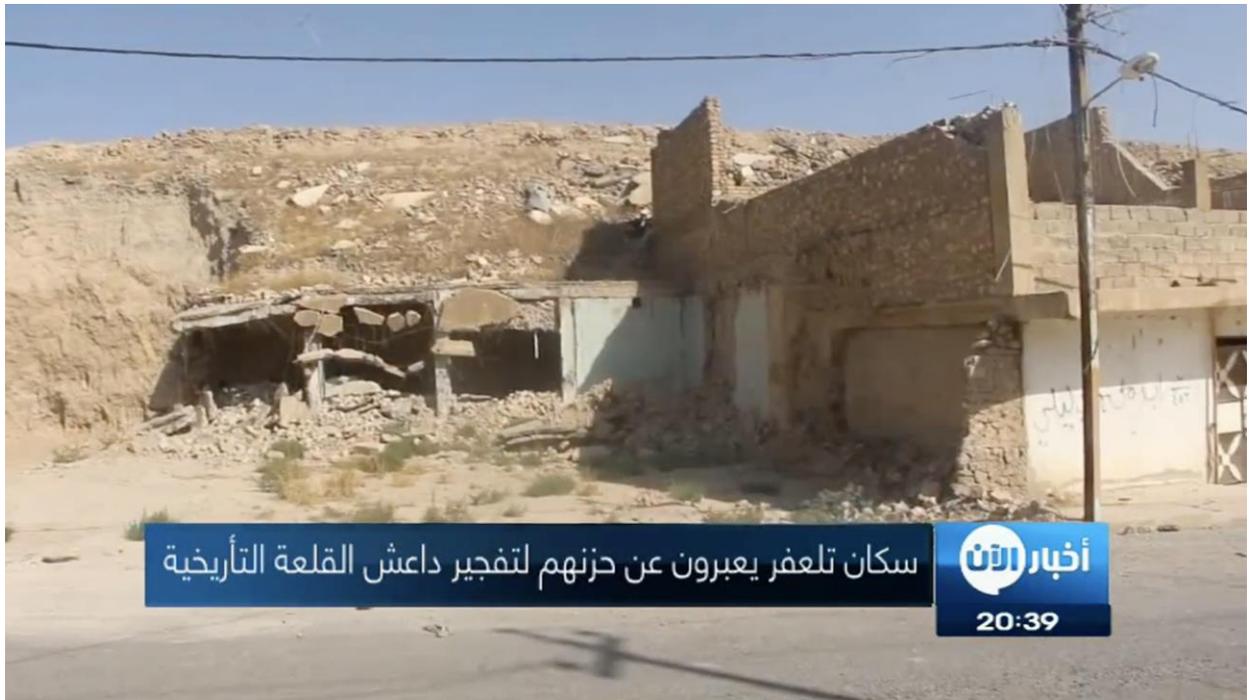
Video still of damage to buildings around the base of the mound, as well as the piles of building material from the structures formerly on top of the mound, seen from the west (Al-Aan Arabic Television; October 4, 2017)

Video still of damage to buildings around the base of the mound, seen from the west (Al-Aan Arabic Television; October 4, 2017)

Video still of damage to buildings around the base of the mound as well as an area where ISIS looted the site with earthmoving equipment, seen from the west (Al-Aan Arabic Television; October 4, 2017)

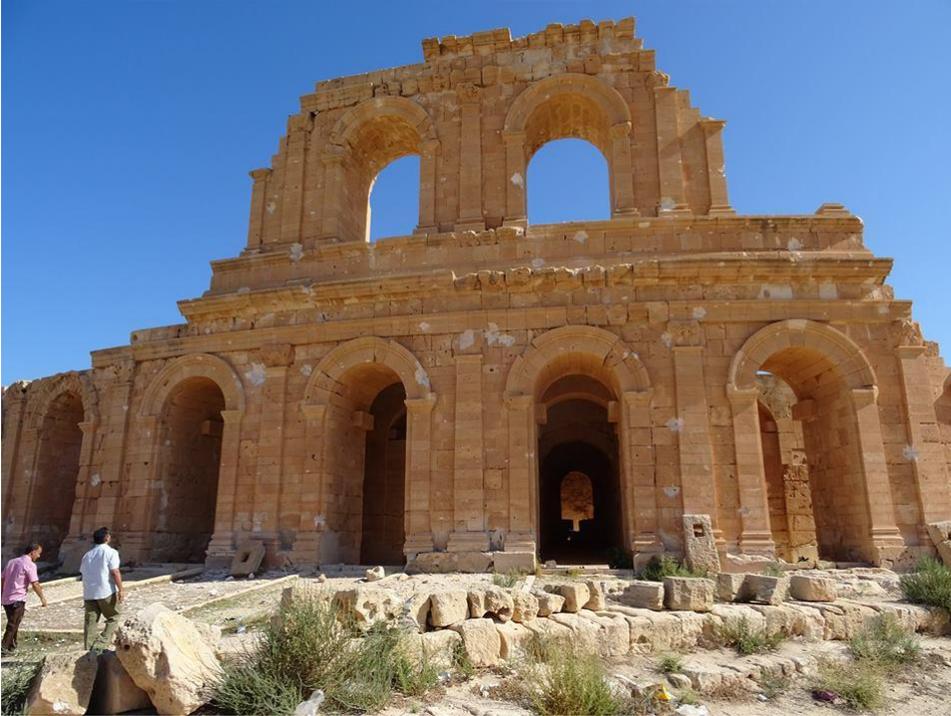
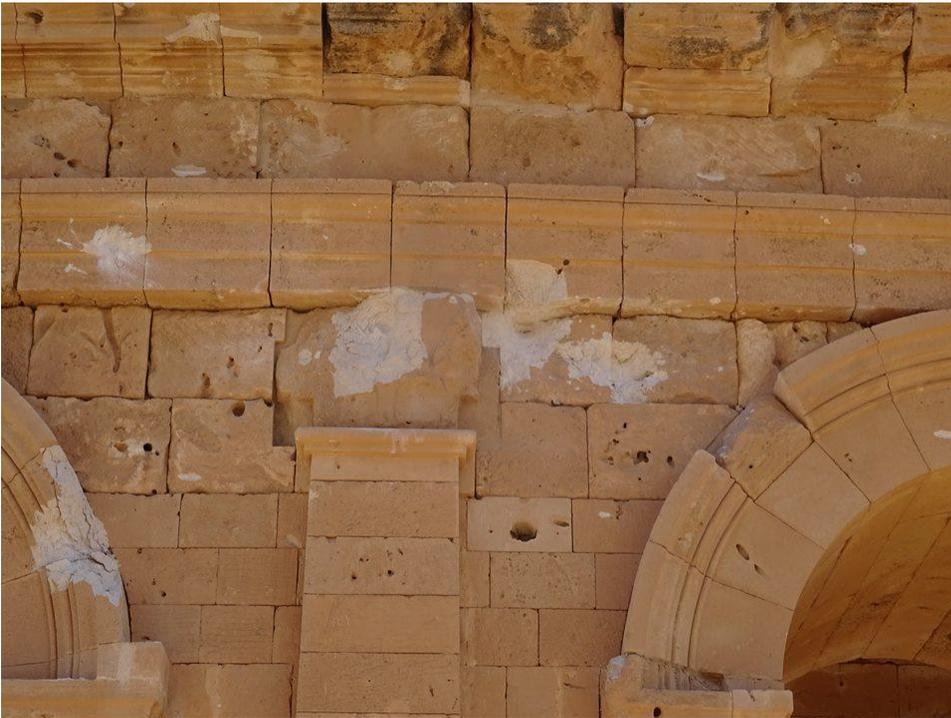
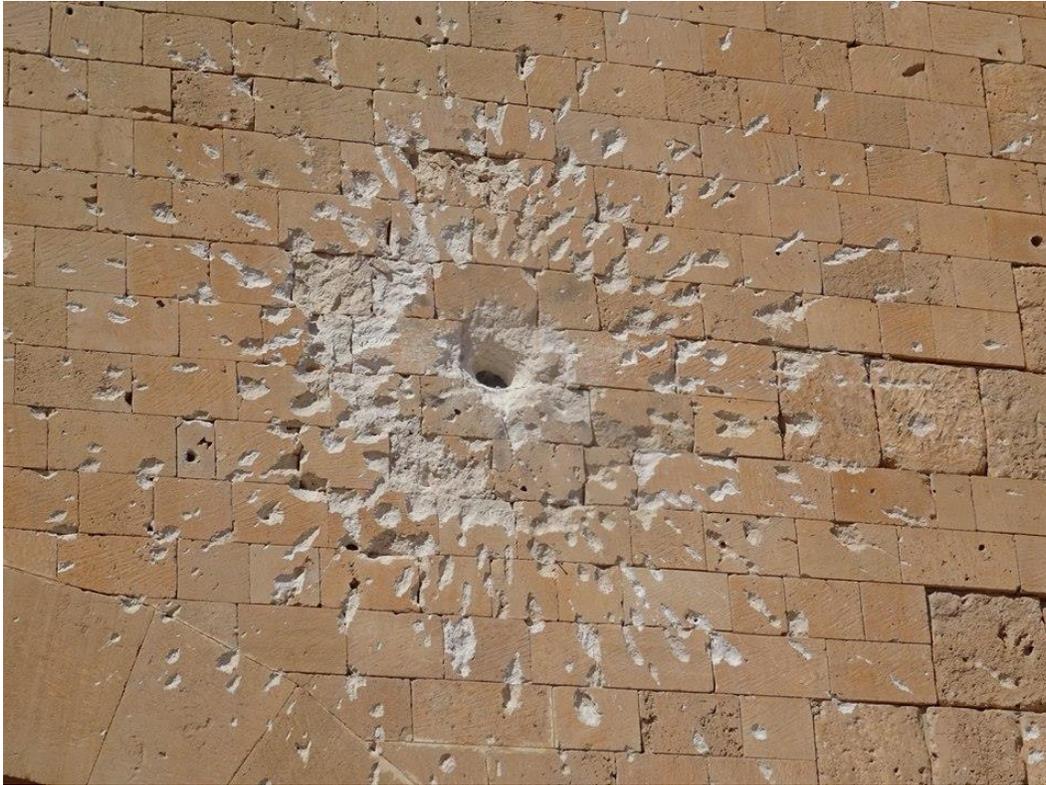
Damage to the Sabratha theatre (Hafed Walda; October 9, 2017)

Detail of damage to the Sabratha theater (Hafed Walda; October 9, 2017)

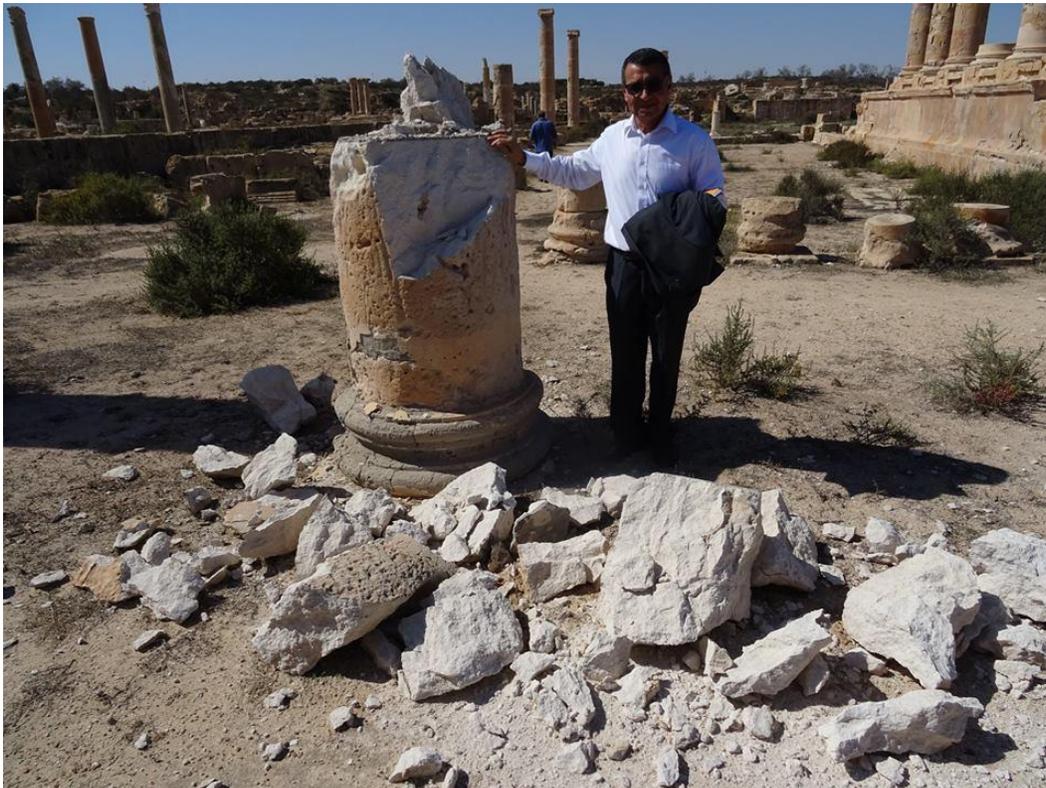
Damage to a column of one of the basilicas on site (Hafed Walda; October 9, 2017)

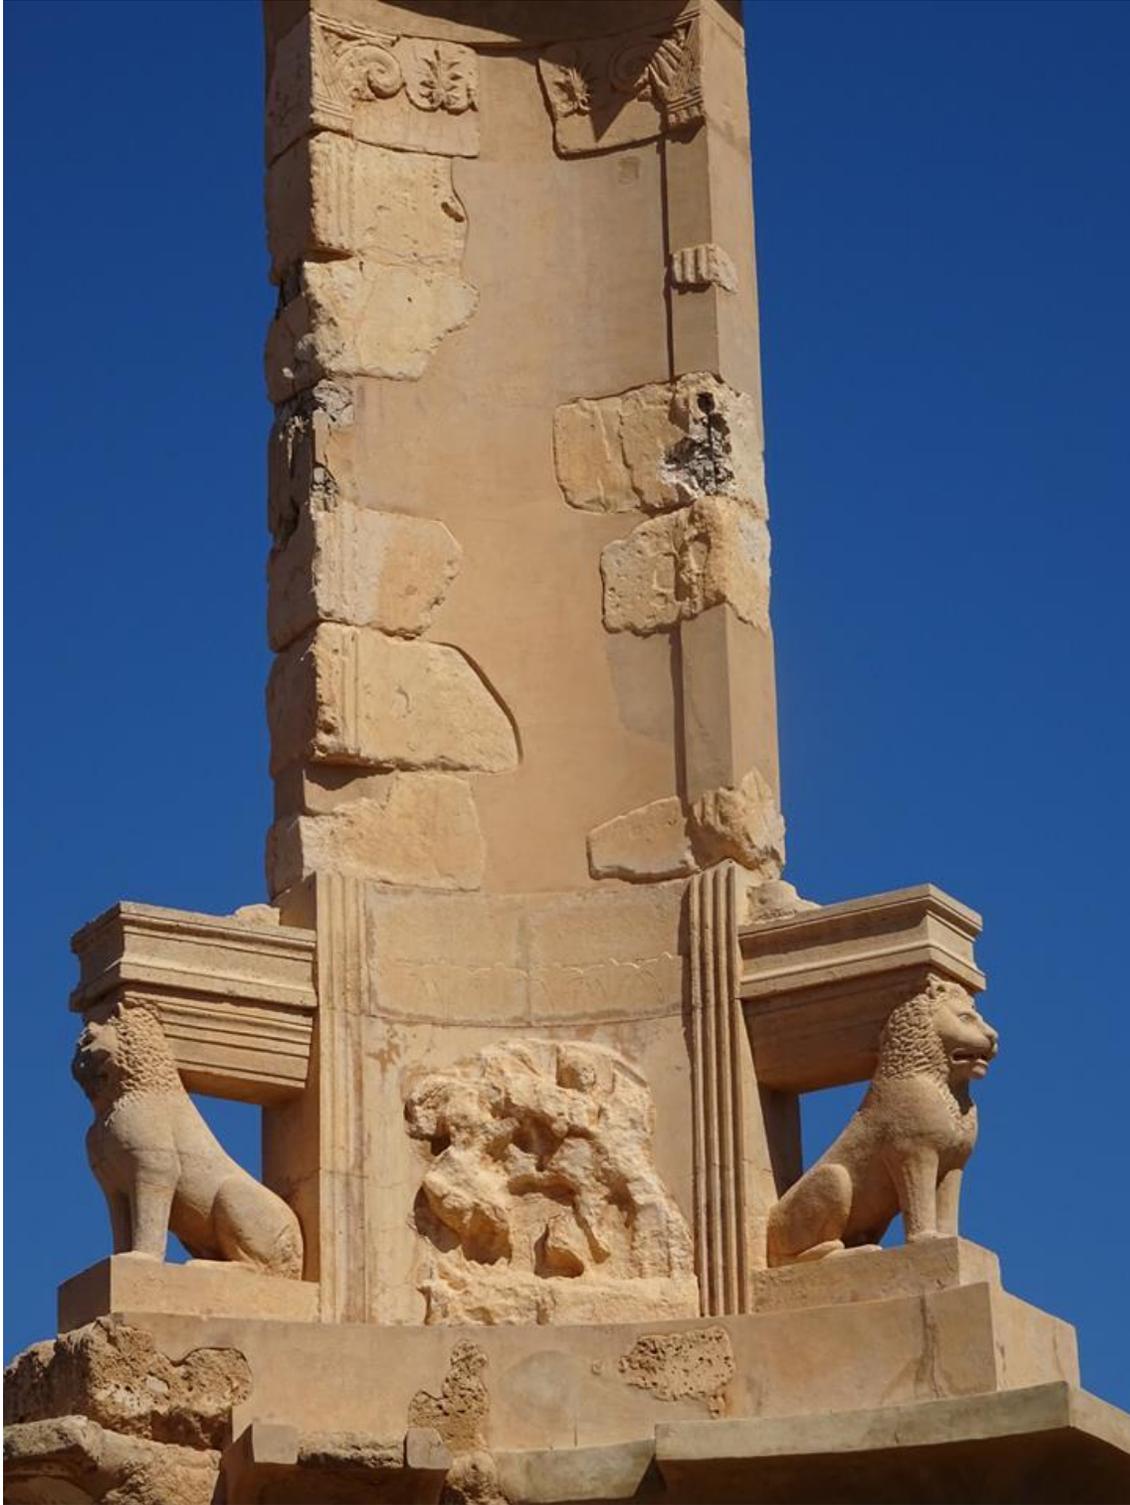
Superficial damage to the Punic funerary Mausoleum of Bes (Hafed Walda; October 9, 2017)

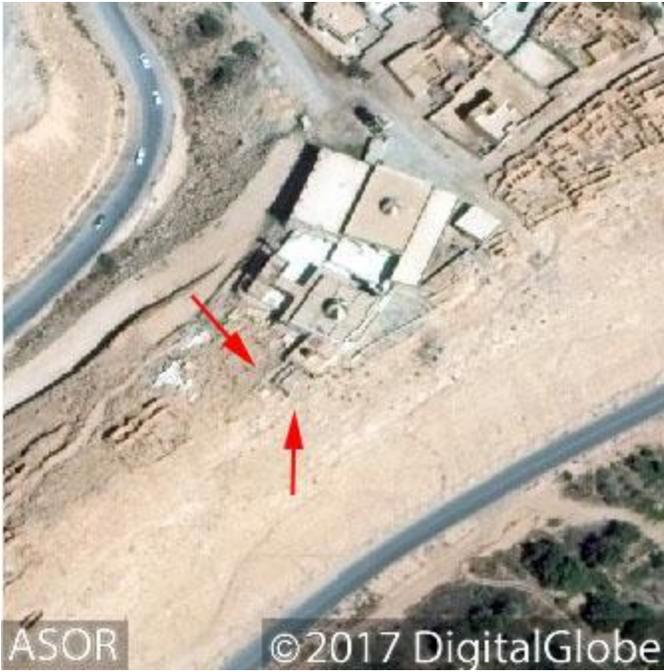
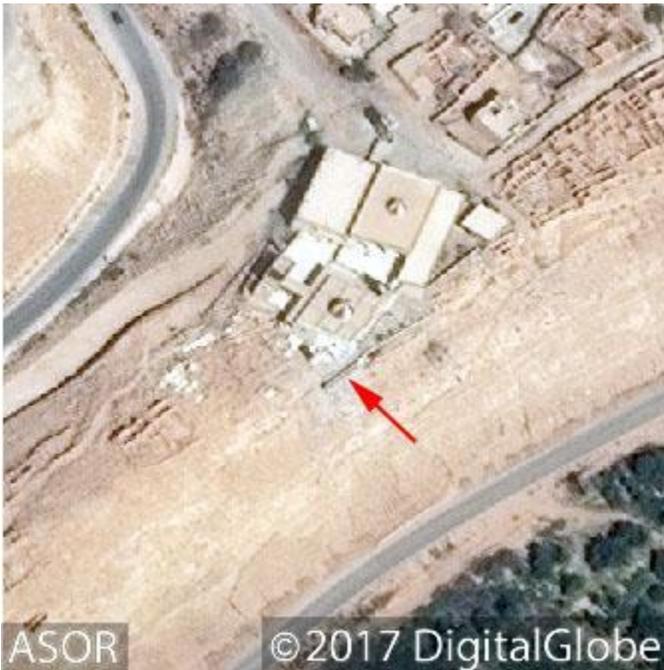
Initial damage to the mosque; former location indicated by red arrows (DigitalGlobe NextView License; February 2, 2015)

Increased damage to the mosque as indicated by the red arrow (DigitalGlobe NextView License; September 29, 2016)

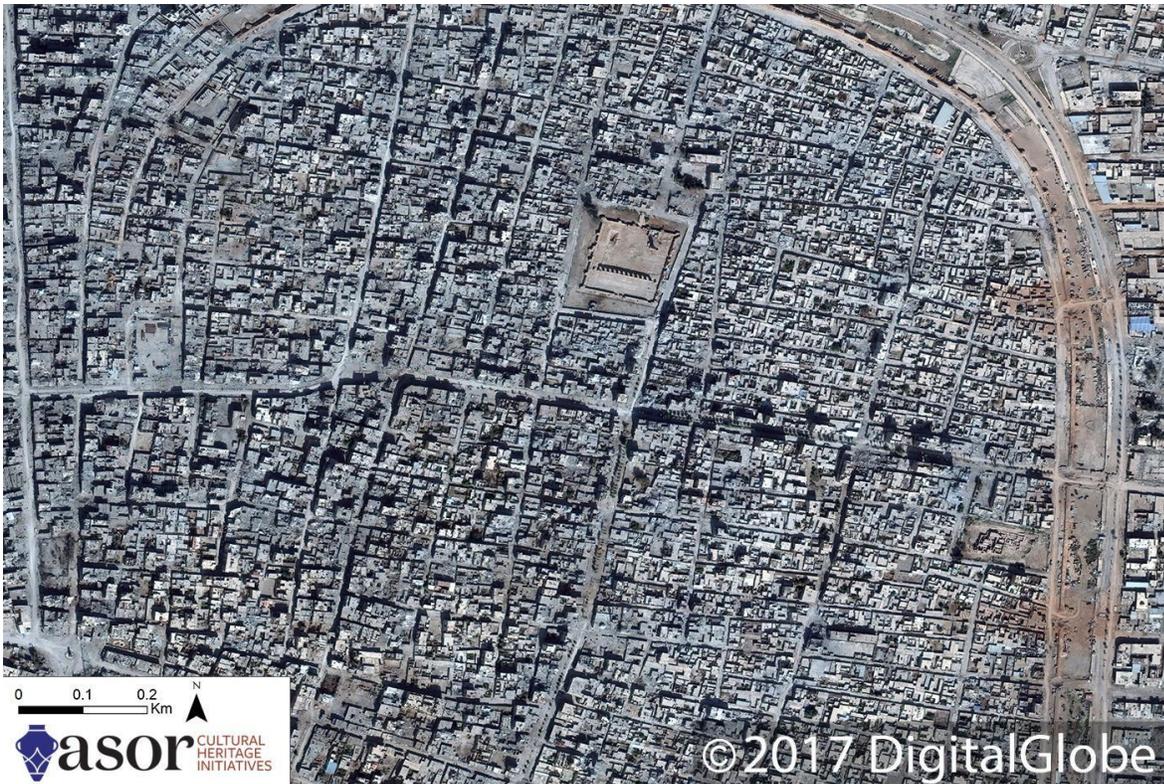
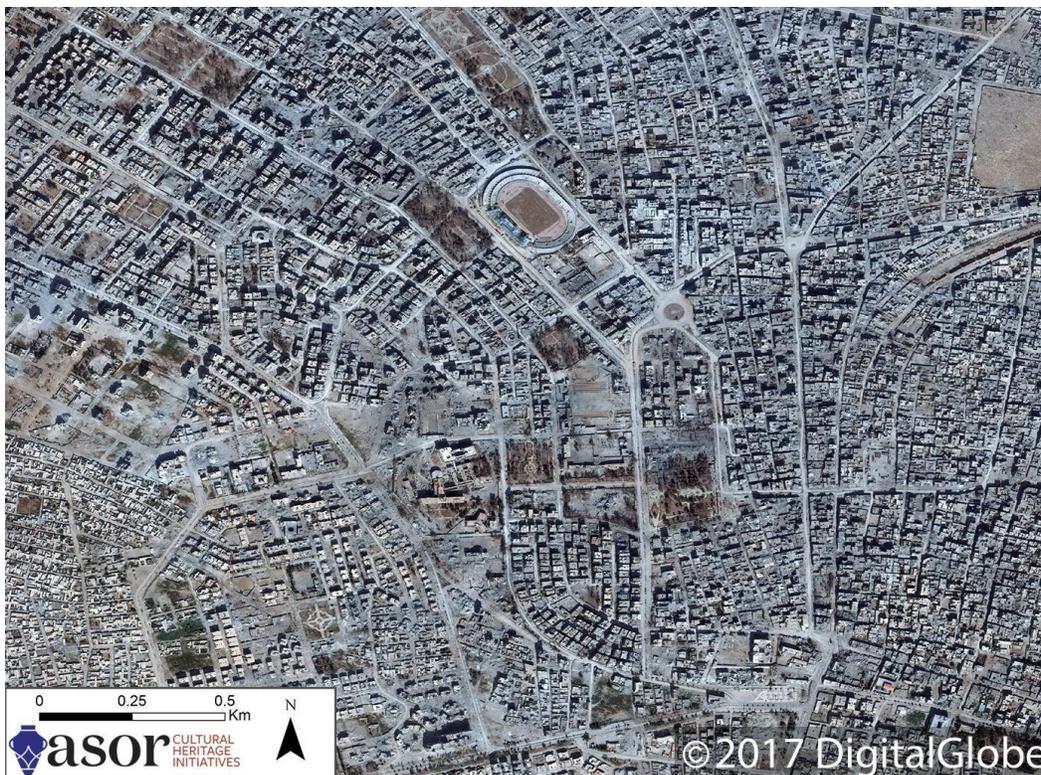
Conflict damage is extensive in western Raqqa neighborhoods. The areas around the hospital and stadium were constantly bombarded with airstrikes during the offensive, leading to severe destruction of residential and administrative buildings and mosques. Many of the mosques damaged in this area were completely destroyed, such as Abdul Rahman bin Auf Mosque. Located close to the children's hospital, which was reportedly used by ISIS as a headquarters, this mosque was destroyed in a US-led Coalition airstrike in late July (see **ASOR CHI Incident Report SHI 17-0141 in August 2017 Monthly Report**). The satellite images below illustrate the breadth of the damage, with the majority of neighborhoods in Raqqa affected by collapsed buildings and scattered debris.

Old City of Raqqa with severe damage (DigitalGlobe NextView License; October 21, 2017)

Western Raqqa with severe damage (DigitalGlobe NextView License; October 21, 2017)
