ASOR Syrian Heritage Initiative (SHI): Planning for Safeguarding Heritage Sites in Syria¹

NEA-PSHSS-14-001

Weekly Report 8 – September 29, 2014

Michael D. Danti and Kurt W. Prescott

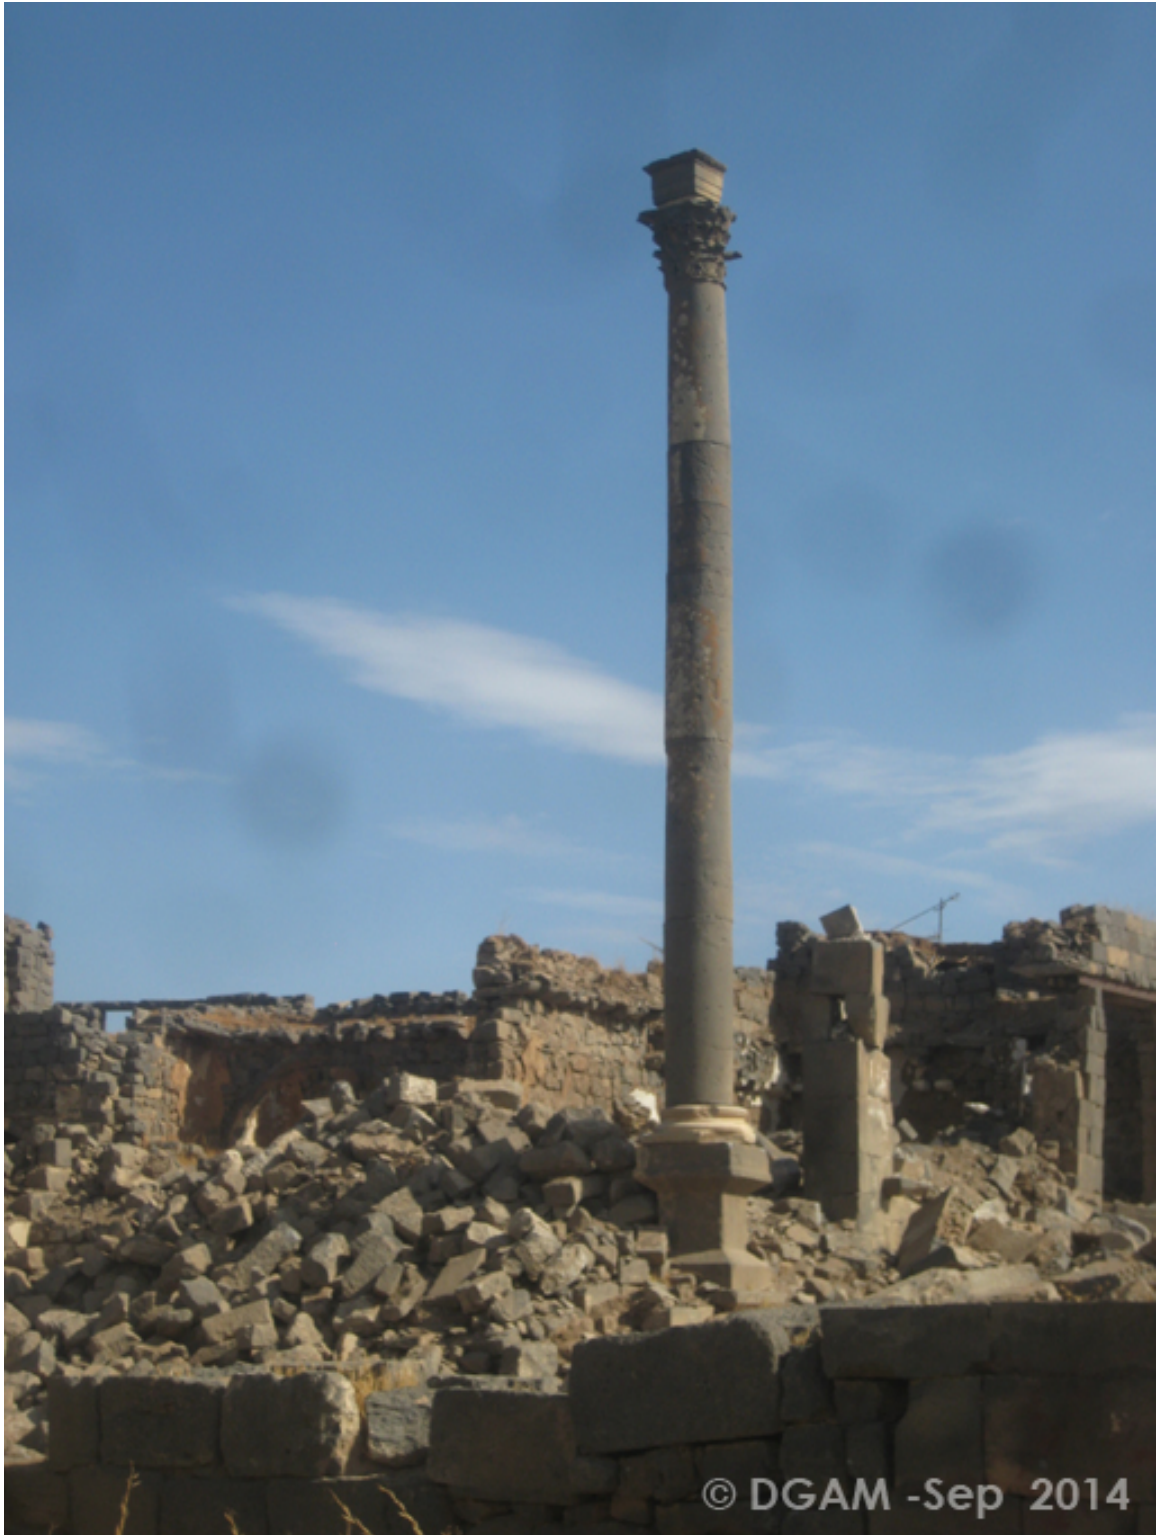
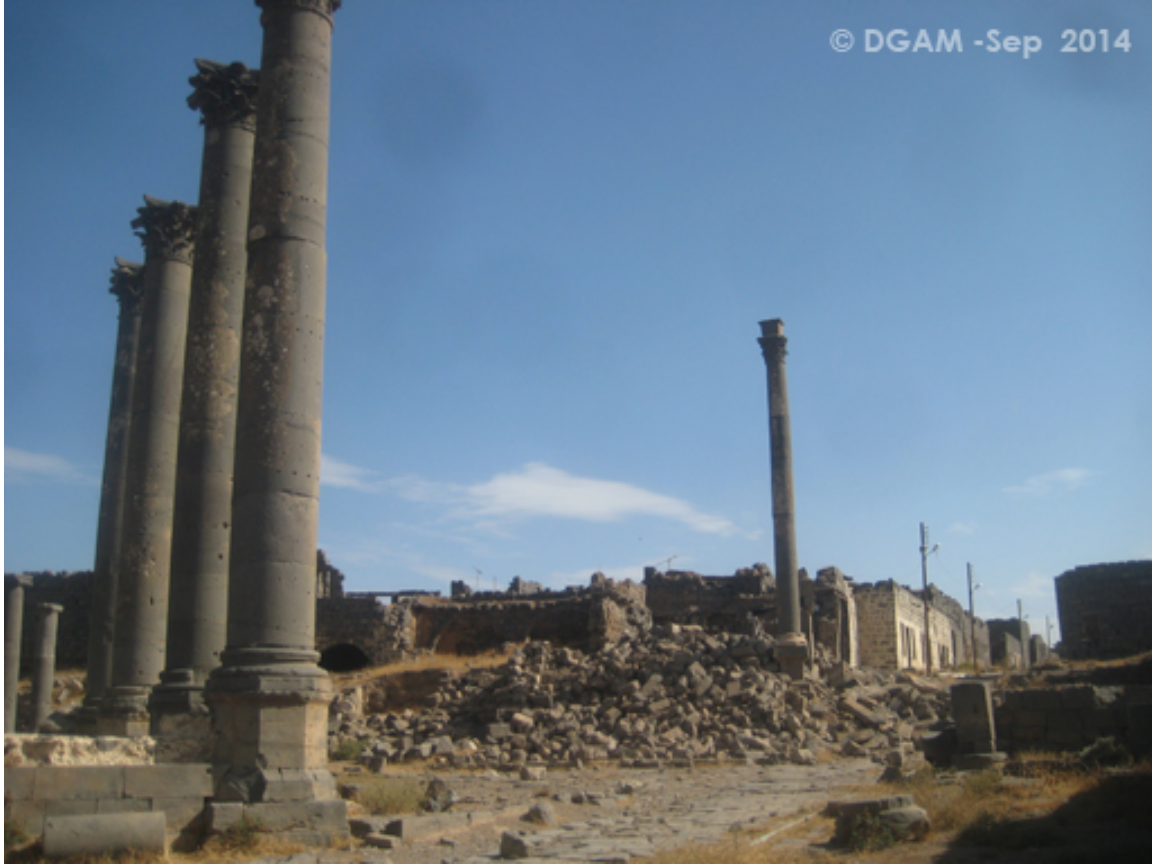
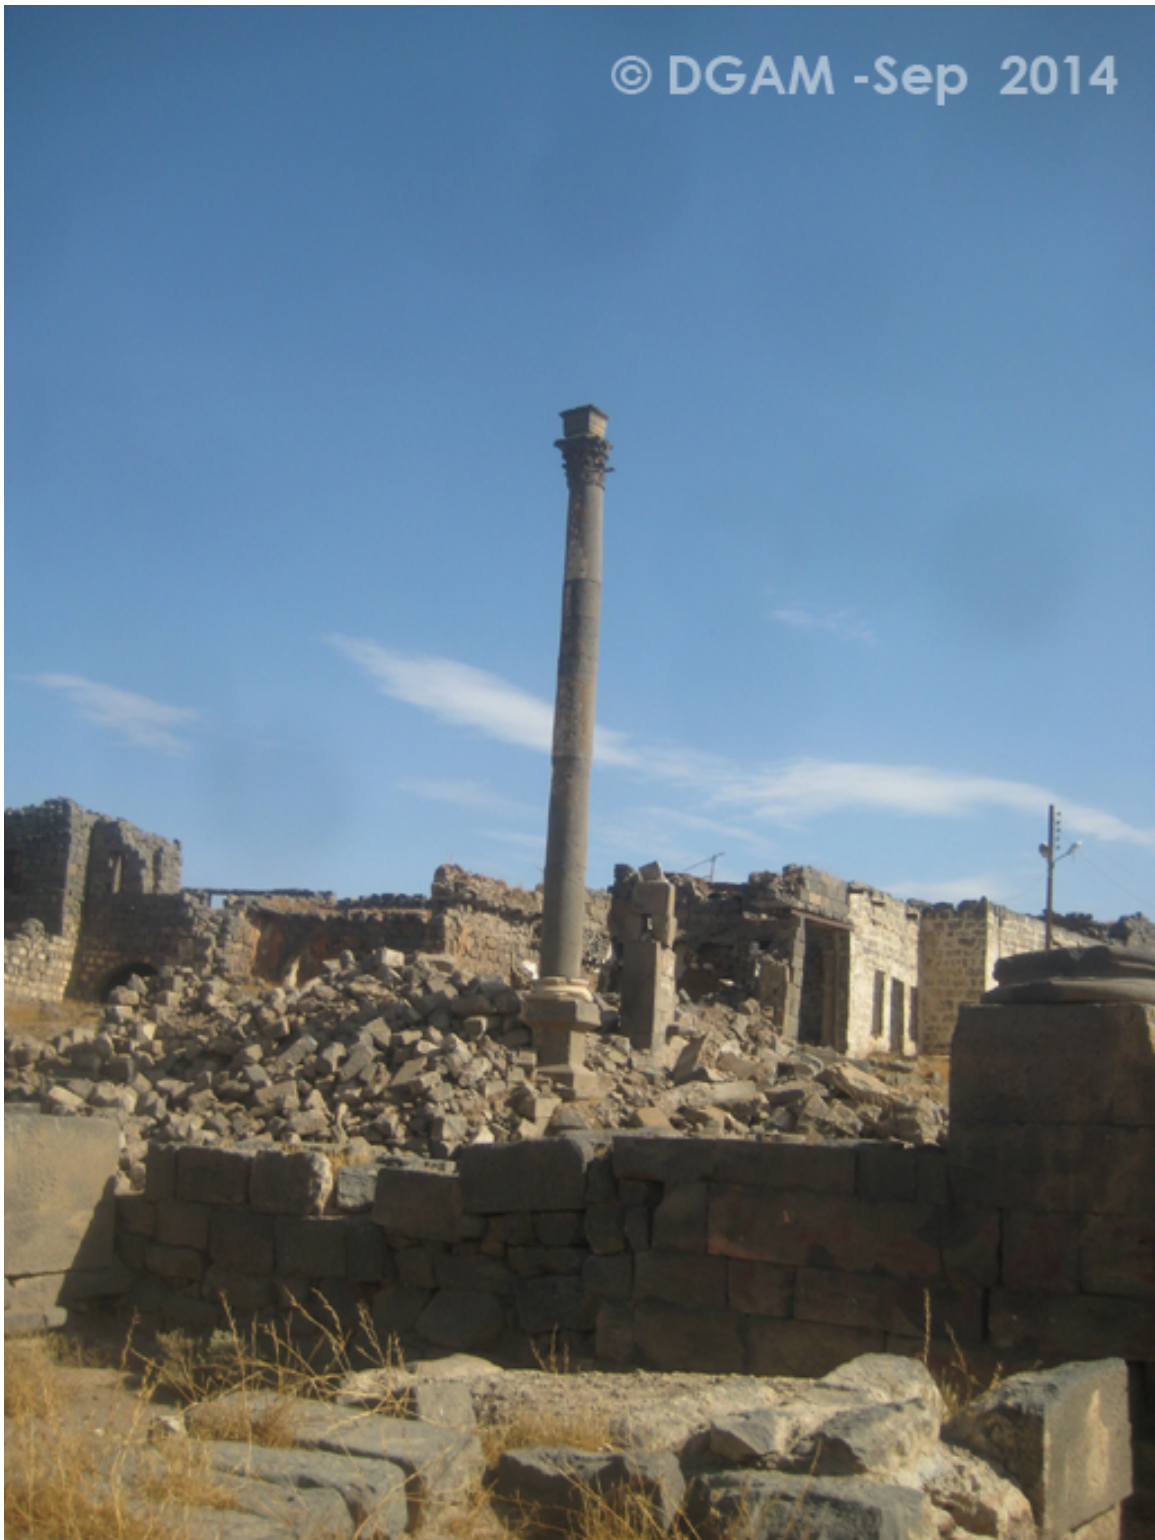
The DGAM reports that most of the architectural elements and the carved friezes have collapsed.

The Kalybe, “Cradle of the King’s Daughter”, or Nymphaeum at Bosra (DGAM)

The Kalybe, "Cradle of the King's Daughter" or Nymphaeum at Bosra (DGAM)

The Kalybe, "Cradle of the King's Daughter," or Nymphaeum at Bosra (DGAM)

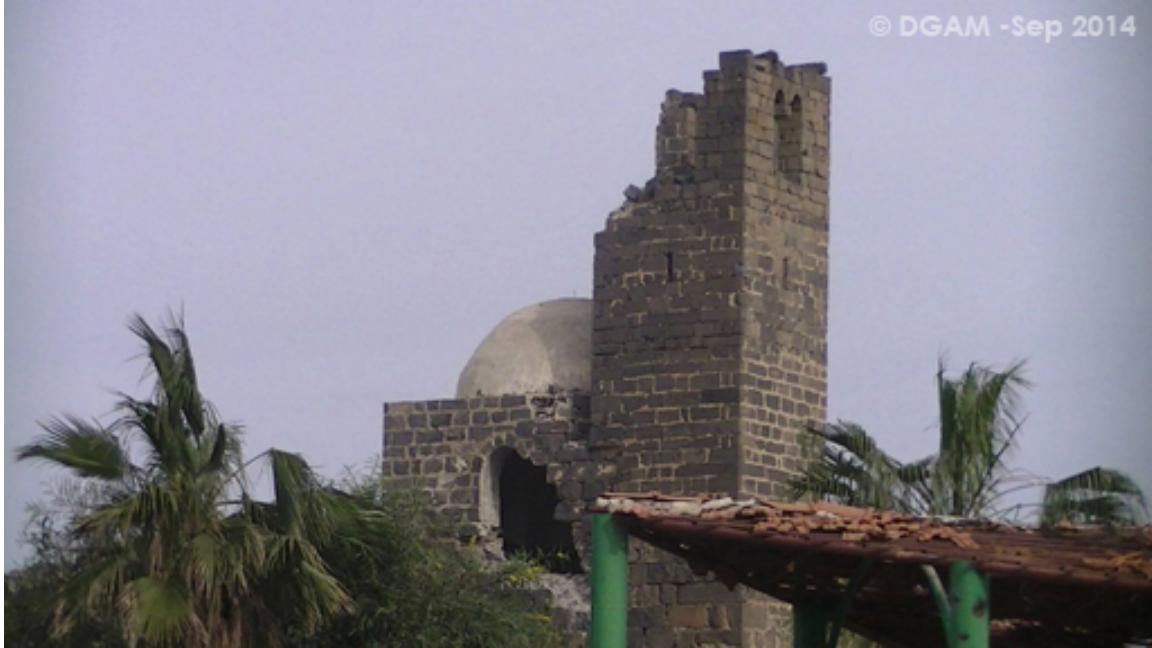
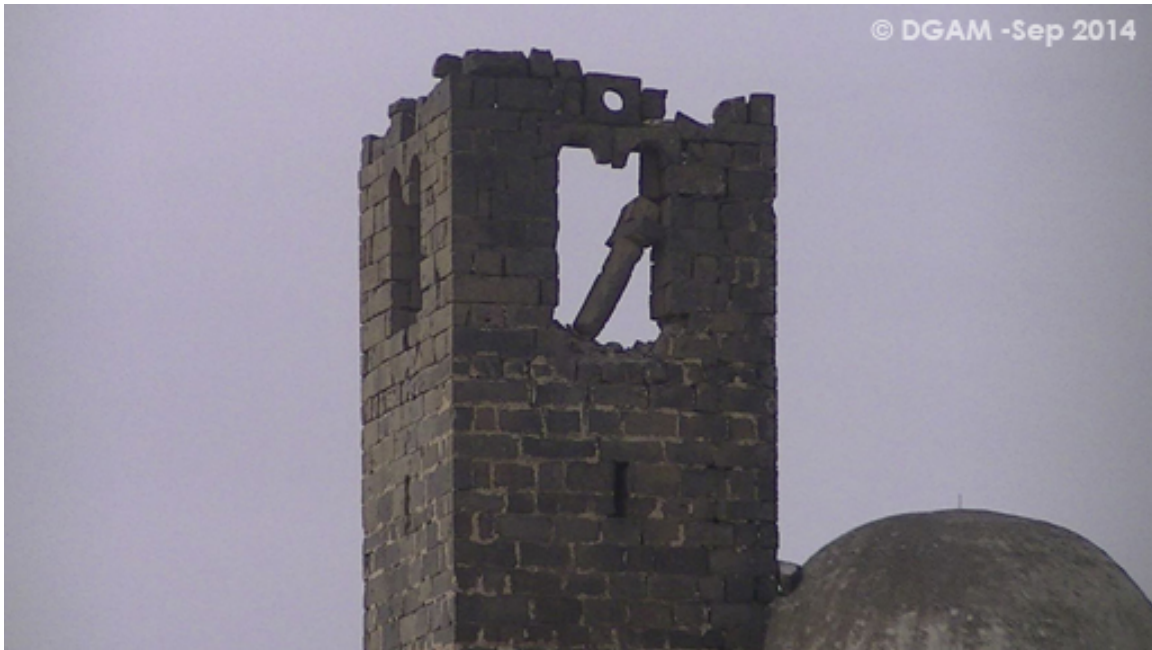
- **Abou al Feda Mosque, Bosra** (Lat. 32.51772, Lon. 36.4829)
The DGAM reports damage to the mosque's interior walls and ceiling, including several collapsed masonry courses in the upper walls south of the minaret.

Abou al Feda Mosque, Bosra (DGAM)

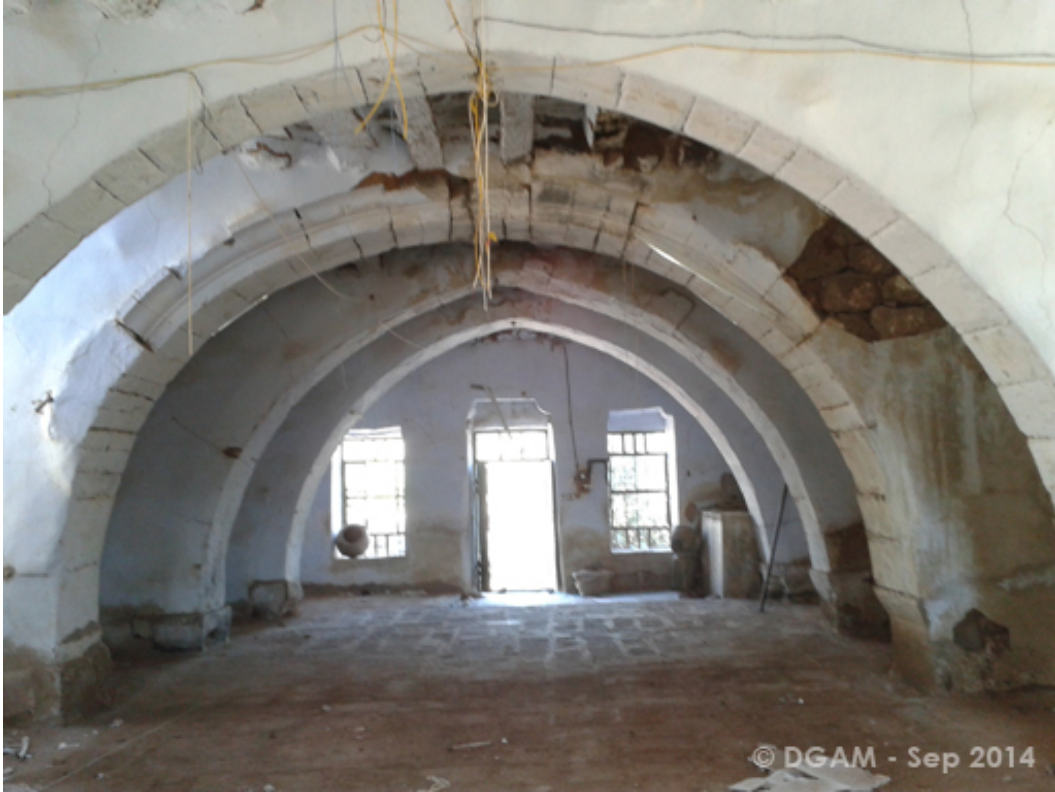
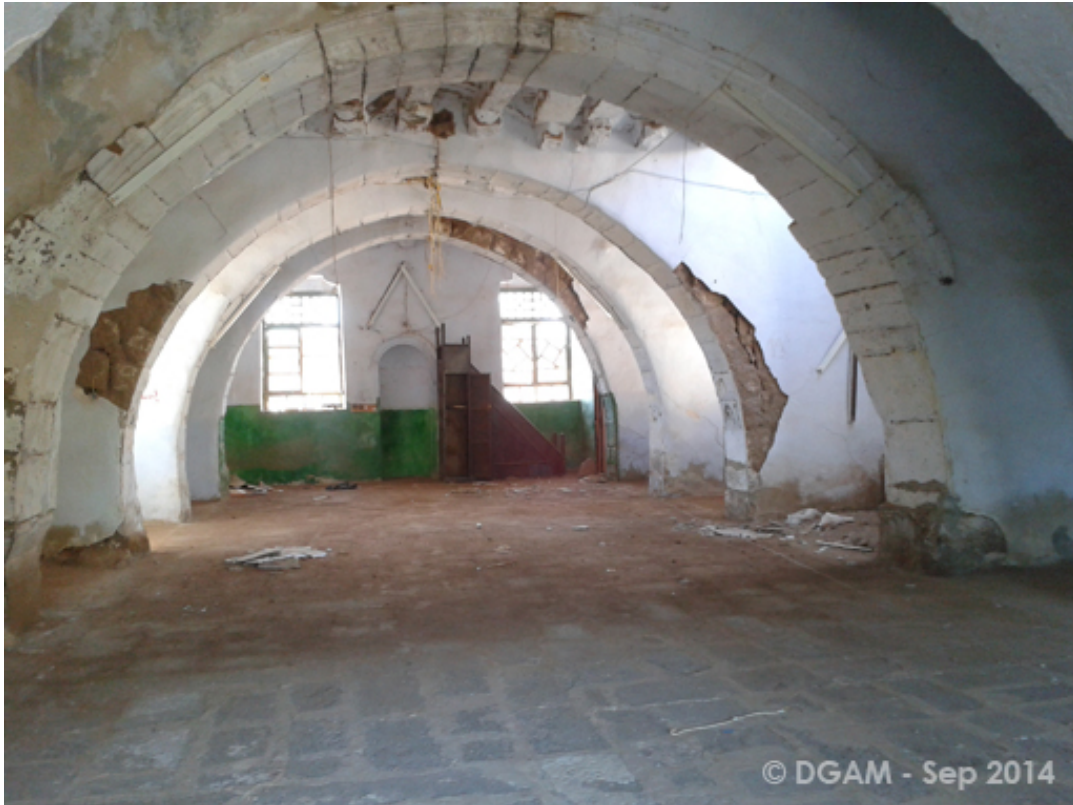
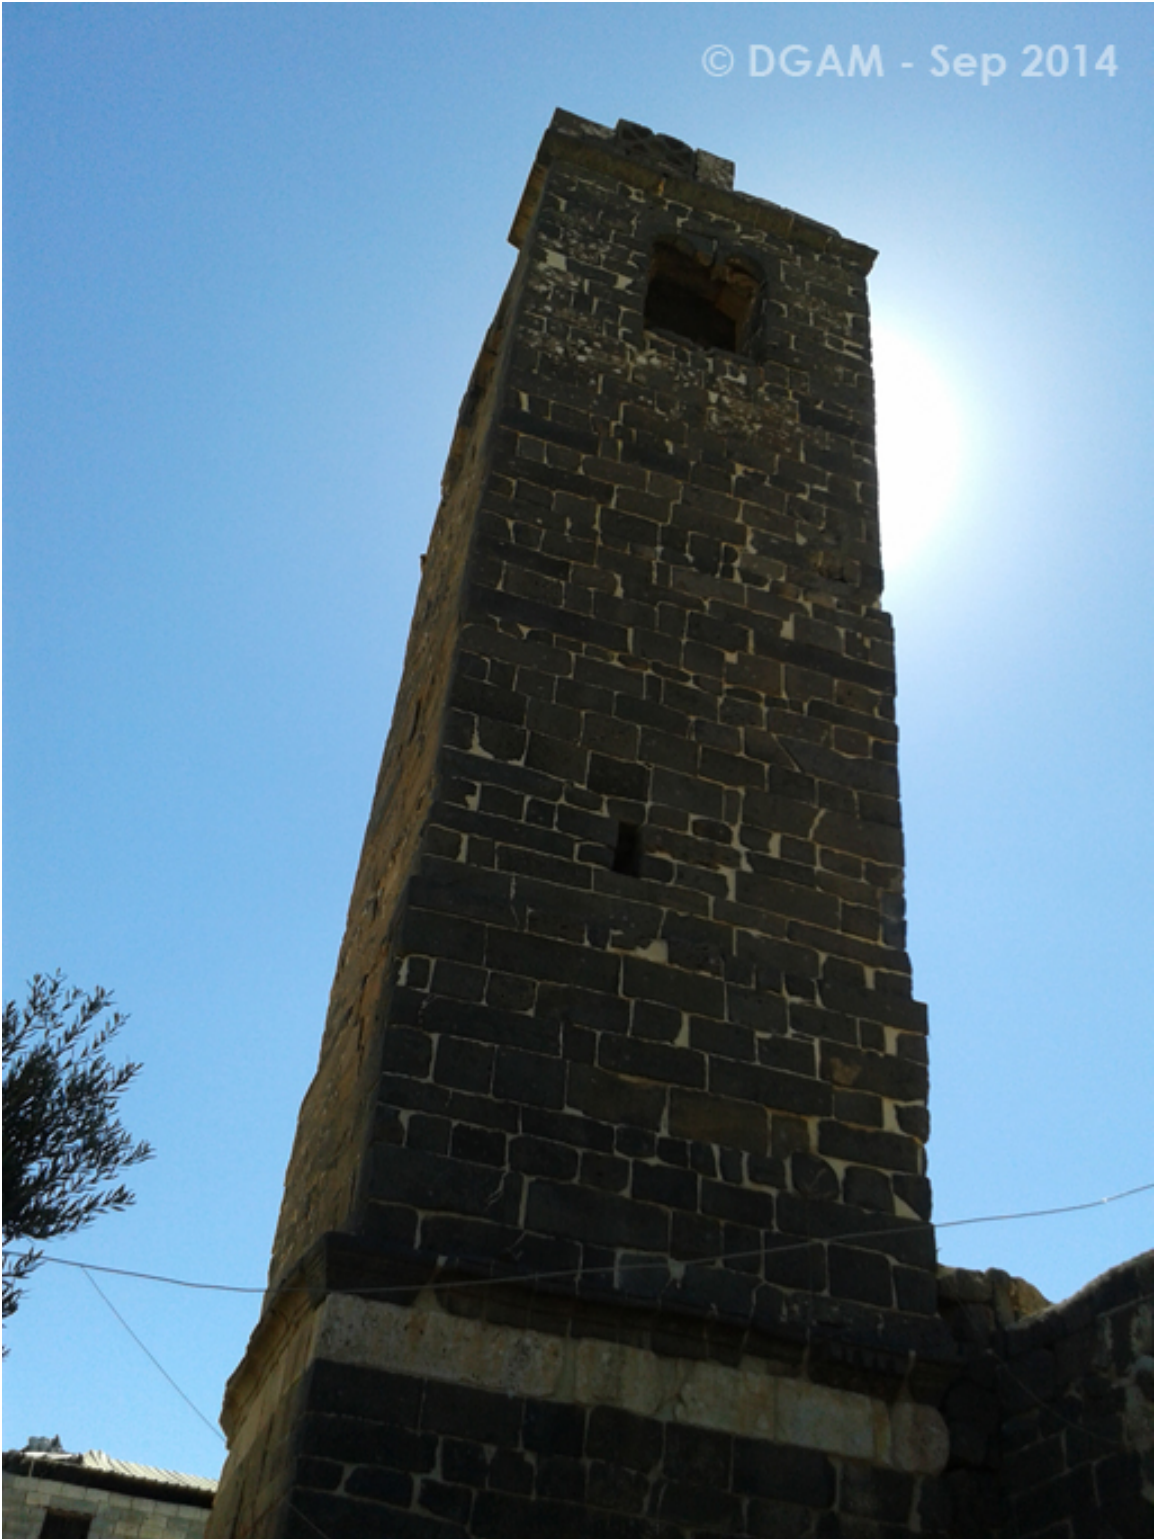
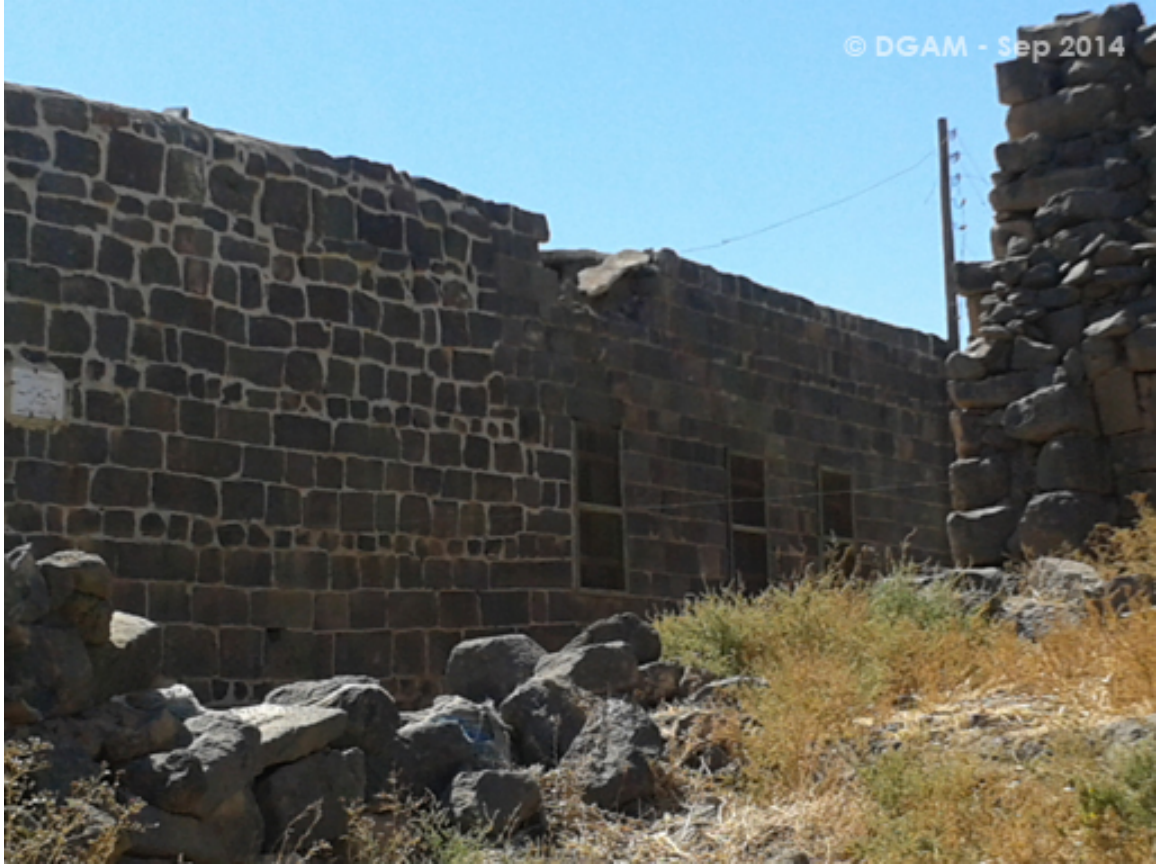
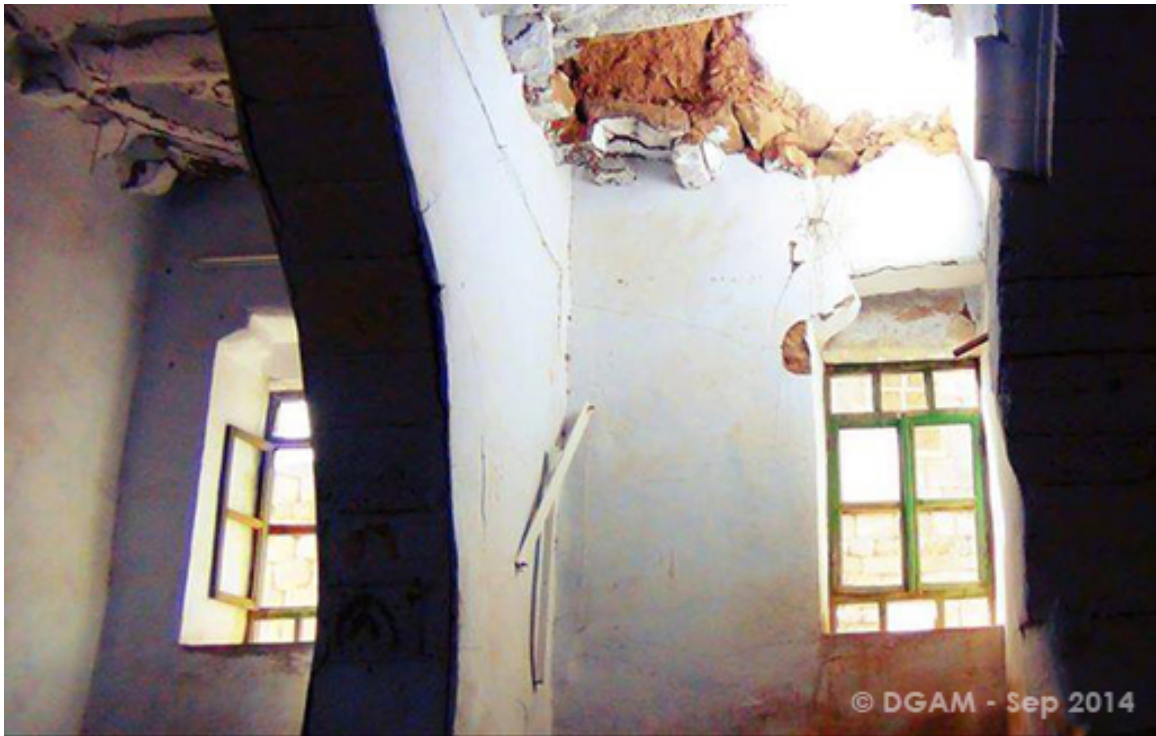
The DGAM reports that the southwestern ceiling and the small columns that decorated the minarets were damaged. Several stones over the north arches have collapsed.

Fatima Mosque, Bosra (DGAM)

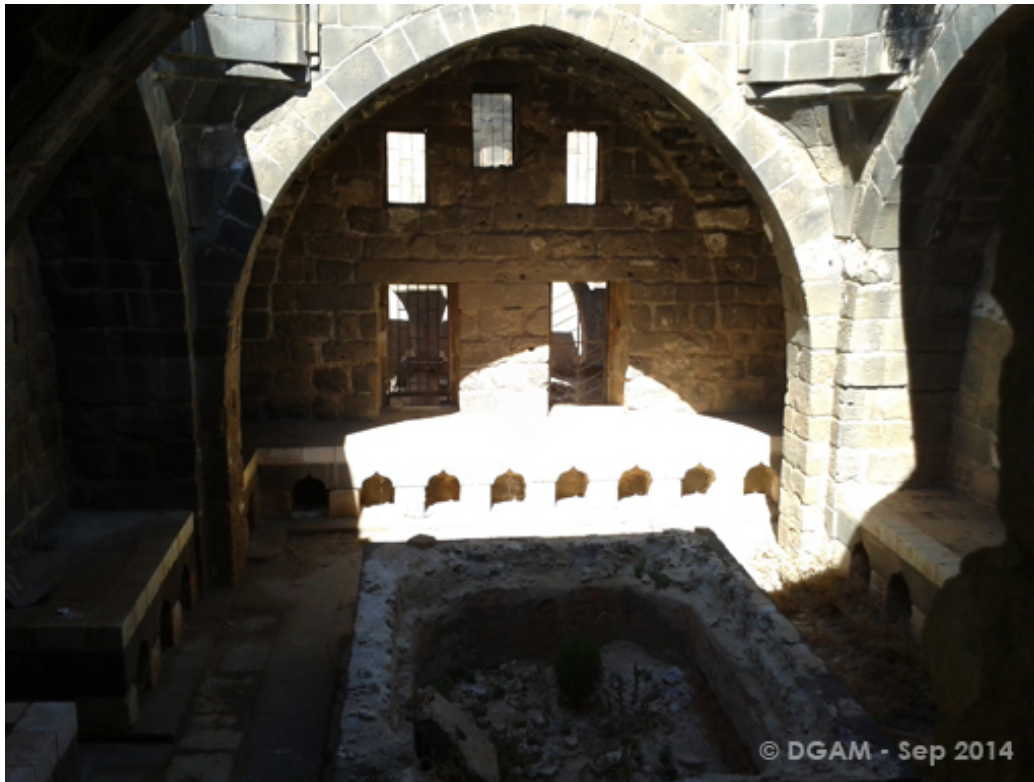
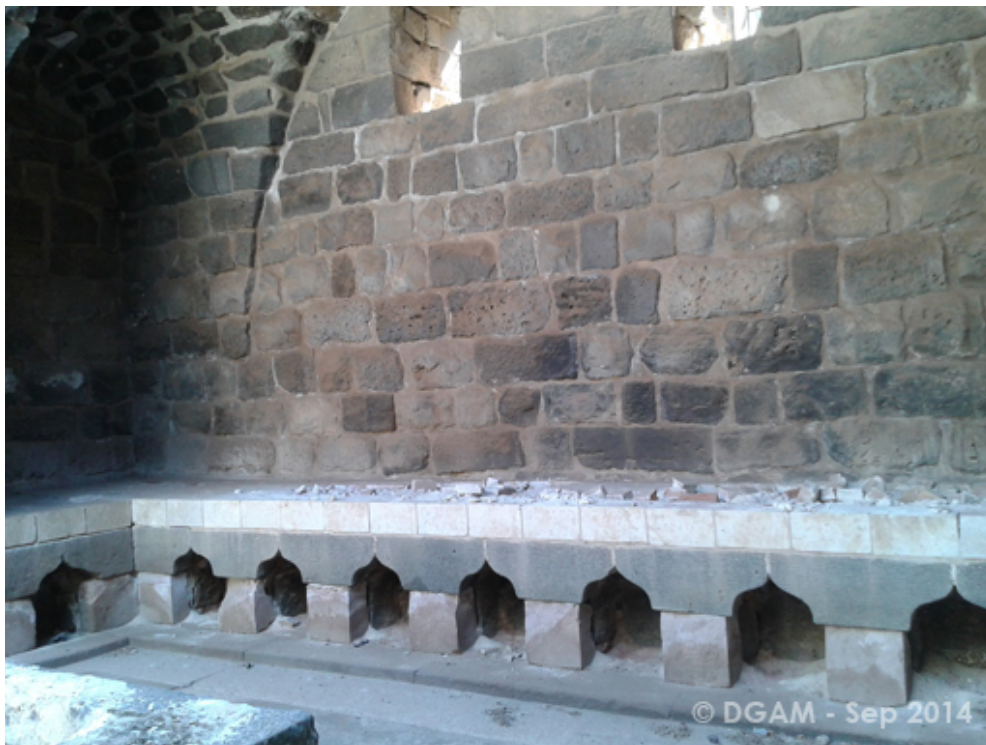
The brick that previously covered the water fountain in the reception room has been removed.

Manjak Hamam, Bosra (DGAM)

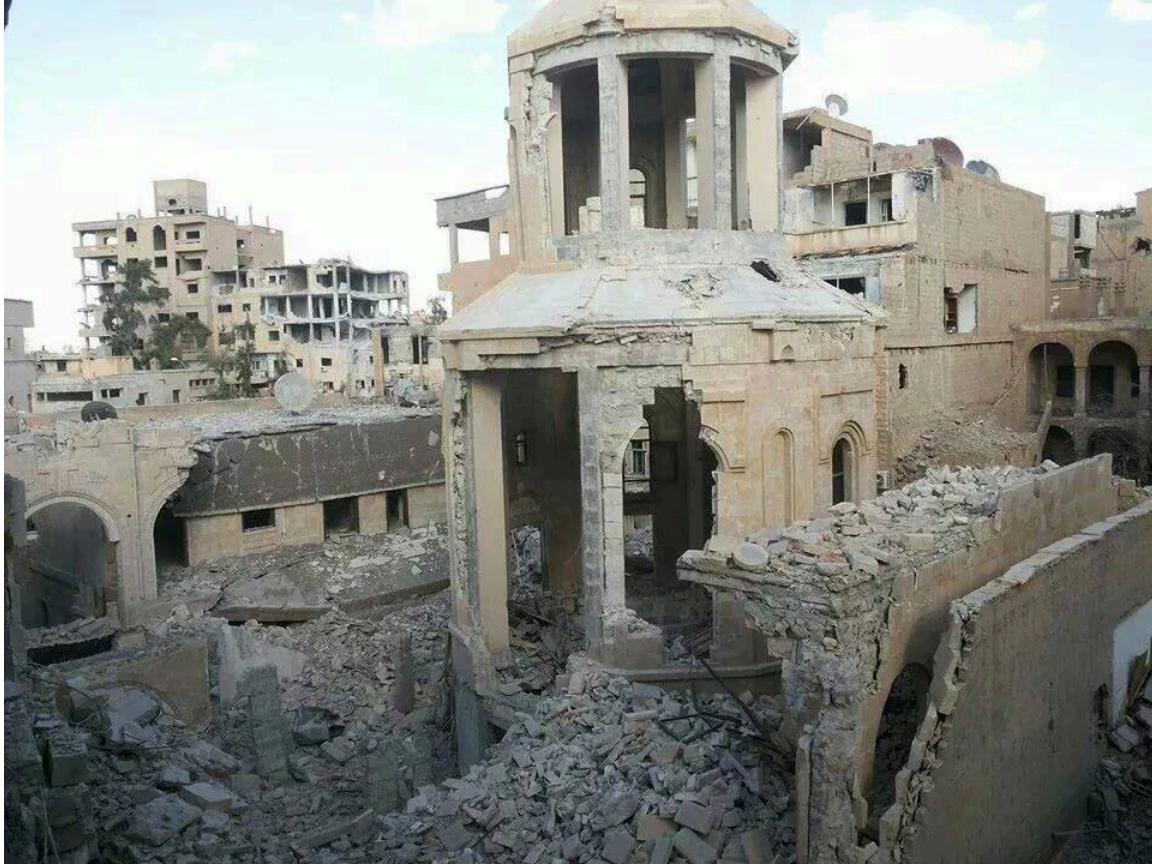
Source of Destruction: Verified intentional destruction by Islamic State militants. Various news agencies reported that IS destroyed the church by packing it with explosives. Islamic State has carried out similar intentional destructions in northern Iraq and northern Syria on historic and modern monuments and buildings as well as ancient artifacts.

Destruction of the Armenian Genocide Church in Deir ez-Zor (Armenian Weekly)
