# ASOR Syrian Heritage Initiative (SHI): Planning for Safeguarding Heritage Sites in Syria<sup>1</sup>

NEA-PSHSS-14-001

Weekly Report 13 – November 3, 2014

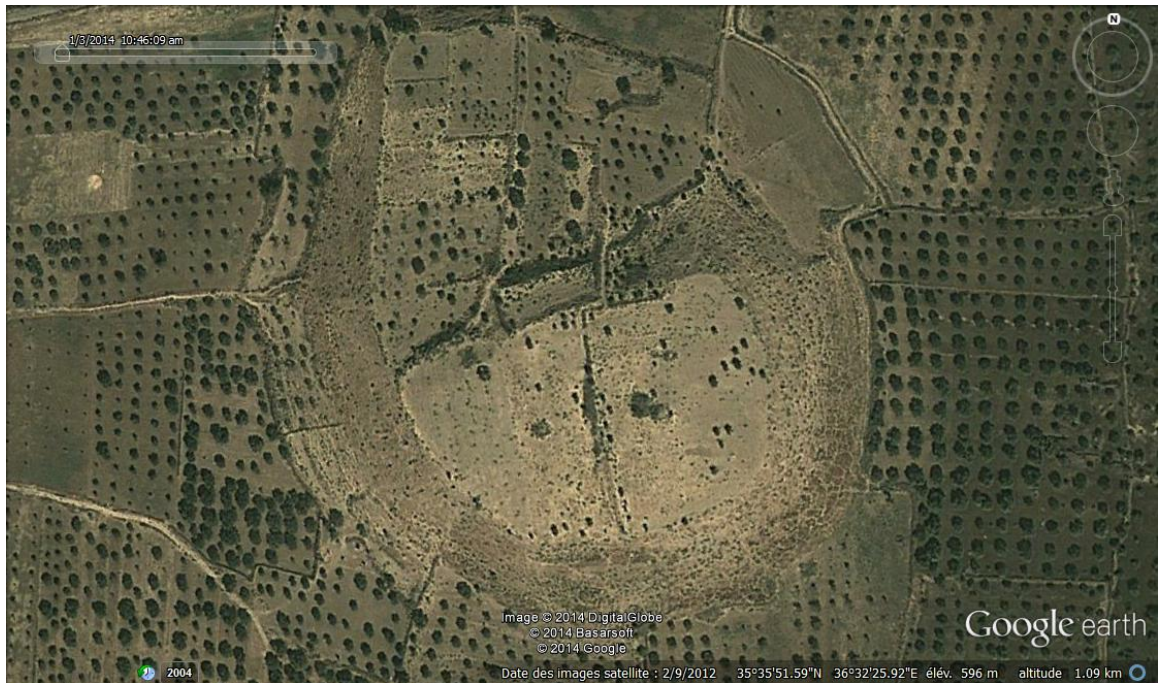
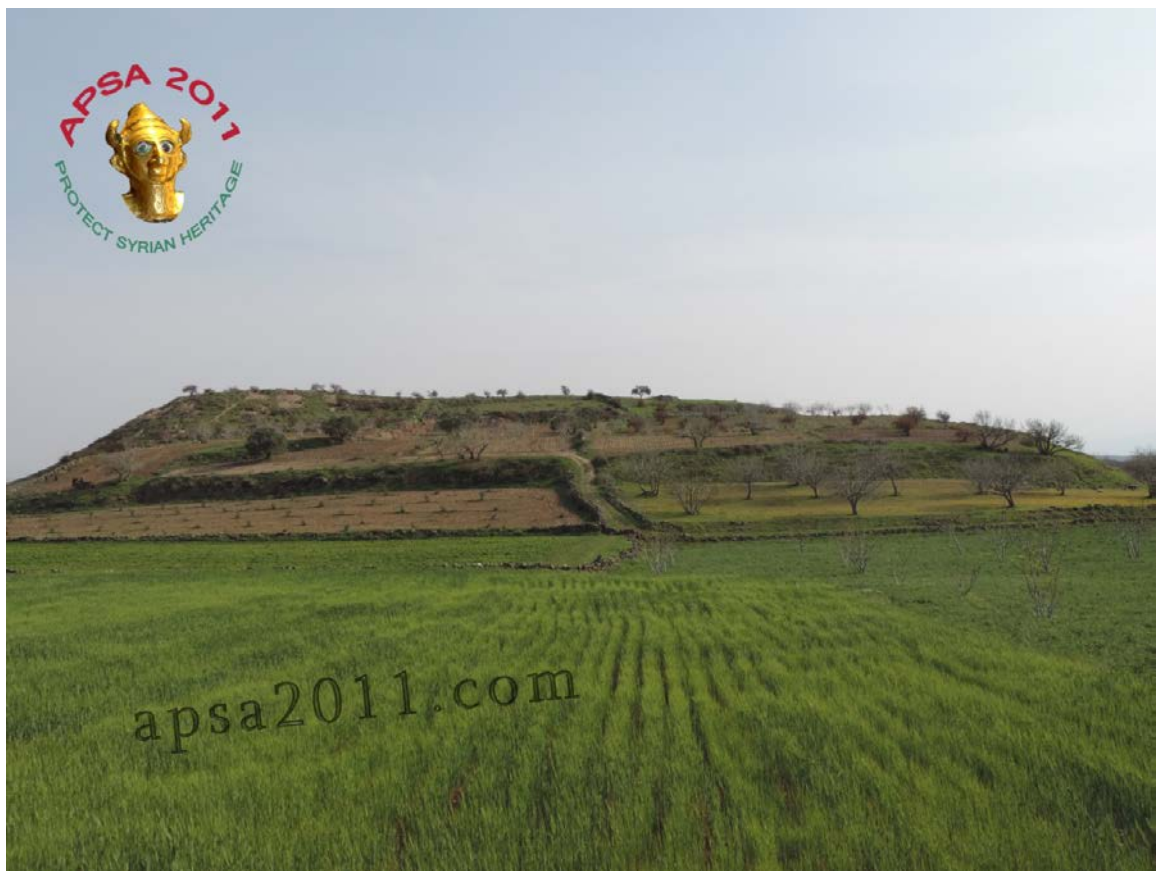
**Source of Destruction:** Based on a recent site visit by APSA, the site of Tell Hizareen has been subject to extensive illegal excavations. Numerous looters have been using metal detectors to explore the site, while more than fifty pits have been dug in different parts of the site. Looters have unearthed potsherds and terracotta figurines from multiple time periods.

Tell Hizareen (Google Earth)

Tell Hizareen (APSA)

**Monitoring Recommendations and Mitigation Measures:** SHI may request new satellite imagery of the mound as well as neighboring sites. This pattern of looting with metal detectors is reportedly widespread across Syria.

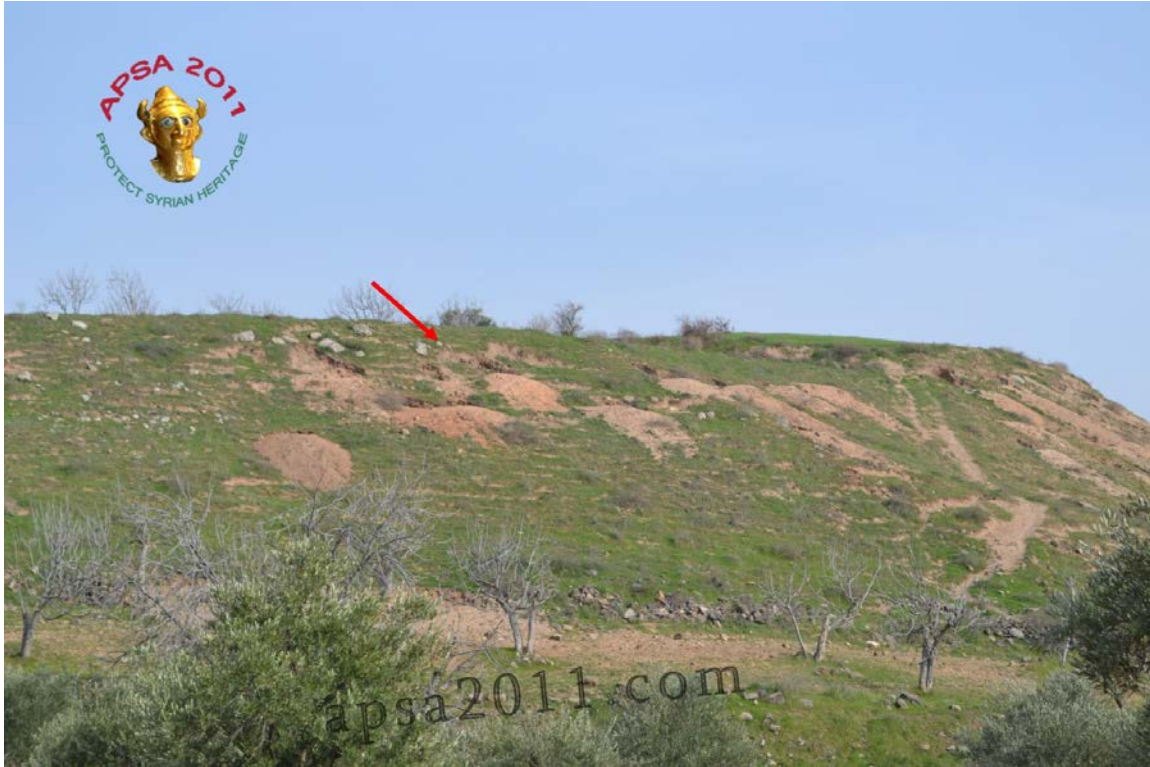
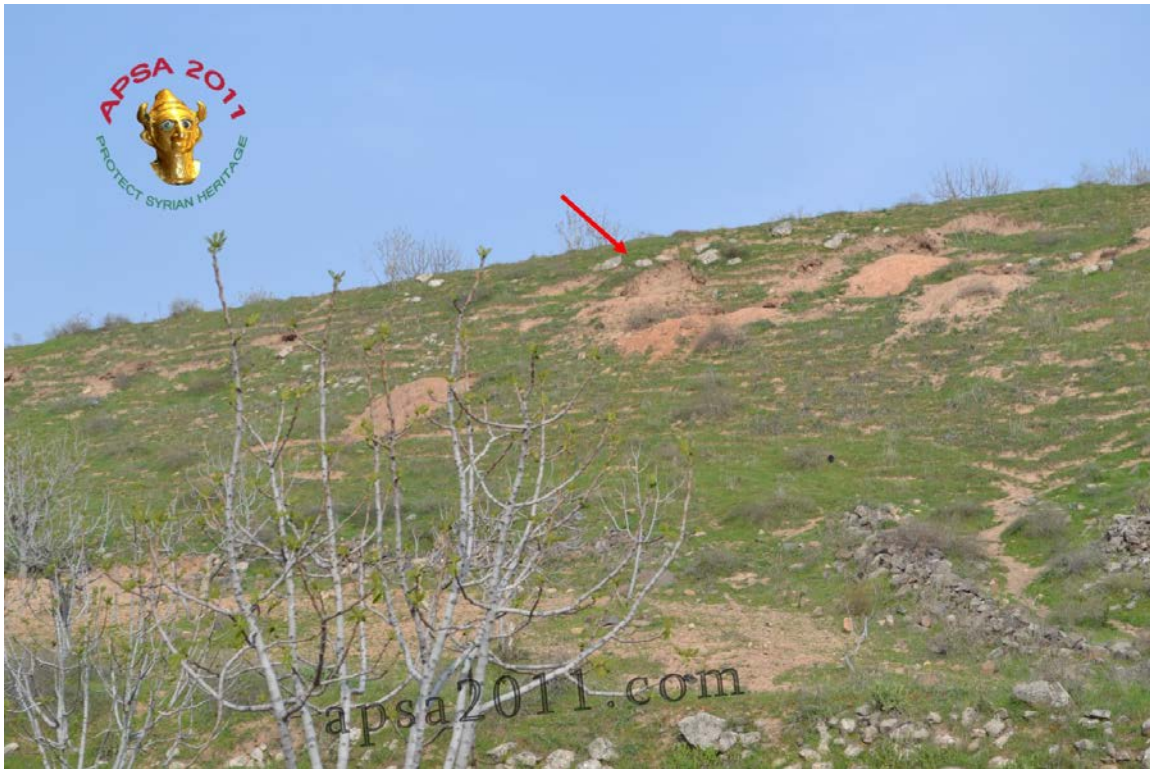
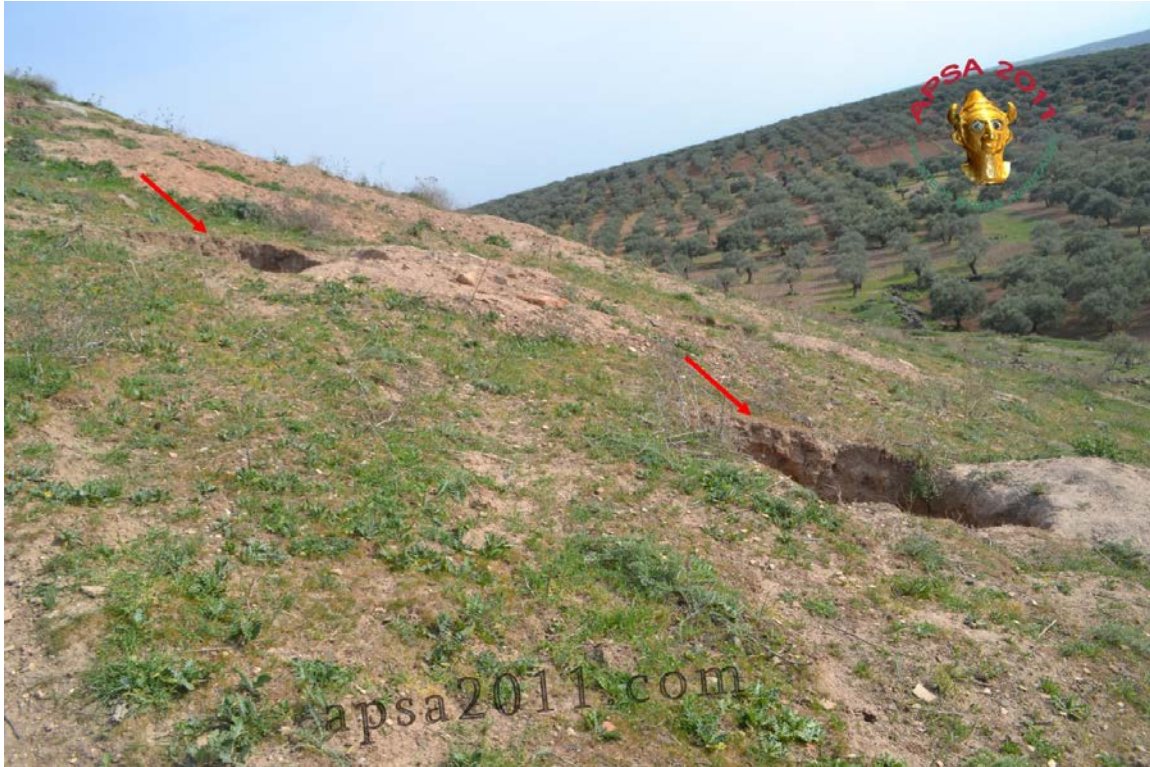
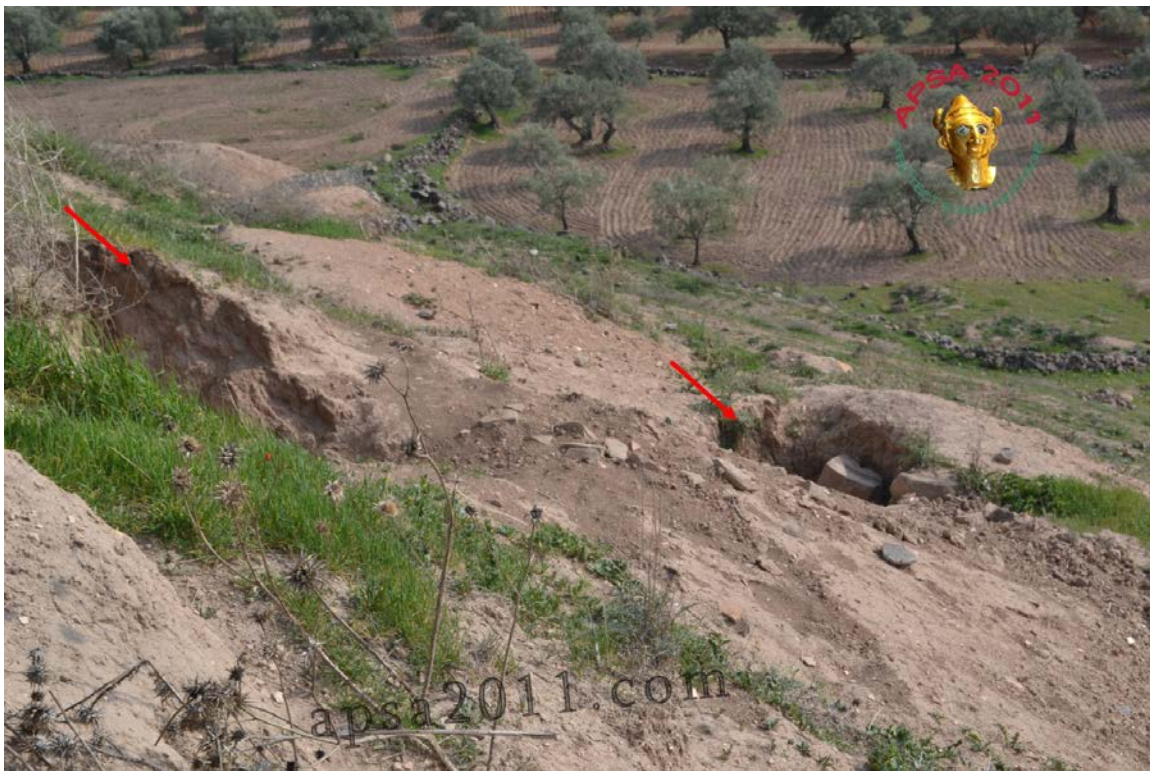
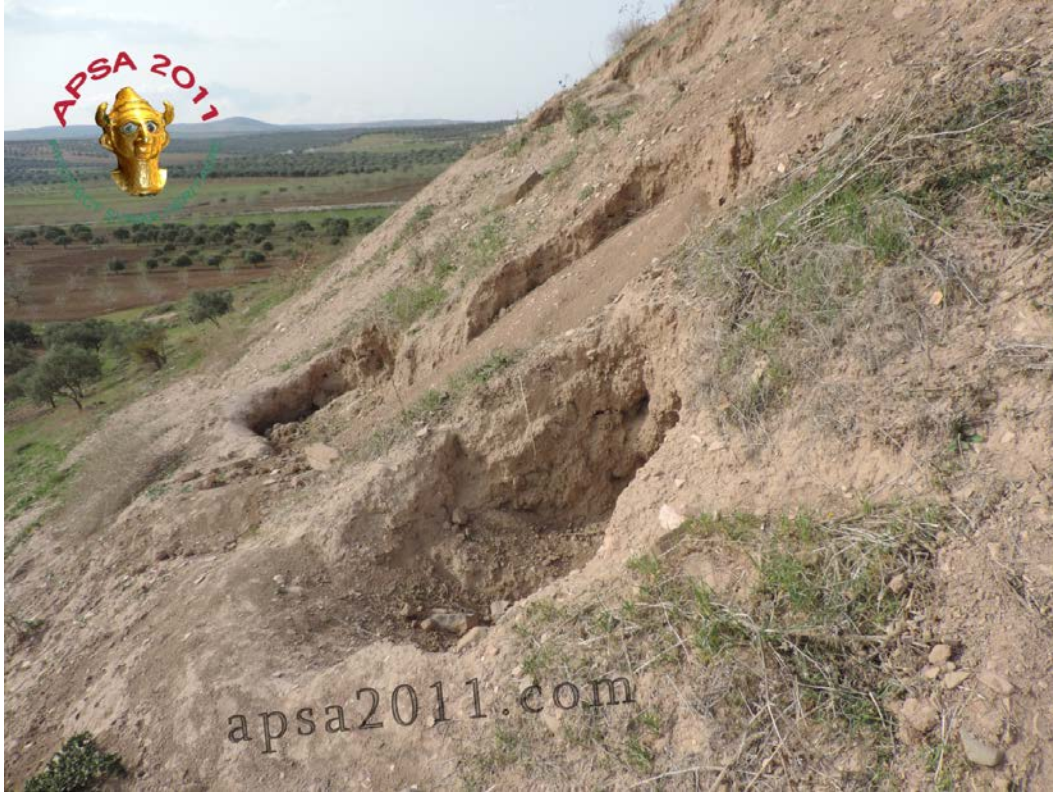
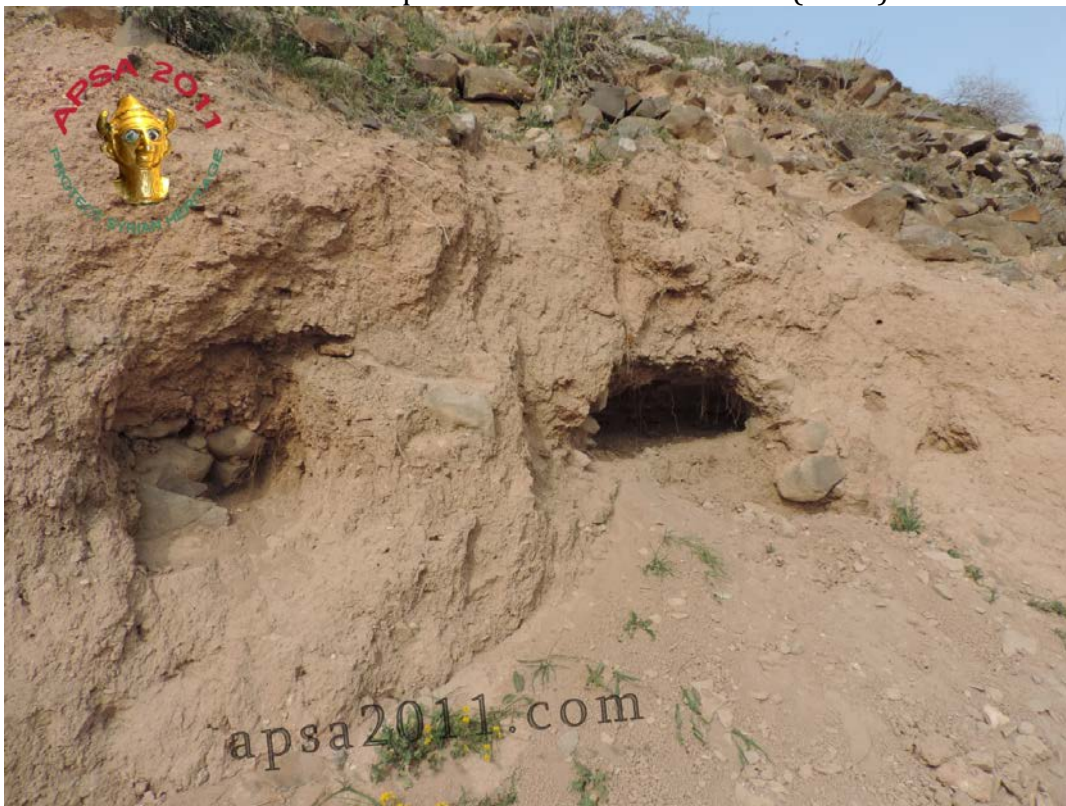
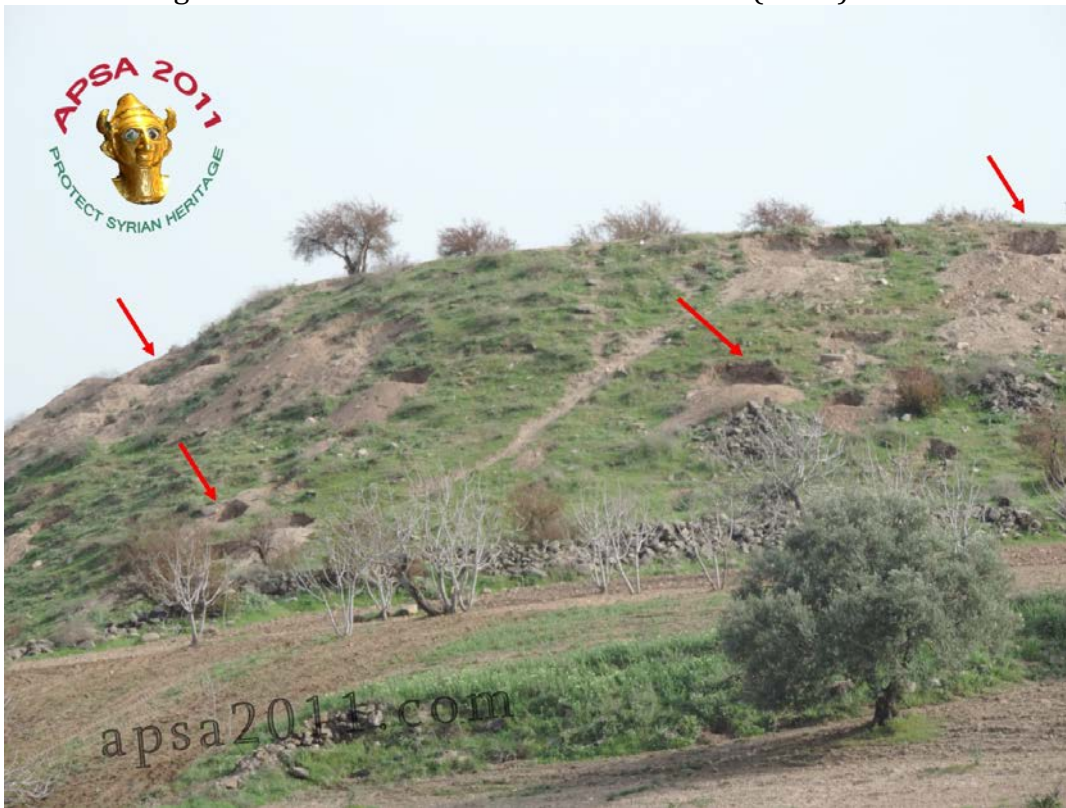
Looter excavations on the slopes of Tell Hizareen in 2014 (APSA).

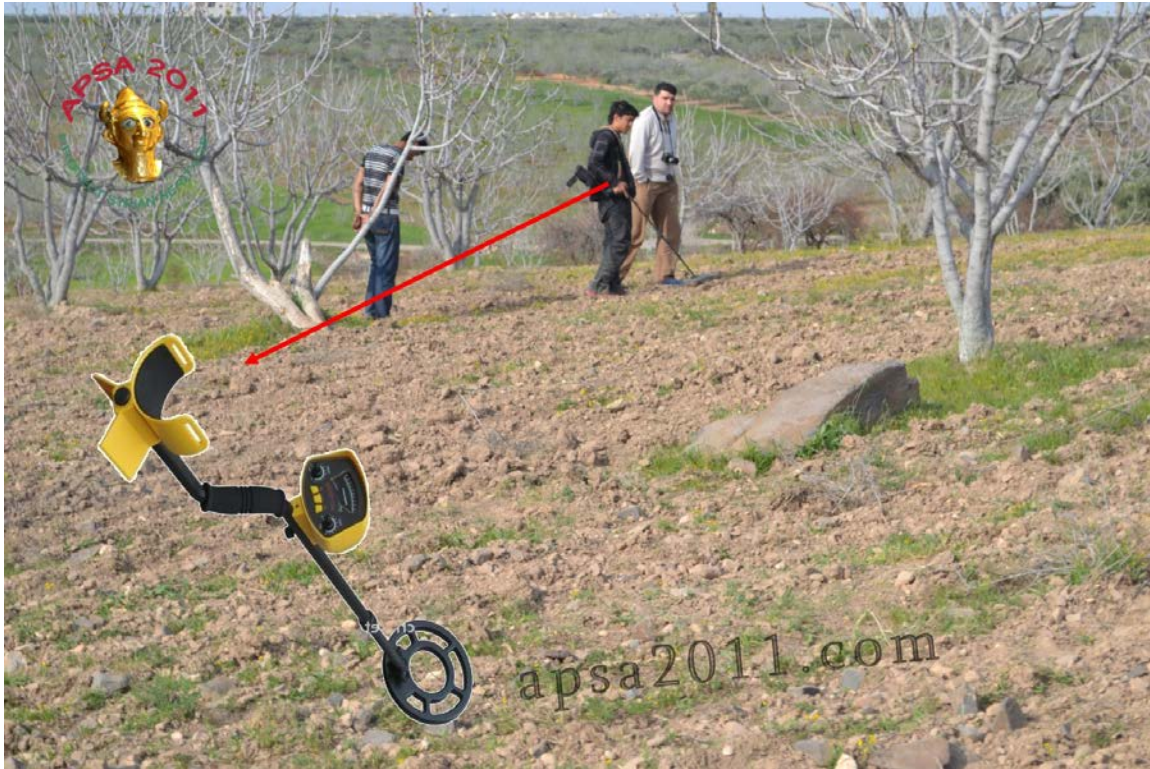
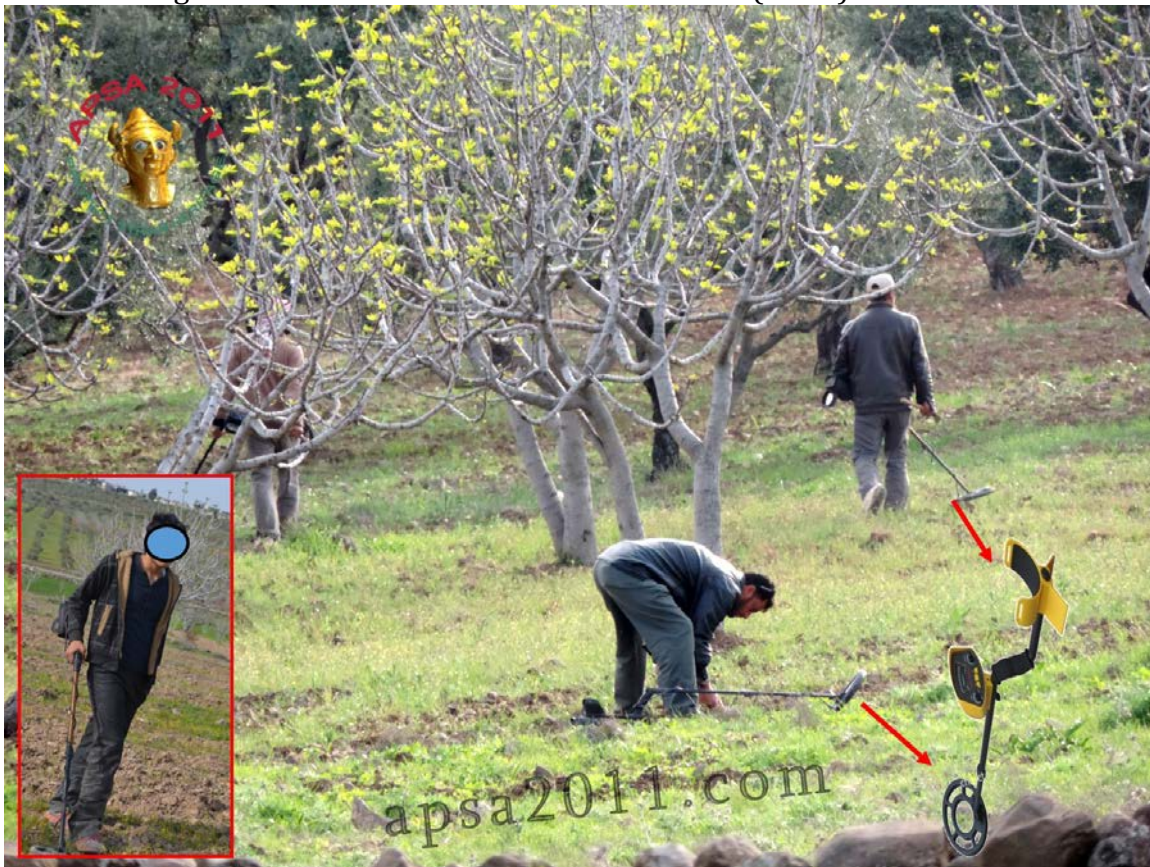
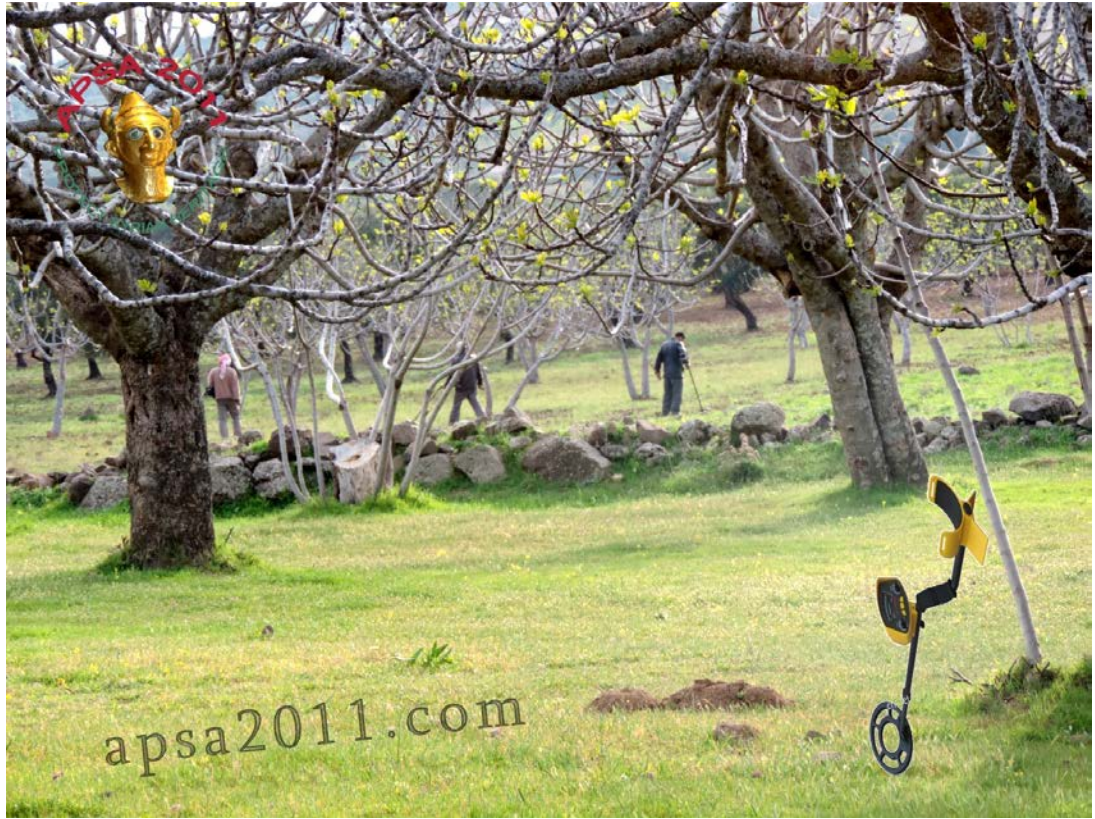
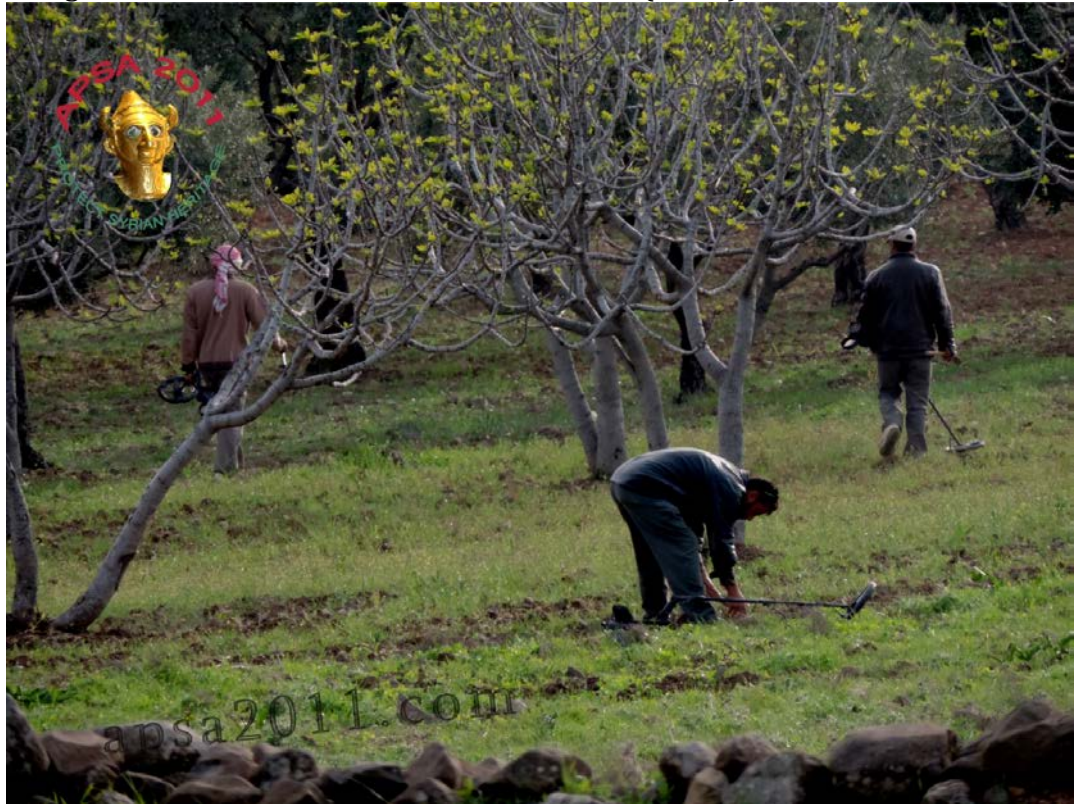
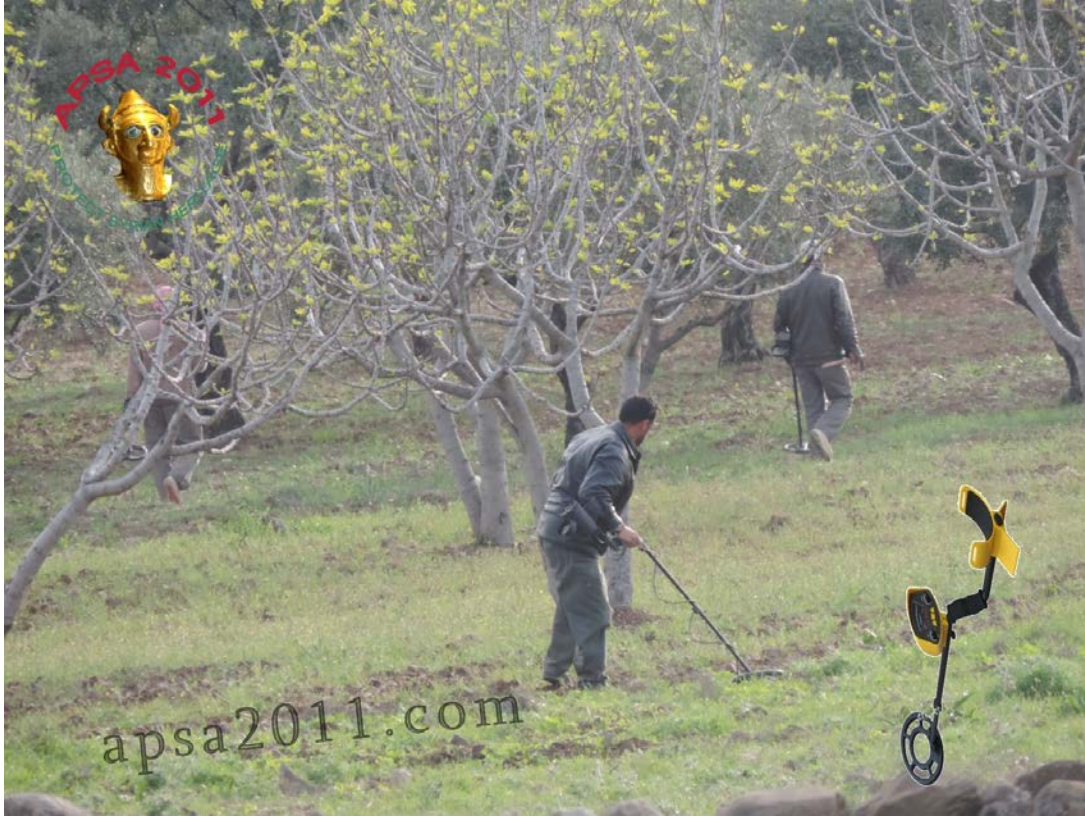
- 2) There is now clear evidence of the looting of sites using metal detectors given the recent APSA report on Tell Hizareen.

Looters using metal detectors at Tell Hizareen in 2014 (APSA).

\*Monitoring groups should focus on investigating whether there is an upsurge in the marketing of metal artifacts of probable Syrian provenance.
