# ASOR Syrian Heritage Initiative (SHI): Planning for Safeguarding Heritage Sites in Syria<sup>1</sup>

NEA-PSHSS-14-001

Weekly Report 13 – November 3, 2014

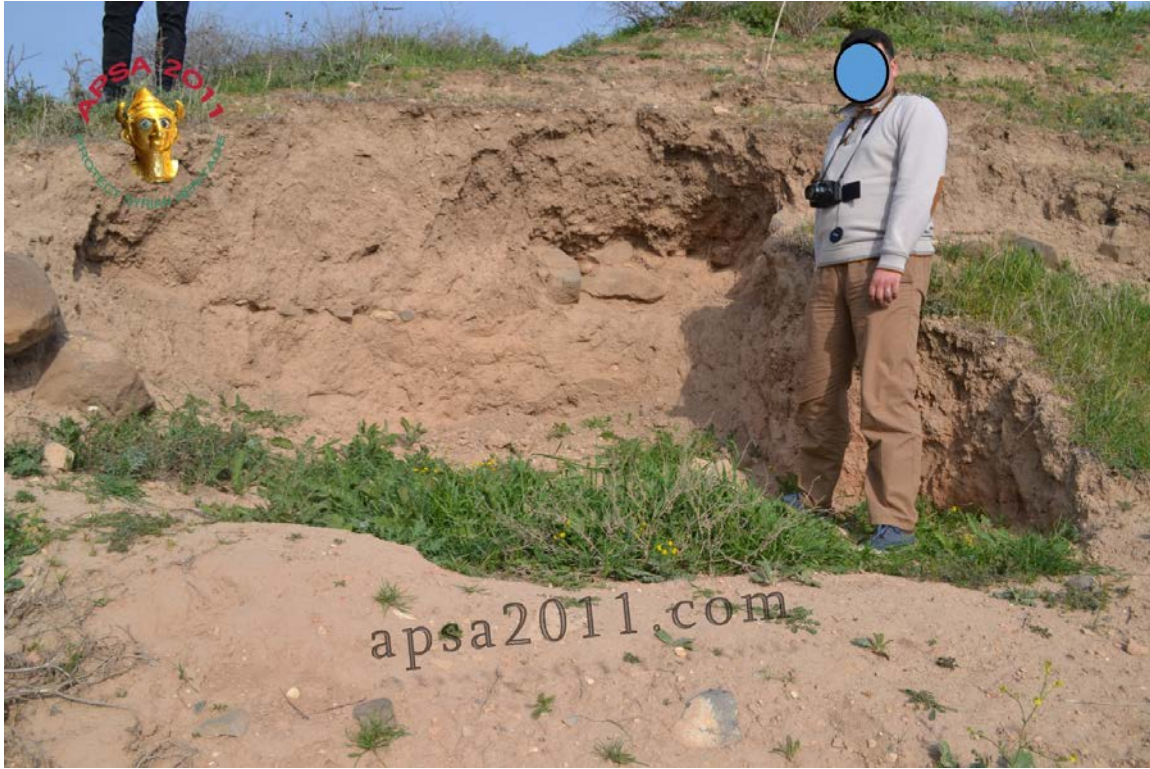
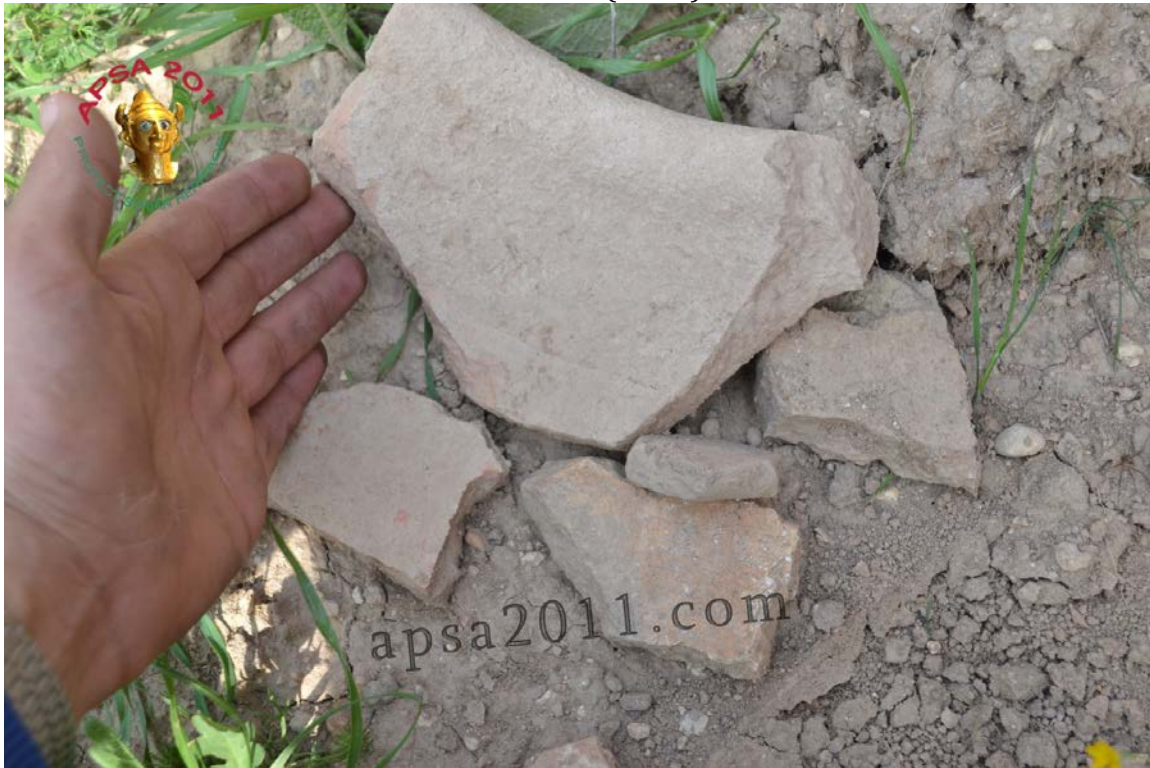
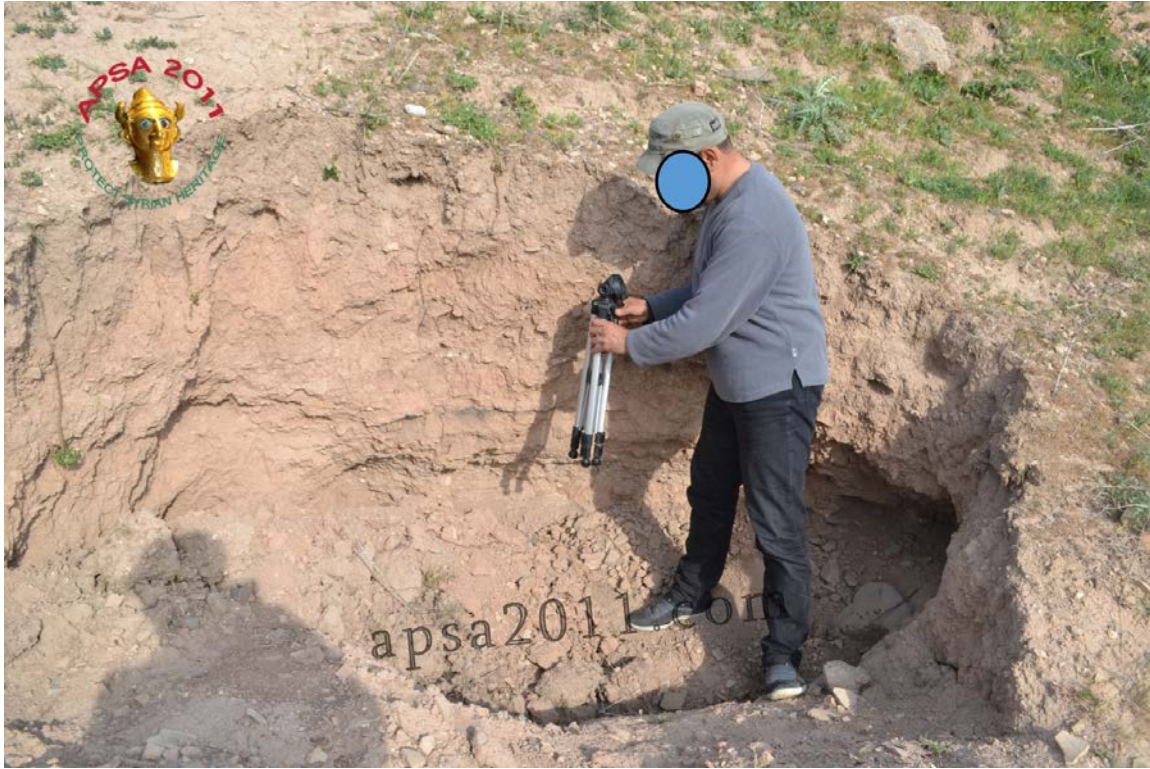
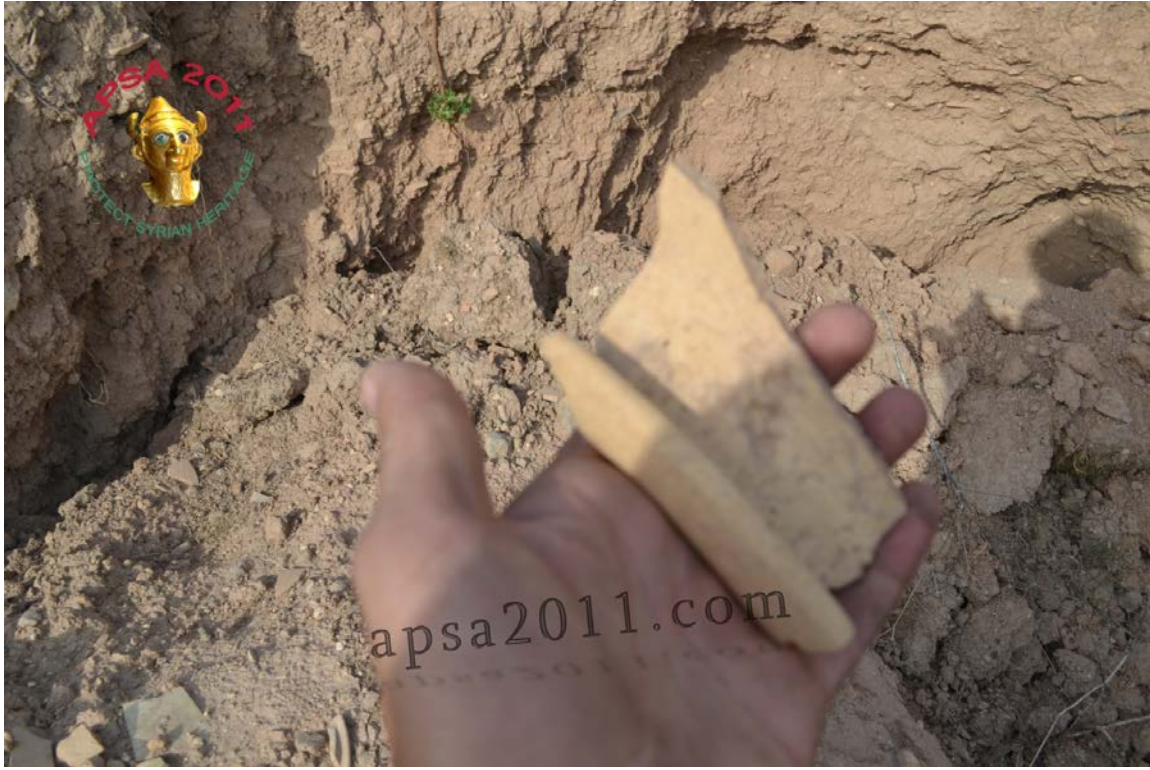
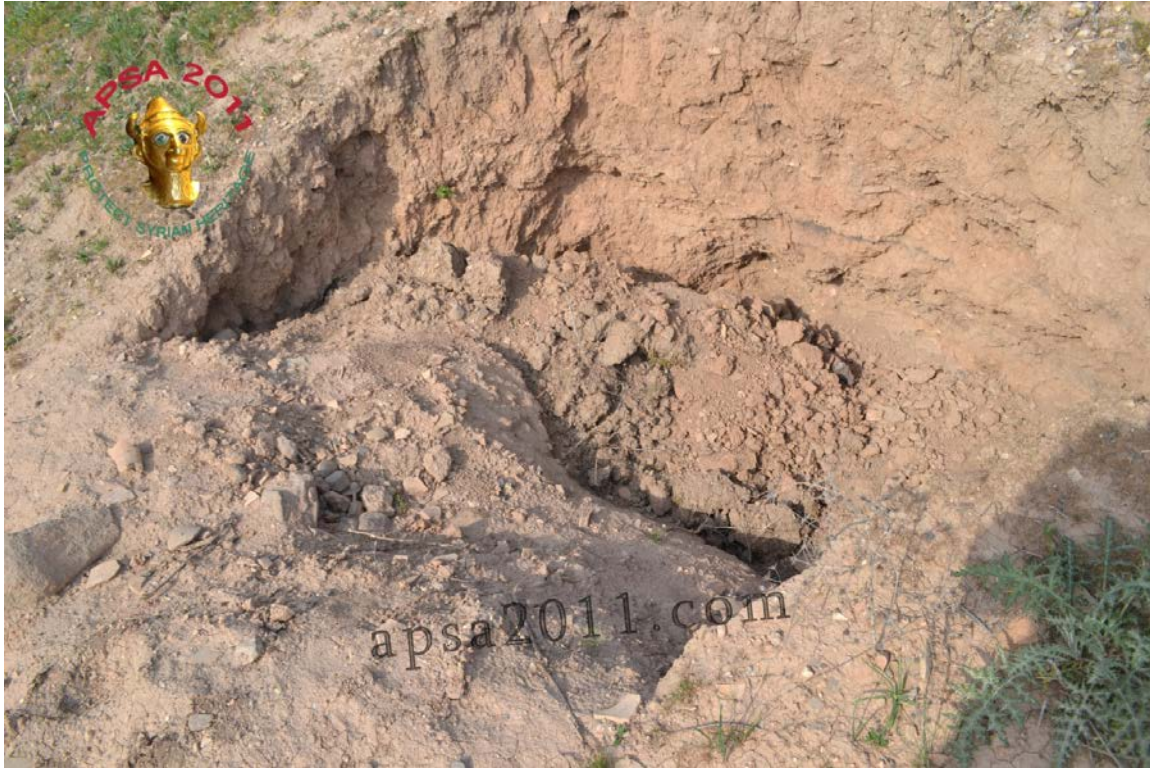
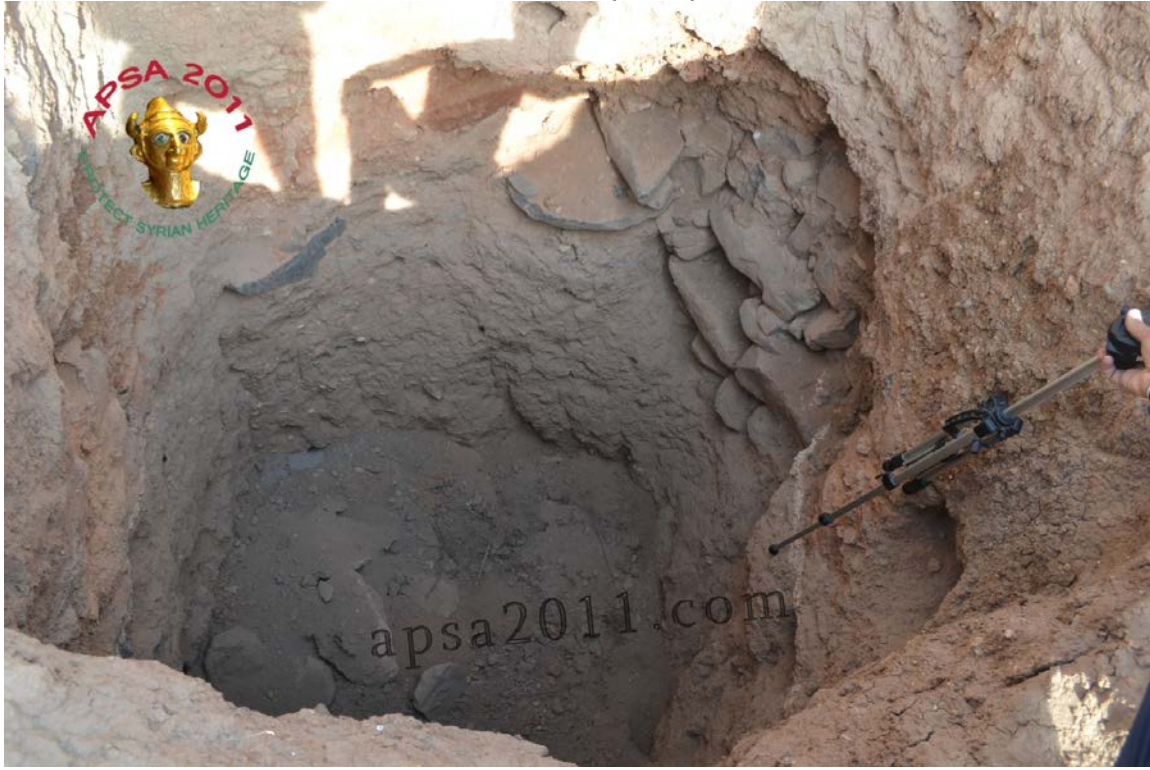
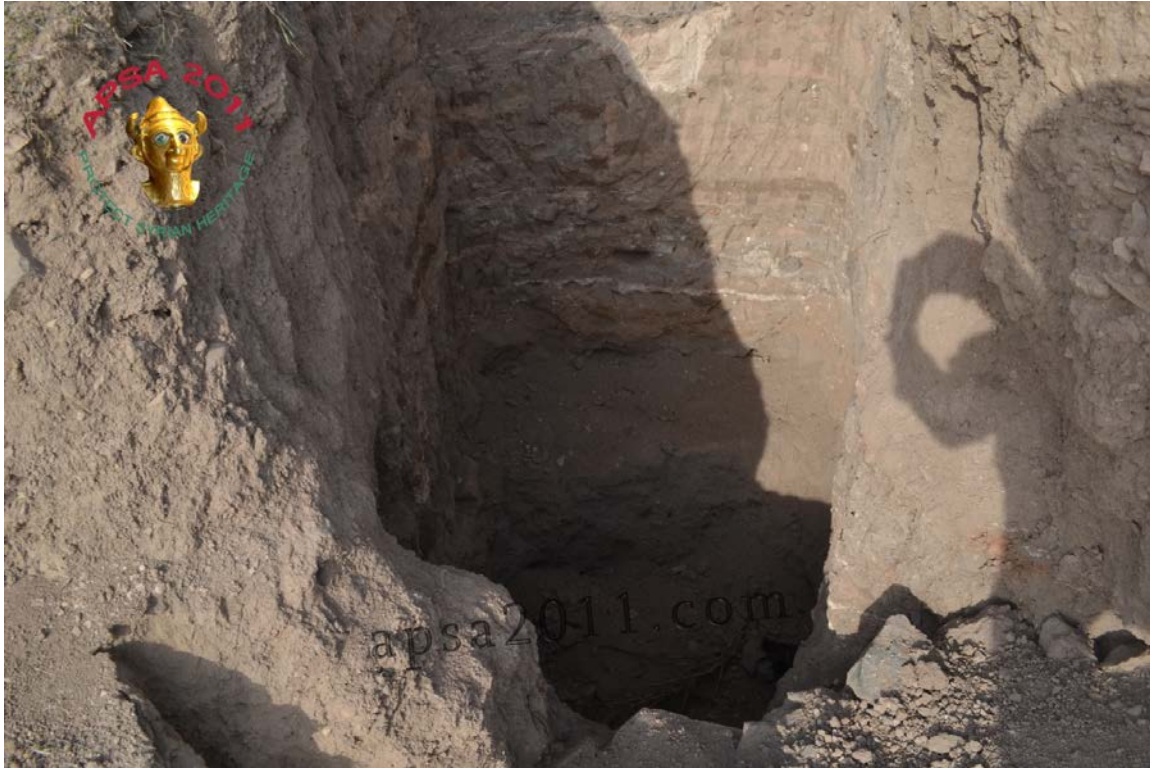
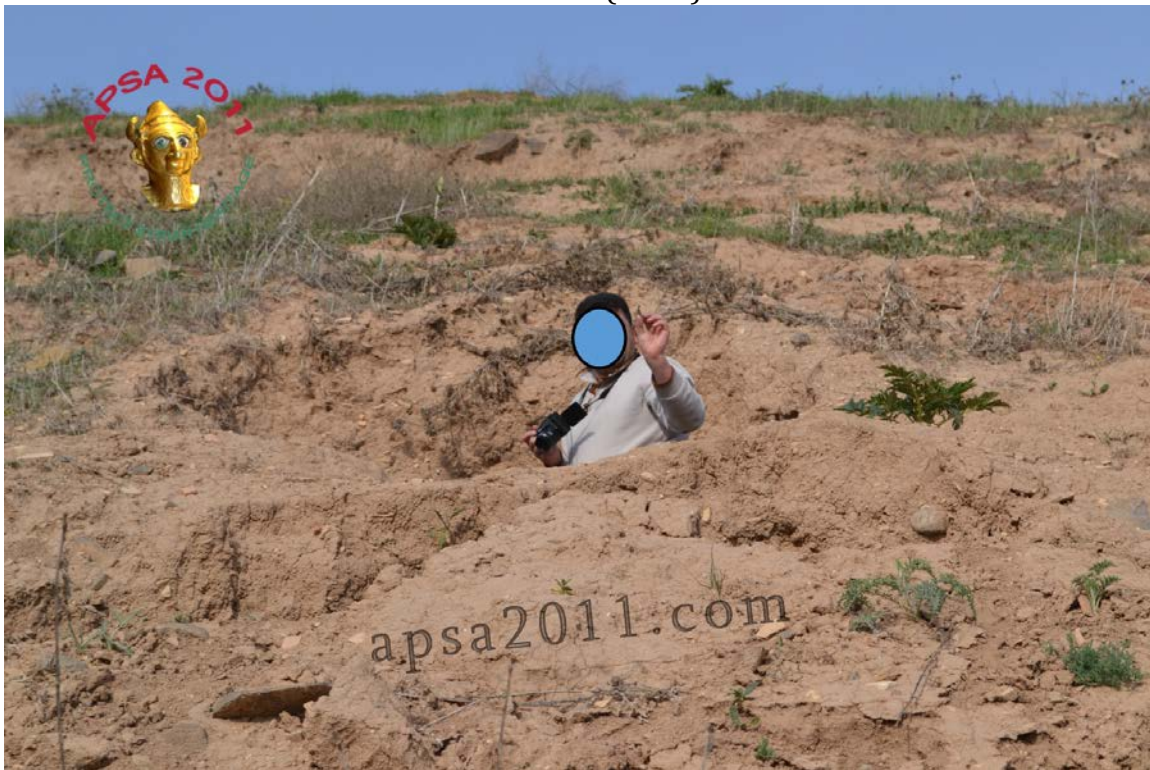
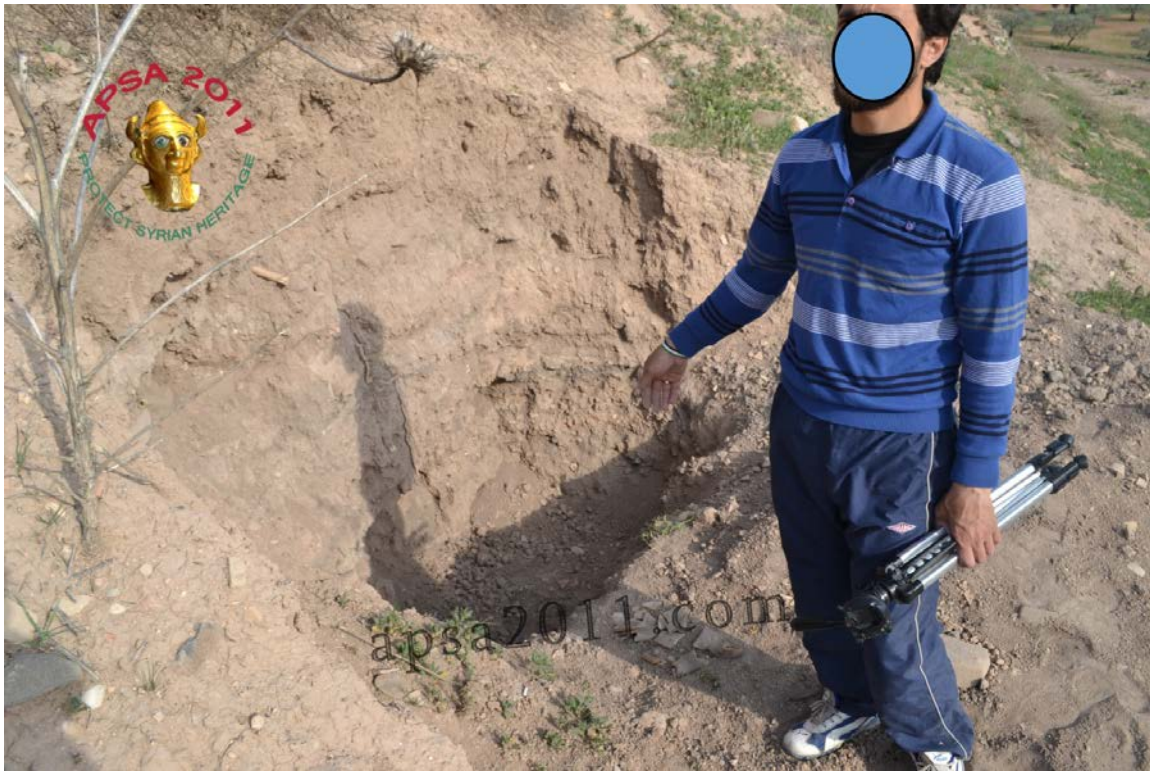
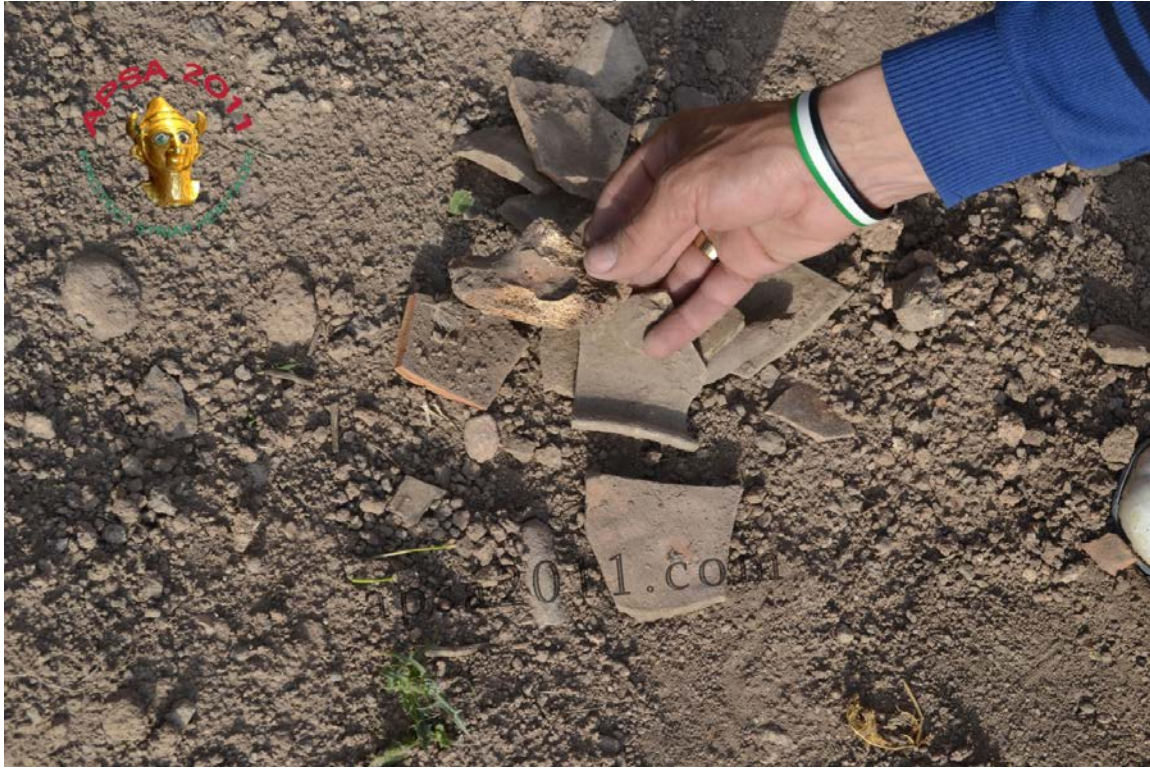
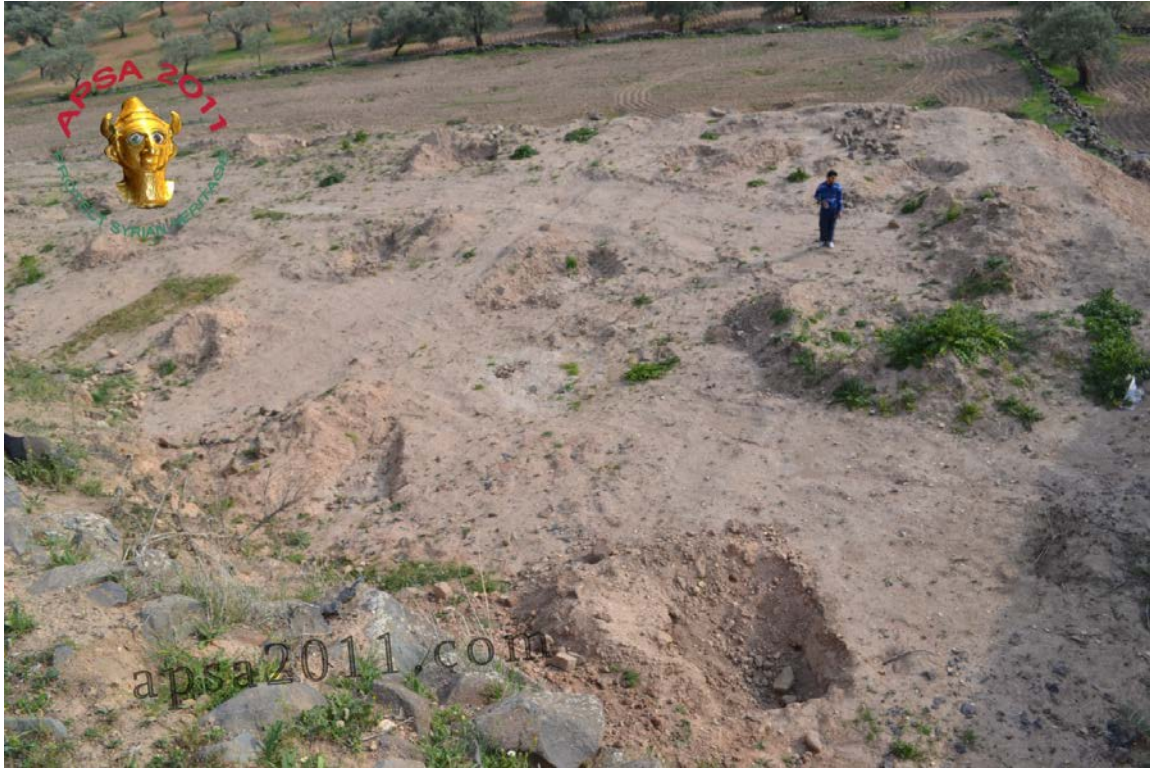
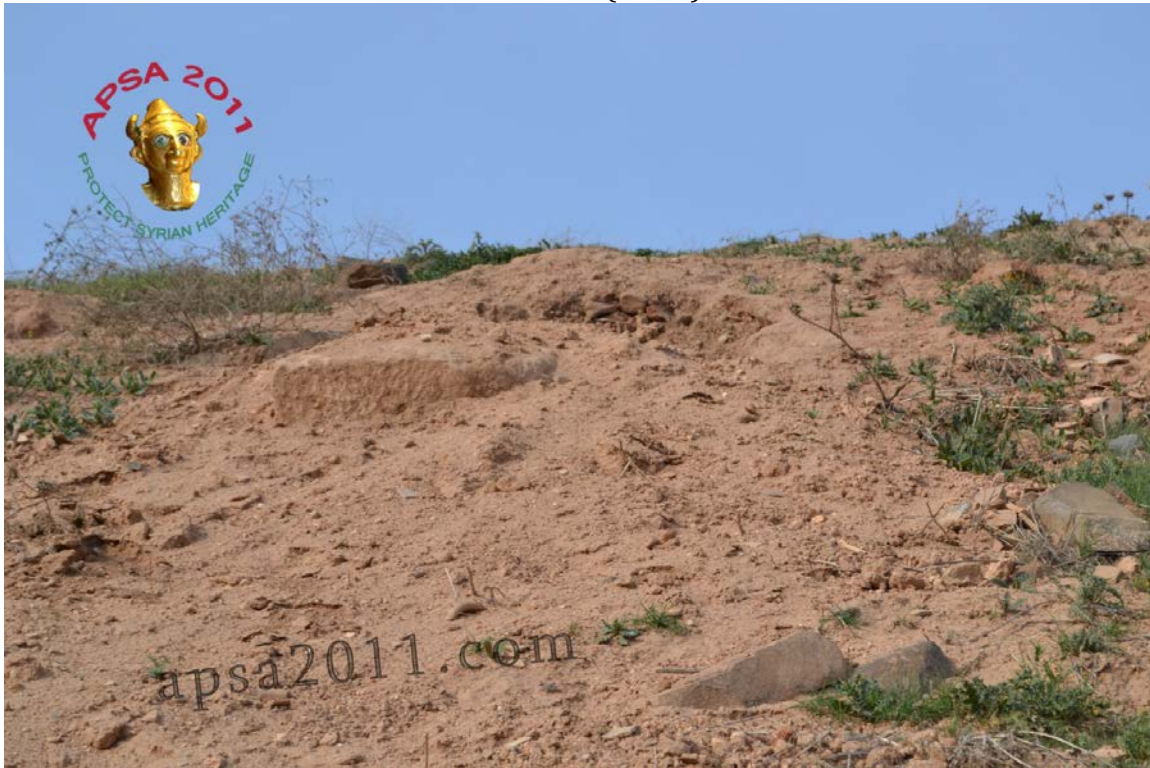
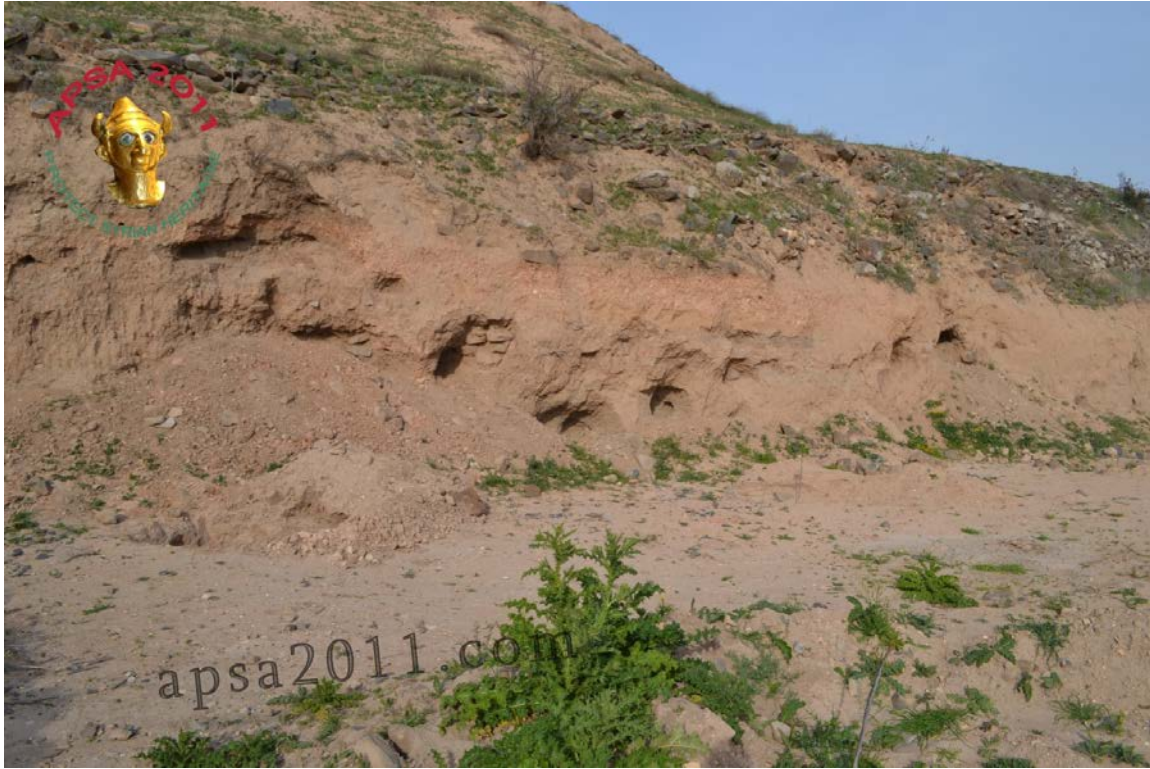
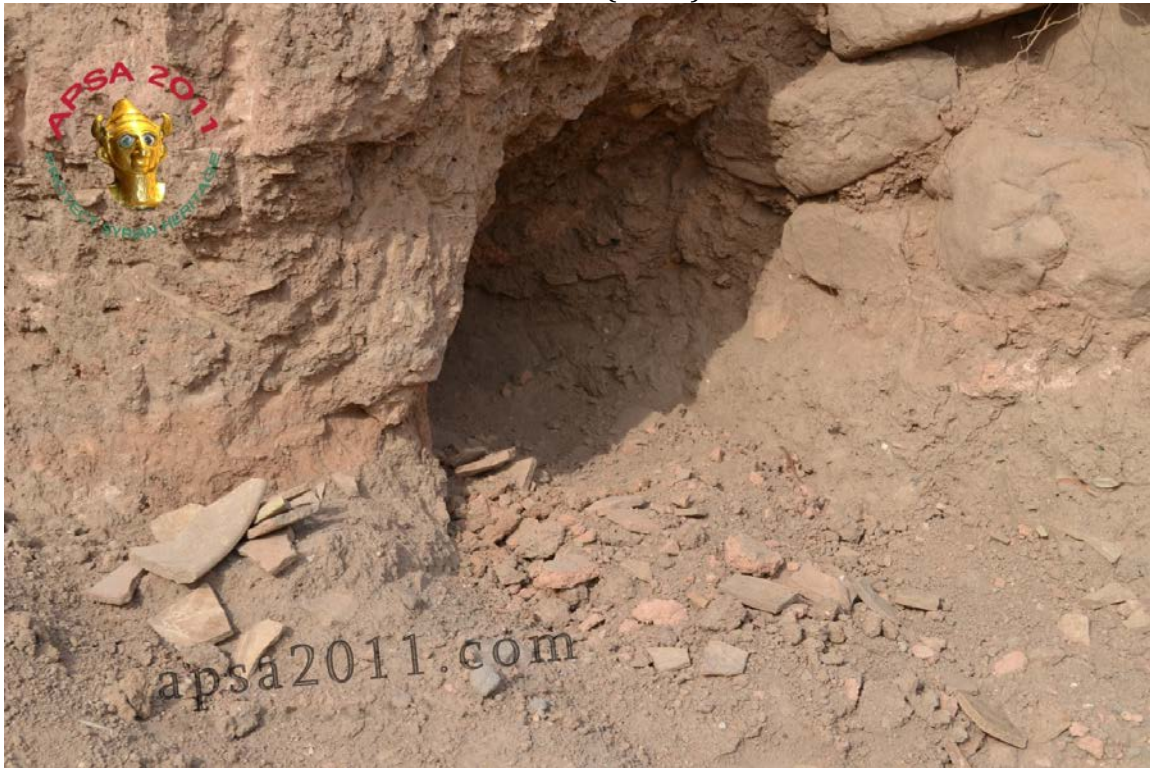
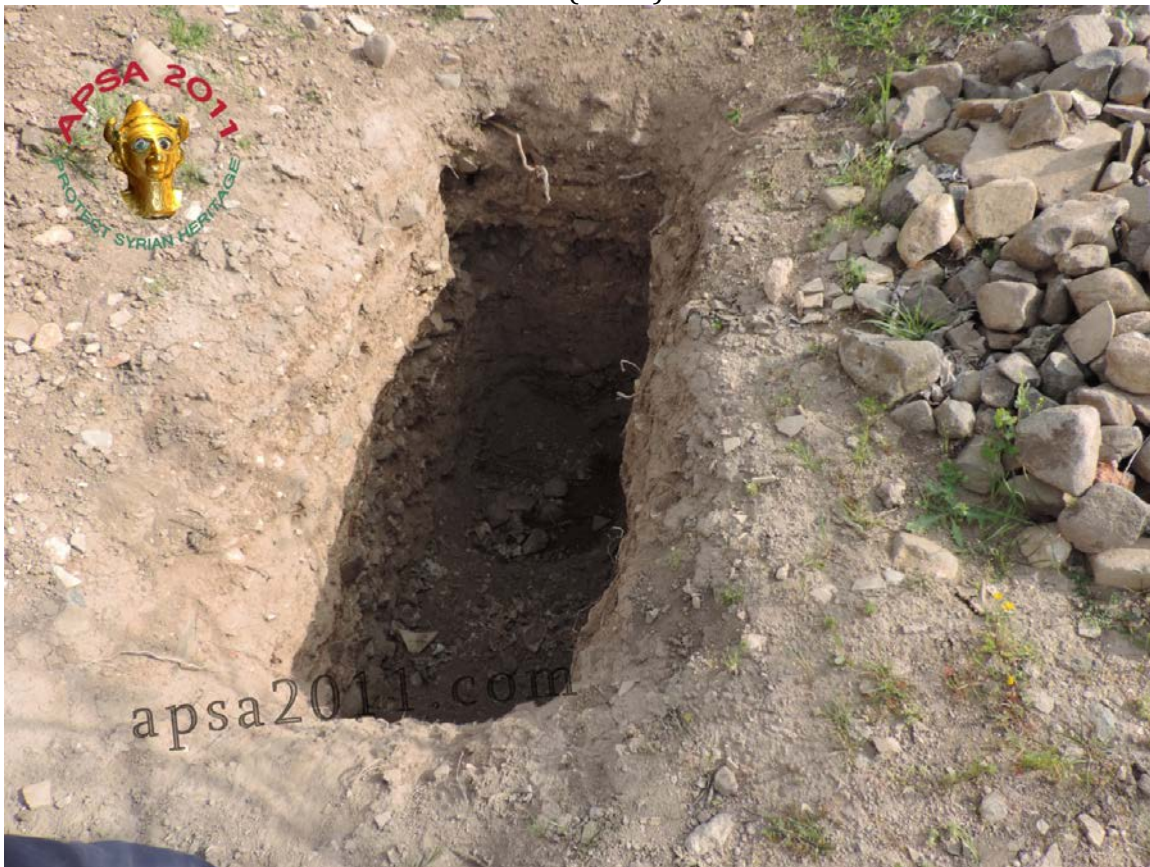
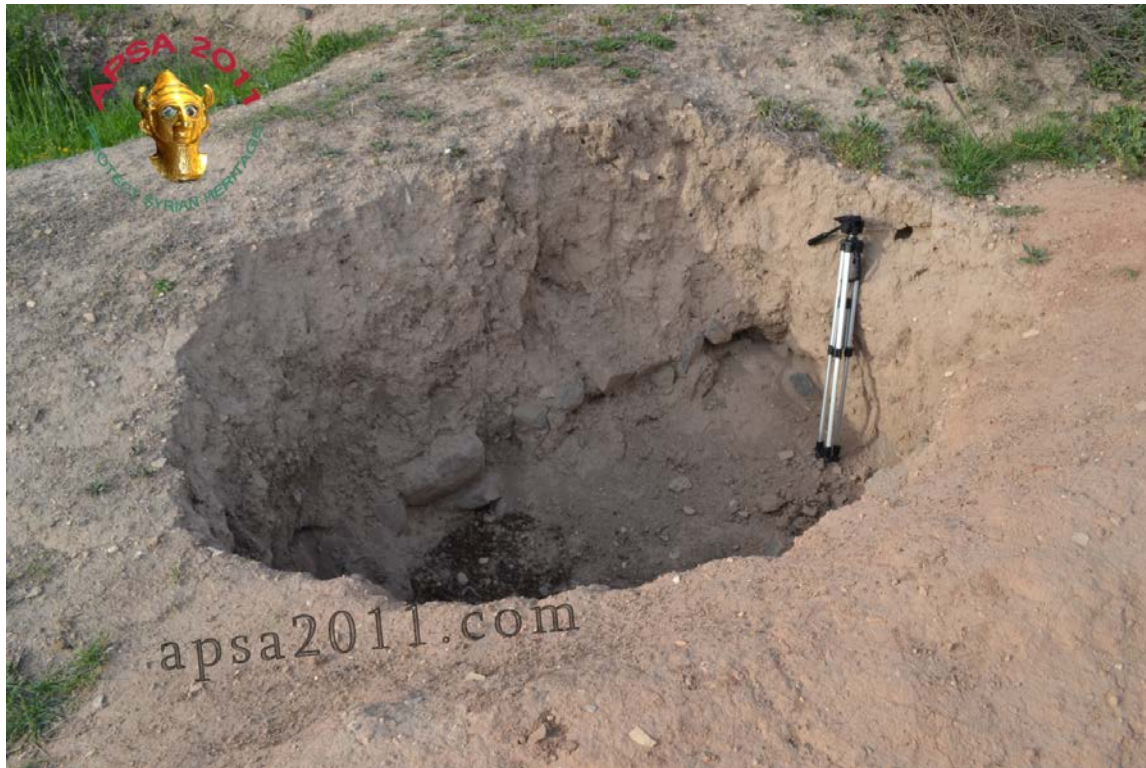
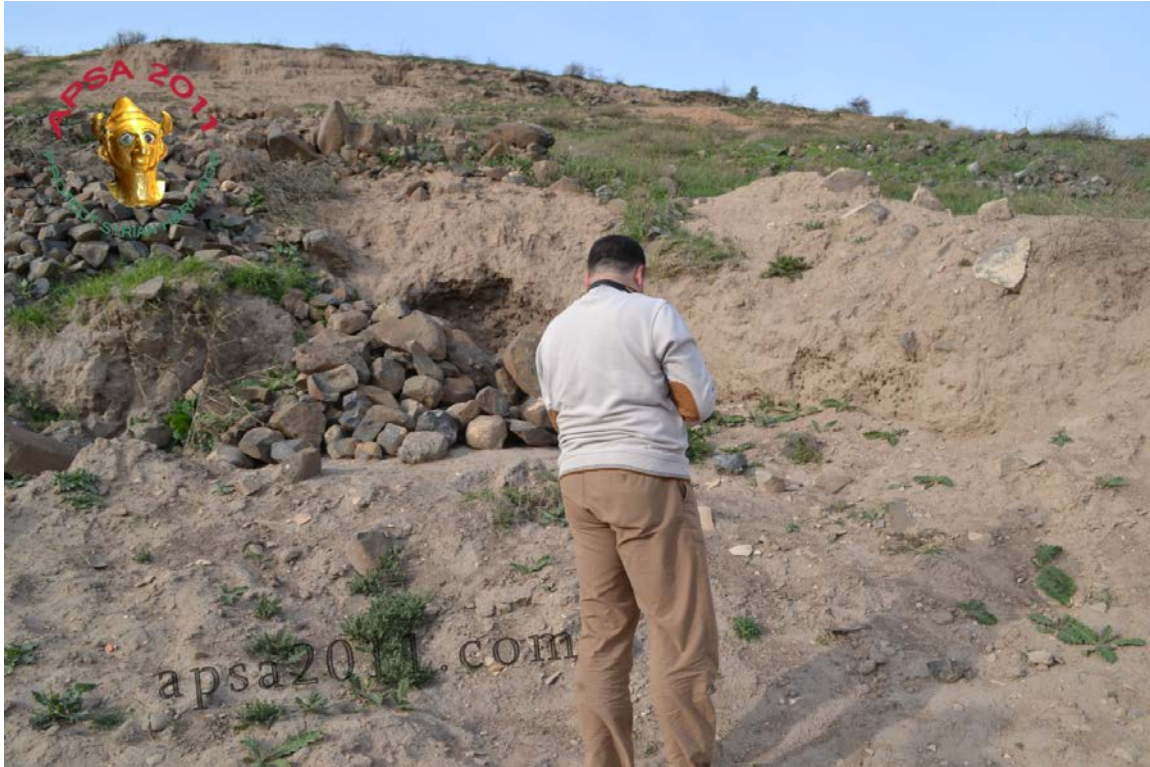
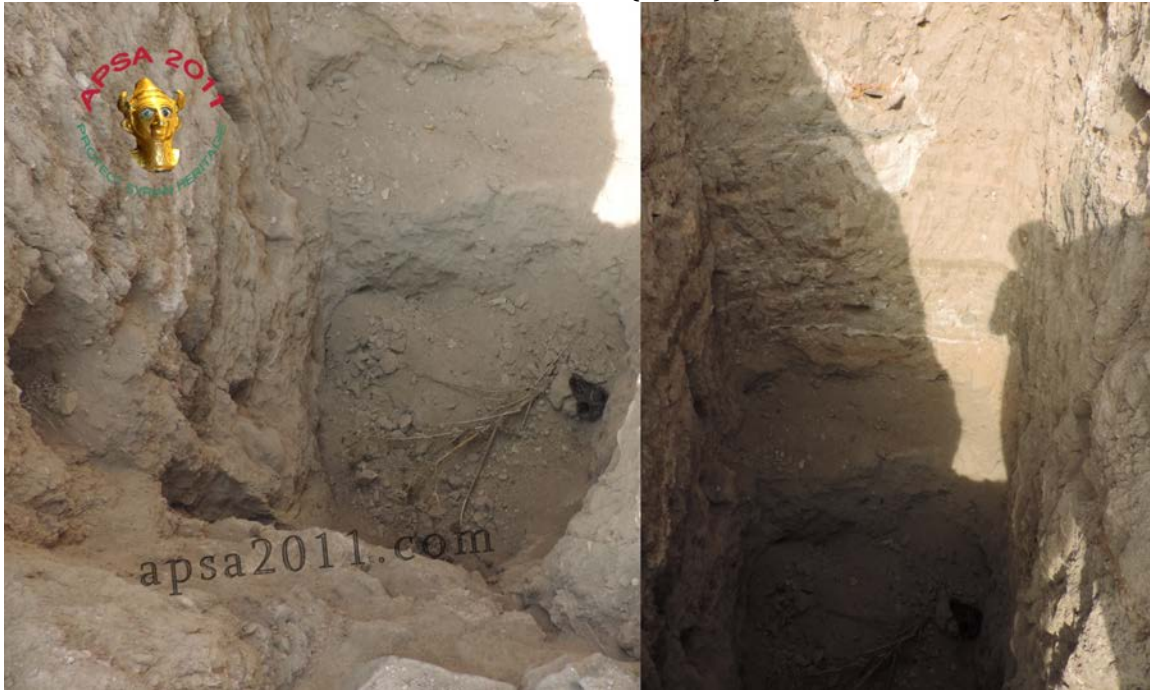
**Source of Destruction:** Based on a recent site visit by APSA, the site of Tell Hizareen has been subject to extensive illegal excavations. Numerous looters have been using metal detectors to explore the site, while more than fifty pits have been dug in different parts of the site. Looters have unearthed potsherds and terracotta figurines from multiple time periods.

Looter excavations at Tell Hizareen in 2014 (APSA).

**Monitoring Recommendations and Mitigation Measures:** SHI may request new satellite imagery of the mound as well as neighboring sites. This pattern of looting with metal detectors is reportedly widespread across Syria.

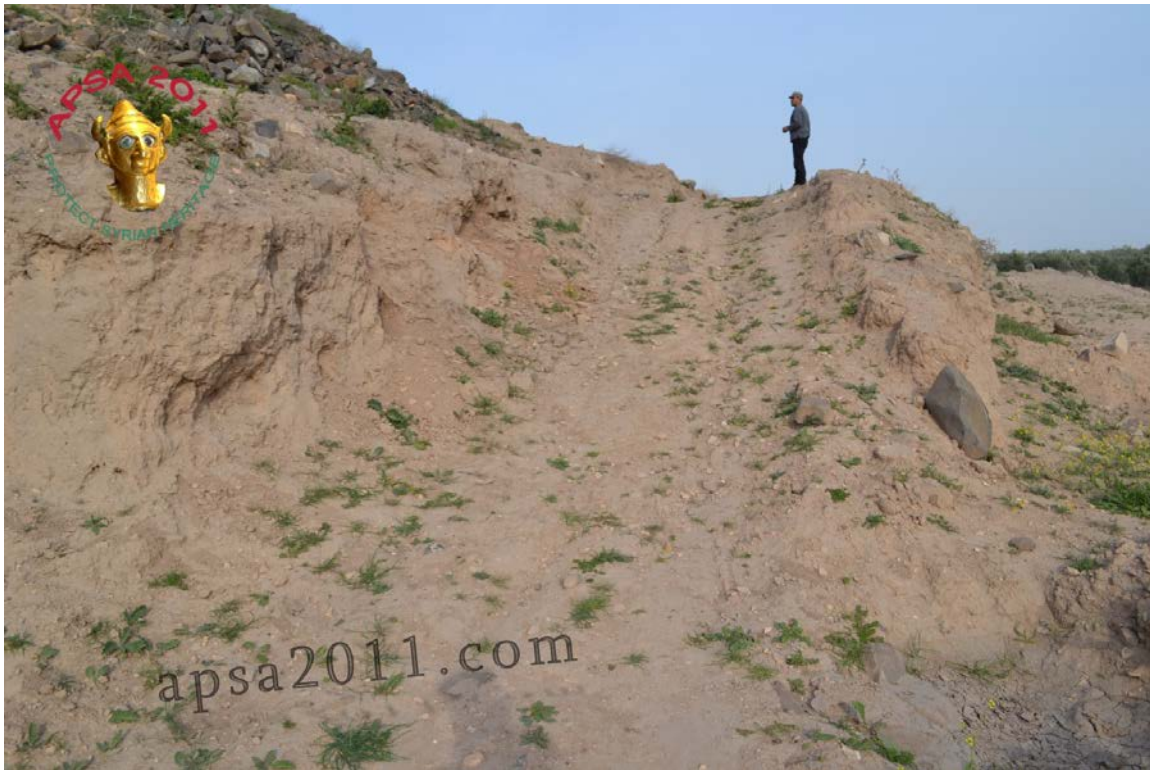
Site disturbance at Tell Hizareen in 2014 (APSA).

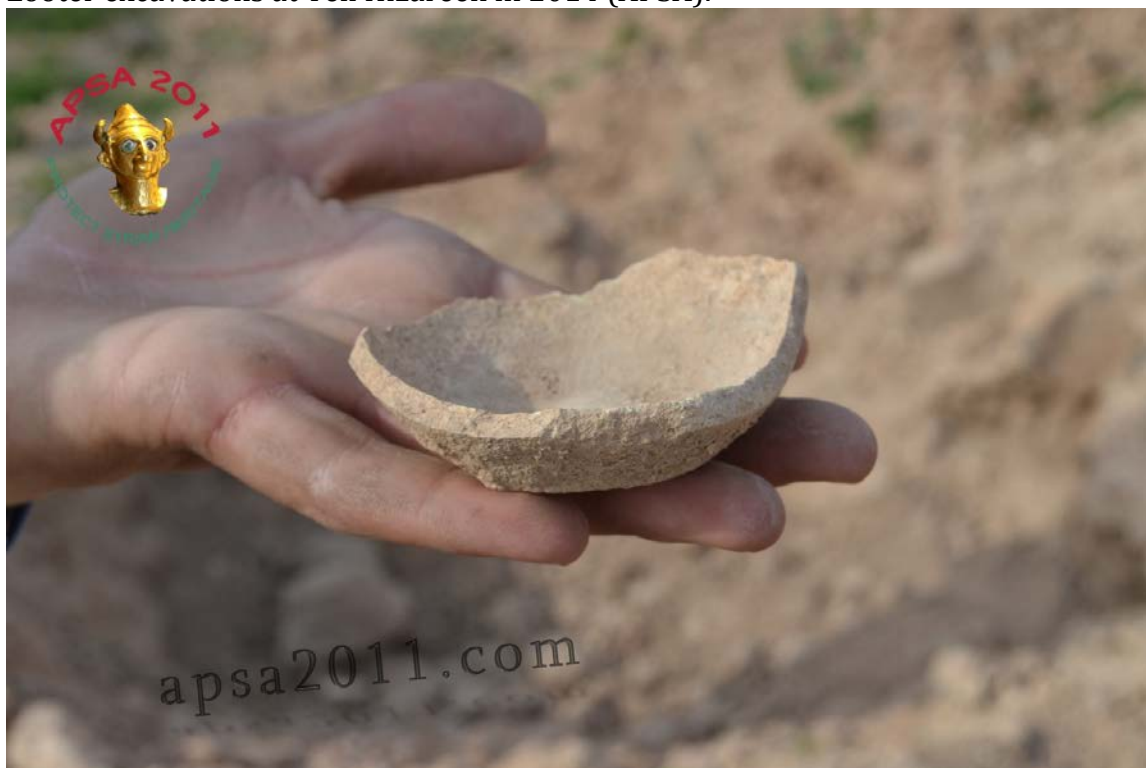
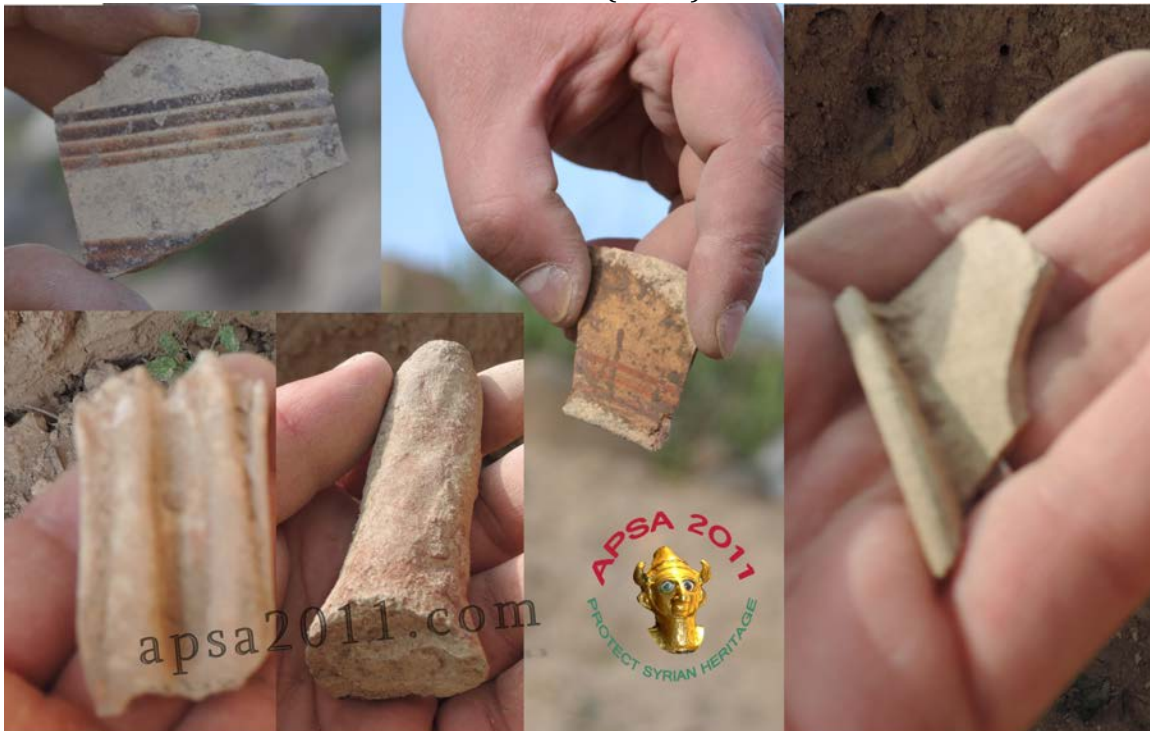
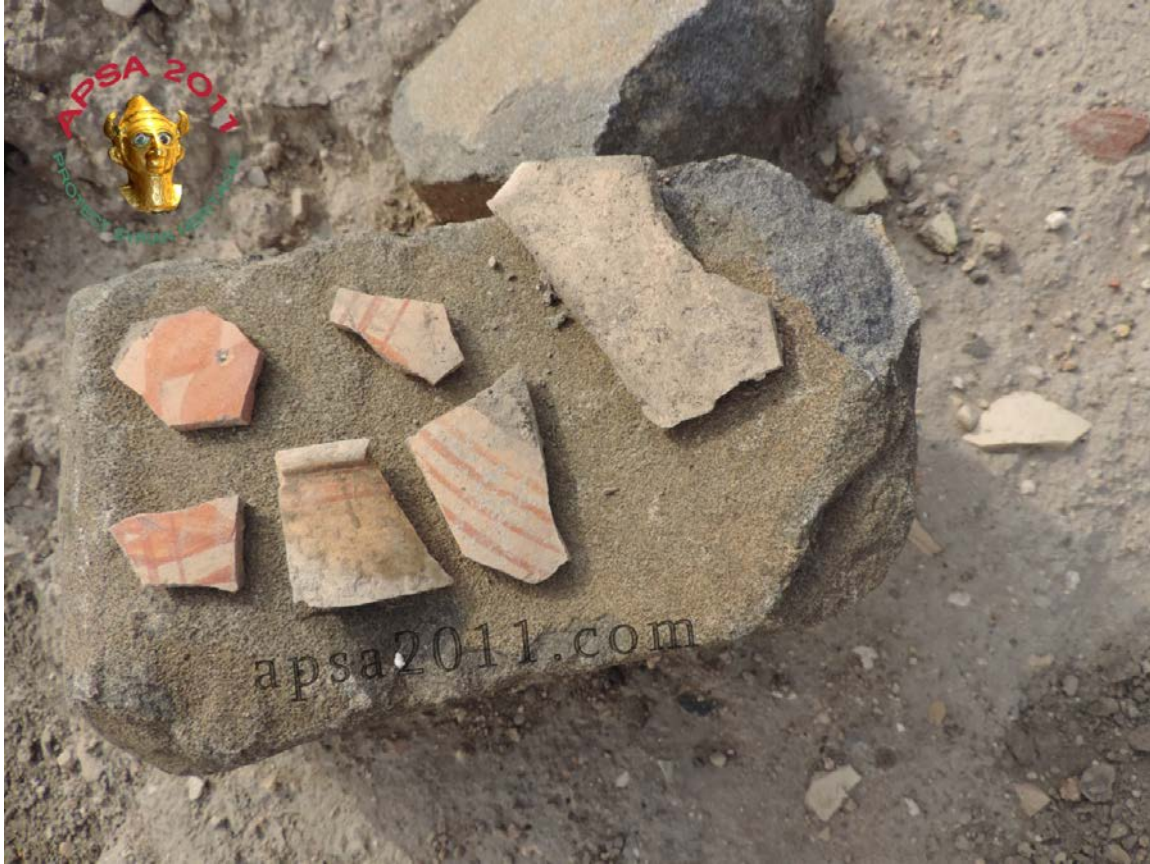
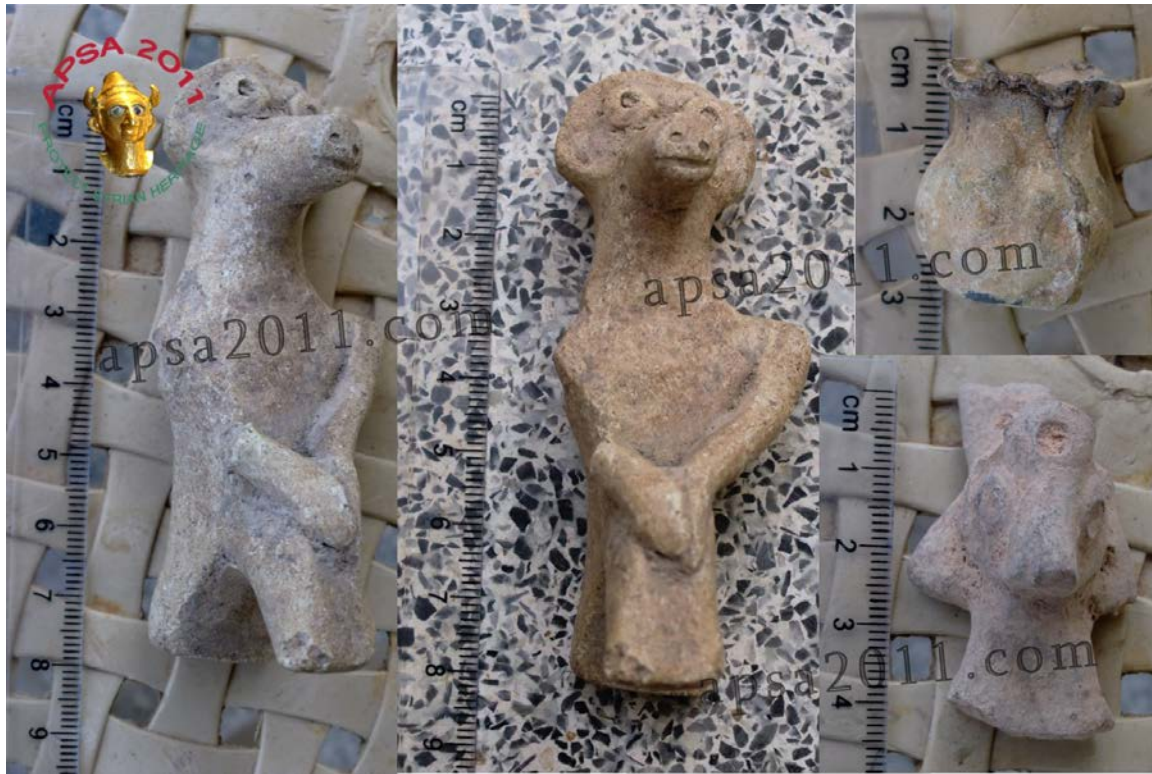
Surface sherd from Tell Hizareen (APSA).

Surface collection from Tell Hizareen in 2014 (APSA).

Terracotta figurines from Tell Hizareen.

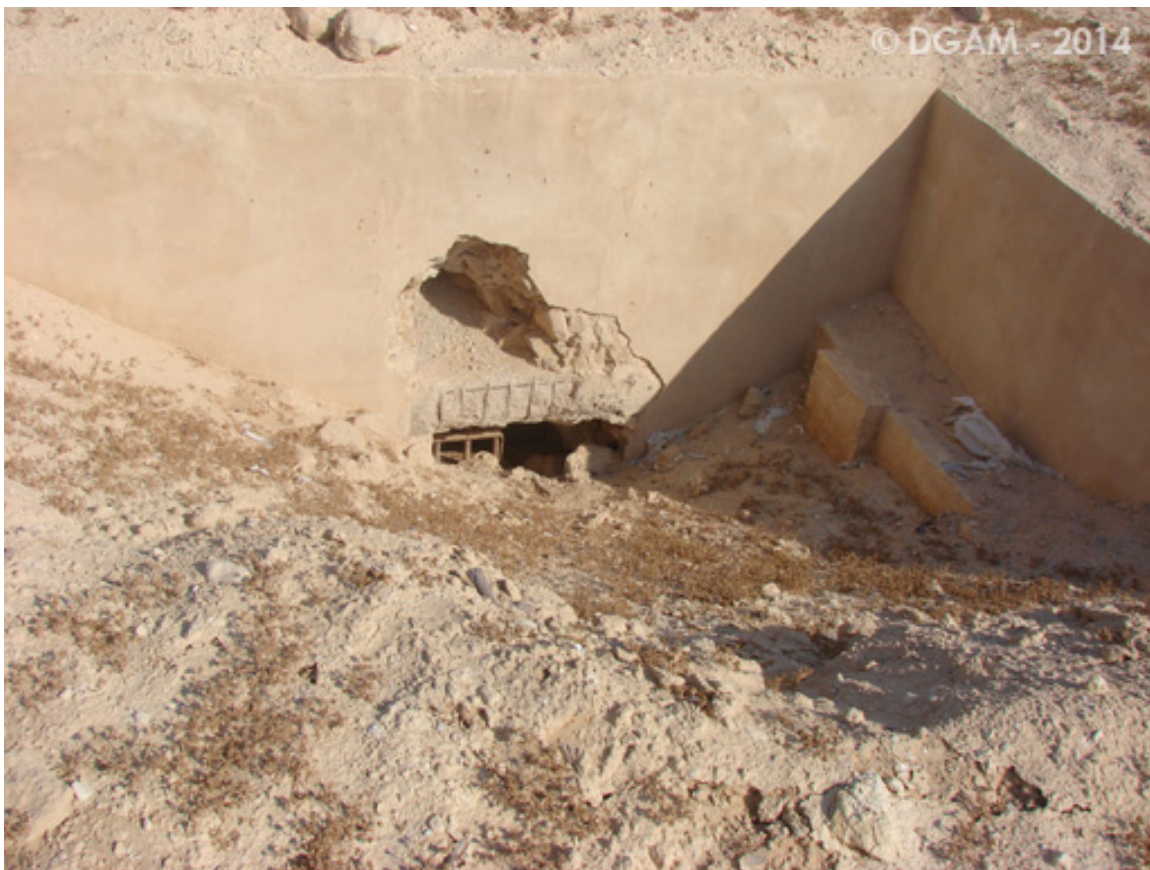
At the beginning of the crises on 2011 the DGAM undertook protective measures against vandalism and theft in the tomb by reinforced its gate and covered the tomb with soil. According to the DGAM team the looters remove the soil, broke into a tomb by took off and expanded the air vent over the gate. The thieves stole 22 funeral bust and child head stone represented in the Scene funerary feast.

Entrance to the looted Artaban Tomb, Palmyra (DGAM)

**Monitoring Recommendations and Mitigation Measures:** Palmyra is already a high priority site for SHI monitoring and evaluation. The antiquities market is being monitored for Pamyrene material, and these efforts will be expanded in coming months.
