# ASOR Syrian Heritage Initiative (SHI): Planning for Safeguarding Heritage Sites in Syria<sup>1</sup>

NEA-PSHSS-14-001

Weekly Report 13 – November 3, 2014

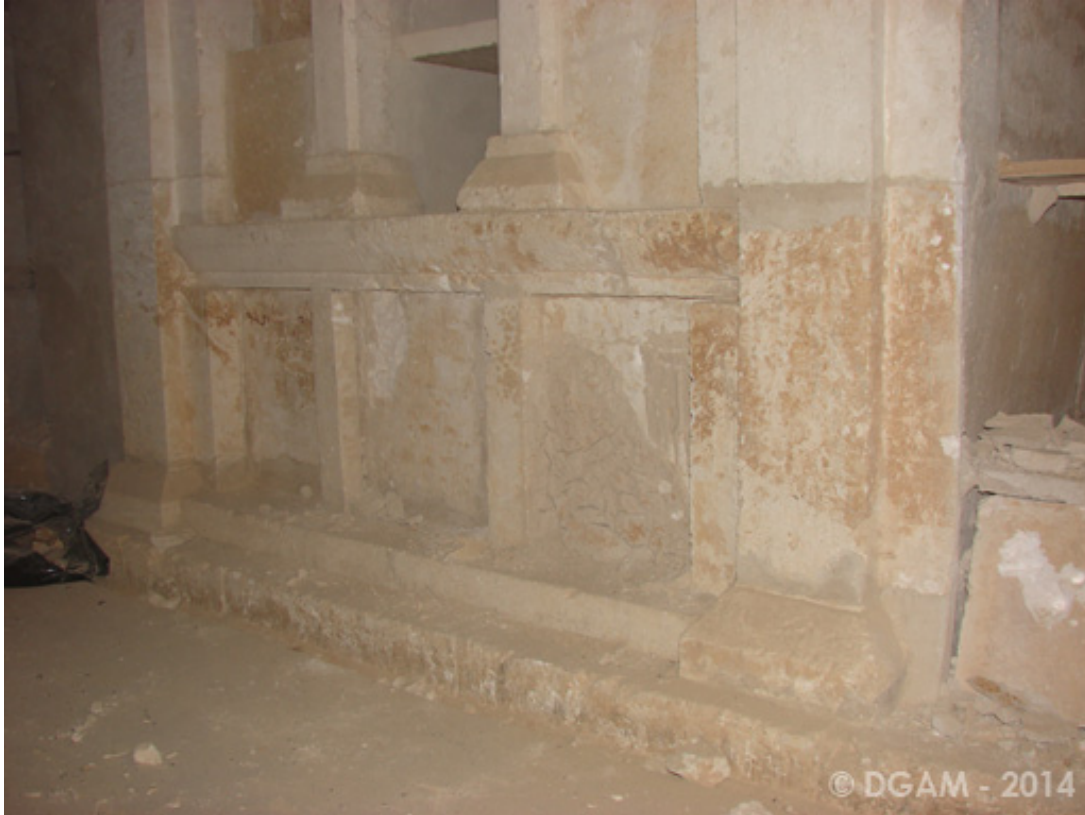
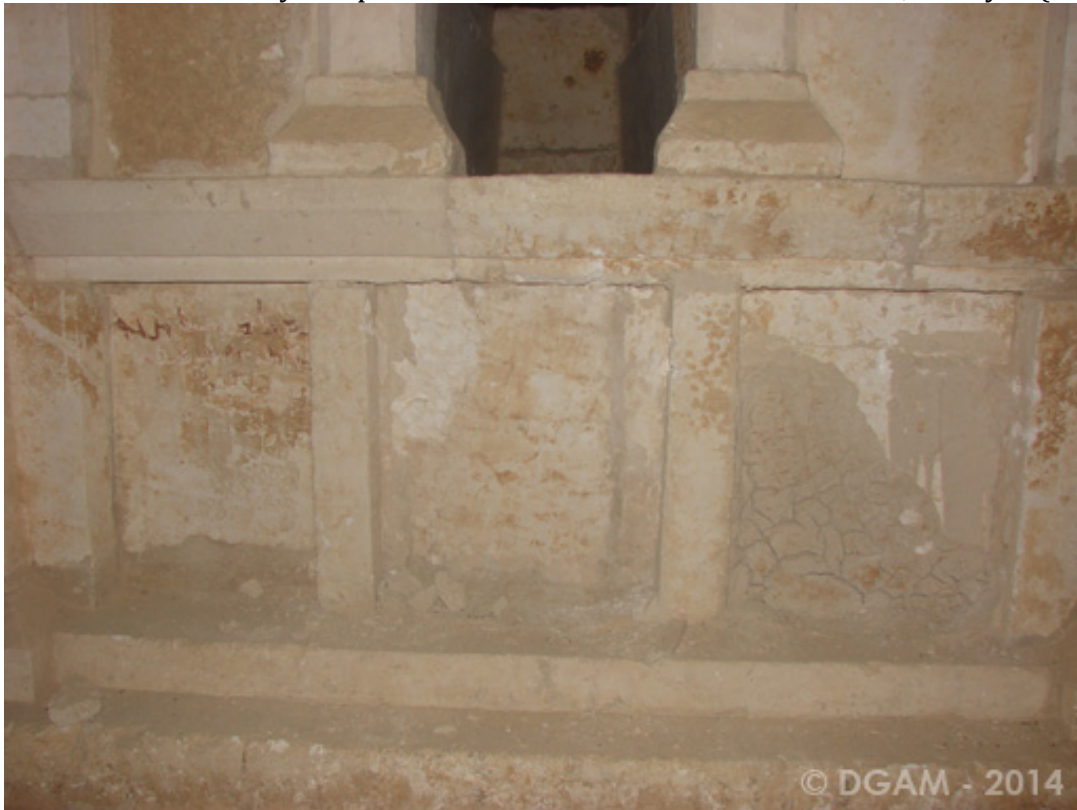
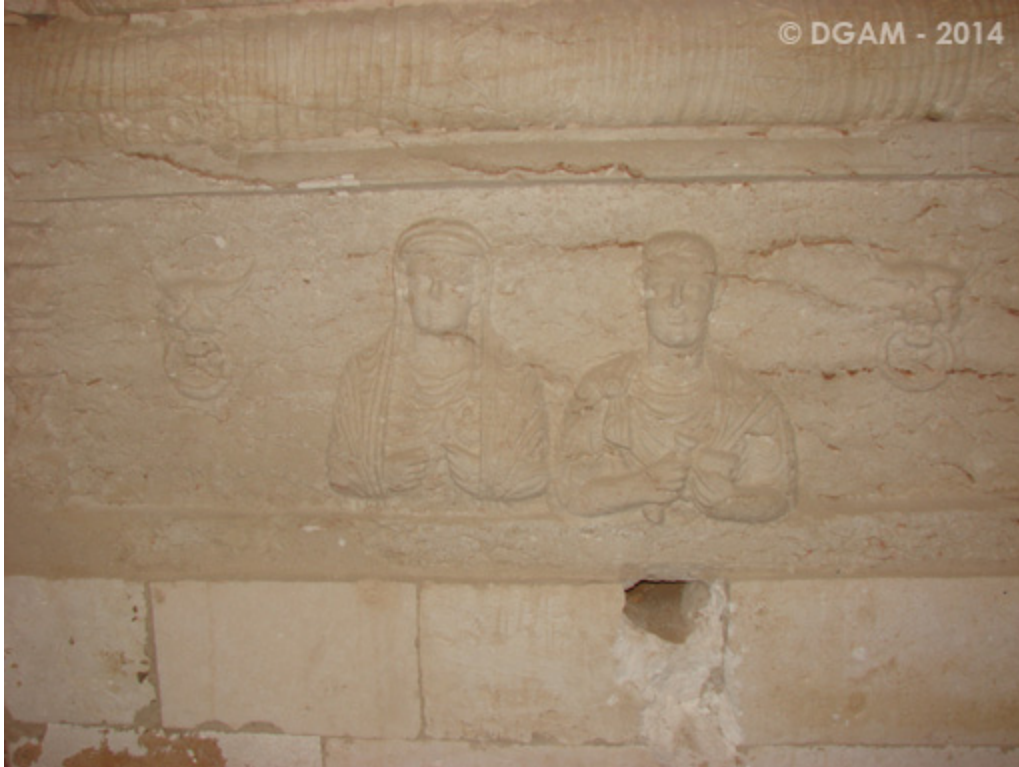
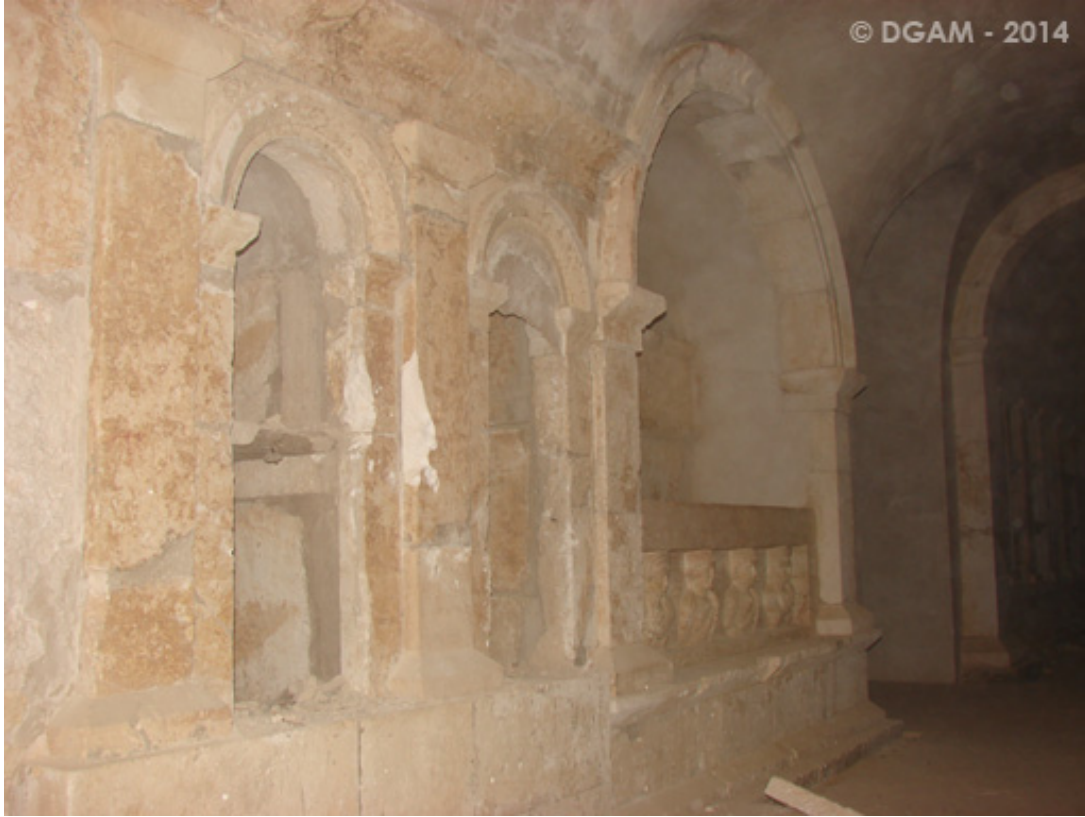
At the beginning of the crises on 2011 the DGAM undertook protective measures against vandalism and theft in the tomb by reinforced its gate and covered the tomb with soil. According to the DGAM team the looters remove the soil, broke into a tomb by took off and expanded the air vent over the gate. The thieves stole 22 funeral bust and child head stone represented in the Scene funerary feast.

Locations of funerary sculptures looted from the Artaban Tomb, Palmyra (DGAM)

**Monitoring Recommendations and Mitigation Measures:** Palmyra is already a high priority site for SHI monitoring and evaluation. The antiquities market is being monitored for Pamyrene material, and these efforts will be expanded in coming months.

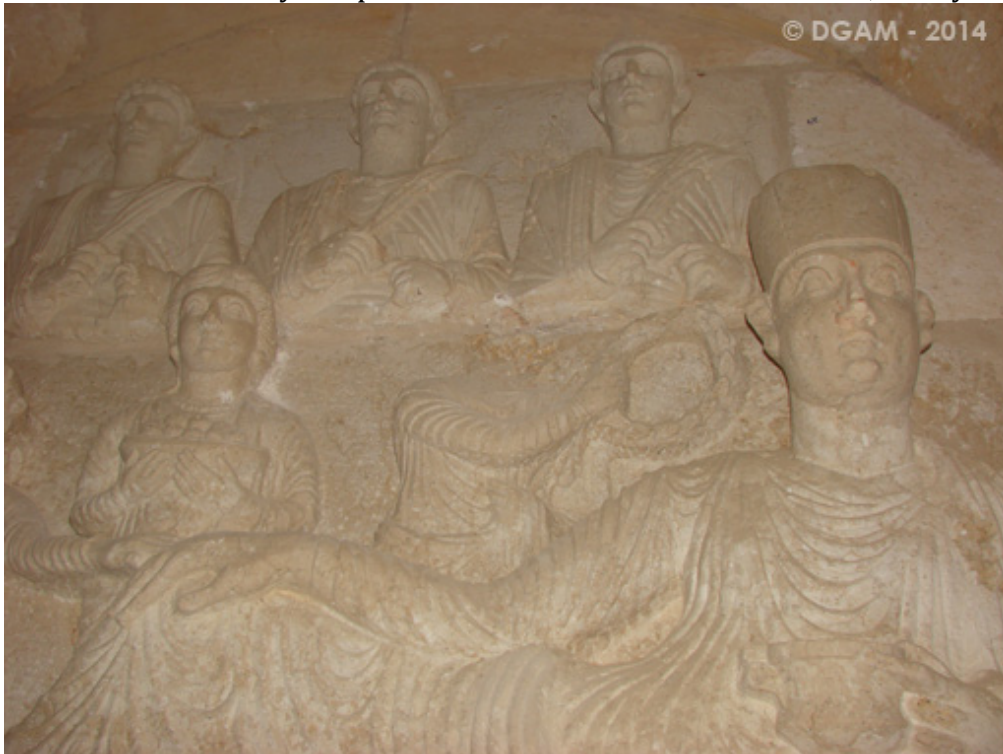
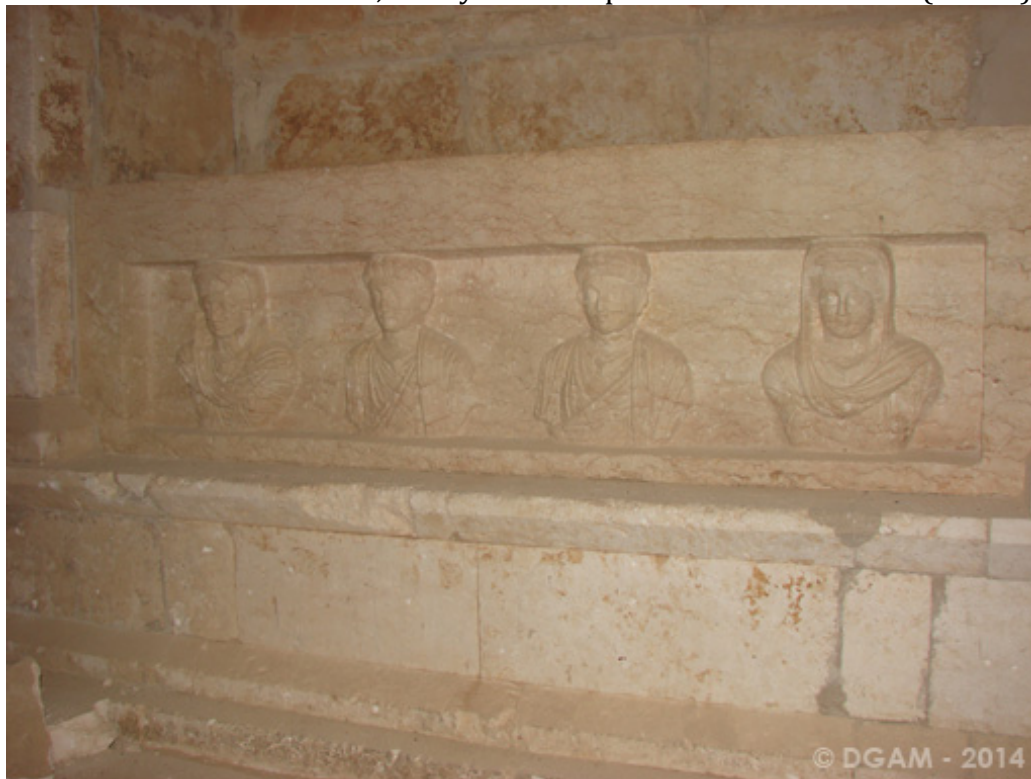
Funerary sculptures in the Artaban Tomb, Palmyra (DGAM)

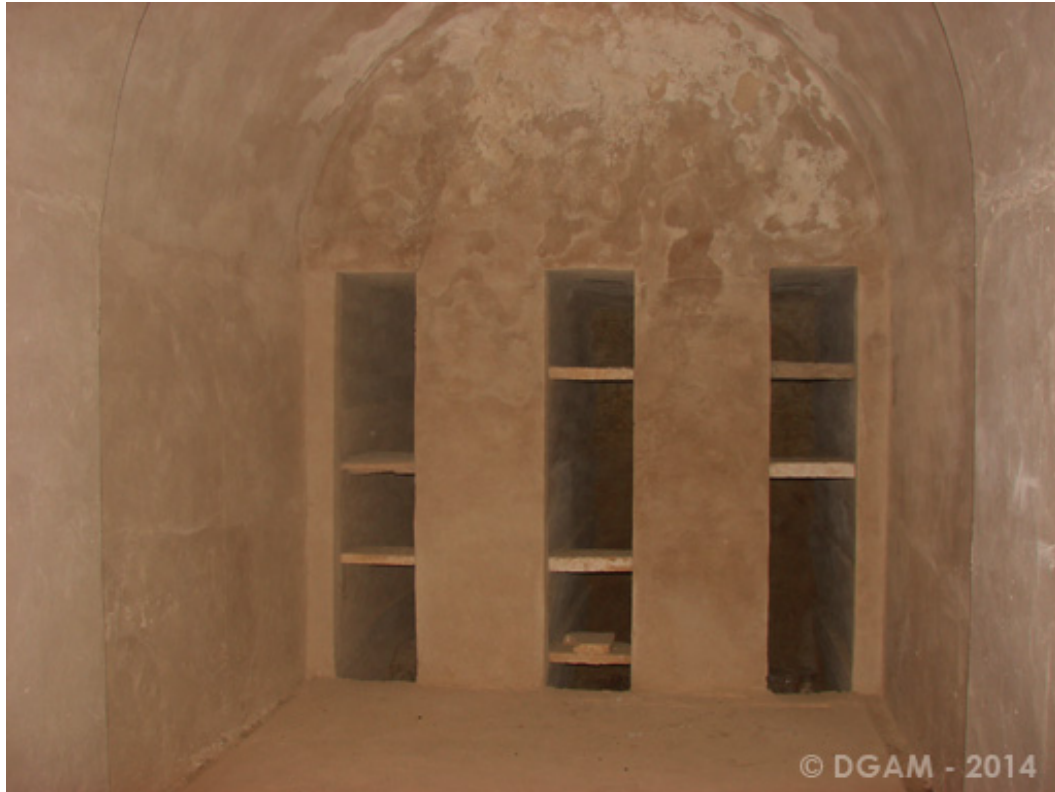
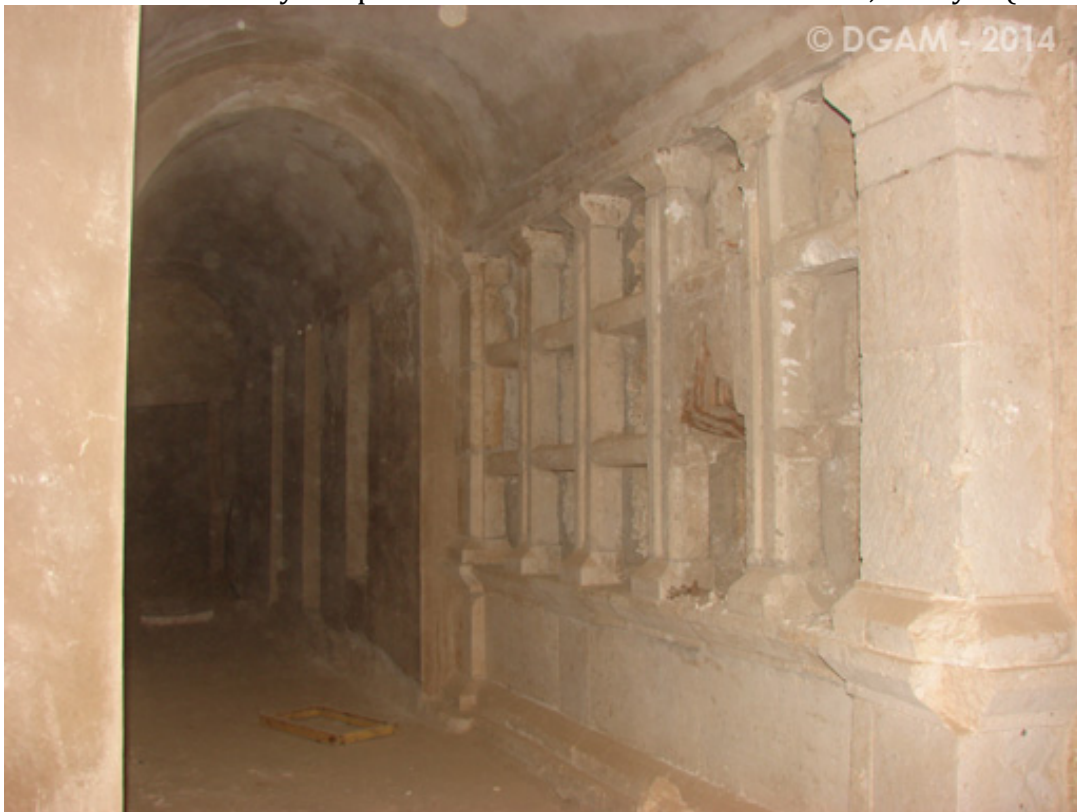
*Loculi* in the Artaban Tomb, Palmyra — sculptural elements looted (DGAM)
