ASOR Cultural Heritage Initiatives (CHI): Planning for Safeguarding Heritage Sites in Syria and Iraq¹

S-JO-100-18-CA-004

November 2018 Monthly Appendices

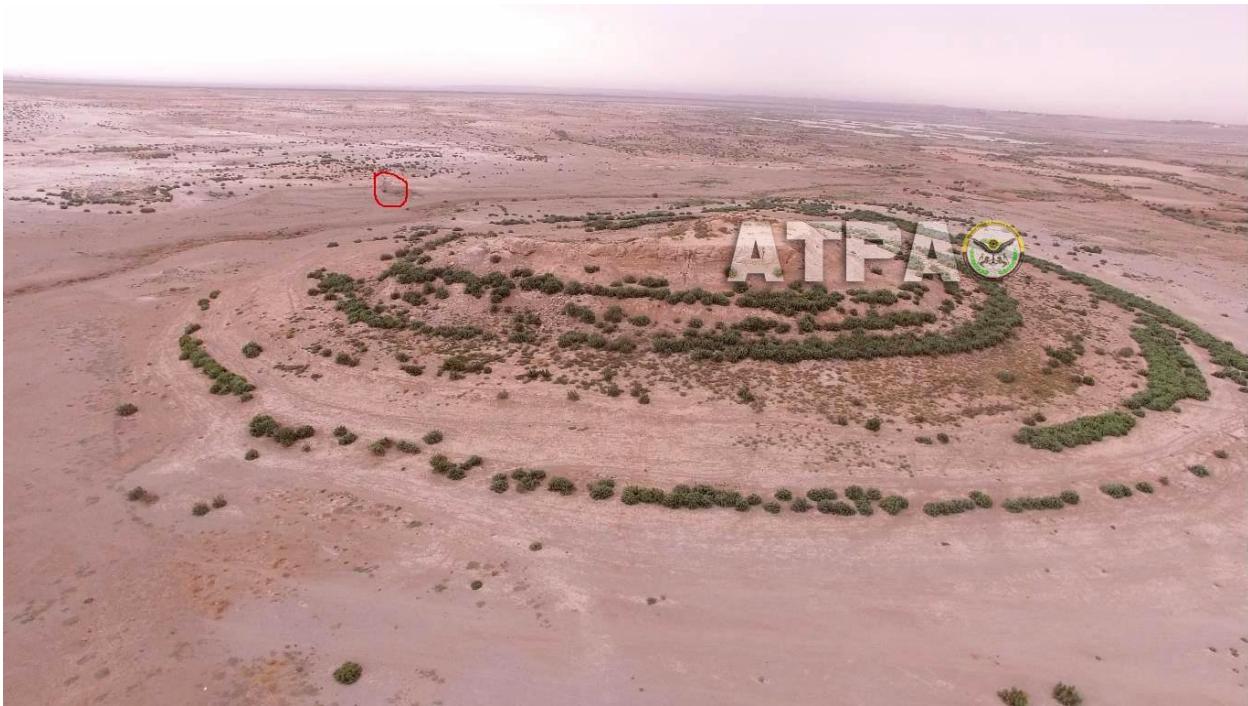
A drone photo of Abu Hafour (ATPA; October 24, 2018)

Incident Source and Description: On October 24, 2018 the Authority of Tourism and the Protection of Antiquities (ATPA) reported that illicit excavations had occurred at an unspecified time at the archaeological sites of Abu Hafour and Abu Hujayrah.³² Photographs posted by the ATPA show a small number of possible looting pits along the slopes of the two sites. Their depth and width are unclear. This damage occurred after July 10, 2018 as these pits are not visible in DigitalGlobe satellite imagery from that date.

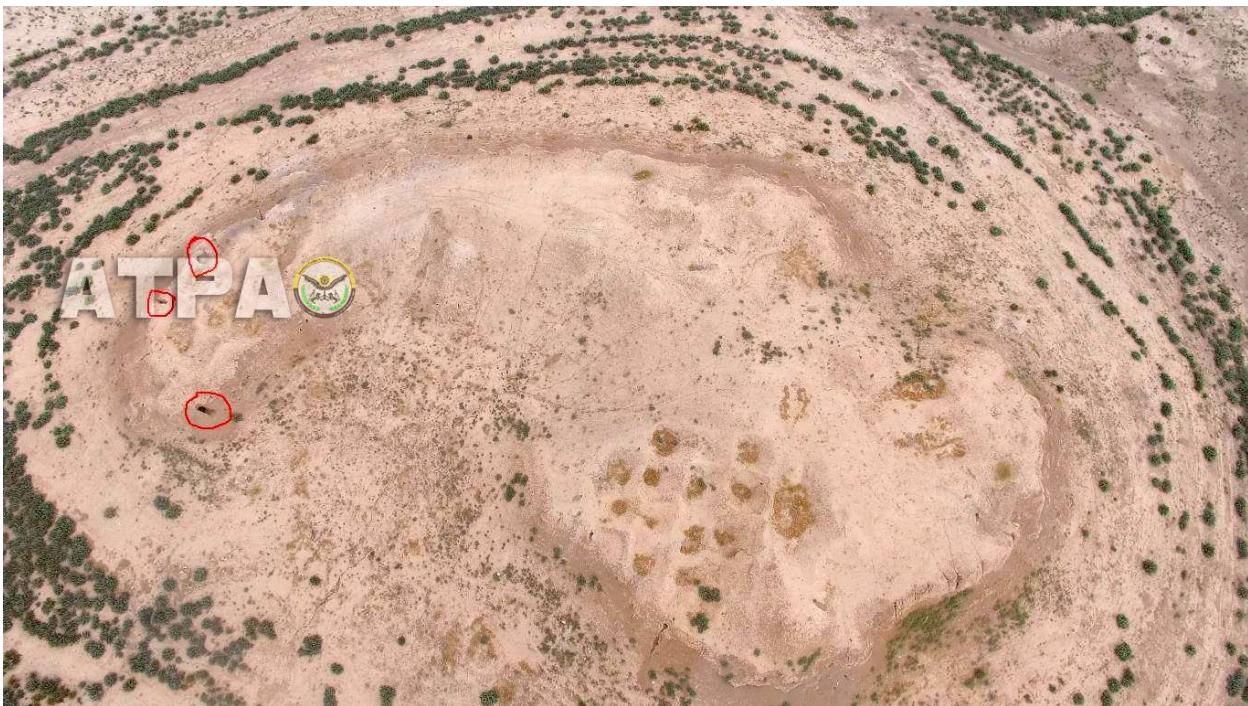
A drone photo of Abu Hujayrah (ATPA; October 24, 2018)

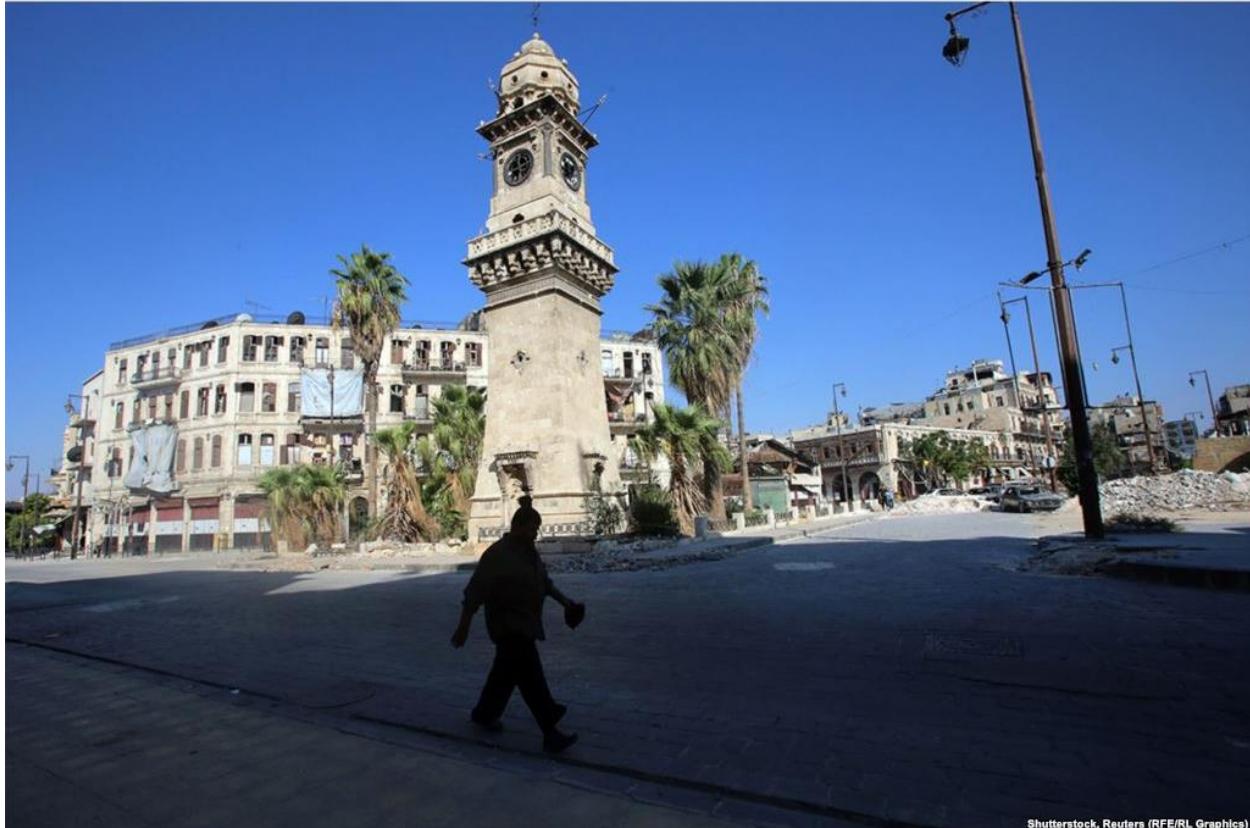
The Bab al-Faraj Clock Tower showing the missing clock faces and piles of rubble in the background
(Radio Free Europe Radio Liberty; November 4, 2016)

Description of Previous Damage to Site: The clock tower is located on the edge of the historical city, and was always in control of the Syrian Armed Forces. The nearby Sheraton Aleppo Hotel was used as a military barracks for the SARG forces.³⁵ In 2016, a photo showed piles of rubble around the clock tower and missing clock faces, but no other damage was noted to the tower.³⁶

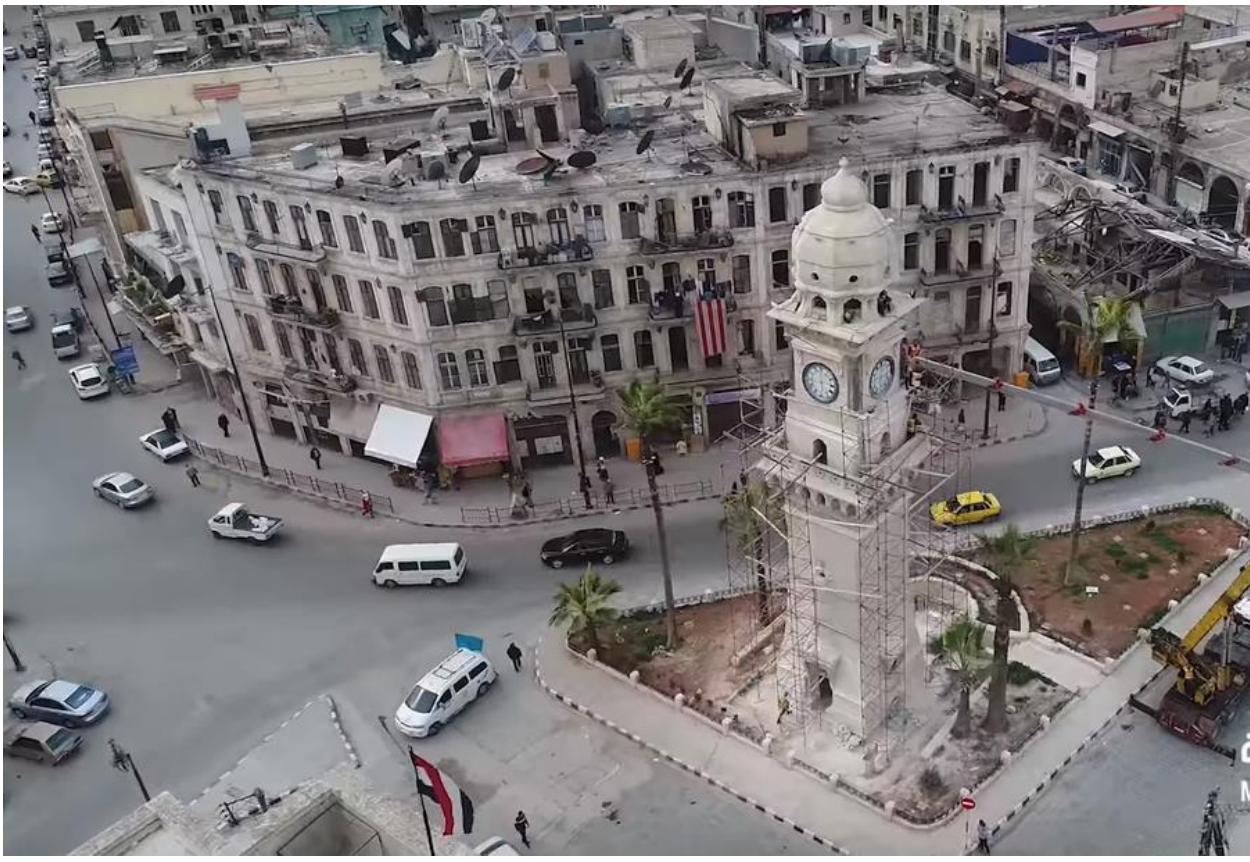
Video still of the Bab al-Faraj Clock Tower showing the tower's current condition (RT; November 9, 2018)

Heritage Response Source (organization) and Description of Work: On November 9, 2018 RT published a video from the Syrian Ministry of Tourism showing reconstruction and cleaning activities around Aleppo.³⁴ As seen in the video, the Bab al-Faraj Clock Tower has been cleaned and the clock faces have been replaced. The square surrounding the clock tower has also been cleaned and restored.

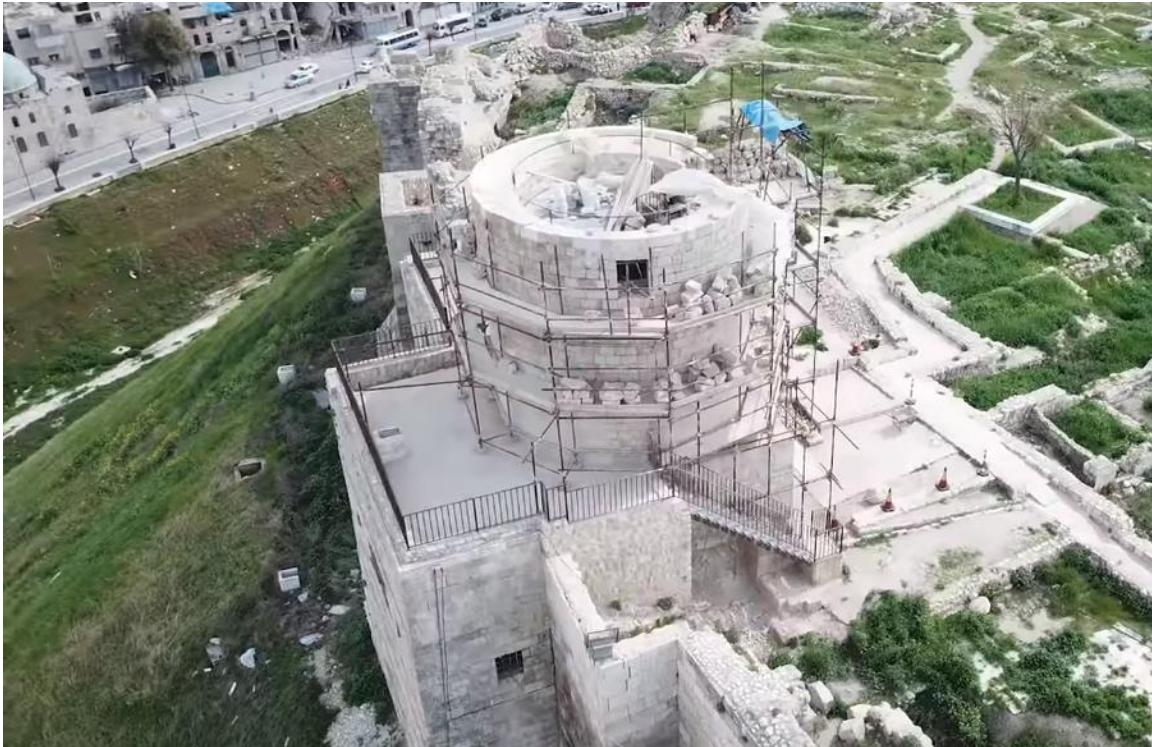
Video still of the reconstruction of a tower on the western side of the citadel (RT; November 9, 2018)

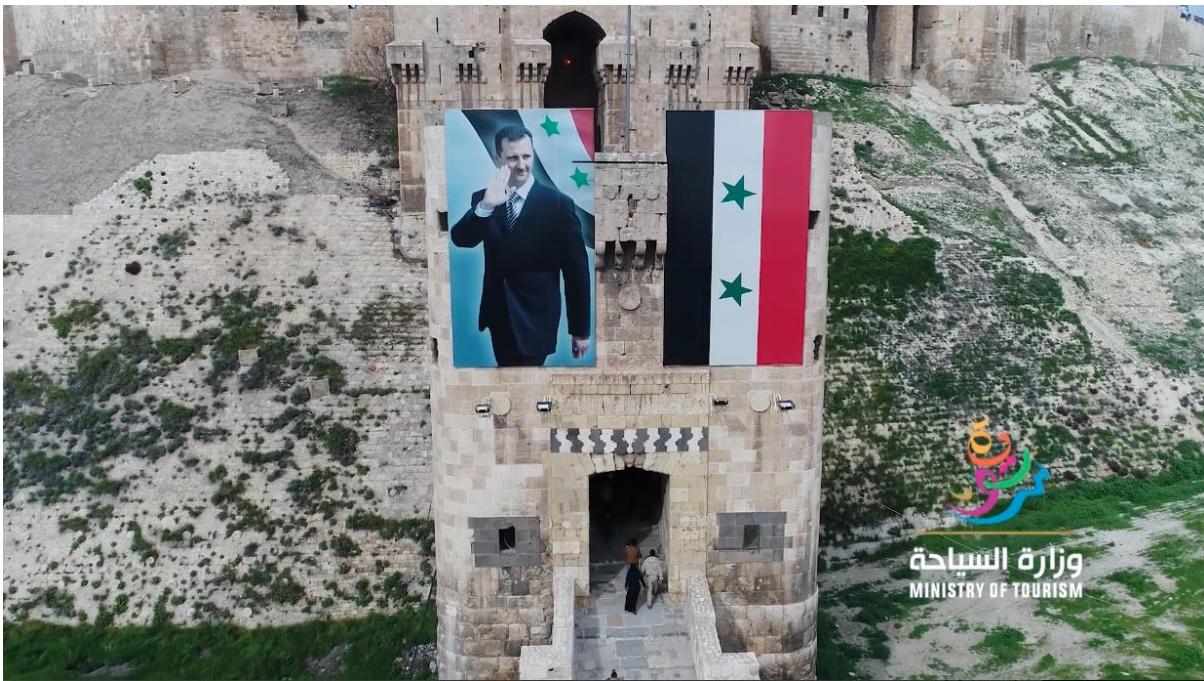
Video still of the Aleppo Citadel with a poster of President Bashar al-Assad visible on the wall (RT; November 9, 2018)

Monitoring Recommendations and Mitigation Measures: ASOR CHI will continue to monitor the condition of the Aleppo Citadel, as well as the condition of other cultural heritage sites located in regions subject to reconstruction.

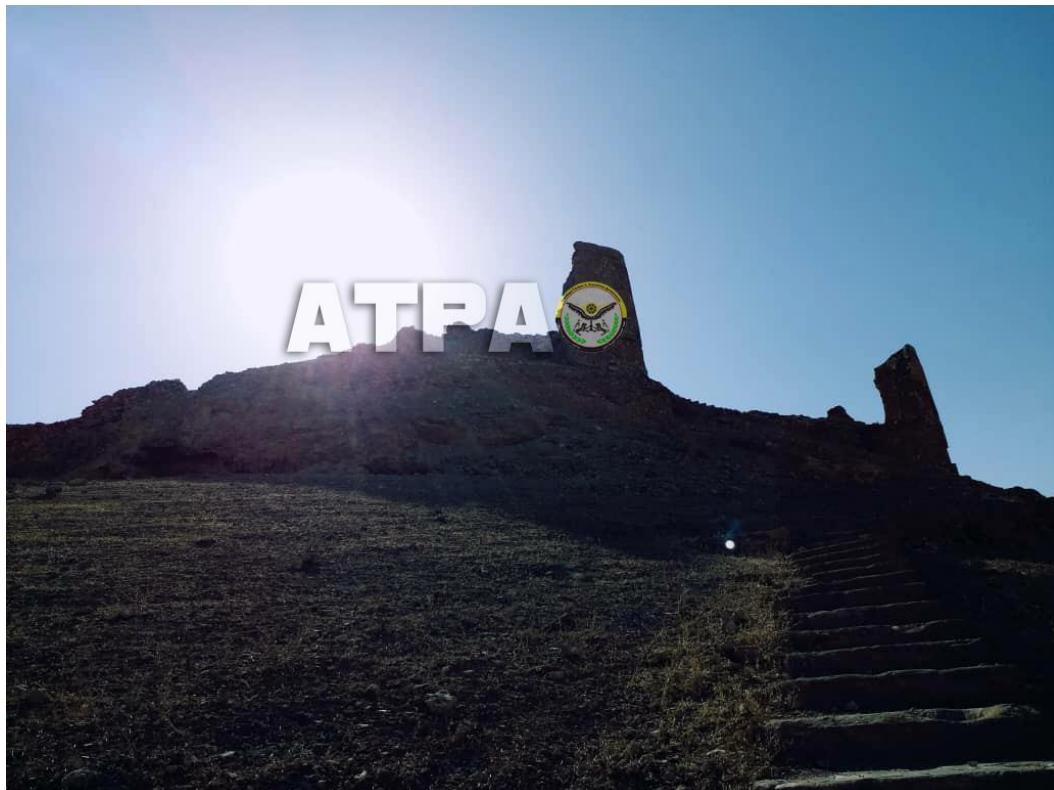
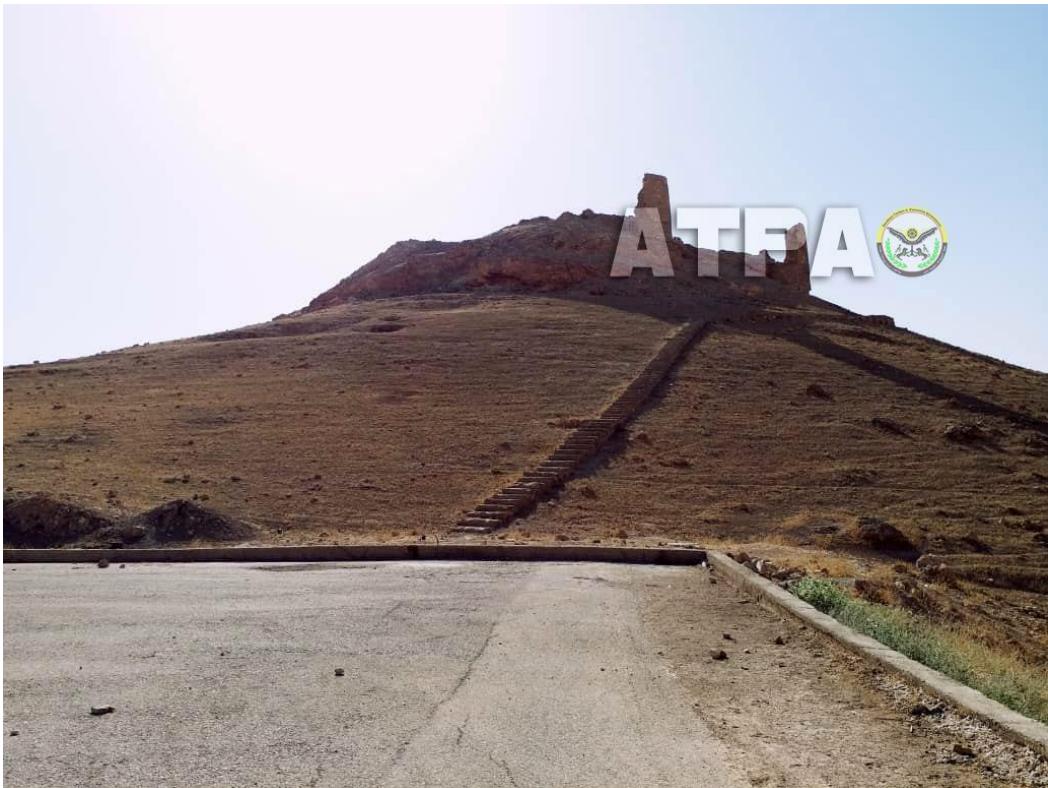
Qalaat Sukara before cleaning and restoration (ATPA; October 31, 2018)

Description of Previous Damage to Site: According to APSA, airstrikes were conducted against ISIS militants that were believed to be occupying the site. In addition, there are unconfirmed reports of damage to the north side of the castle.⁴⁹ For more information on previous damage to Qalaat Sukara, see **ASOR CHI Incident Report SHI 14-0075** in **Weekly Report 14**.

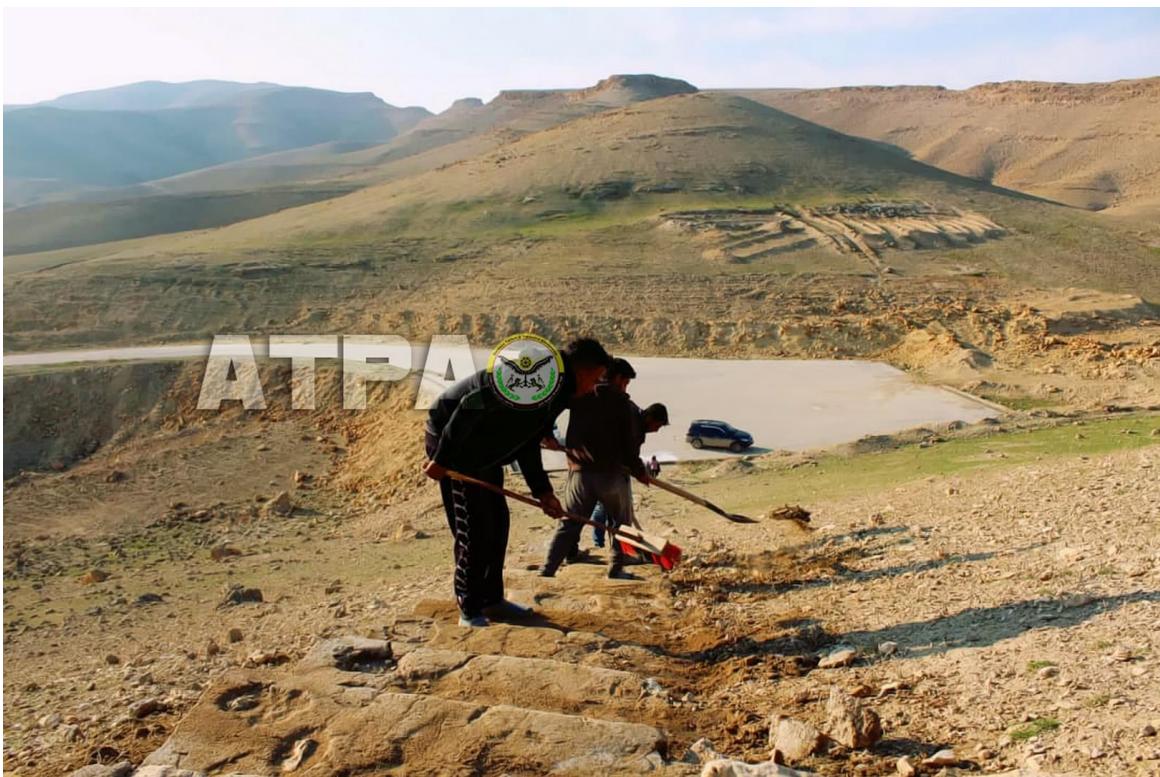
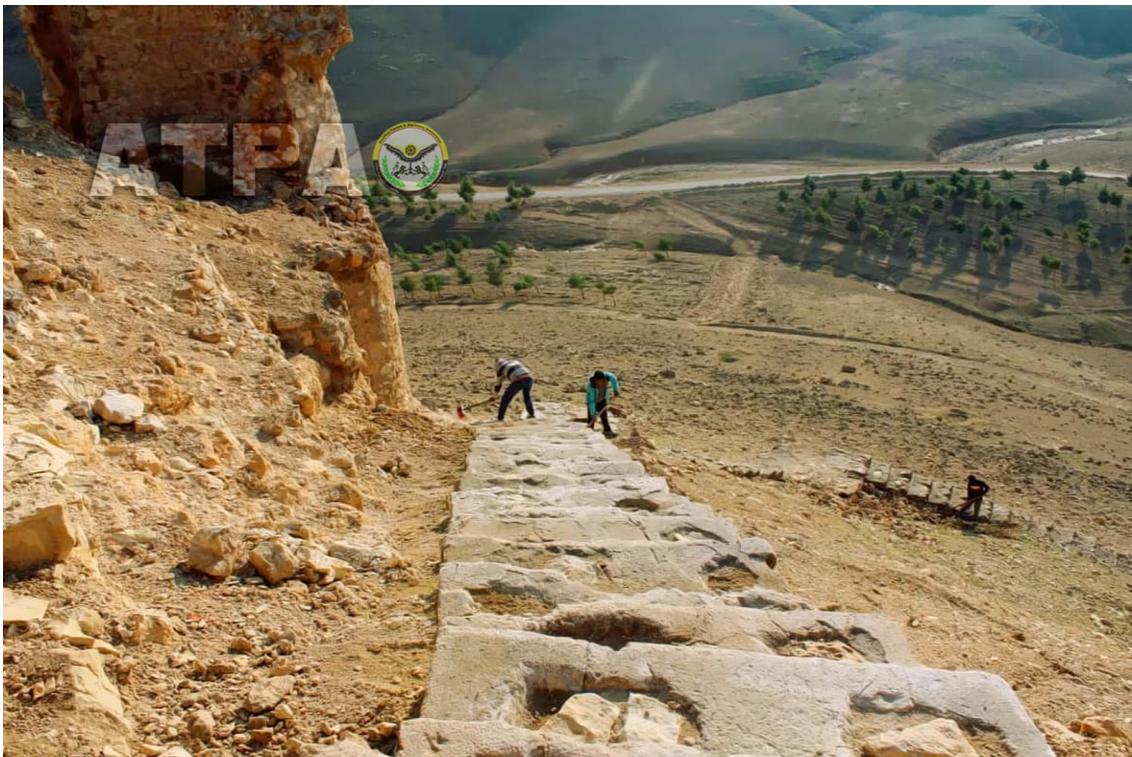
The cleaning of the steps leading up to Qalaat Sukara (ATPA; November 15, 2018)

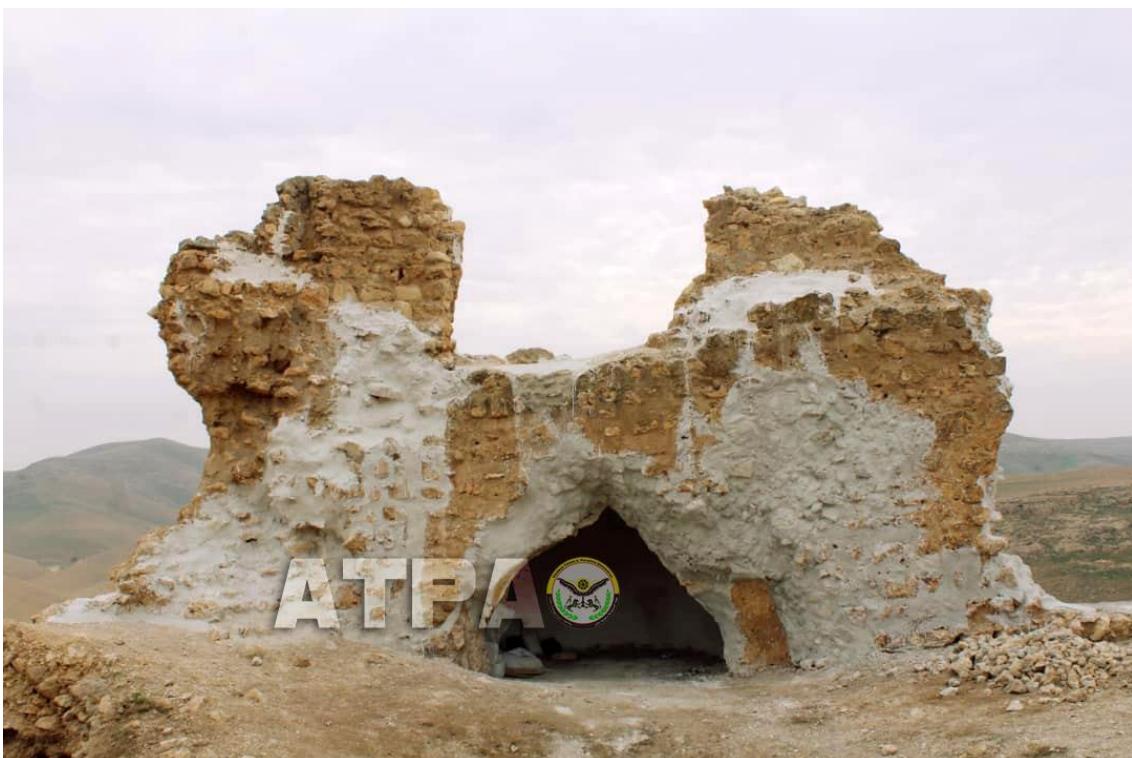
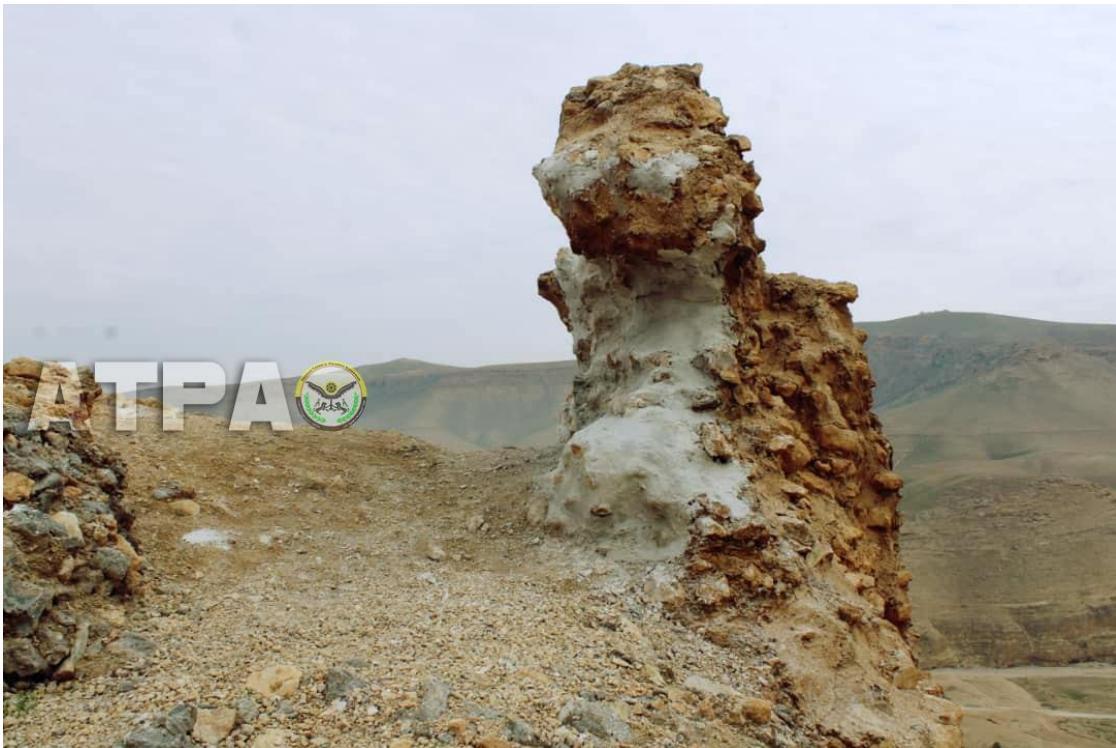
Conservation work at Qalaat Sukara with the application of plaster to stabilize the bricks (ATPA; November 26, 2018)

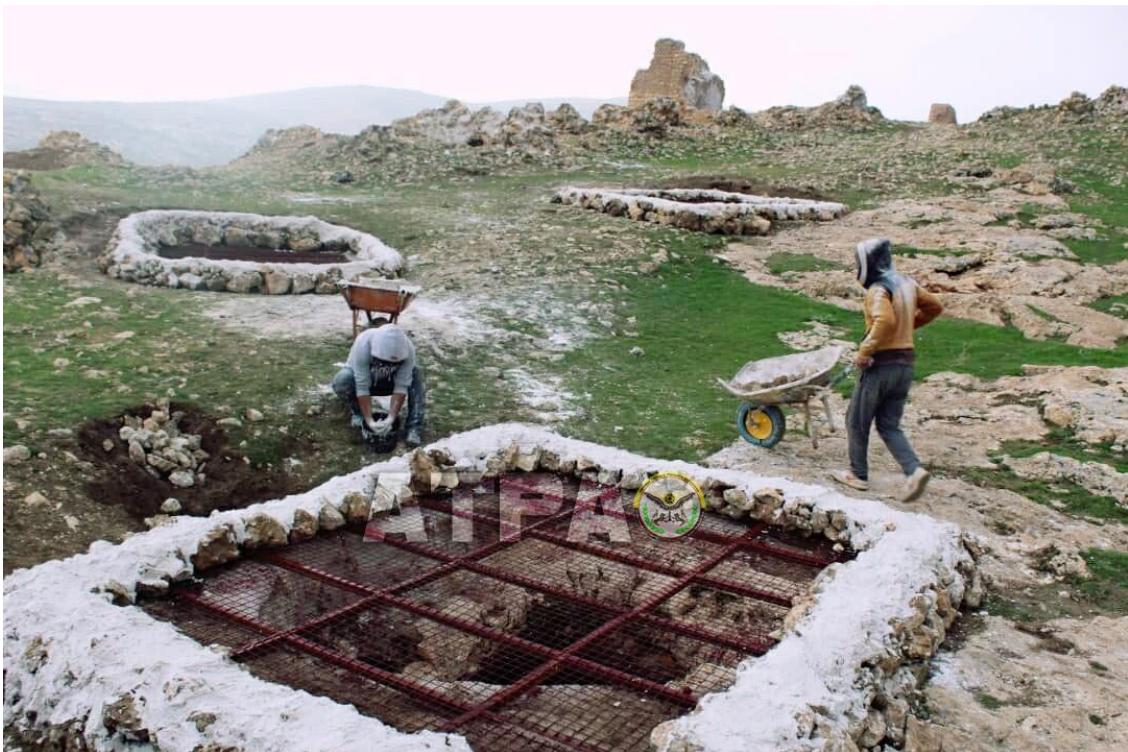
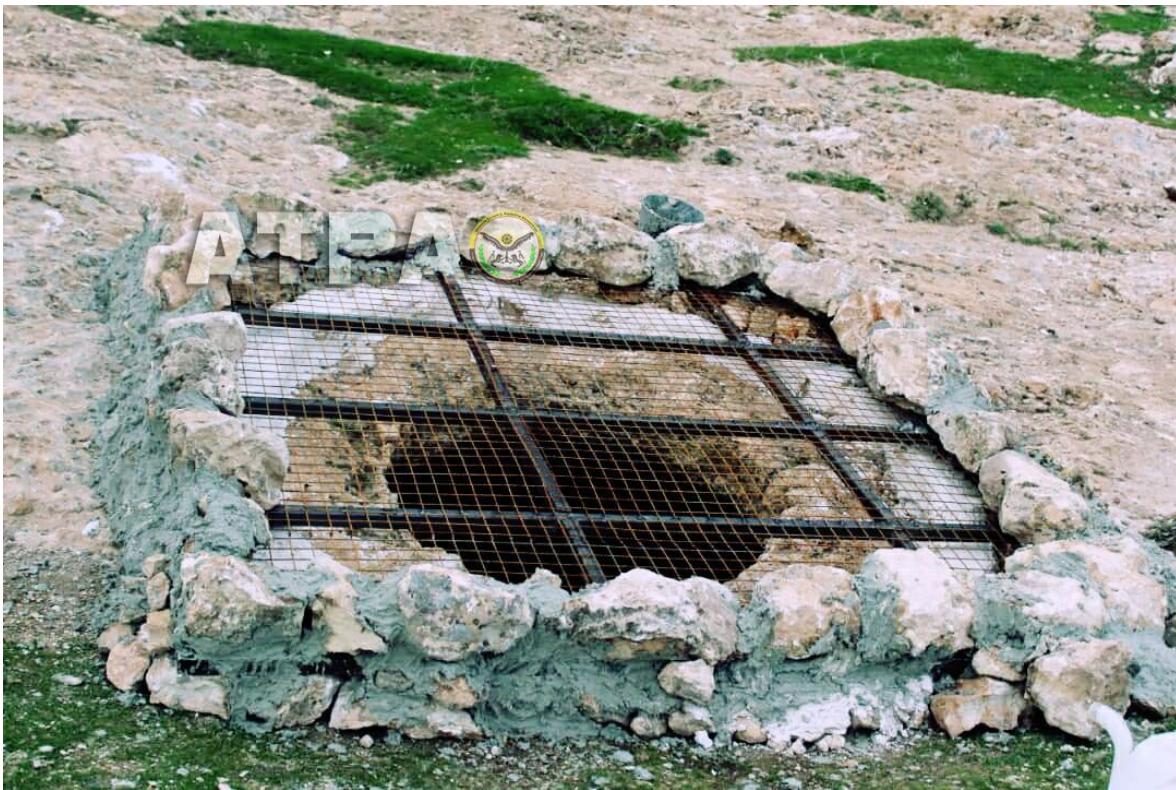
Conservation work at Qalaat Sukara with the application of plaster to stabilize metal grates that show the underground chambers (ATPA; November 26, 2018)

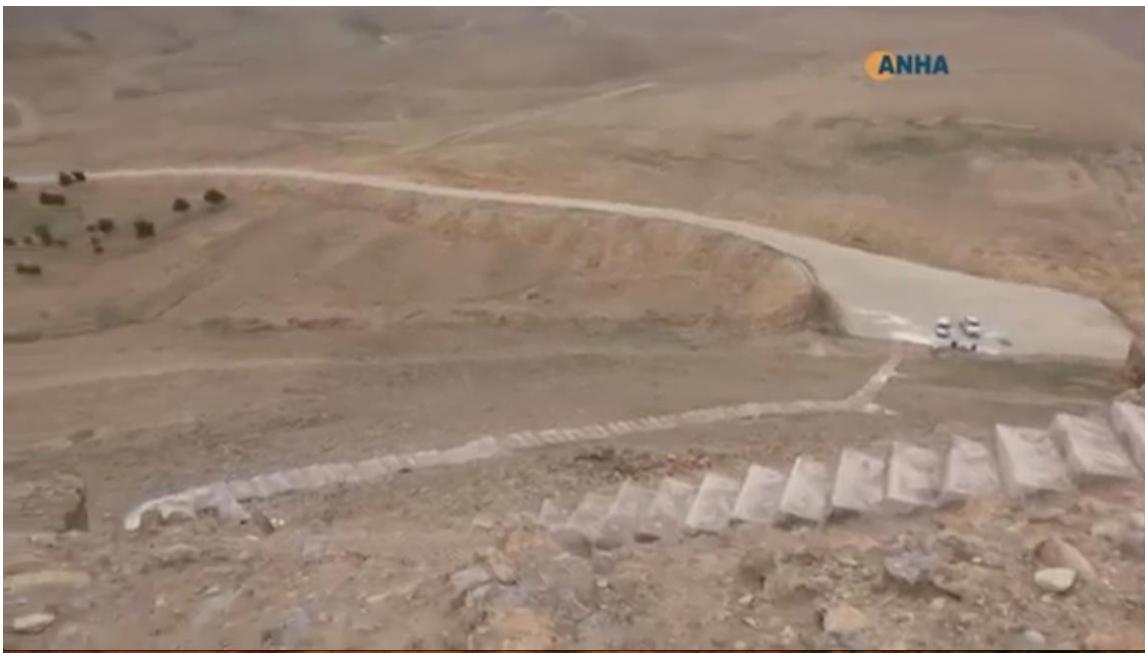
The completed stairs from the parking lot to Qalaat Sukara (Hawar News; November 22, 2018)

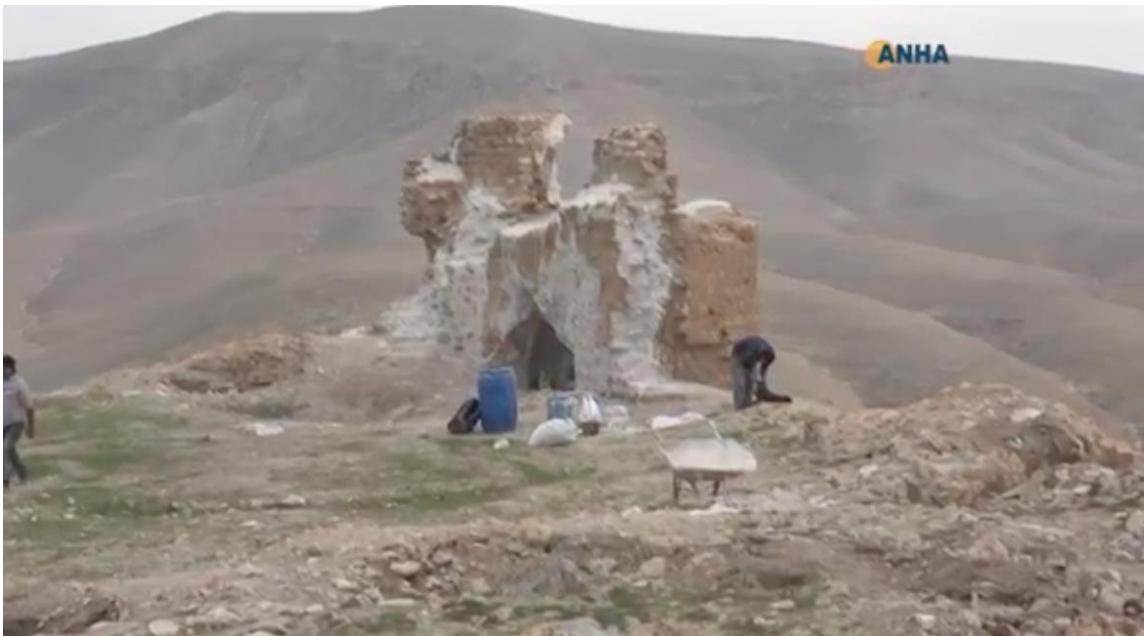
Conservation work in progress at Qalaat Sukara (Hawar News; November 22, 2018)

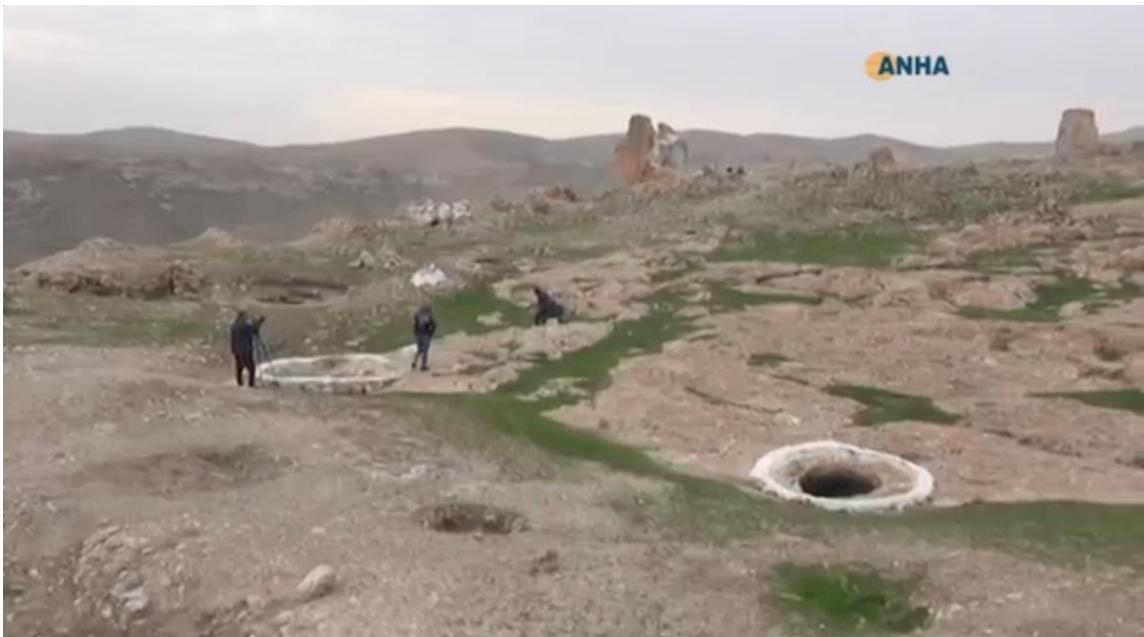
The top of Qalaat Sukara showing conservation work (Hawar News; November 22, 2018)

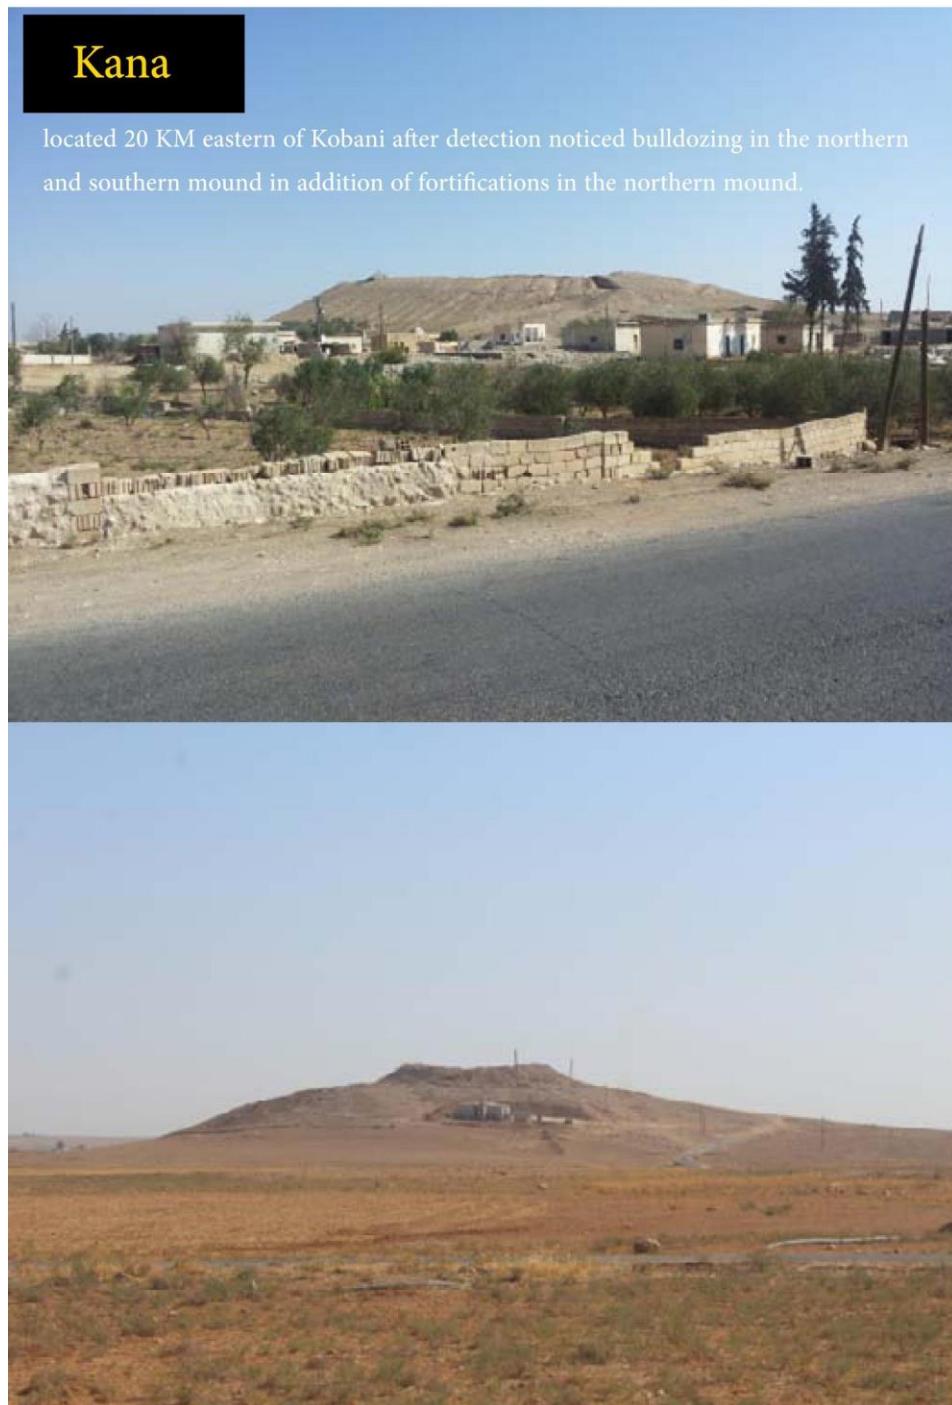
Bulldozing of the top of the mounds; the southern mound is at the top of the image and the northern mound is on the bottom (ATPA; December 30, 2017)

Incident Source and Description: On November 6, 2018 TRT Haber published a video showing drone footage over two tells: Tell Bandar Khan and Tell Bandar Khan Nord.⁵¹ Screenshots of this video were published on the individual Twitter feed Qalaat al-Mudiq.⁵² The video shows that the tops of the mound have been bulldozed, creating berms around the top of the tells. Military emplacements have also been built into the tops of the mounds and trenches have been dug around the base of the northern tell. Both TRT Haber and Qalaat al-Mudiq stated that the damage is due to YPG/SDF forces militarizing the mounds. On December 30, 2017 the Authority of Tourism and Protection of Antiquities (ATPA) reported that the top of the mound had been bulldozed.⁵³

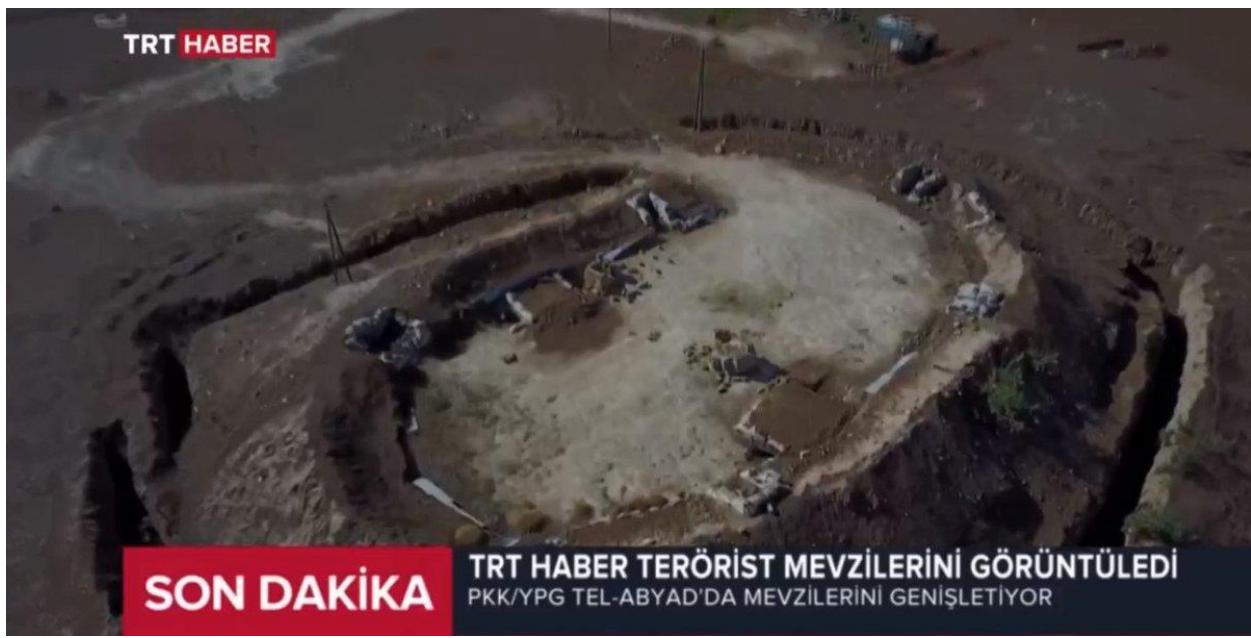
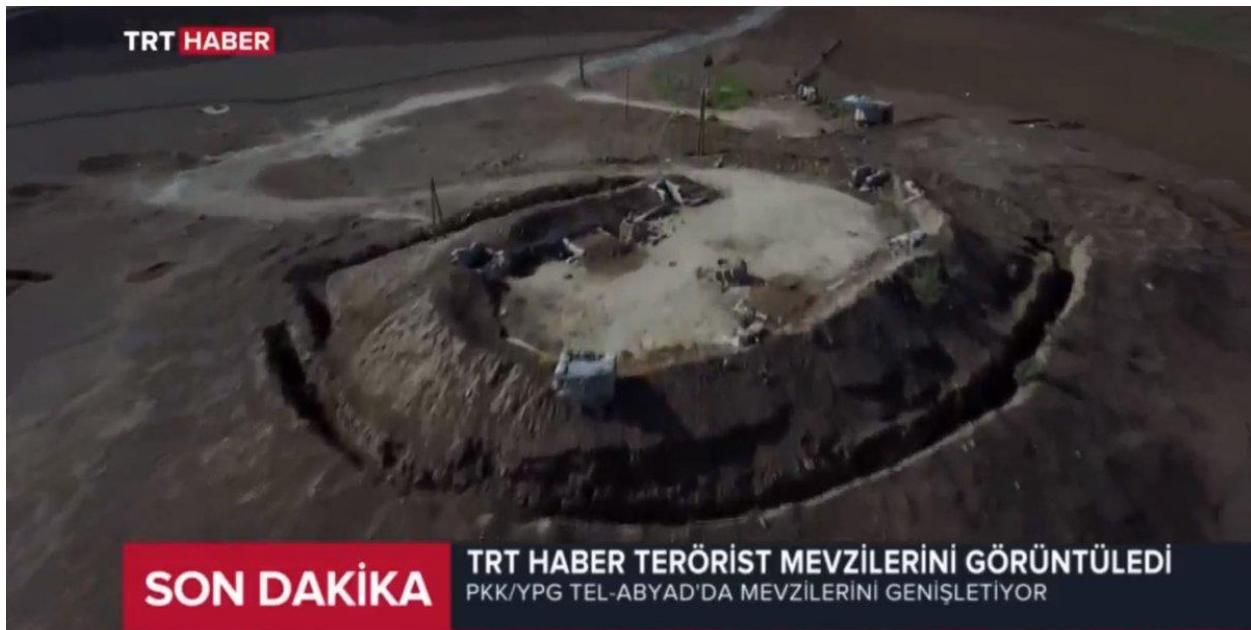
Video still of the top of the northern mound showing bulldozing, creation of berms, and military emplacements around the top of the tell and trenching around the base of the tell (TRT Haber, November 11, 2018)

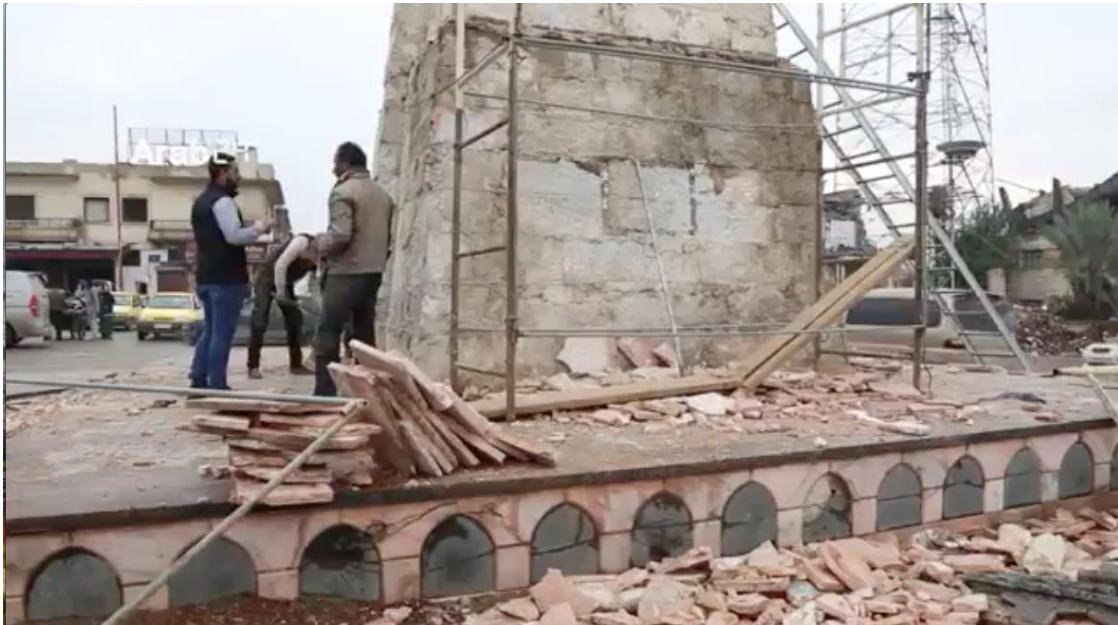
Video still showing the base of the clock tower (Syrian Forces from the Front; November 13, 2018)

Heritage Response Source (organization) and Description of Work: On November 13, 2018 Syrian Forces from the Front published a video showing the cleaning and restoration of the Raqqa Clock Tower.⁵⁵ A team from the Civil Council and the People's Council of Raqqa is cleaning the clock tower, repairing the faces, and creating a mosaic of cultural art on the roundabout where the tower is located. According to the video, this work is being done to erase the memories of the executions that were committed in the square.

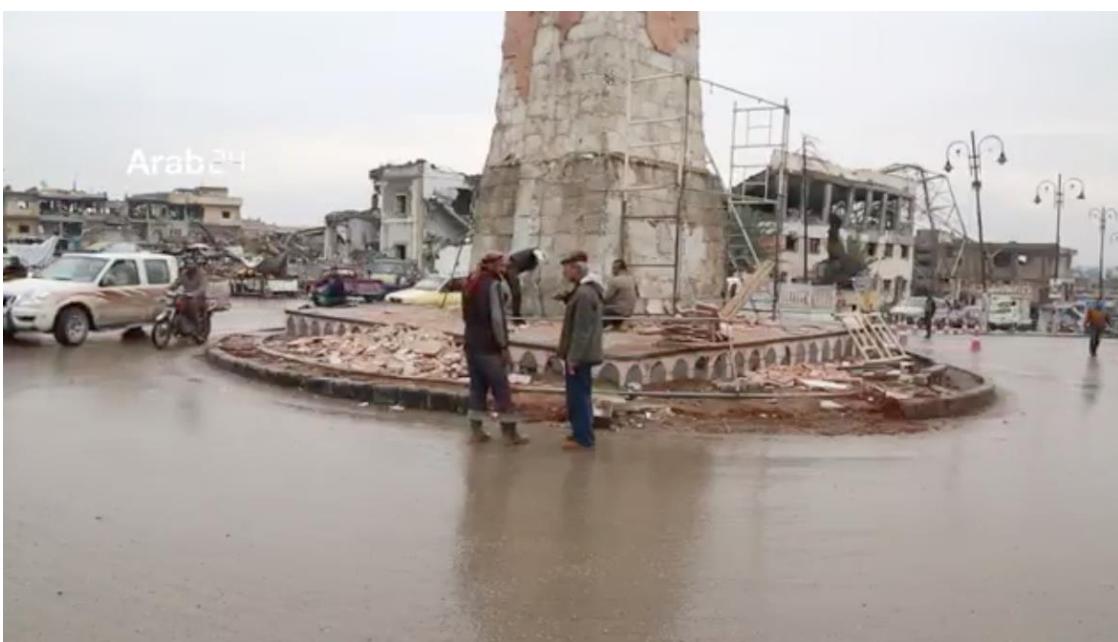
Video still showing the base of the clock tower and the roundabout (Syrian Forces from the Front; November 13, 2018)

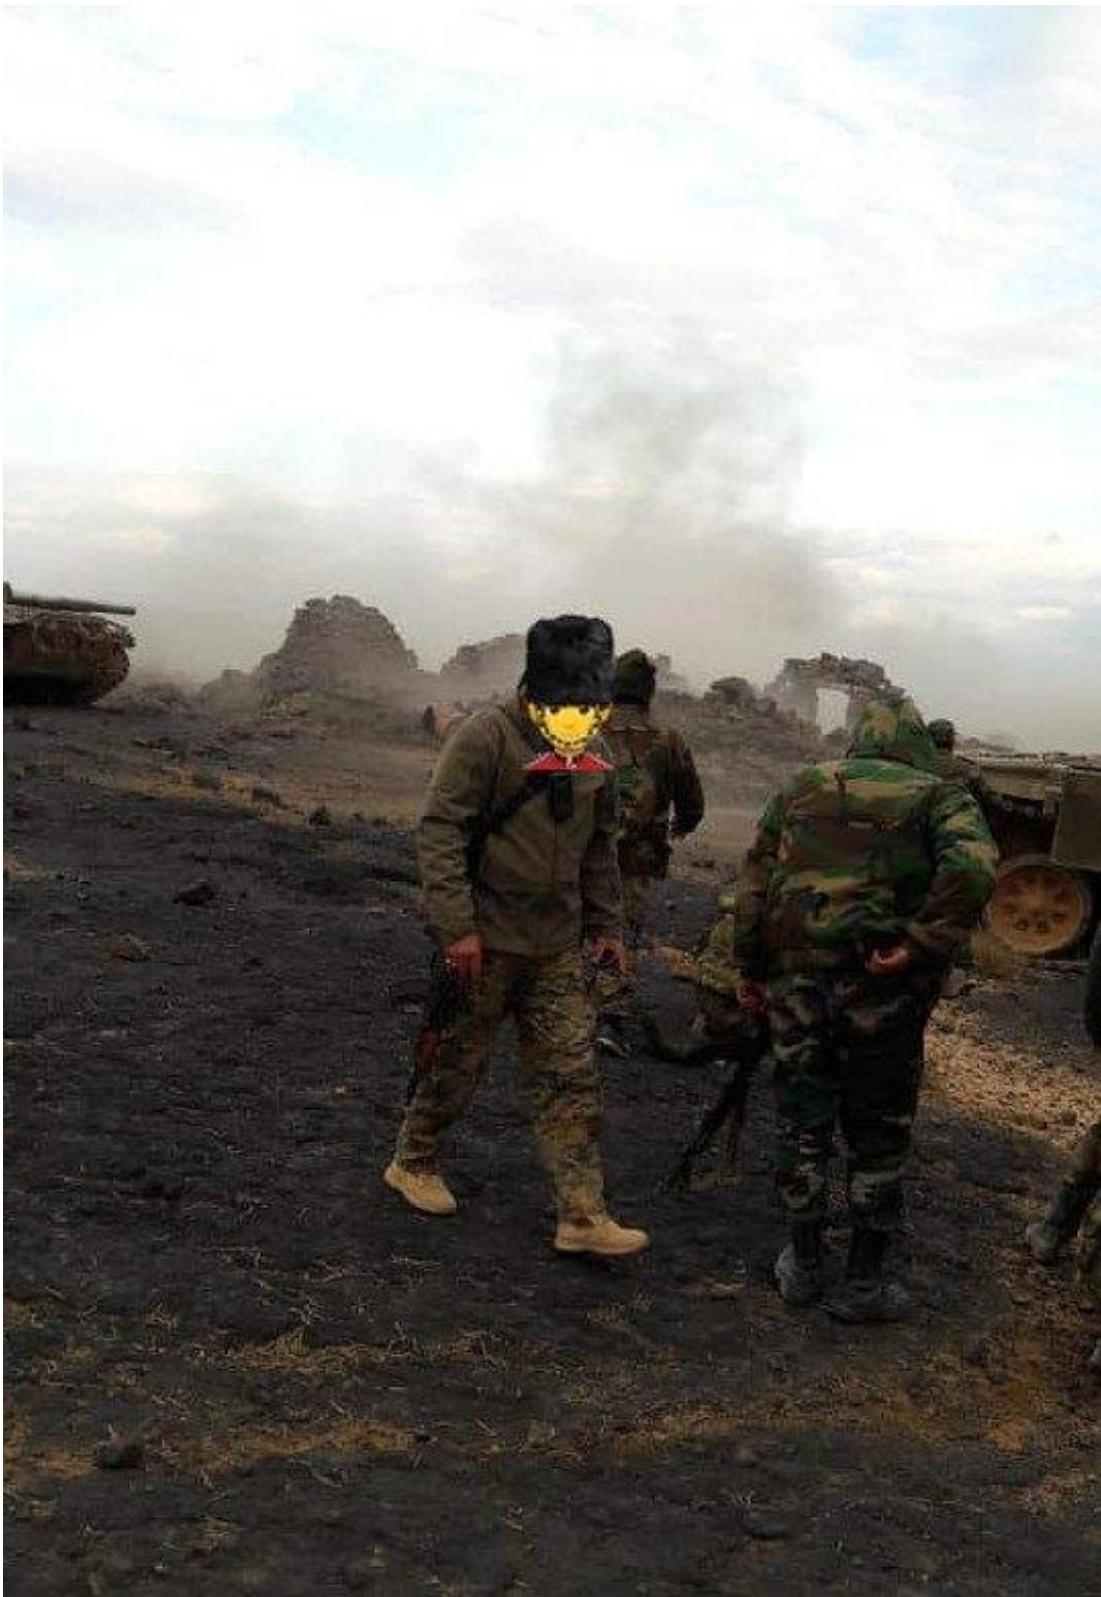
Pro-regime forces active in the vicinity of the tomb, seen in the background (Qalaat al-Mudiq; November 16, 2018)

Monitoring Recommendations and Mitigation Measures: ASOR CHI will continue to monitor the condition of Qabr Sheikh Hussein, as well as the condition of other cultural heritage sites located in regions subject to military activity.
