ASOR Cultural Heritage Initiatives (CHI): Planning for Safeguarding Heritage Sites in Syria and Iraq¹

S-JO-100-18-CA-004

November 2018 Monthly Appendices

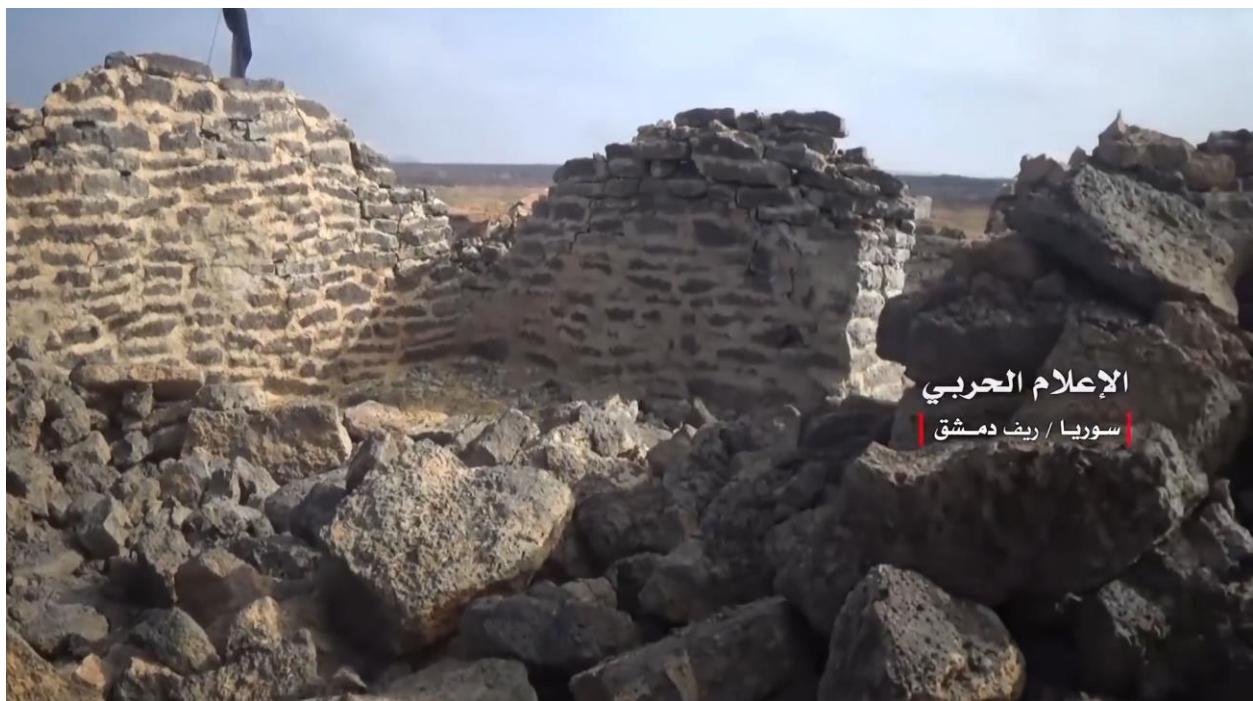
Video still of the walls of the tomb (War Media; November 18, 2018)

Incident Source and Description: On November 16, 2018 SARG forces recaptured the area of Qabr Sheikh Hussein in the al-Safa Volcanic Field from ISIS.⁶¹ Photographs and video taken by regime soldiers reveal that Qabr Sheikh Hussein has been heavily damaged.⁶² Only parts of the walls and a few doorways remain standing. The circumstances surrounding the destruction of the site as well as its condition prior to the recent fighting in the area are unknown.⁶³

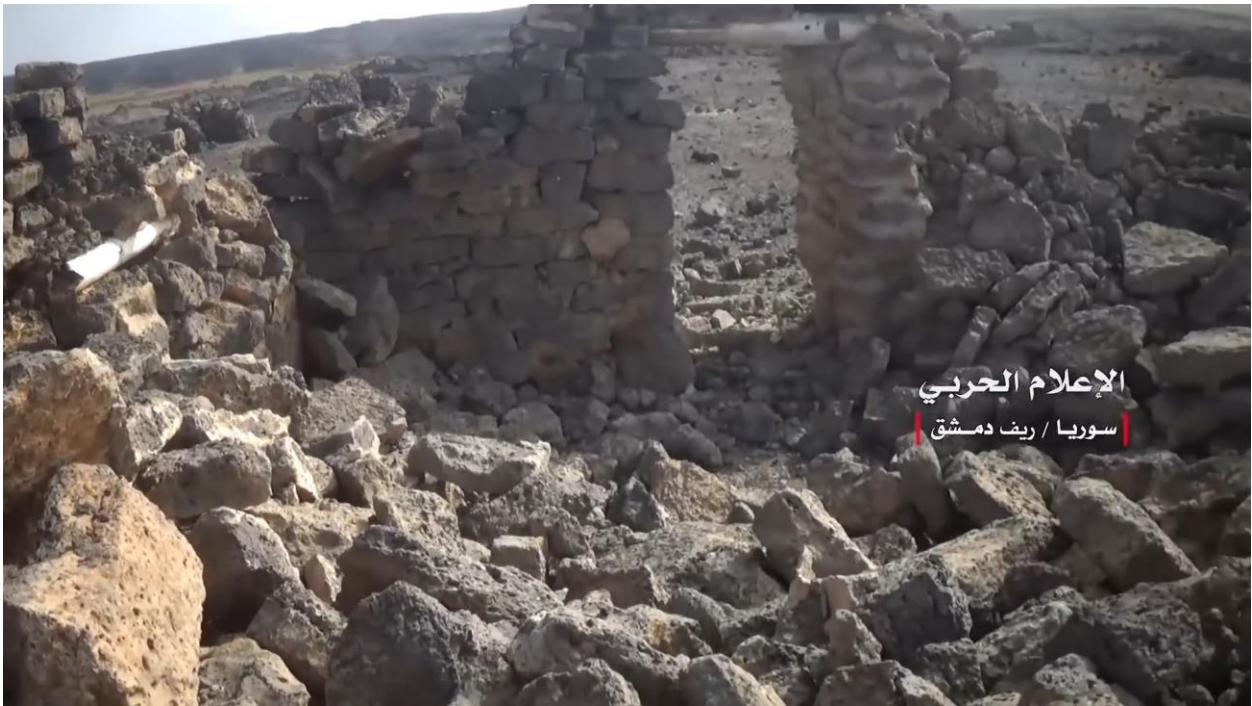
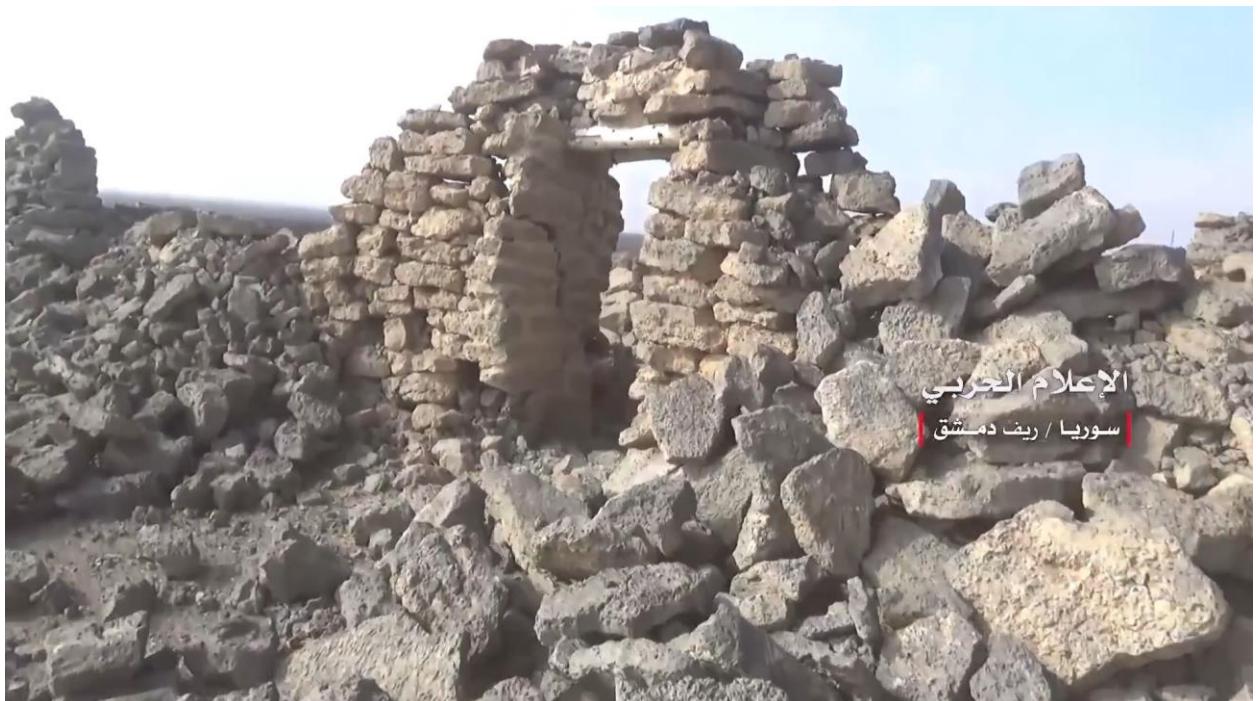
Video still of an entrance into the tomb (War Media; November 18, 2018)

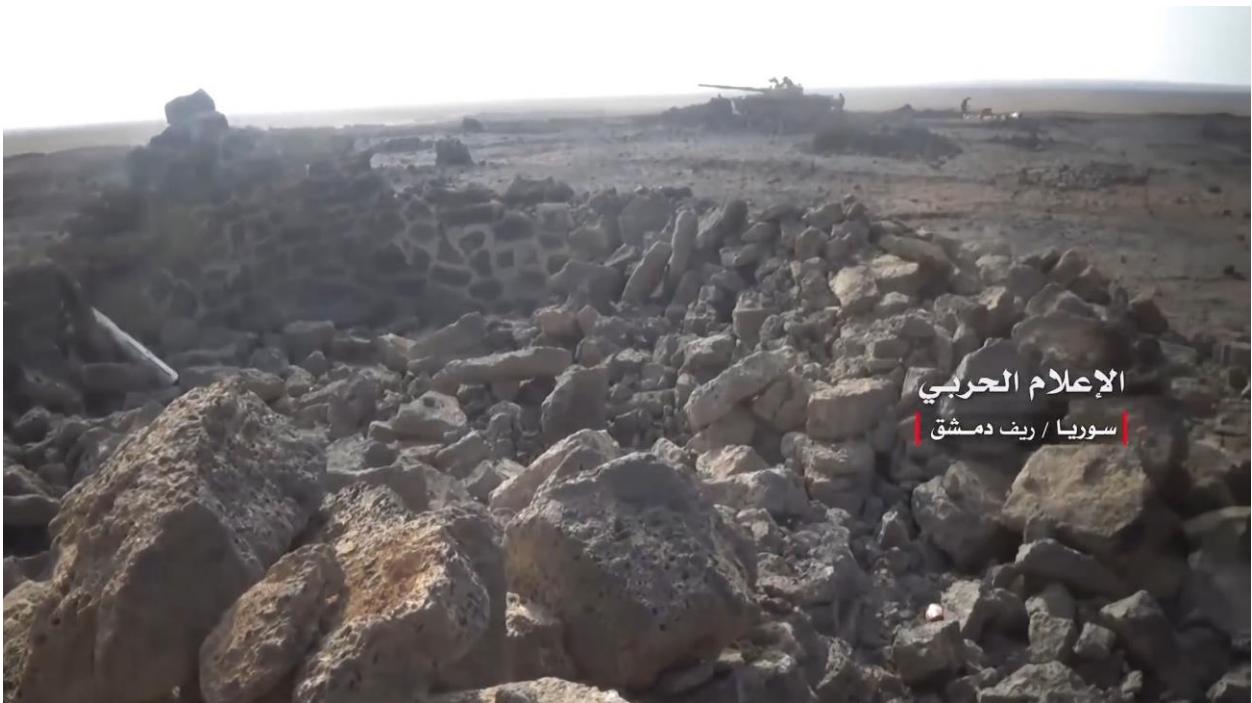
Video still of the remains of the tomb with Syrian forces visible in the background (War Media; November 18, 2018)

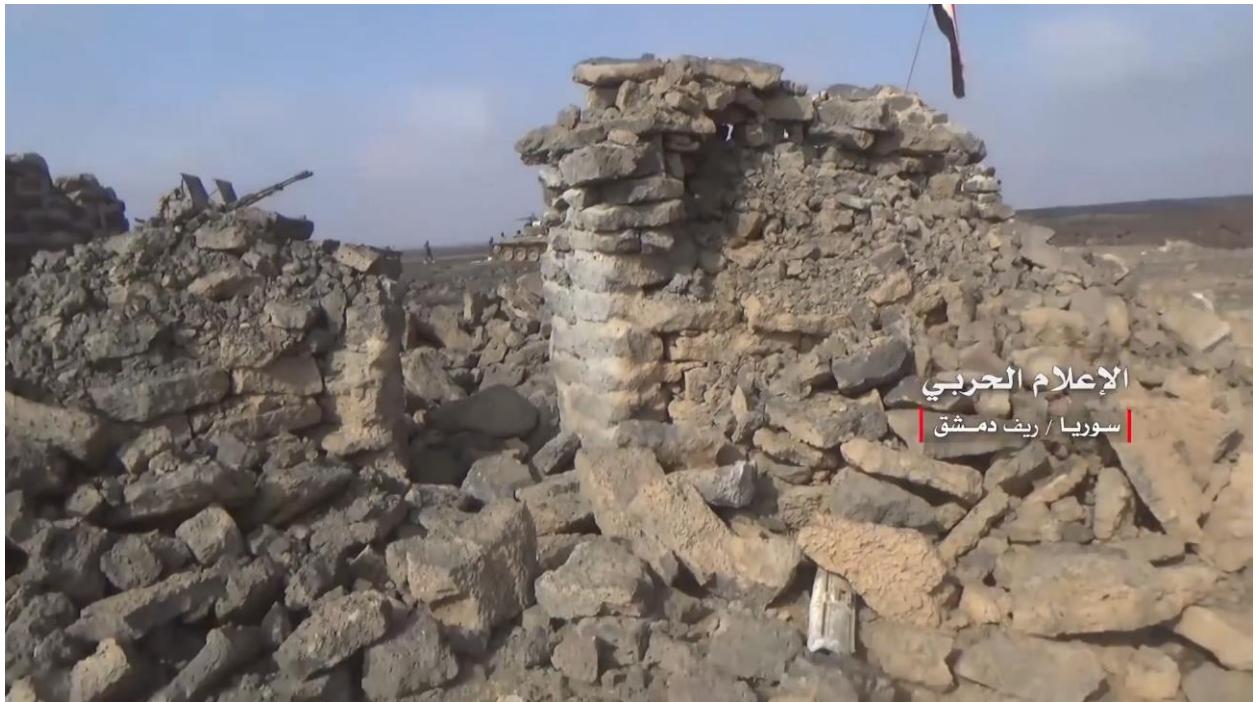
Video still of a doorway into the tomb (War Media; November 18, 2018)

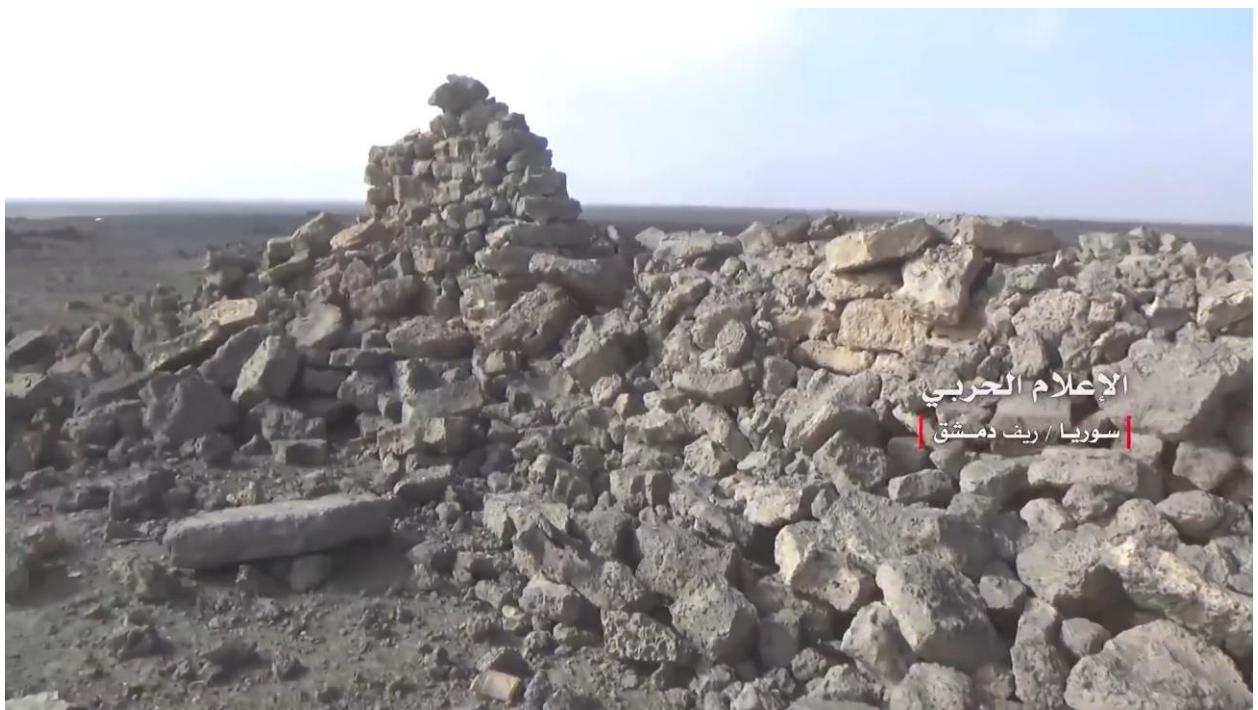
Video still of one corner of the tomb (War Media; November 18, 2018)

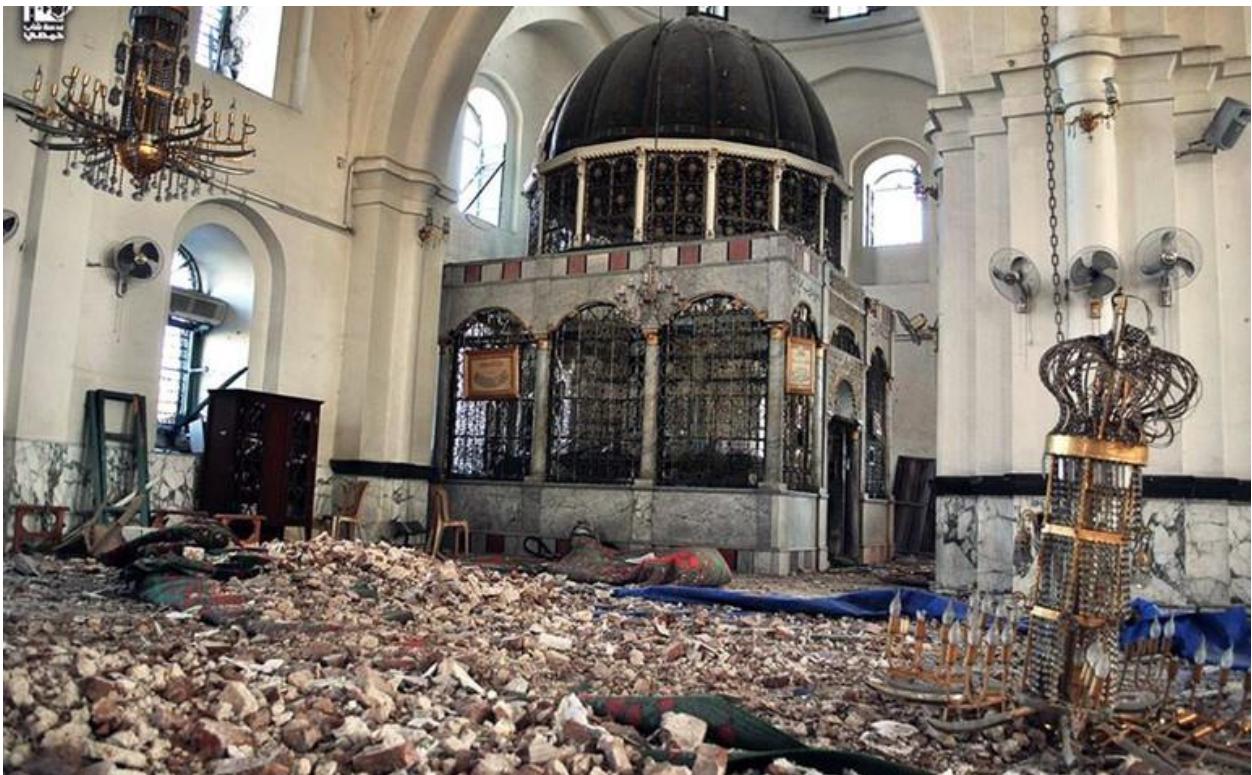
The condition of the tomb inside the Khaled ibn al-Walid Mosque following aerial bombardment and shelling (Bab al-Shiba; July 10, 2013)

The DGAM conflict report, released May 2015, stated that severe damage was sustained with approximately 40% of the mosque sustaining structural damage; approximately 80% of the damage was to the interior, including furnishing and decoration. On October 21, 2015 the DGAM reported the restoration of the outer walls and minaret had begun.⁷² In September 2016, photographs showed scaffolding on the exterior of the mosque.⁷³

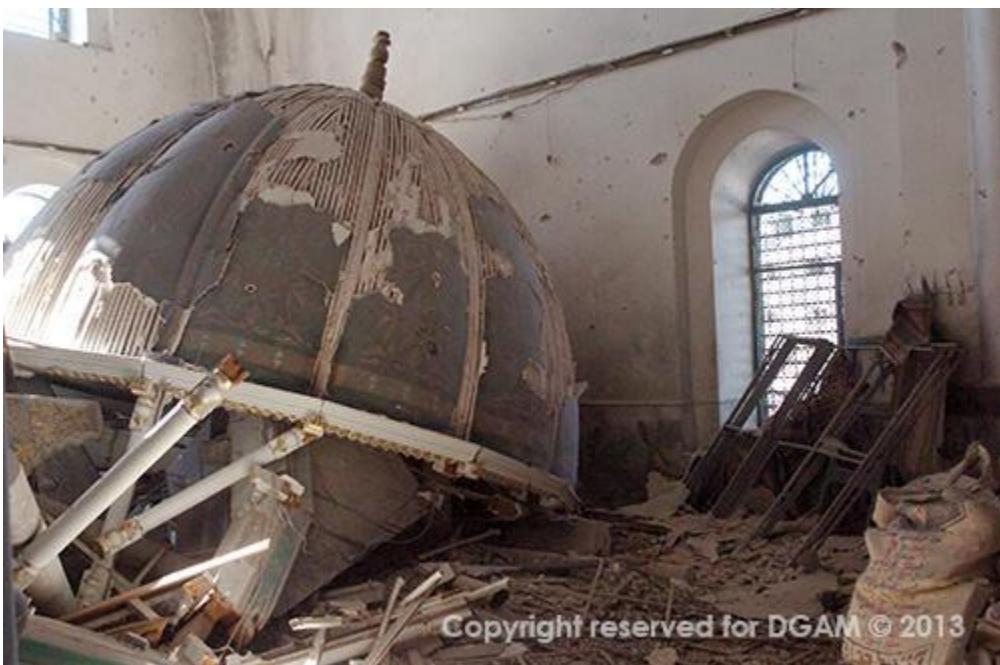
The tomb inside the Khaled ibn al-Walid Mosque after destruction (DGAM; October 8, 2013)

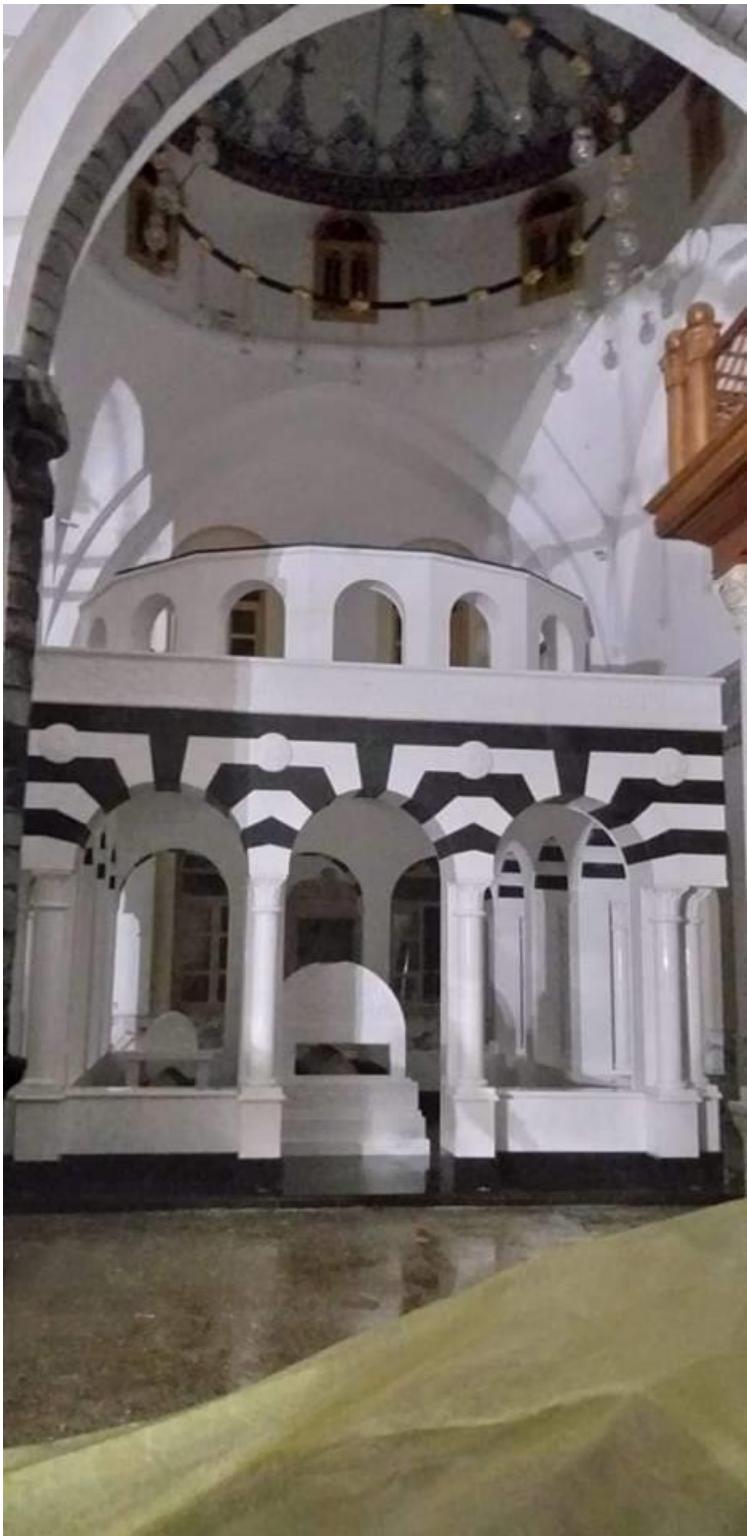
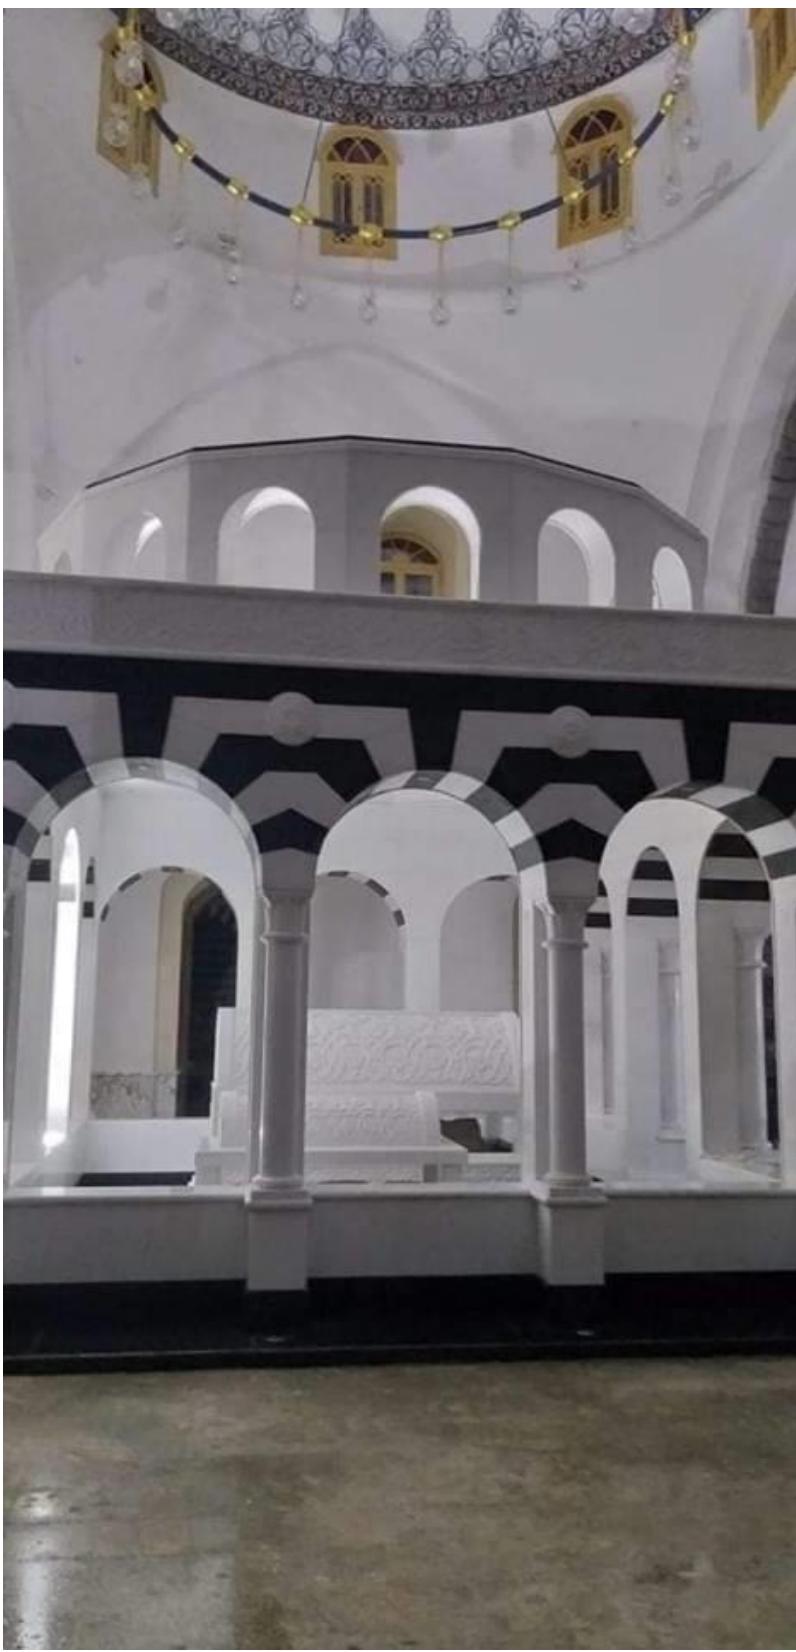
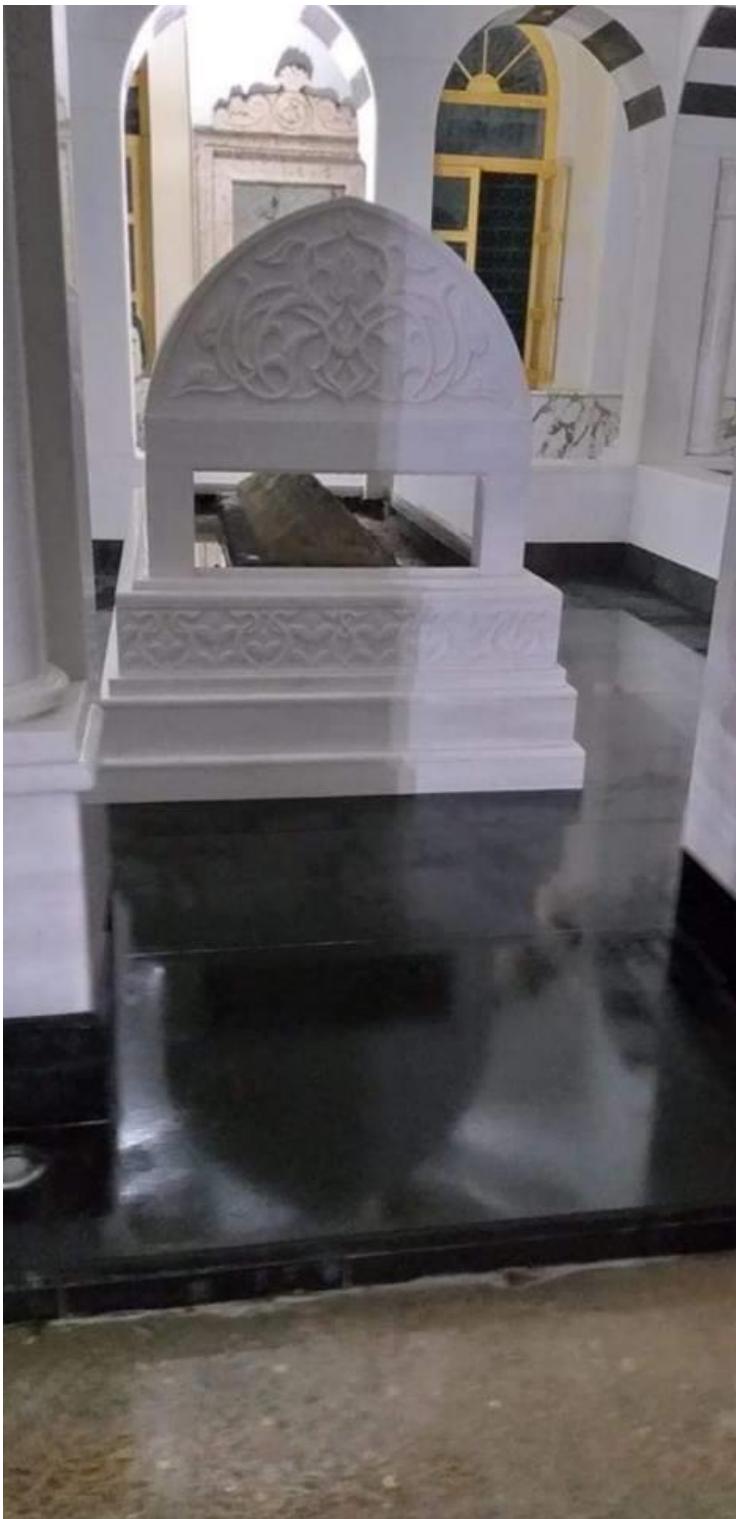
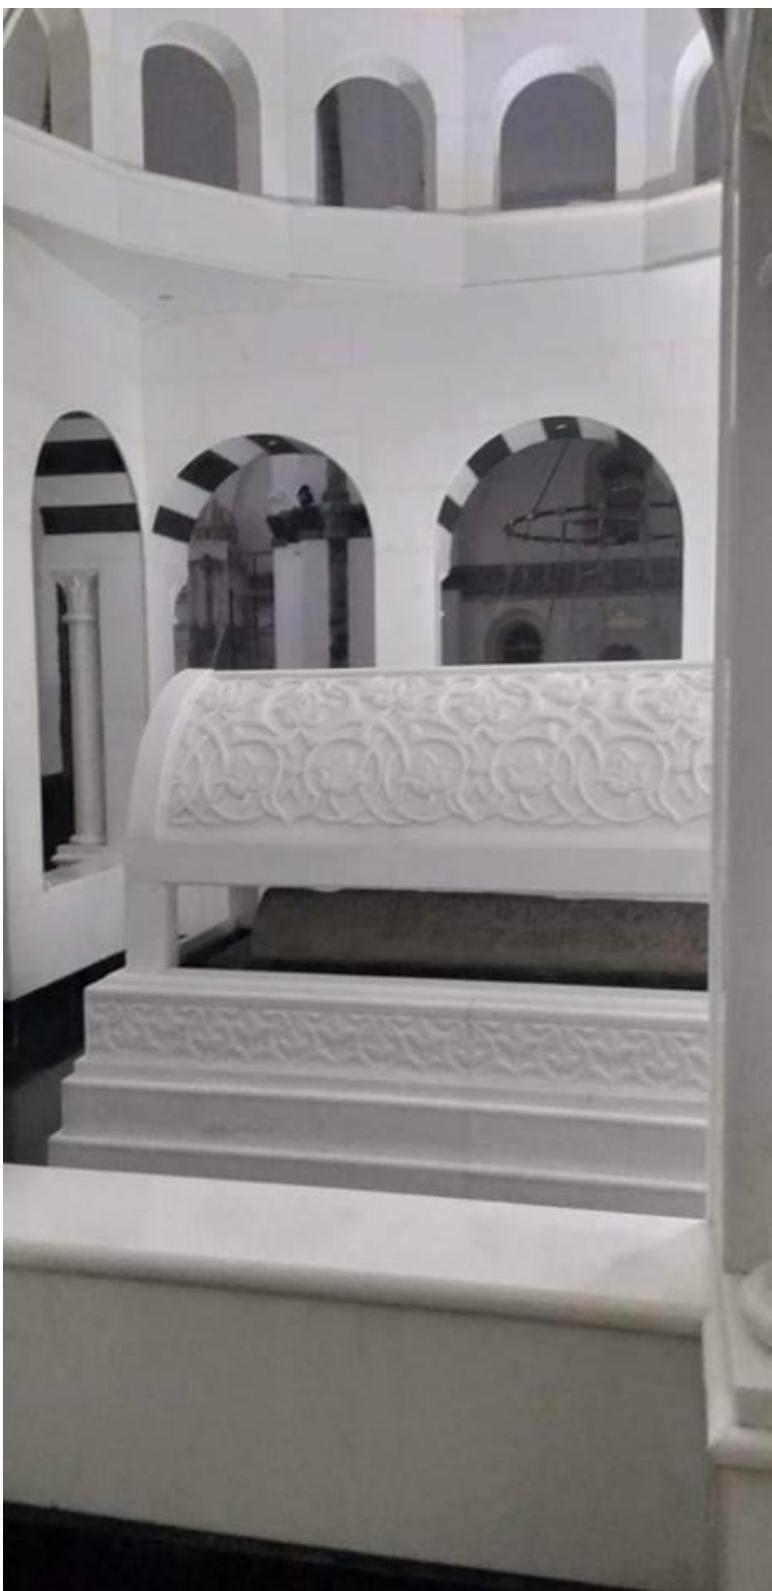
The tomb inside the Khaled ibn al-Walid Mosque after reconstruction (Museum of Ancient Photos of the City of Homs: November 20, 2018)

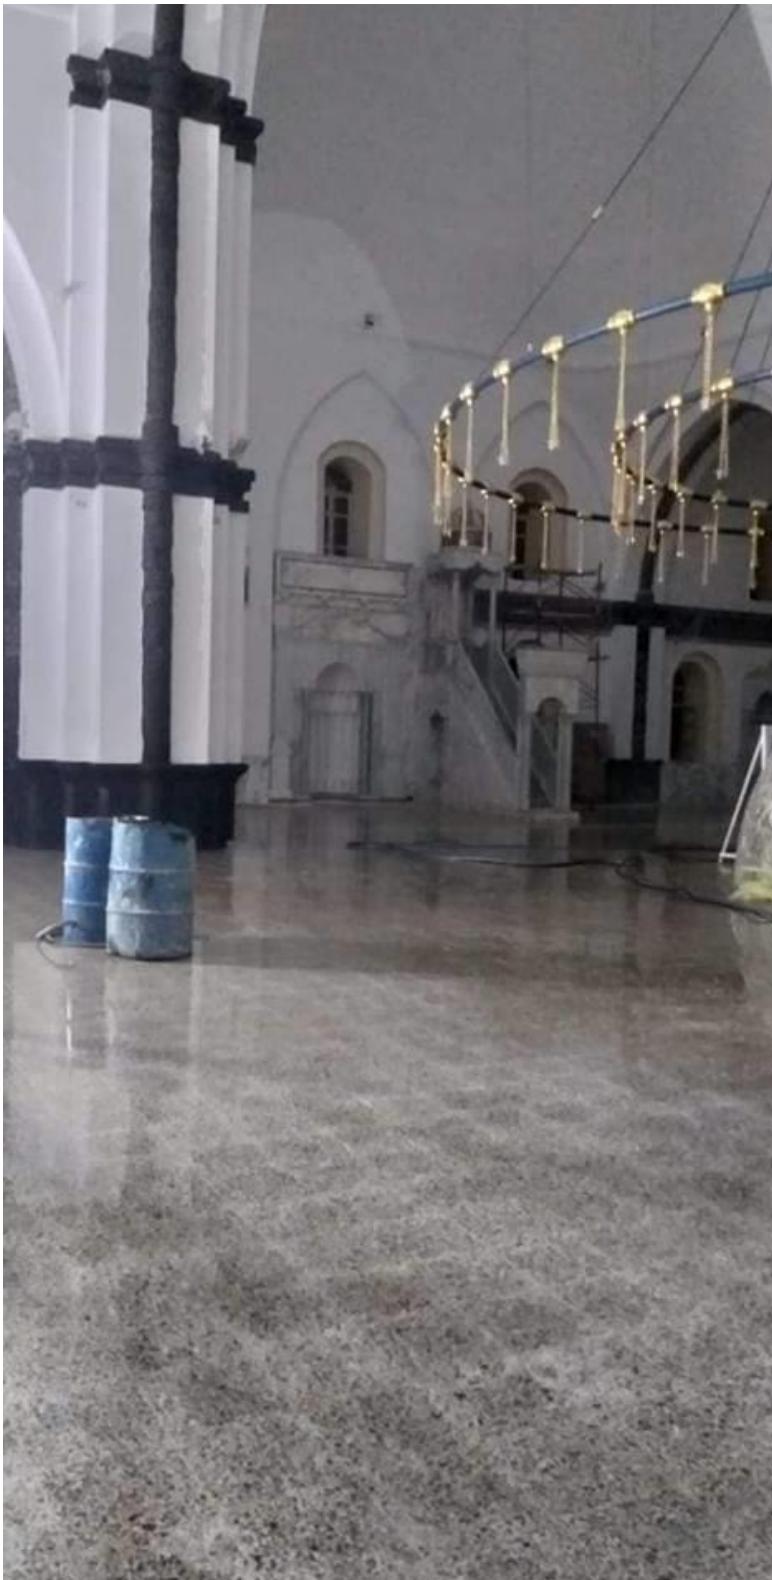
The mihrab inside the Khaled ibn al-Walid Mosque after reconstruction (Museum of Ancient Photos of the City of Homs: November 20, 2018)

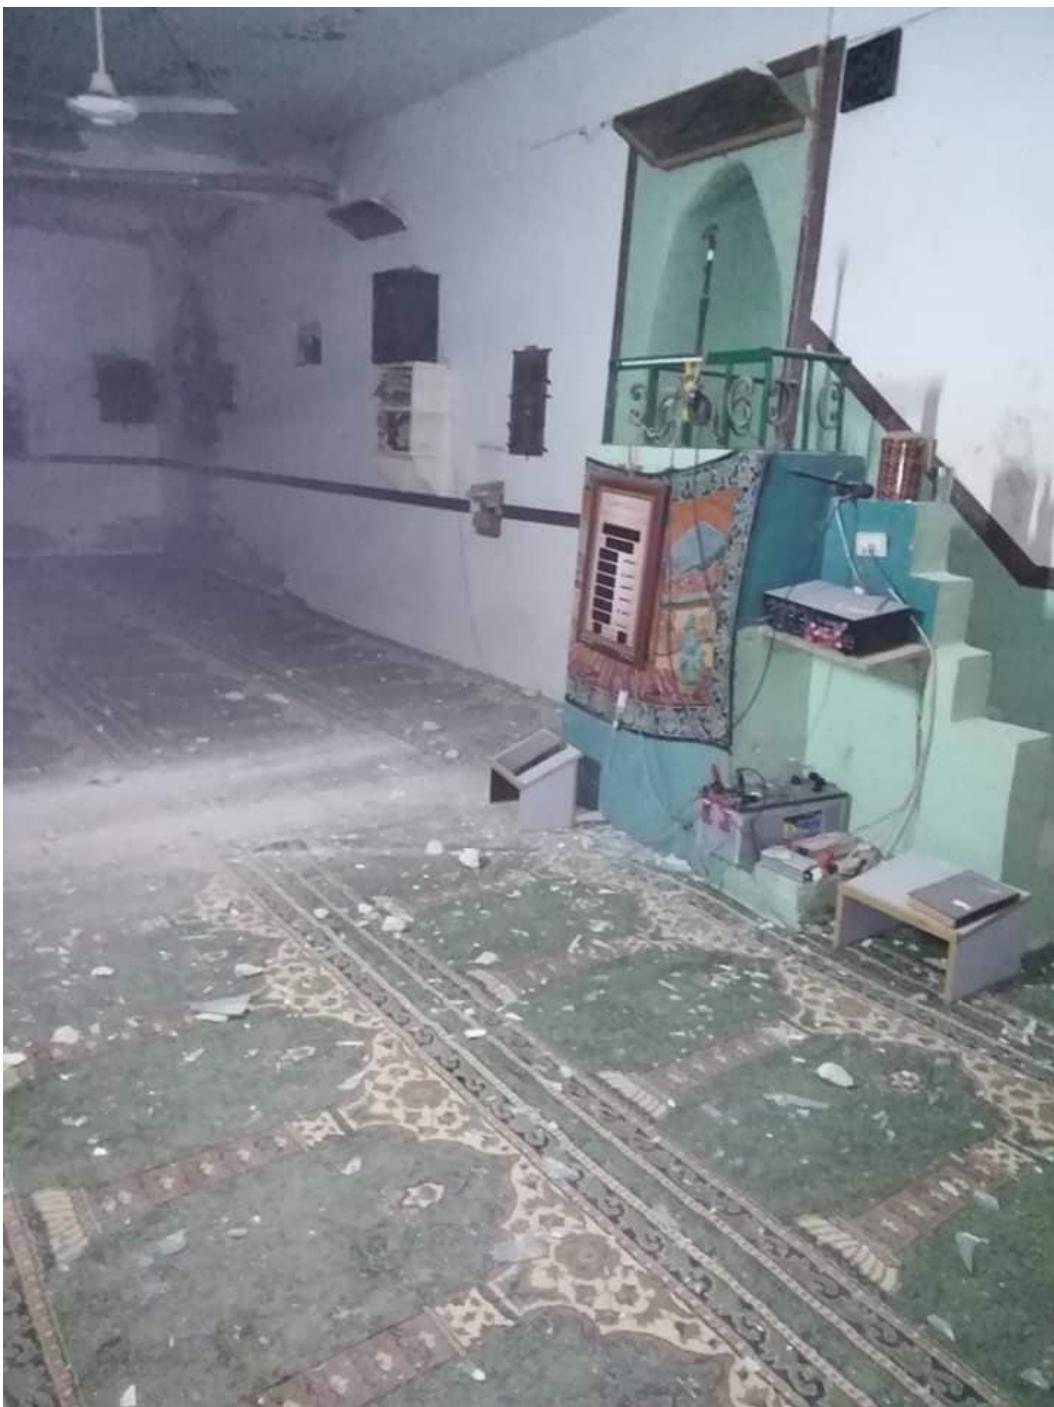
The interior of the mosque (Media Center in Talafah Village; November 20, 2018)

Incident Source and Description: On November 20, a SARG artillery bombardment damaged the Talafah Mosque.⁷⁵ The shelling caused multiple holes in the walls of the building and spread debris over the floor. The bombardment was reportedly in response to casualties inflicted on SARG forces during an attempt to infiltrate opposition territory.⁷⁶

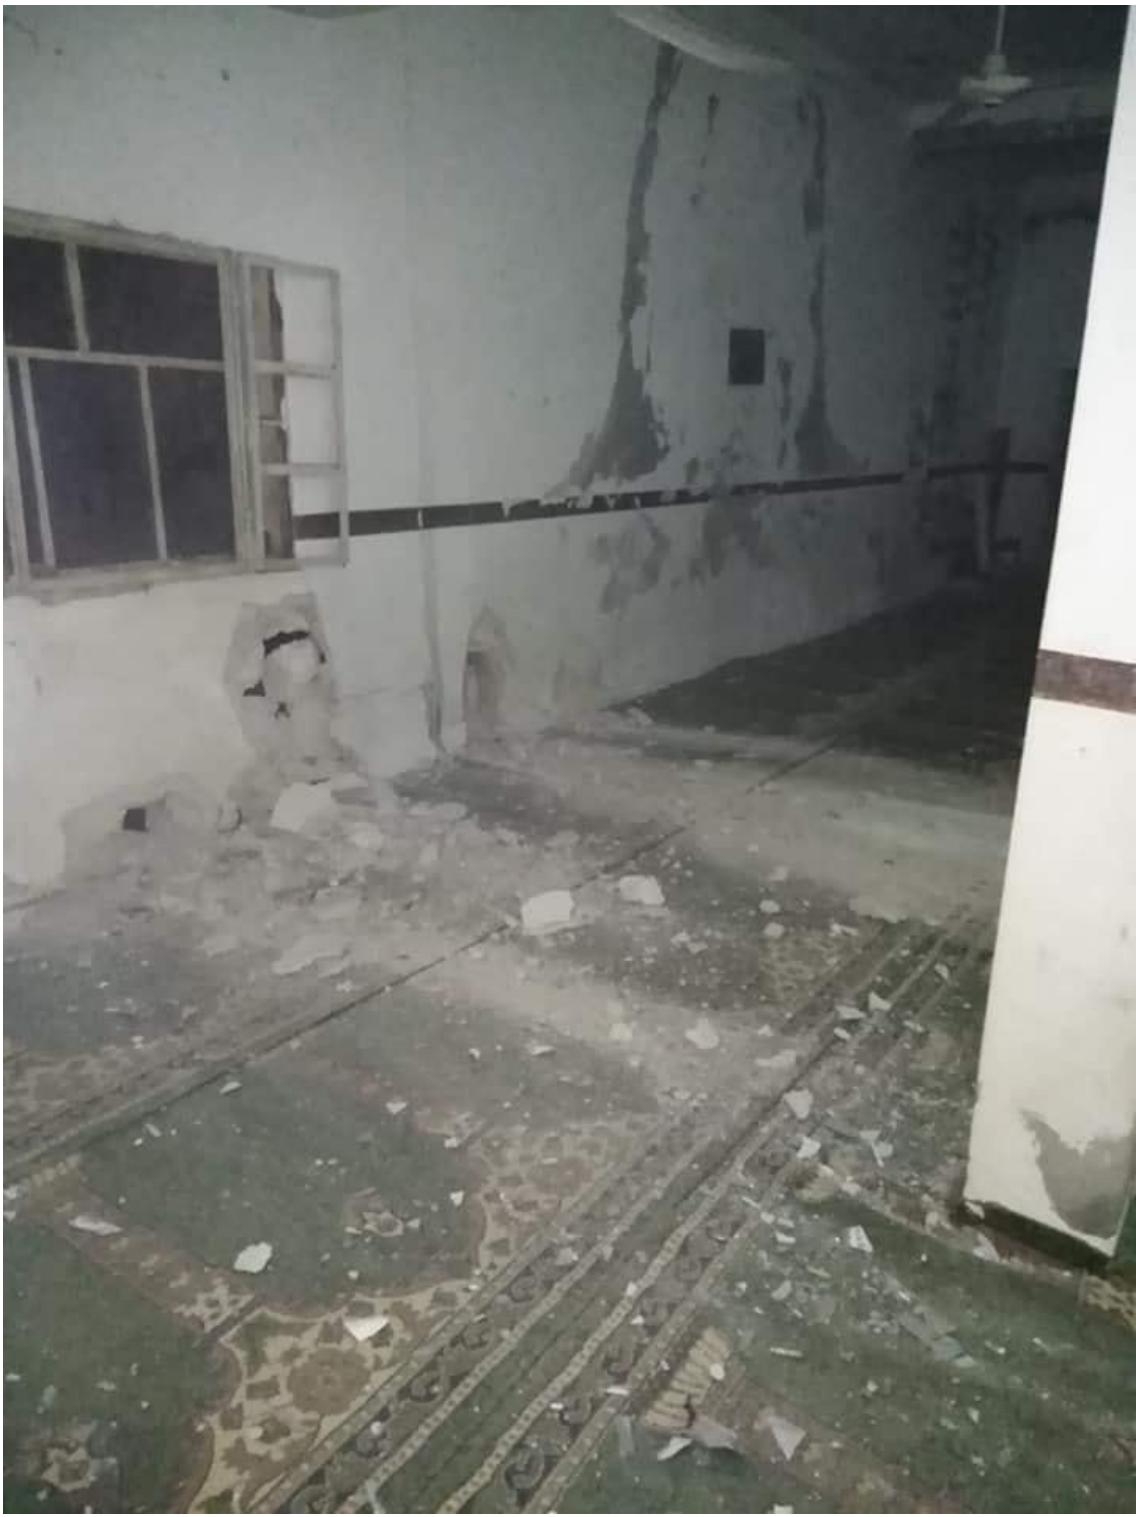
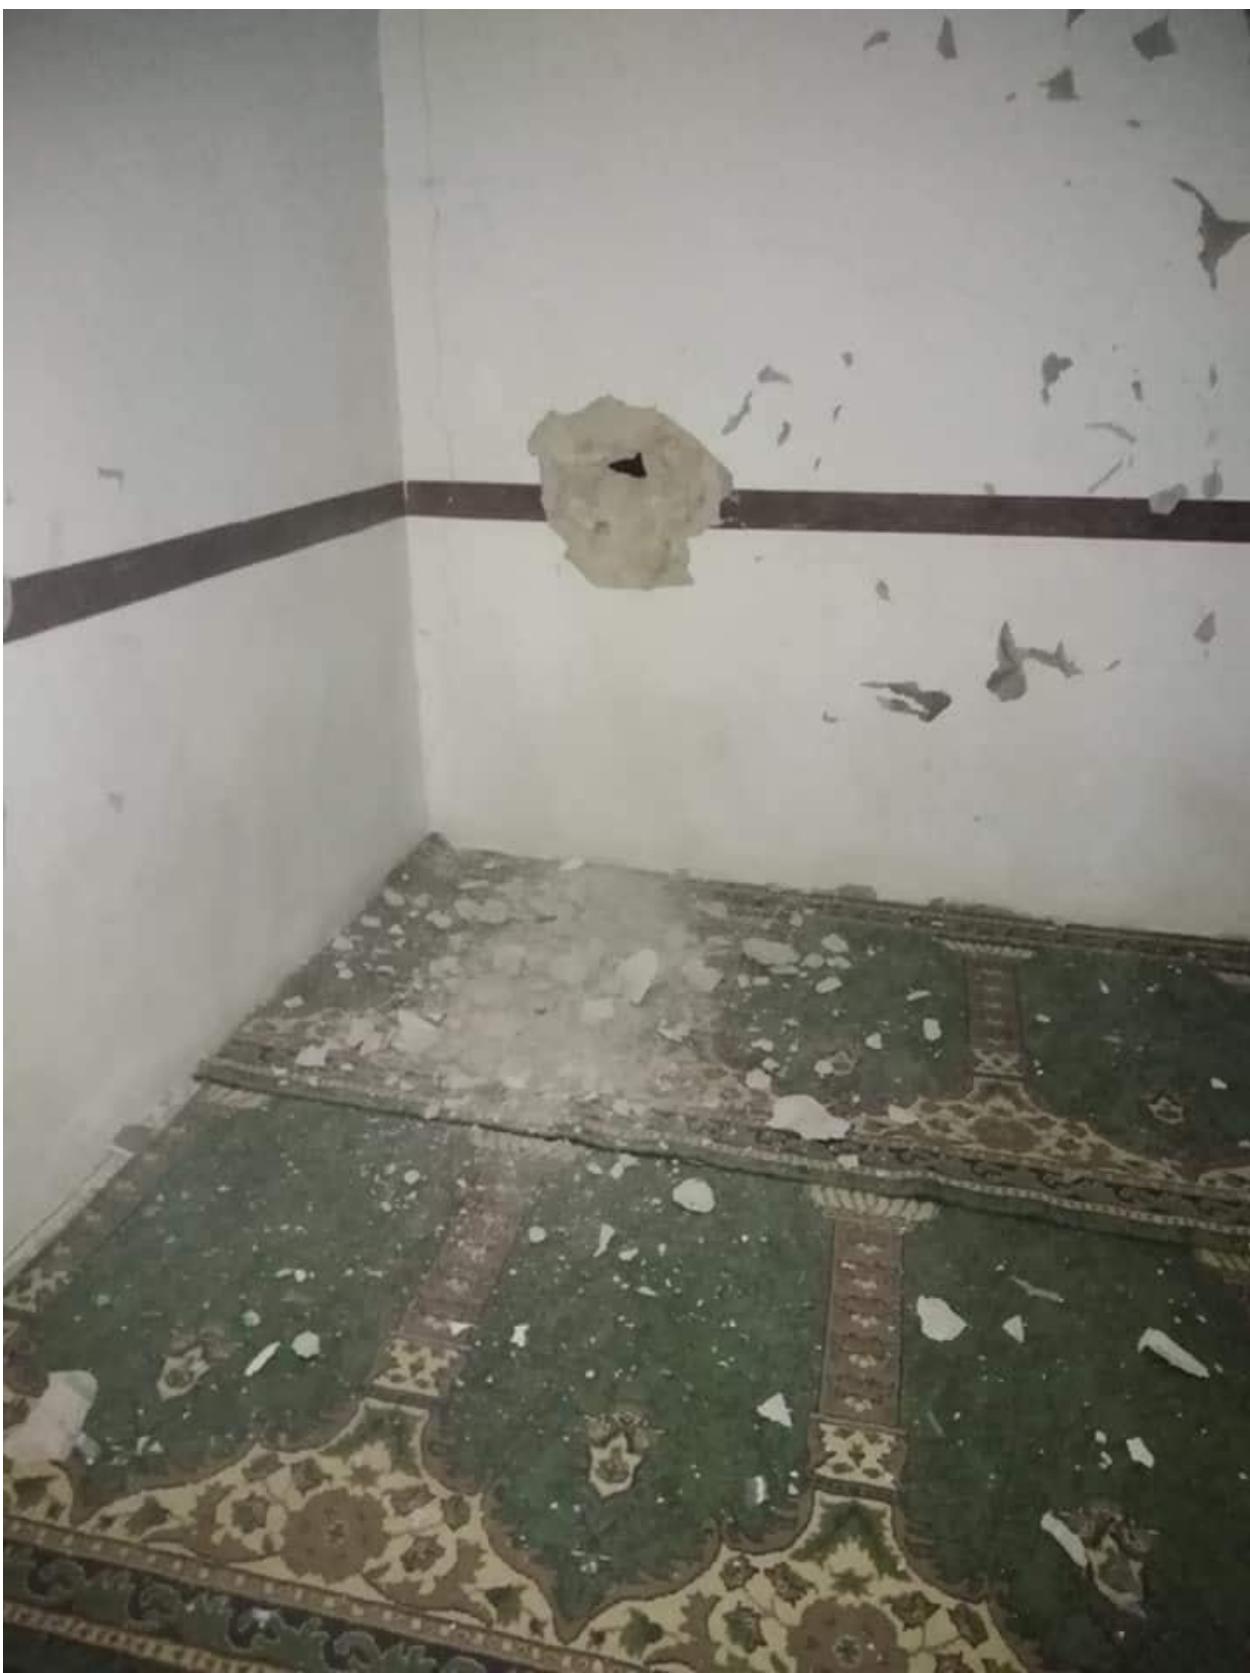
Damage to a wall in the mosque (Media Center in Talafah Village; November 20, 2018)

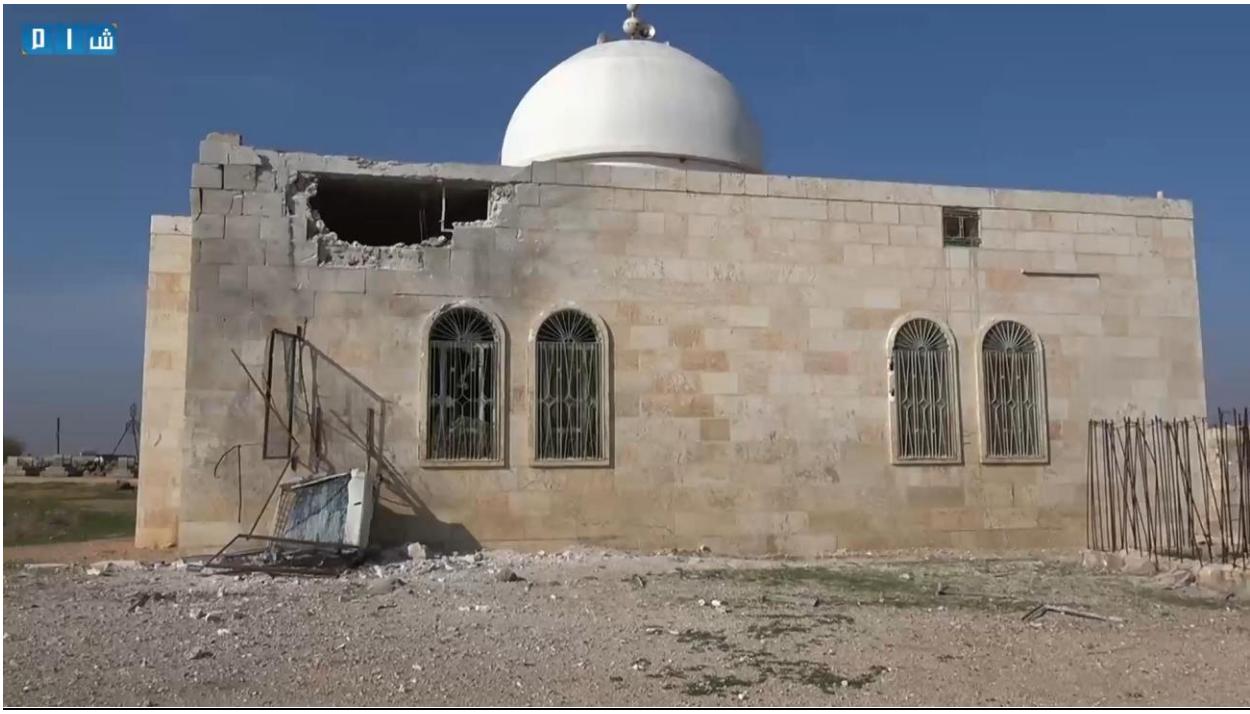
Video still of a hole in the eastern wall of the mosque (Shaam Network; November 19, 2018)

Incident Source and Description: On November 17, 2018 a SARG missile-artillery bombardment damaged the Qatra Mosque.⁷⁷ A hole is visible at the top of the eastern wall of the mosque as well as scorching around the opening. Debris is strewn across the interior of the mosque, but its contents appear to be largely intact. Based on the location of the damage to the mosque, the bombardment likely came from SARG positions east or southeast of Qatra. The bombardment also damaged tents in an IDP encampment west of Qatra and killed at least two civilians.⁷⁸

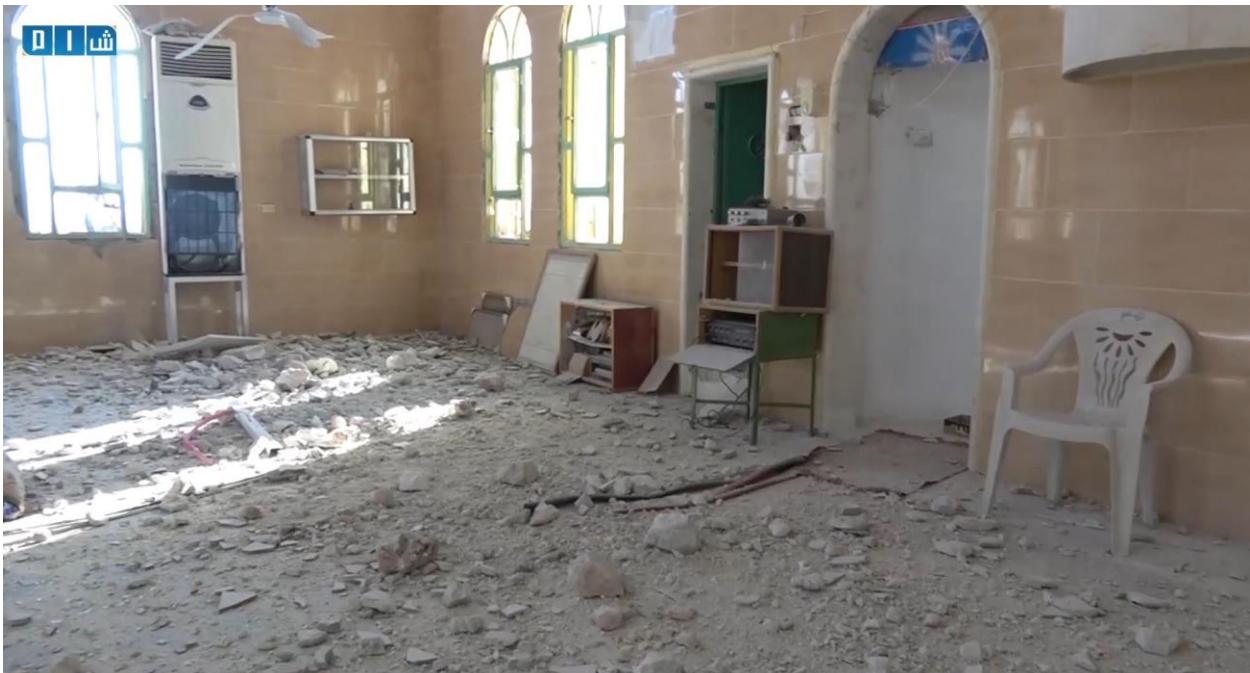
Video still of the interior of the mosque (Shaam Network; November 19, 2018)

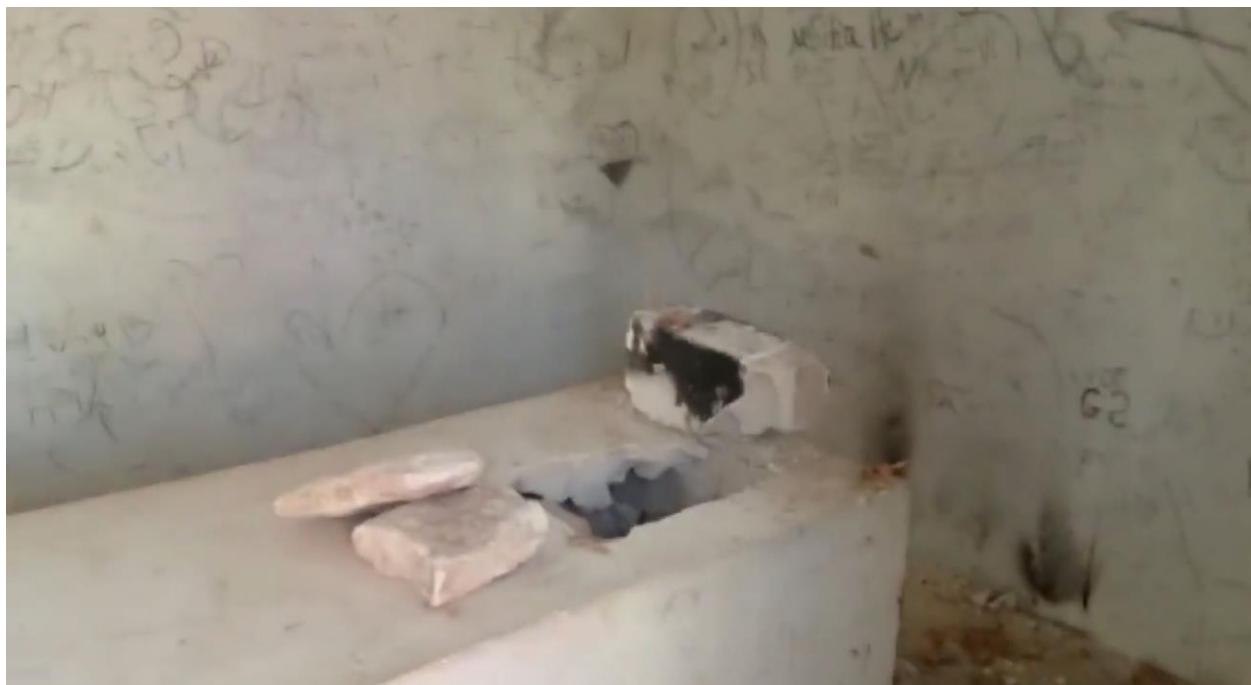
Video still of the damage to the sarcophagus (Hawar News; November 11, 2018)

Incident Source and Description: On November 11, Hawar News reported that members of Ahrar al-Sharqiya, a unit in the Turkish-backed Free Syrian Army, had vandalized the Af Ghiri Shrine in search of gold and other treasure.⁷⁹ A video posted by Hawar News showed damage to the sarcophagus in the middle of the shrine as well as possible graffiti on the interior walls.⁸⁰ The damage to the sarcophagus consisted of a hole smashed through one end of the feature. A pile of stones is visible within the sarcophagus.

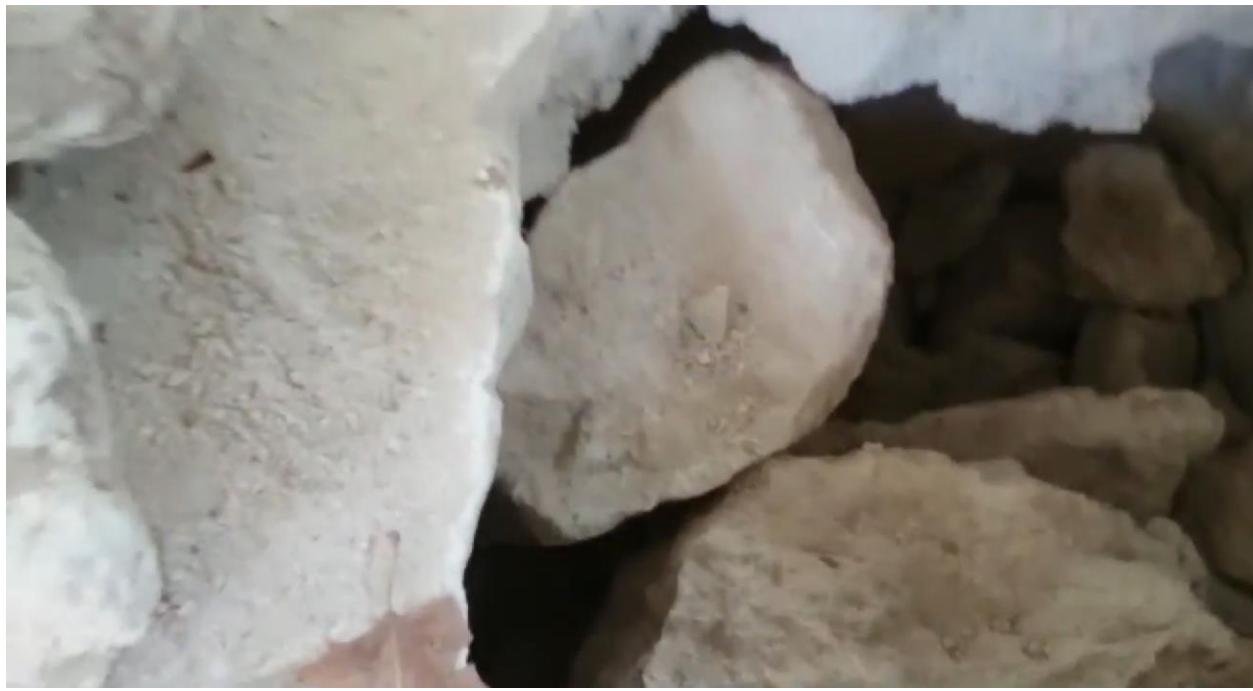
Video still of the stones inside of the sarcophagus (Hawar News; November 11, 2018)
