ASOR Cultural Heritage Initiatives (CHI): Planning for Safeguarding Heritage Sites in Syria and Iraq¹

S-JO-100-18-CA-004

November 2018 Monthly Appendices

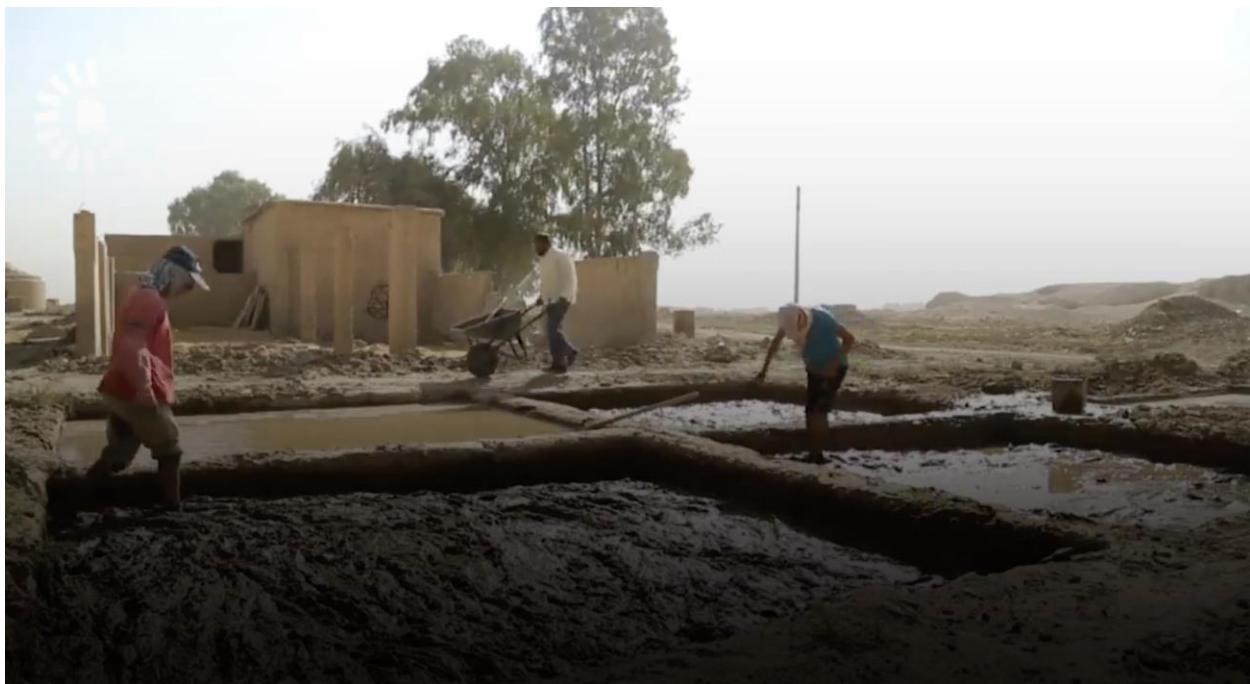
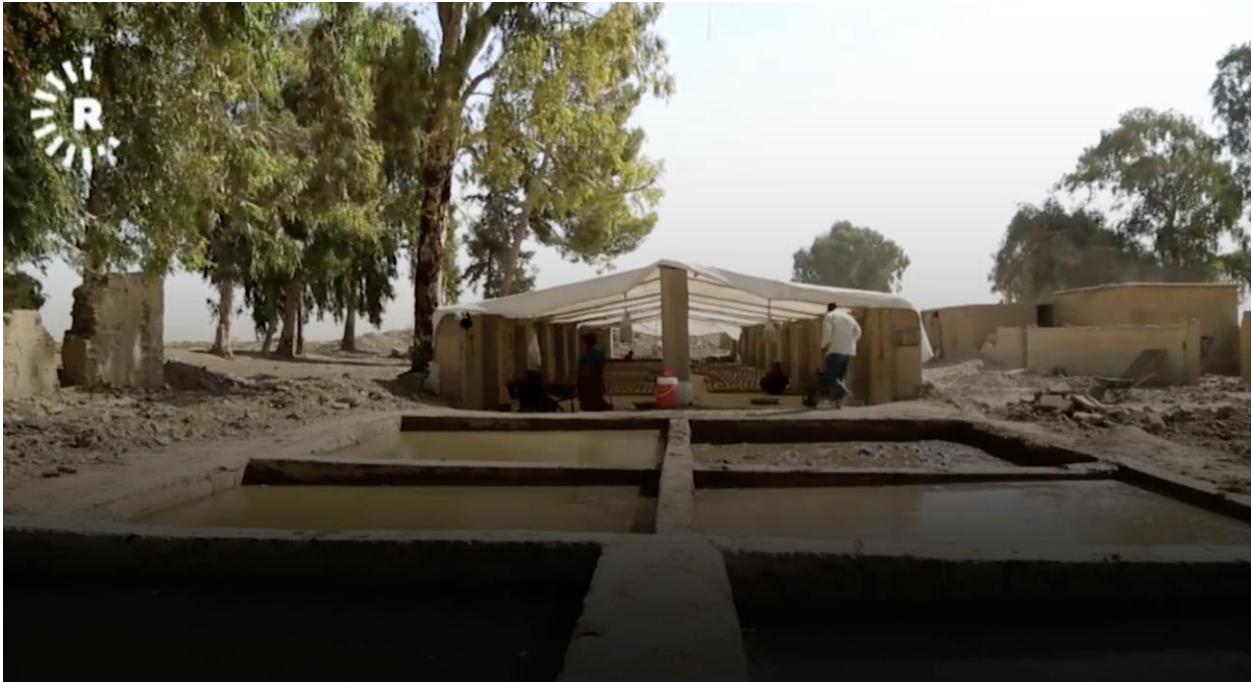
Video still of clay preparation (Rudaw; November 23, 2018)

Video still of clay preparation and the brick-drying shed (Rudaw; November 23, 2018)

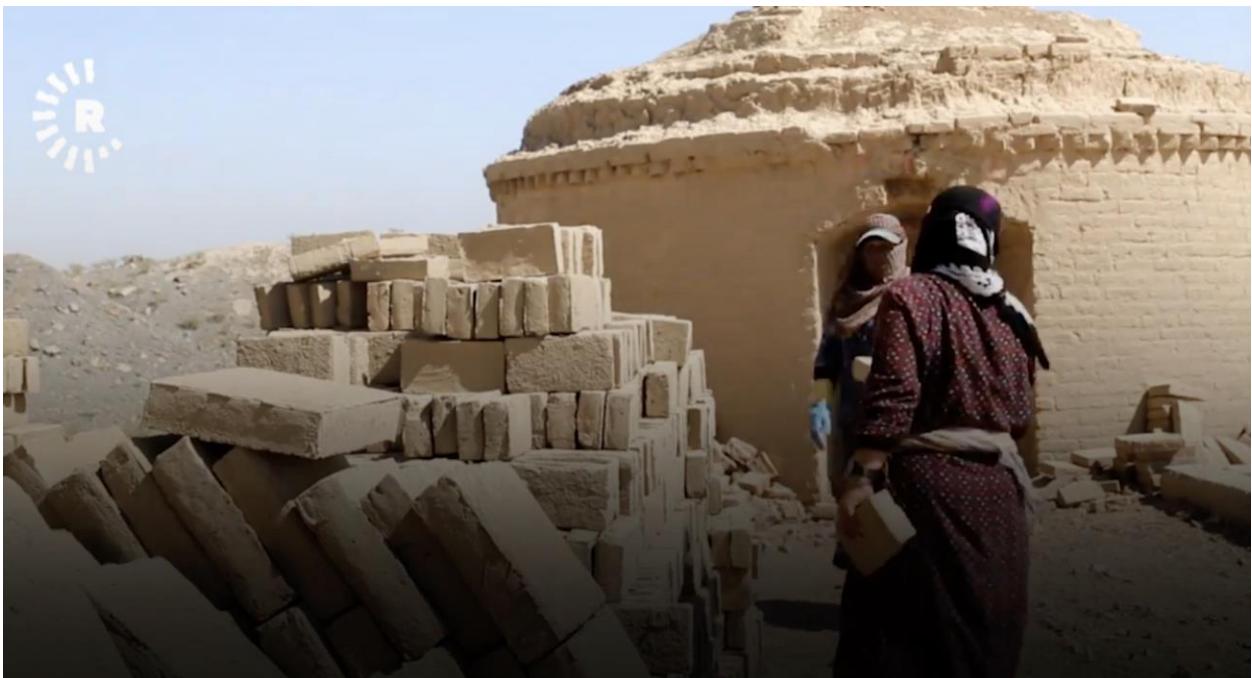
Video still of sun-dried bricks outside of the kiln (Rudaw; November 23, 2018)

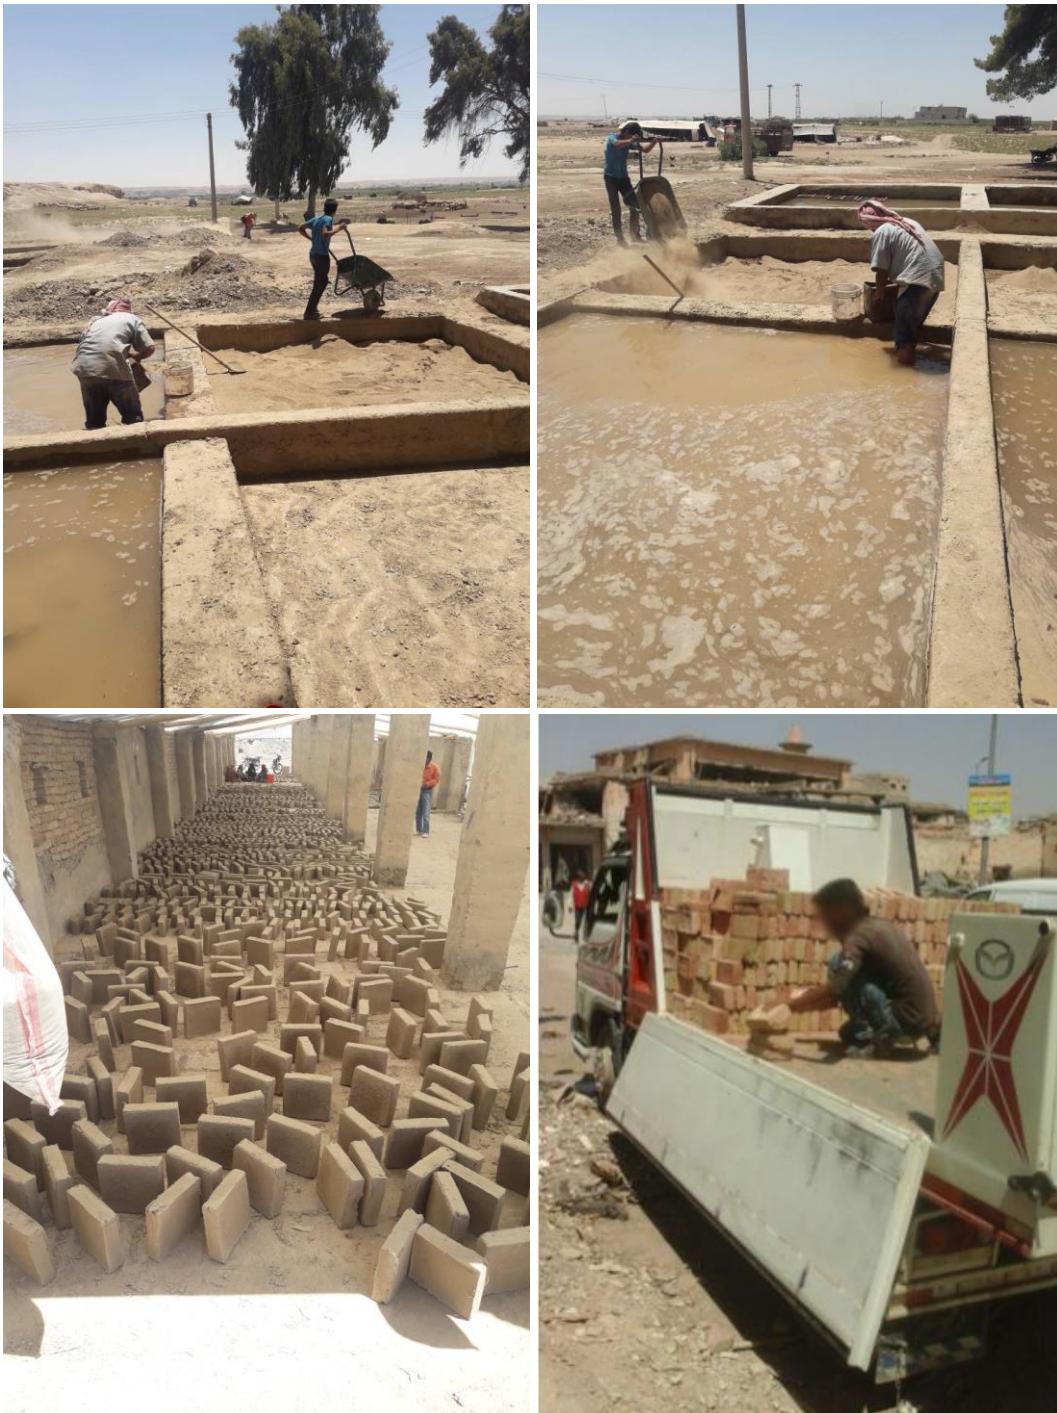
The ASOR CHI sponsored project to restart production at the Heraqla brickyard near Raqqa to produce appropriate, traditional bricks for the stabilization of the Raqqa Museum (ASOR CHI).

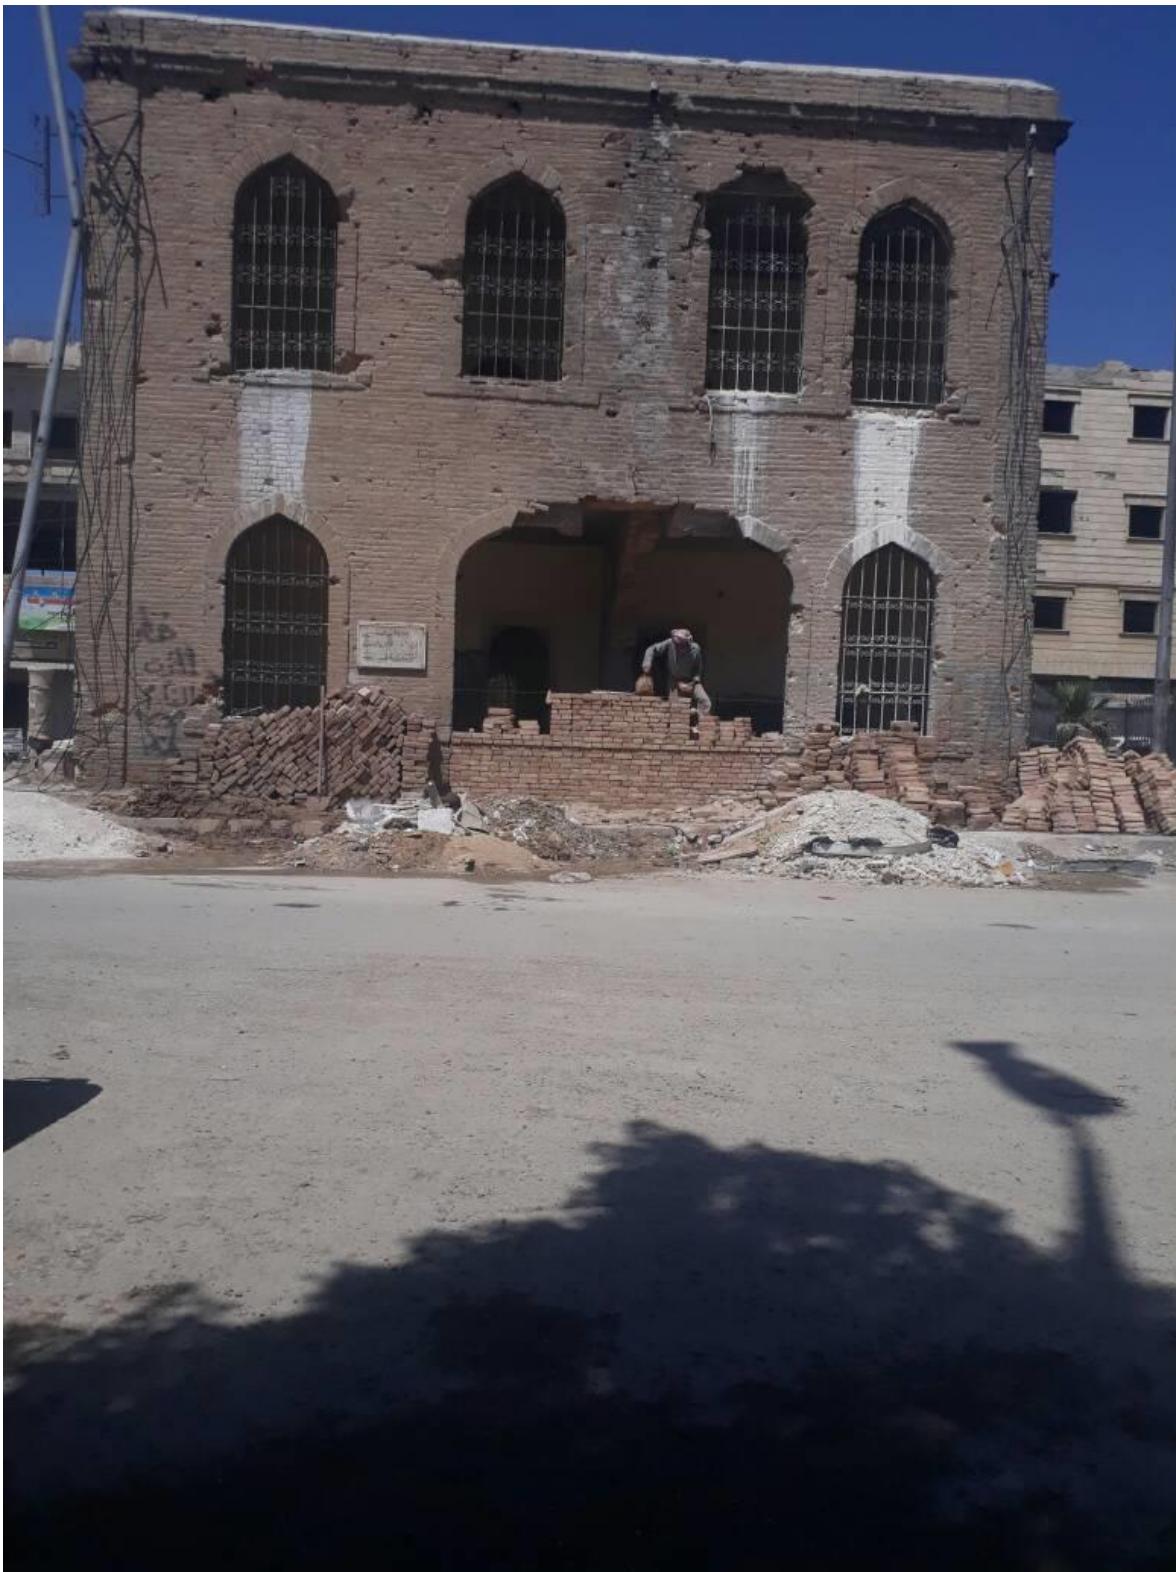
The ASOR CHI sponsored project to rebuild the east wall of the heavily damaged Raqqa Museum. This construction was one part of a much larger stabilization effort focused on the building's interior, exterior, and gardens (ASOR CHI).

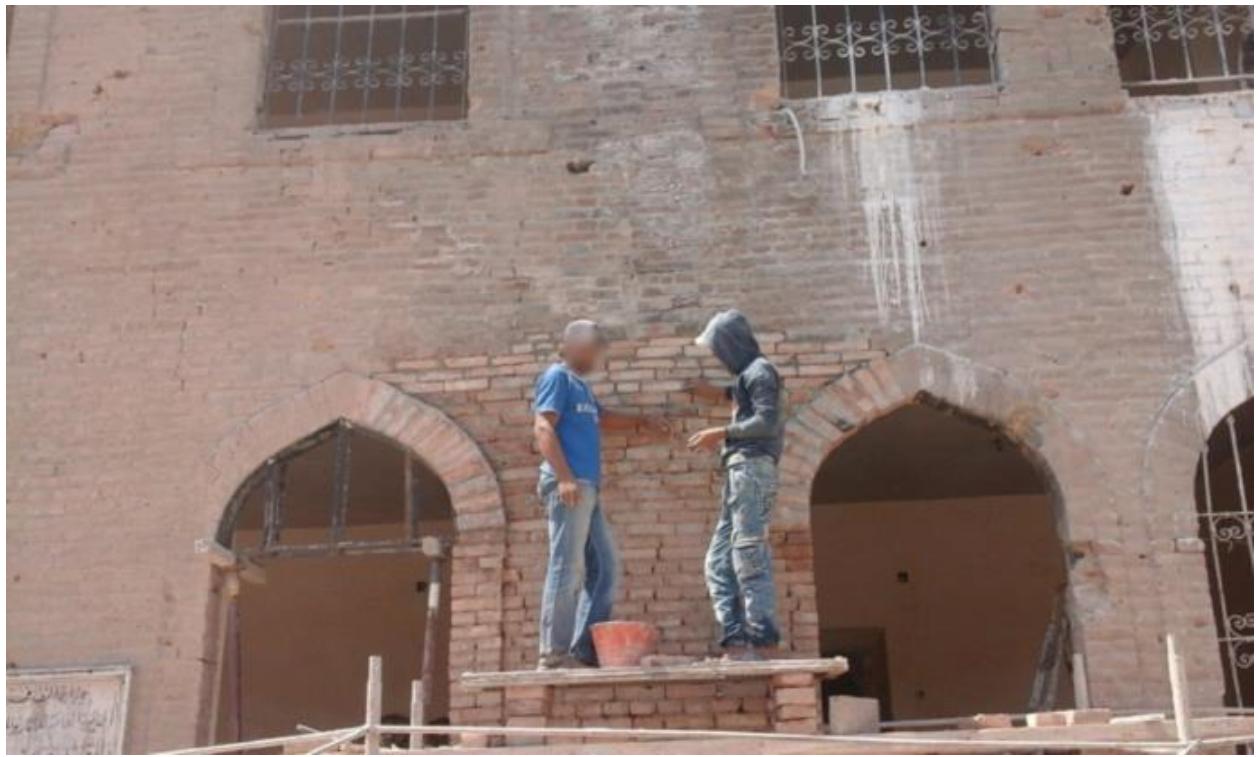
The repaired east wall of the Raqqa Museum using bricks from the refurbished Heraqla Brickyard (ASOR CHI).

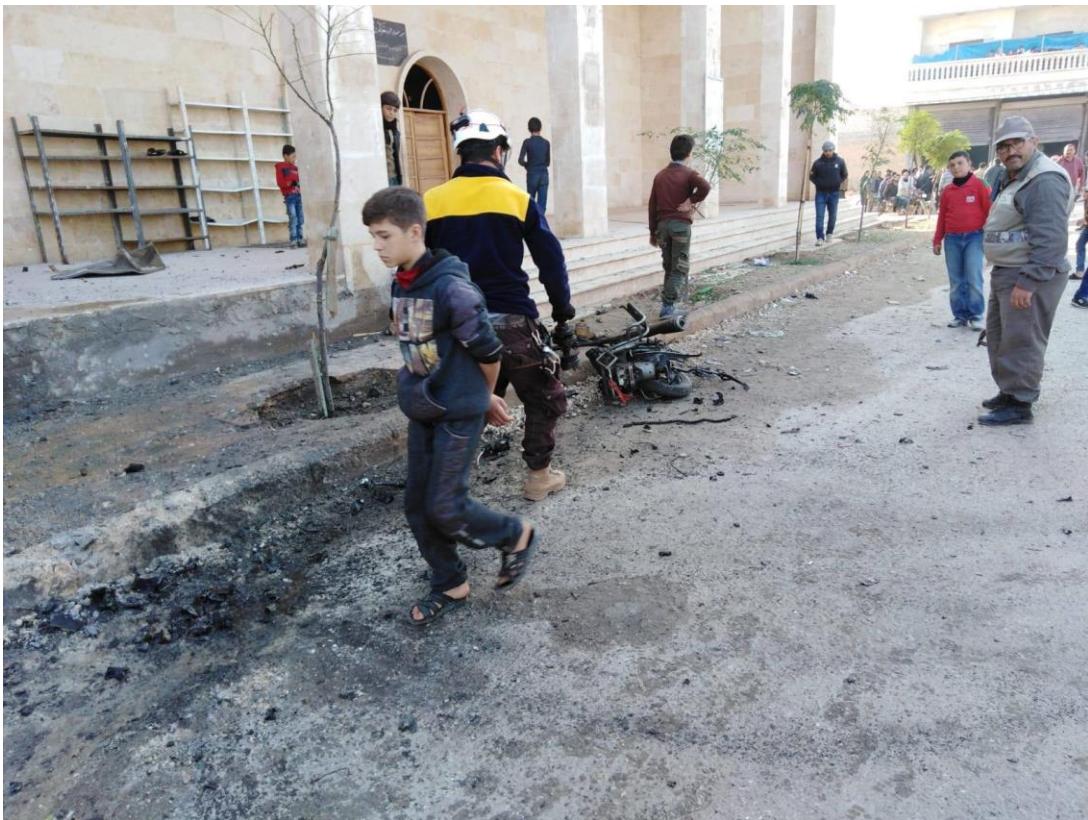
The aftermath of the explosion (Syria TV; November 10, 2018)

Incident Source and Description: On November 10, 2018 a VBIED (motorcycle) exploded in front of al-Yakn Mosque in Qabasin.⁸⁴ The explosion caused minor damage to the facade of the mosque. The group responsible for the attack is unknown.
